Study of flank wear topography and surface-deformation of cemented carbide tools after turning Alloy 718

8th CIRP Conference on High Performance Cutting (HPC 2018)

Philipp Hoier*, Amir Malakizadi, Peter Krajnik, Uta Klement

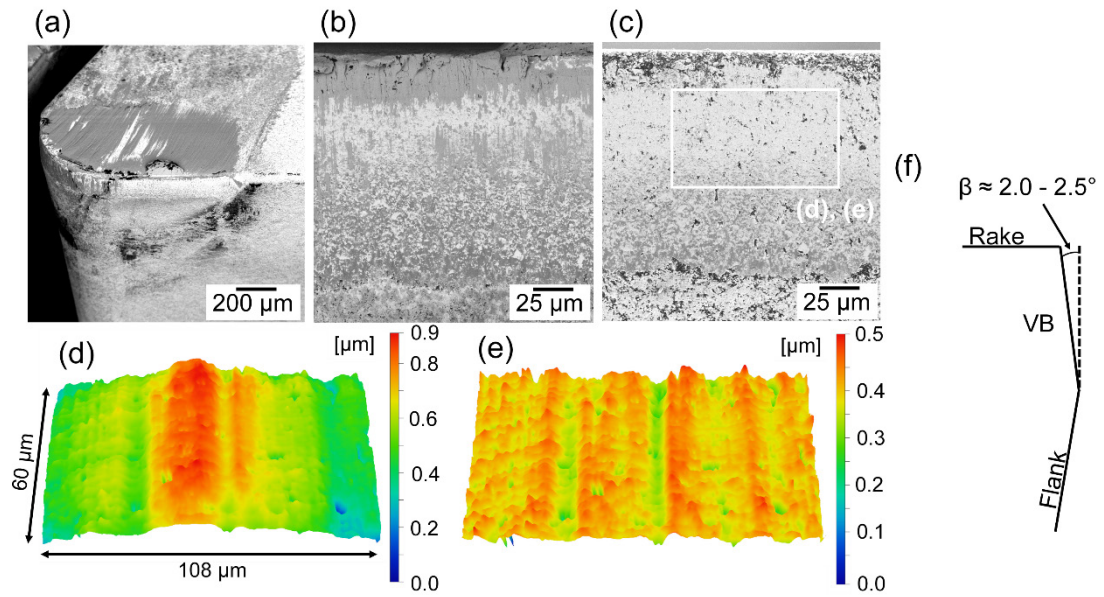
Fig. 1. Worn cutting edge after the conducted tests: (a) tilted overview; flank wear land at higher magnification (b) before and (c) after etching in HCl; 3D topography of the flank wear land obtained by WLI (d) before and (e) after filtering for removal of waviness; schematic cross-sectional view of the flank wear land (VB) with its inclination angle (β). The workpiece sliding direction during cutting is from top to bottom.

Figure 1 shows SEM micrographs of one of the worn tools before (Fig. 1a and b) and after (Fig. 1c) the etching procedure for removal of adhered Alloy 718 from the worn surfaces. As seen in Fig. 1a, the majority of the chip contact-zone on the rake face and parts of the flank wear land are subjected to

adhesion of Alloy 718 (dark contrast). Removal of adhered workpiece material is therefore necessary to reveal the true wear topography. As seen in Fig. 1c, etching in HCl led to removal of the majority of adhered workpiece material from the flank wear land. In Figs. 1d and e, WLI scans of the adhesion free flank wear land are shown. The 3D topography image (Fig. 1d) reveals large-scale waviness, whereas grooves on smaller scale are evident in Fig. 1e together with pits in the worn surface. Note that the grooves are aligned parallel to the workpiece sliding direction. The WLI scan furthermore revealed that the surface of the flank wear land is vertically inclined by around 2 to 2.5 ° (see schematic in Fig. 1f).

Smoothly worn WC grains together with presence of grooves at different length scales (see Figs. 1e and 2) indicate that abrasion is an active wear mechanism. This is likely due to presence of different hard, abrasive phases (nm and μm -sized, see section 2) in the superalloy microstructure. However, both the large-scale waviness and inclination of the flank wear land (Figs. 1d and e) indicate that the tool geometry was altered by plastic deformation of the tool material.

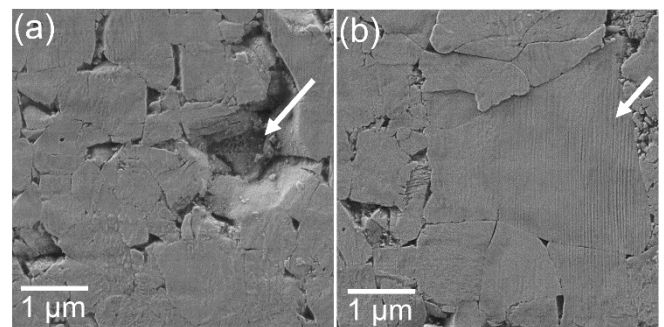
Fig. 2. Wear topography viewed at high magnification: (a) pit in flank wear land; (b) abrasion marks on WC grain. The sliding direction of the workpiece is from top to bottom.

Figure 2 shows the flank wear topography imaged at higher magnification. Figure 2a shows a SEM micrograph of a pit which was previously revealed by WLI (Fig. 1). Such pits can be formed due to adhesion and subsequent pull-out of individual WC grains. The WC grains are smoothly worn with occasional presence of nm-sized abrasion marks or grooves (see arrow in Fig. 2b) aligned parallel to the sliding direction.

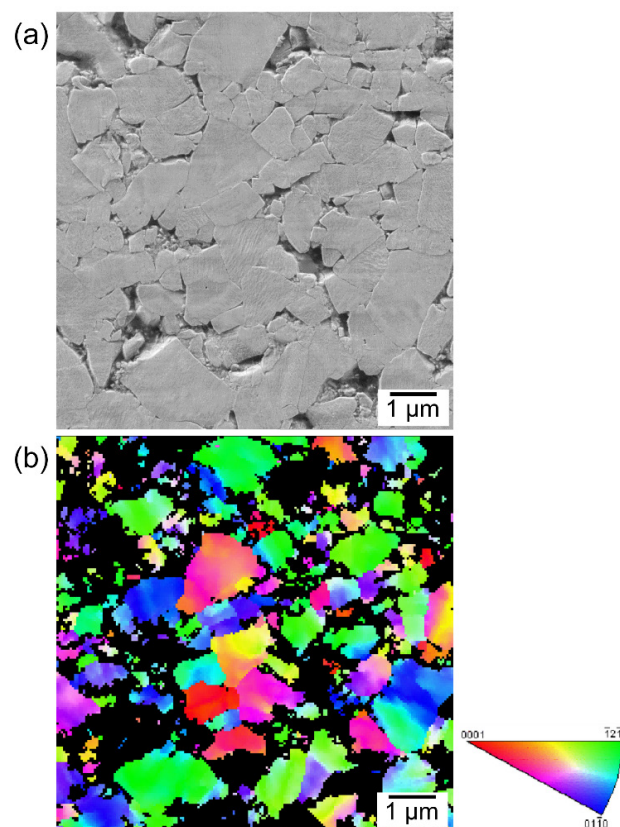
EBSO examination was performed to observe whether plastic deformation contributes to the flank wear. Figure 3 shows a SEM micrograph combined with an EBSO orientation map of the same area. The EBSO map is displayed in inverse pole figure (IPF) coloring. For every measured point (pixel), the local crystallographic orientation of the respective worn WC grain is shown according to the provided color code.

Even though the EBSO orientation map in Fig. 3b has a significant fraction of non-indexed (black) areas, many individual WC grains are clearly distinguishable (compare to SEM micrograph). Non-indexed areas can mainly be attributed to the voids present in the worn surface. Additionally some of the WC surfaces could not be indexed. However, the indexed, individual WC grains are characterized by noticeable color variations (see Fig. 3b) which indicate crystallographic orientation spread (misorientation) and hence that the worn grains exhibit intragranular strain. Note that an undeformed grain would be shown with a single color.

Fig. 3. Characteristics of flank wear land: (a) SEM micrograph of worn WC grains; (b) corresponding EBSD scan presented as inverse pole figure map (non-indexed pixels appear in black). The workpiece sliding direction during cutting was from top to bottom. The inverse pole figure color code is provided on the right.
