Microstructural Characteristics of Vehicle-Aged Heavy-Duty Diesel Oxidation Catalyst and Natural Gas Three-Way Catalyst

Keywords: catalyst deactivation; diesel; natural gas; SEM; TEM; poisoning

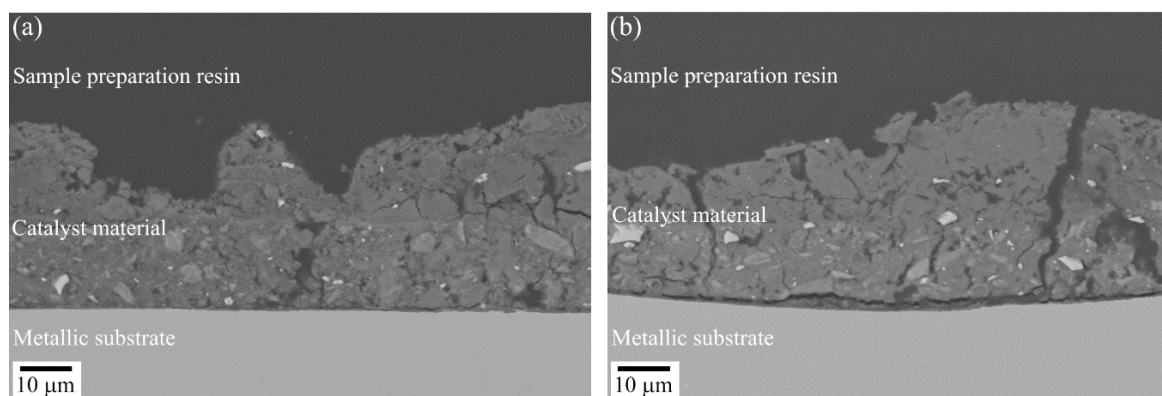
The cross-sectional SEM images of the diesel oxidation catalyst in the used form are presented in Figure 1. The diesel oxidation catalyst washcoat is an alumina-based mix of metal oxides, mainly zirconium, cerium and lanthanum, supporting the platinum catalysts. Platinum is spread evenly across the layers.

Figure 1. The cross-sectional SEM image of the diesel oxidation catalyst, (a) the inlet part of the vehicle-aged catalyst and (b) the outlet part of the vehicle-aged catalyst.

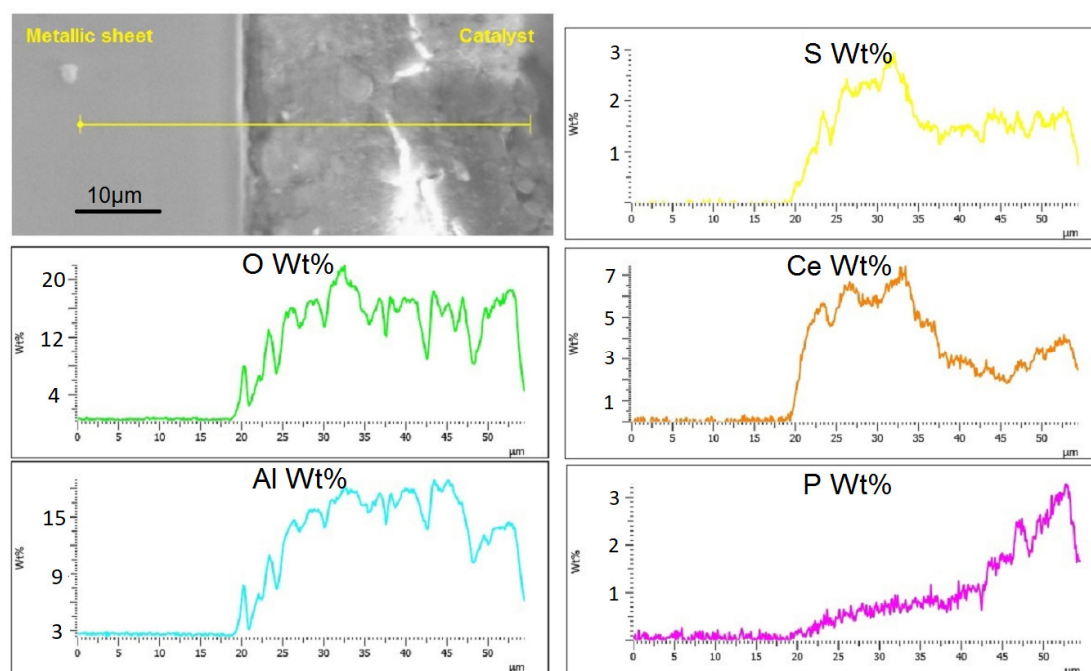
The SEM-EDS line analyses of selected elements in the inlet catalyst sheet are shown in Figure 2. Both the SEM-EDS line analyses and spot analyses indicate a higher sulphur content in the inner layer of the washcoat. As can be seen from Figure 2, the sulphur content follows the content of ceria in the washcoat, indicating an attachment between S and Ce. Sulphur is a known poison for ceria [19–23].

Phosphorus content follows alumina (Al and O) near the surface and decreases towards the bottom layer of the washcoat. The SEM-EDS spot analyses of layers of the inlet catalyst washcoat give sulphur contents maxima of 10 wt % for the ceria-rich inner layer and 5 wt % for the outer layer containing less ceria. Phosphorus was detected, but there are challenges in the calculations due to the P K_{α} -peak overlapping with the Pt M_{α} -peak and the Zr L_{α} -peak in the spectrum. However, the amount of phosphorus is significantly higher in the outer rather than in the inner layer. The EDS results from the used inlet and outlet diesel oxidation catalyst layers were similar.

Figure 2. SEM-EDS line analysis from the vehicle-aged diesel (inlet) catalyst.

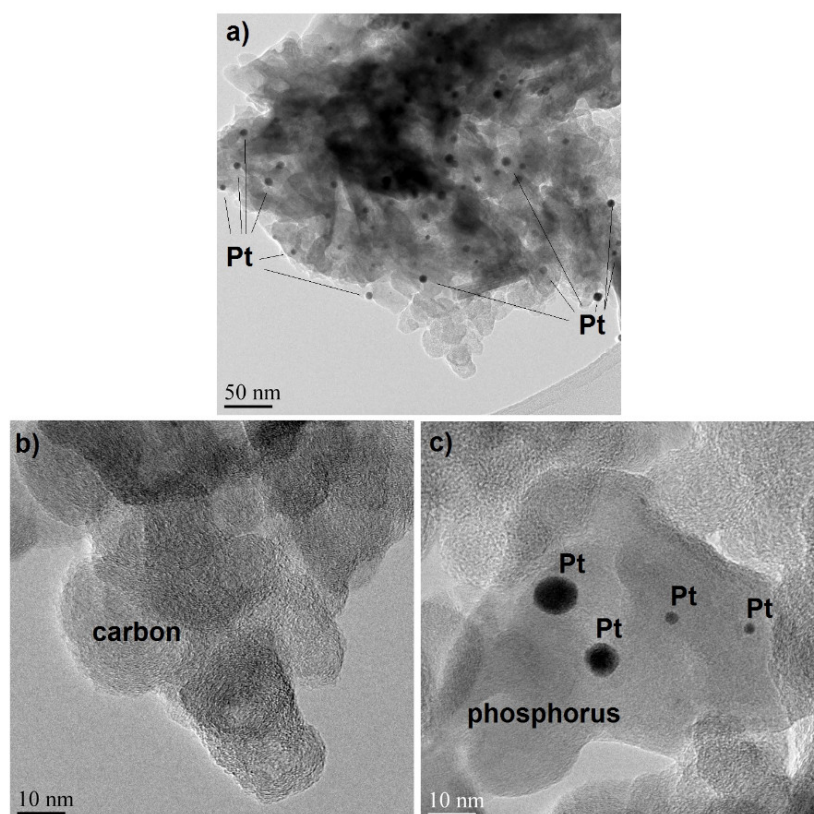
The EDS analyses from the TEM samples supported the SEM-EDS analyses (Figure 2). Detected poisons in the aged diesel oxidation catalyst samples, from both the inlet and outlet, were S, P, K, Ca and Zn, sulphur clearly with the highest percentage. These are typical poisons in diesel engines originating from fuels, lubricants and detergents [4]. TEM images from the fresh diesel oxidation catalyst sample (Figure 3a,b) show the fine structure of the washcoat with small Pt particles. The size of the Pt particles was <5 nm measured from the STEM images. In the used inlet sample (Figure 4a,c), the size of the platinum particles was 7.0 ± 1.9 nm (100 particles measured). Thus, the particle size increased slightly in the vehicle ageing. In addition, carbon (soot) and phosphorus were detected

regularly (Figure 4b,c). Phosphorus exposure is known to cause such growth and shape effects in the noble metals [11,12].

Figure 4. TEM images from (a) the vehicle-aged diesel inlet catalyst. (b) and (c) showing the carbon and phosphorus poisoned areas, respectively.

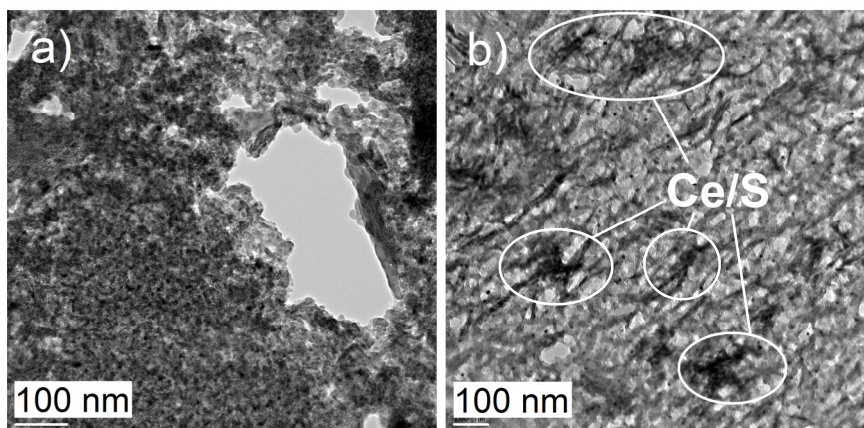
The cross-sectional TEM images from the fresh and vehicle-aged diesel oxidation catalysts are presented in Figure 5. The cross-sectional TEM–EDS map images from selected elements for the used inlet diesel sample are shown in Figure 6. In the studied sample, sulphur and phosphorus were the only poisons with a sufficient amount to be included in the EDS map. As seen in Figure 6, ceria and sulphur cover the same area in the analysed cross-section, as also indicated in the SEM-EDS line analyses (Figure 2). These Ce- and S-rich areas are clearly detectable as darker areas in the TEM images in Figure 5b. Phosphorus covers the washcoat more evenly, following the contents of aluminium and

Figure 5. The cross-sectional TEM images of (a) the fresh diesel oxidation catalyst and (b) the vehicle-aged inlet diesel oxidation catalyst.

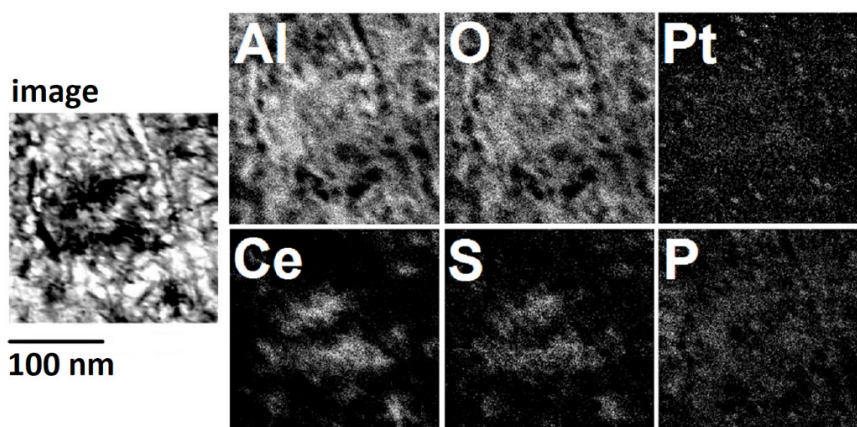
oxygen (Figure 6), as seen in the SEM-EDS line analyses (Figure 2). Overall, the platinum particles have grown in use, and there seem to be larger Pt particles outside the Ce/S-rich area than inside this area. A possibility of the Ce/S effect on the Pt particle sintering could be an interesting topic for future investigations, while such a phenomenon has not been extensively reported.

Figure 6. Cross-sectional TEM-EDS map from the vehicle-aged diesel (inlet) catalyst.

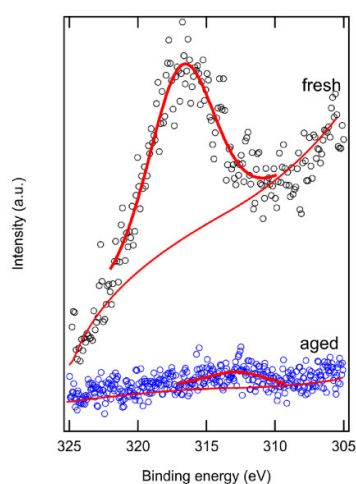
The XPS analysis indicated that the binding energy of the platinum 3d_{5/2} line was 316.4 eV in the fresh sample and 312.5 eV in the aged one (Figure 8). This suggests that significant platinum reduction takes place during ageing [24]. As for catalyst poisons, survey scans showed prominent spectral lines for sulphur and phosphorus, and thus they were measured more thoroughly. The S 2p line was observed at 169.1 eV, whereas the P 2s line was located at 190.8 eV. The binding energies indicate that the poisons appear on the catalyst surface as sulphate and phosphate compounds [24]. The sulphur content was found to be 5.3 wt % and the phosphorus content 7.0 wt %.

Figure 8. XPS spectra on platinum 4d5/2 lines measured from the diesel oxidation catalyst. While Shirley background subtraction has been used in the analysis, the background lines in the images have been drawn to guide the eye.

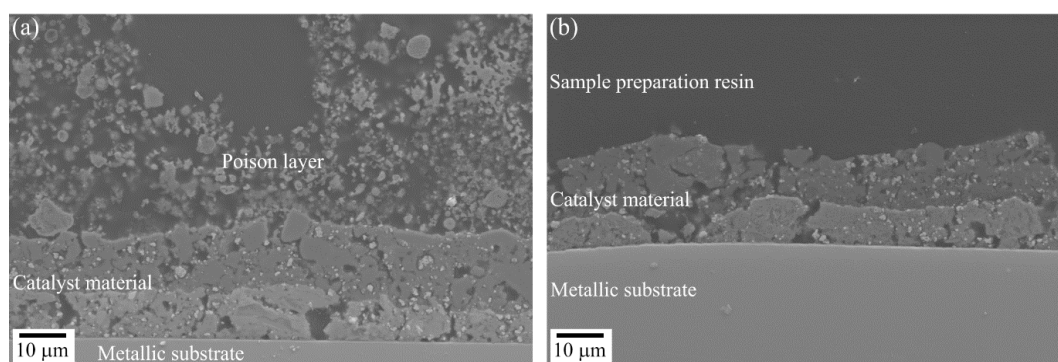
The cross-sectional SEM images of natural gas catalysts in the used form are presented in Figure 12. The NG catalyst washcoat is an alumina-based mixture of metal oxides, mainly zirconium and cerium, supporting palladium and platinum catalysts.

Figure 12. The cross-sectional SEM images of the natural gas catalyst, (a) the inlet part of the vehicle-aged catalyst and (b) the outlet part of the vehicle-aged catalyst.

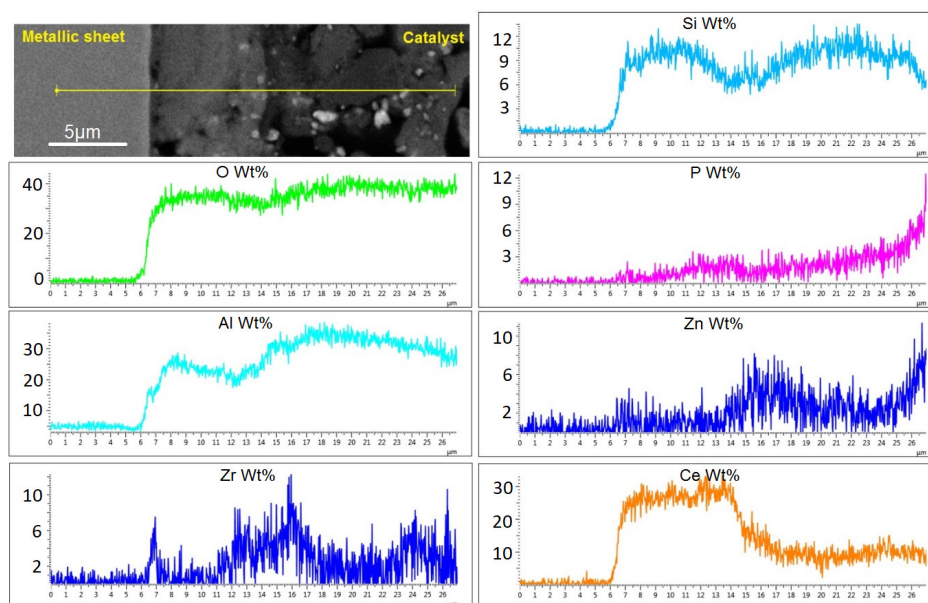
In Figure 13, the SEM-EDS line analyses of the used inlet natural gas catalyst sheet are presented. On the top of the used inlet sample there is a porous layer containing mostly high concentrations of carbon and other poisoning elements, and this is excluded from the line analyses. Contents of poisons in the line analyses showed the presence of zinc, phosphorus and silicon throughout the washcoat. Zinc seems to attach to zirconia with contents up to 10 wt %, while silicon mainly follows the alumina content throughout the washcoat with contents of 5–12 wt %, and phosphorus is mostly in the outer layer of the catalyst with the content of 1–9 wt %. In the SEM-EDS spot analyses, a number of additional poisons were observed, mostly in the outer layer of the catalyst. These included potassium, chlorine, calcium and copper in variable contents depending on the analysed area. The natural gas outlet part did not have any poison layer, and EDS results did not show significant amounts of poisons in the outlet catalyst.

Figure 13. SEM-EDS line analysis from the vehicle-aged natural gas (inlet) catalyst.

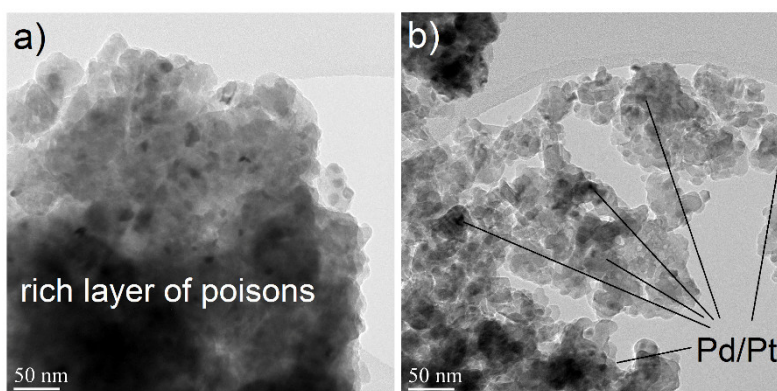
The fine structure of the fresh NG catalyst washcoat is presented in Figure 14. Detected poisons in the TEM-EDS spot analyses from aged natural gas catalyst samples (Figure 15) were S, P, K, Zn, Si, Ca and Cu in various amounts. Copper was not calculated in these analyses, since the powder sample holder is made of copper and thus gives an additional copper signal to the spectrum. The used outlet catalyst showed few or no structural changes or poisonous impurities after use (Figure 15b).

Figure 15. TEM images from the vehicle-aged natural gas catalyst (a) inlet, (b) outlet.

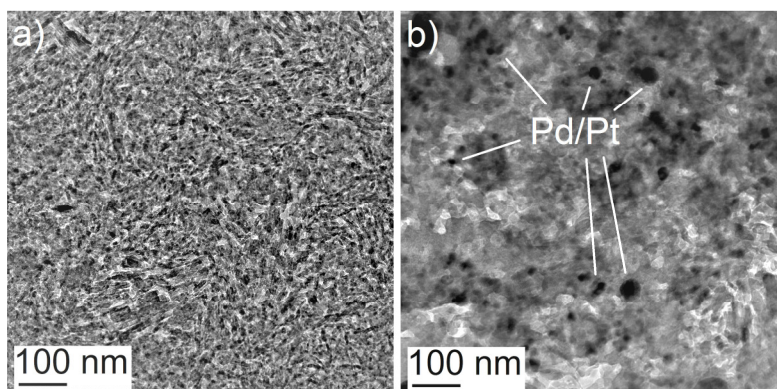
In the NG catalyst inlet part, significant noble metal particle growth was observed after the use, as seen in the cross-sectional TEM images in Figure 16a,b. In the fresh catalyst, the metal particle size was <5 nm, and after use it was 54 ± 23 nm as measured from the STEM images (100 particles measured). The structure of the used inlet catalyst had become more heterogeneous and dense compared to the fresh structure due to heavy sintering during use.

Figure 16. The cross-sectional TEM image of (a) the fresh natural gas catalyst and (b) the vehicle-aged inlet natural gas catalyst.

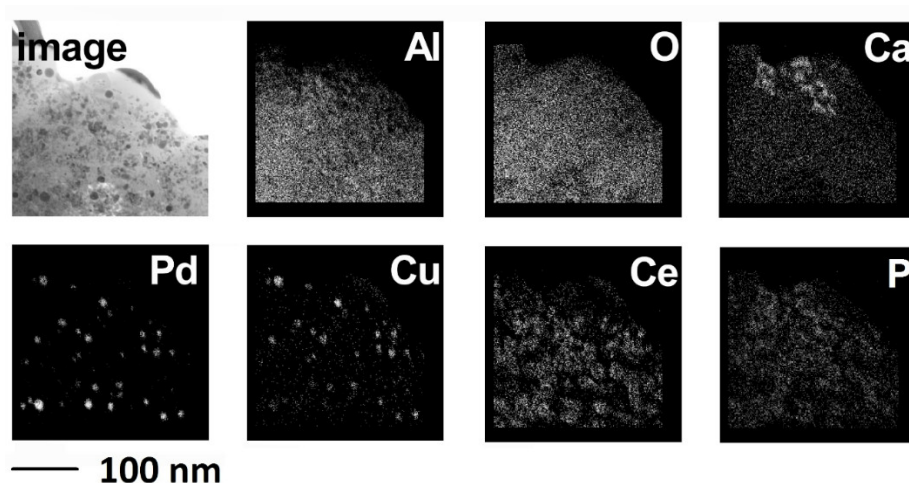
Three main poisoning elements, Ca, Cu and P, were included in the cross-sectional TEM-EDS map (Figure 17) of the inlet NG sample. One possible origin for copper can be the lubricant oil of the natural gas engine. In addition, copper seems to be mainly found together with noble metal particles (Figure 17). The presence of copper in the used catalysts needs further investigations in order to verify the occurrence of the phenomenon. High local concentrations of calcium were detected in both the EDS spot and map analyses. Pt was not included in the EDS map of the used sample due to its low amount. Again, phosphorus was spread quite evenly across the sample. The phosphorus detection has some uncertainties, due to the overlapping of Pt and Zr peaks.

Figure 17. The cross-sectional TEM-EDS map of the inlet natural gas sample.
