THESIS FOR THE DEGREE OF DOCTOR OF PHILOSOPHY

Damage and defects in railway materials:

Influence of mechanical and thermal damage on crack initiation and propagation

CASEY JESSOP

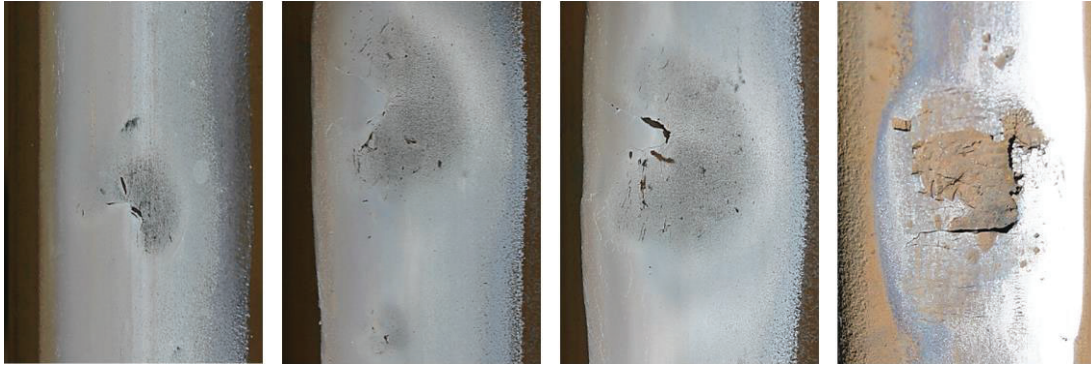
Figure 3. Examples of squats of different severity in field, as well as an example of spalling (far right). [27]

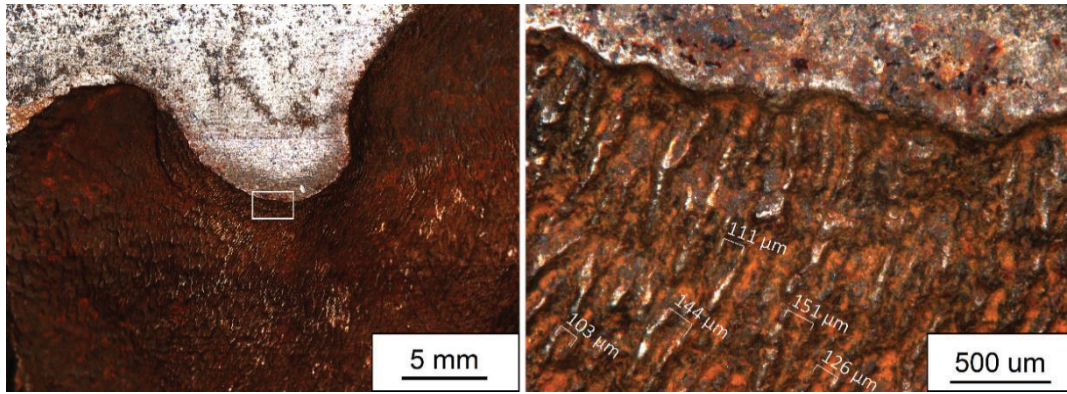
Figure 12. Images from stereomicroscopy of (left) squat surface, and (right) detail close to the tip of the v. [27]

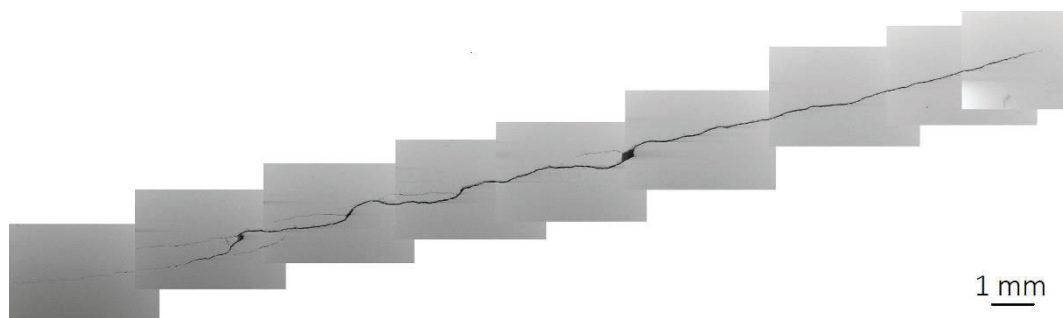
Additional investigation with SEM revealed crack branching in the transverse sections (e.g. Figure 14); while the longitudinal sections provide additional information about the crack geometry below the surface. Figure 13 shows undulations near the end of the crack network as compared to the detail maps. Furthermore, the 3D mapping (Figure 13b) shows a highly textured surface on different scales: some beach marks, ridges, and surface roughness. It can be speculated that the ridges on the fracture surface (Figure 12b) are a result of repeated relative movement of the two crack surfaces in the same direction, while the smoother regions observed near the surface-breaking part of the crack (Figure 12a, top) are a result of rubbing of crack faces in different directions due to an additional shear displacement. This is thought to be a result of the stresses propagating the crack [35].

Figure 14. SEM micrographs of sections from a squat, showing crack branching in transverse sections, not distinguishable by geometric reconstruction.

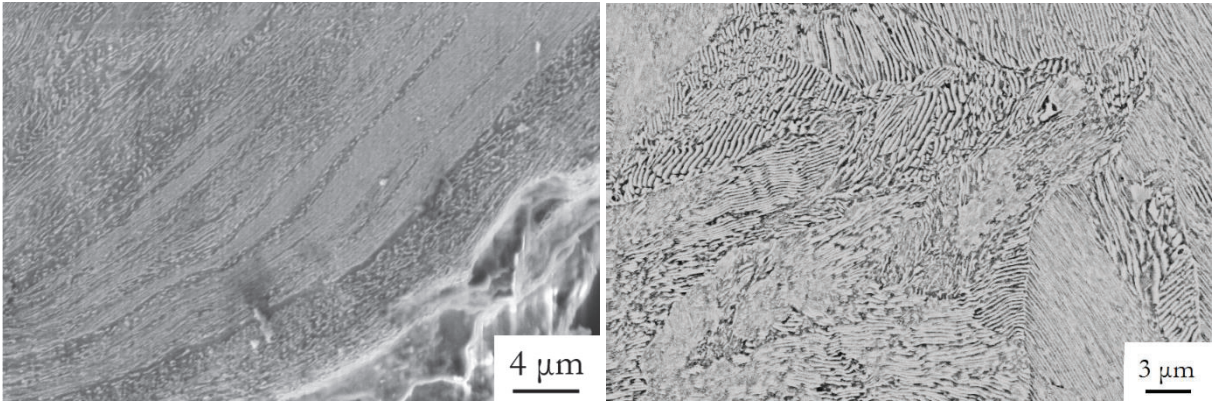
Further metallographic investigation of rail sections taken from the field allowed for a closer look at the area within and around the crack, providing better insight into the mechanisms involved in crack propagation, such as plastic deformation and possible thermal damage. It was found that plastic deformation had occurred, mostly around the surfaces of the crack (e.g. Figure 16). However, it is not seen along the entire length in the transverse sections. Around the crack opening, the deformation of pearlite grains was clearly seen, shown in Figure 16. Realignment of grains was apparent at certain areas along the crack, however, some areas seem unaffected. This suggests the crack did not grow following the severely deformed microstructure, and that other parameters affect the growth path through the bulk of the material.

Figure 16. Deformation of pearlite colonies along the edge of the crack (left), compared to the bulk material (right).

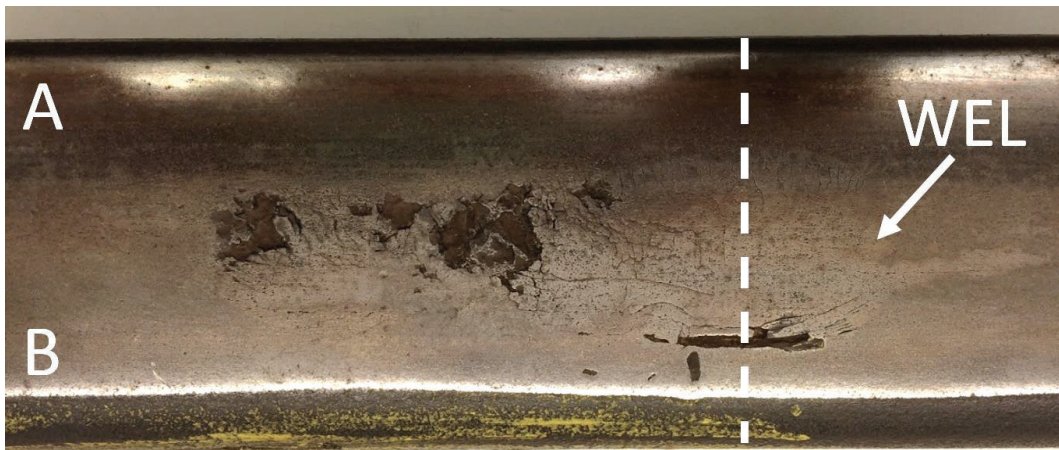
Thermal damage is often found on rails and wheels, and initial inspection of a rail section taken from the field showed quite severe spalling occurring on the surface, in addition to a large thermally damaged strip, the origination of which cannot be determined (Figure 17). The surface was cleaned and etched using Nital in order to reveal the presence of a WEL, suggesting some event caused martensite to form as a thin layer on the rail surface. Many small cracks within this layer highlight the brittle nature of the WEL.

Figure 17. Rail surface after Nital etching; spalling off of large sections is observed in the running band. Section location is shown with a dashed line.

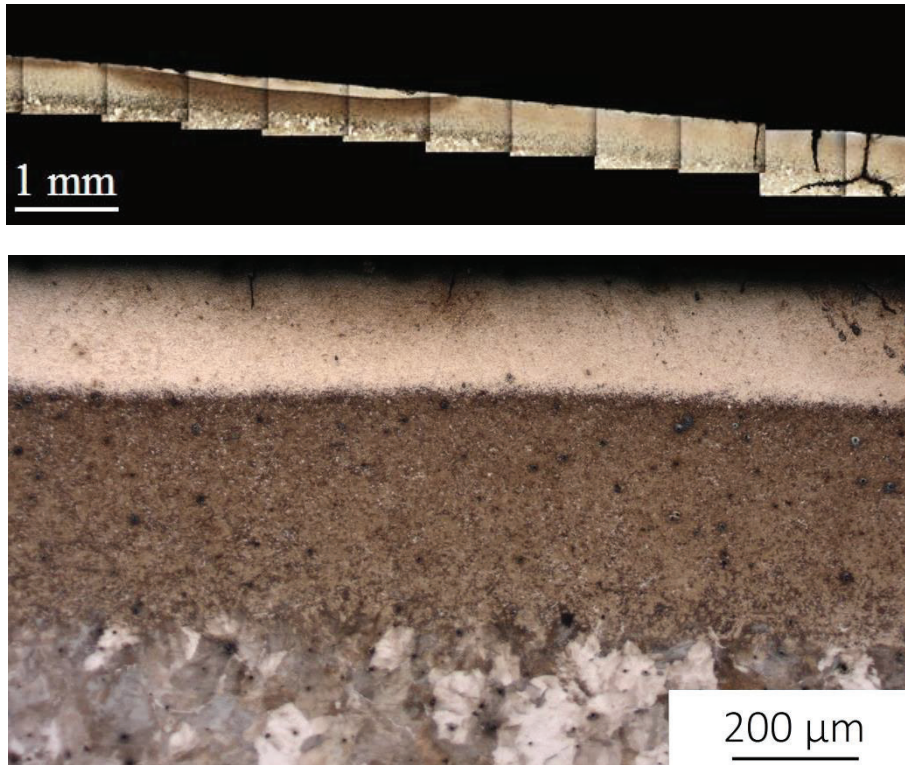
Upon sectioning as shown in Figure 17, the depth of the damage can be more closely examined, including crack patterns and crack depths. The thermal damage is clearly seen in Figure 18. A closer look at the WEL (Figure 18, bottom) shows that there are in fact two different WELs present: a thin ( $\sim 200 \mu\text{m}$ ) layer appears above a thicker ( $\sim 550 \mu\text{m}$ ) layer on the surface. The presence of two layers is the result of multiple occurrences of thermal damage (e.g. wheel burns) on the same place. The primary layer exhibits a heat-affected zone, appearing darker just below the secondary layer, which suggests some tempering of the martensite accompanying a second heating event [66]. Furthermore, near the bottom-right corner of Figure 18 deep cracks are present, traveling through the WEL and along the transition between the WEL and bulk material. This could be due to the rolling contact loading occurring between the wheel and rail, affecting the harder and more brittle material within the WEL as well as causing localized strain concentrations beneath the harder layer.

Figure 18. (top) WEL on cross-section from optical microscopy, and (bottom) close-up of double WELs.

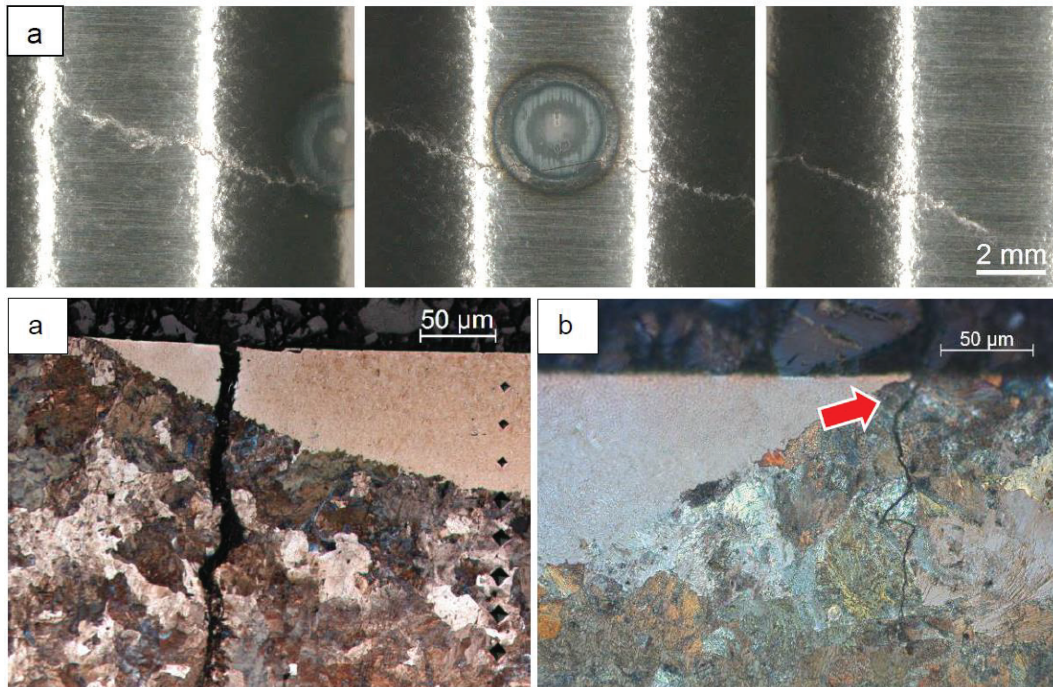
Upon closer examination of the failed test bars with thermal damage, it was found that in some instances, the dominant crack was growing through the WEL (Figure 23), whereas in other test bars, the crack followed the interface between the WEL and the bulk pearlitic material. In addition to metallographic sectioning, X-ray tomography was used to view the crack network in three-dimensions inside the test bar. This method is non-destructive, as previously described, and allowed for the entire crack network to be seen following the WEL on the surface, then propagating in a plane perpendicular to the loading direction, typical of mode I crack propagation. No crack branches were observed.

Figure 23. (a) Crack propagation through WEL on fatigue test bar.[45] (b) The crack initiated in the WEL and propagated down into the bulk material. (c) A small crack initiated at the edge of the WEL (polarized light in optical microscope).[62]

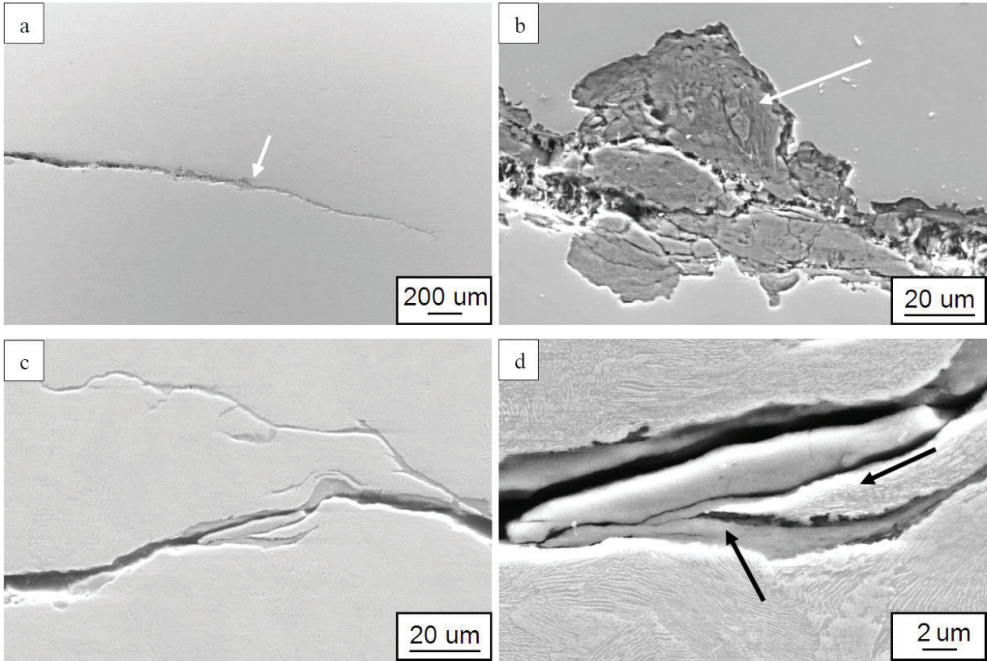
Figure 26. SEM image showing residues in cracks. a) Dark grey material near crack tip are residues, b) close-up showing deformed microstructure within the residues, c) and d) are from a transverse section of the rail.

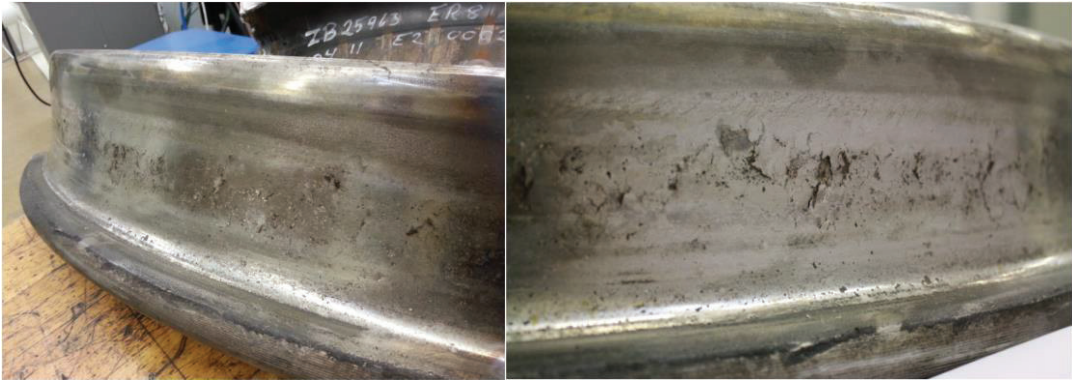
extends approximately 2 mm into the wheel. Furthermore, a crack is seen at a depth of 5 mm from the surface. This confirms that dominant cracks extend to at least to this depth, as seen in the longitudinal section, since each section only represents a 2-dimensional image of the whole crack network. It can be concluded that the main damage mechanism is RCF3.

Figure 31. Wheel treads with RCF1 and RCF3 damage bands.

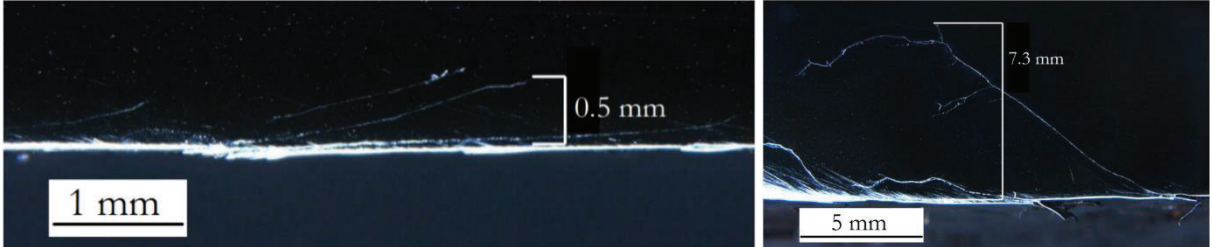
Figure 32. (left) RCF 1 and (right) RCF3 longitudinal sections.

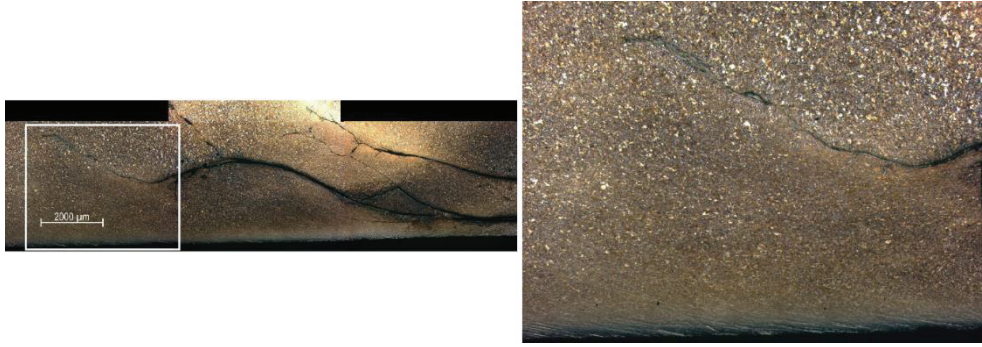
The sections were further examined by optical microscopy, to investigate in particular the occurrence of plastic deformation and thermal damage. No thermal damage was found in any of the sections, however plastic deformation was observed around the cracks. Figure 34 shows an example of plastic deformation in the vicinity of a RCF3 zone crack; the deformation and grain elongation that appears along the surface of the wheel (bottom) and the faces of the crack can be clearly seen in the magnified view. The damage pattern is typical for surface initiated rolling contact fatigue and there were no signs of severe thermal damage.

Figure 34. (Left) Example of cracks in longitudinal section through the RCF3 zone. (Right) Magnified view showing plastic deformation around crack and along the wheel surface (bottom of micrograph).
