Ljungskog, E., Sebben, S., Broniewicz, A. (2019). Flow angularity investigations in an automotive slotted wall wind tunnel. *Energies*, 12(23). <http://dx.doi.org/10.3390/en12234575>

Flow Angularity Investigations in an Automotive Slotted Wall Wind Tunnel

The tunnel under consideration in this work is the Volvo Cars full scale aerodynamic wind tunnel (PVT), which is a closed return tunnel with a slotted wall test section of 27.06 m² cross sectional area. An overview of the tunnel layout can be seen in Figure 1. The tunnel is capable of both aerodynamic and thermodynamic testing due to its systems for control of both temperature and humidity. At its inauguration in 1986, PVT was not equipped with a rolling road, and boundary layer growth was controlled by a suction patch at the upstream end of the test section. The facility was upgraded with a more powerful fan and improved ground simulation in 2006, which both increased the maximum wind speed to 250 km/h and enhanced the simulation of the on road conditions. The ground simulation system consists of a boundary layer scoop at the upstream end of the test section, followed by distributed suction on the floor upstream of the turntabl

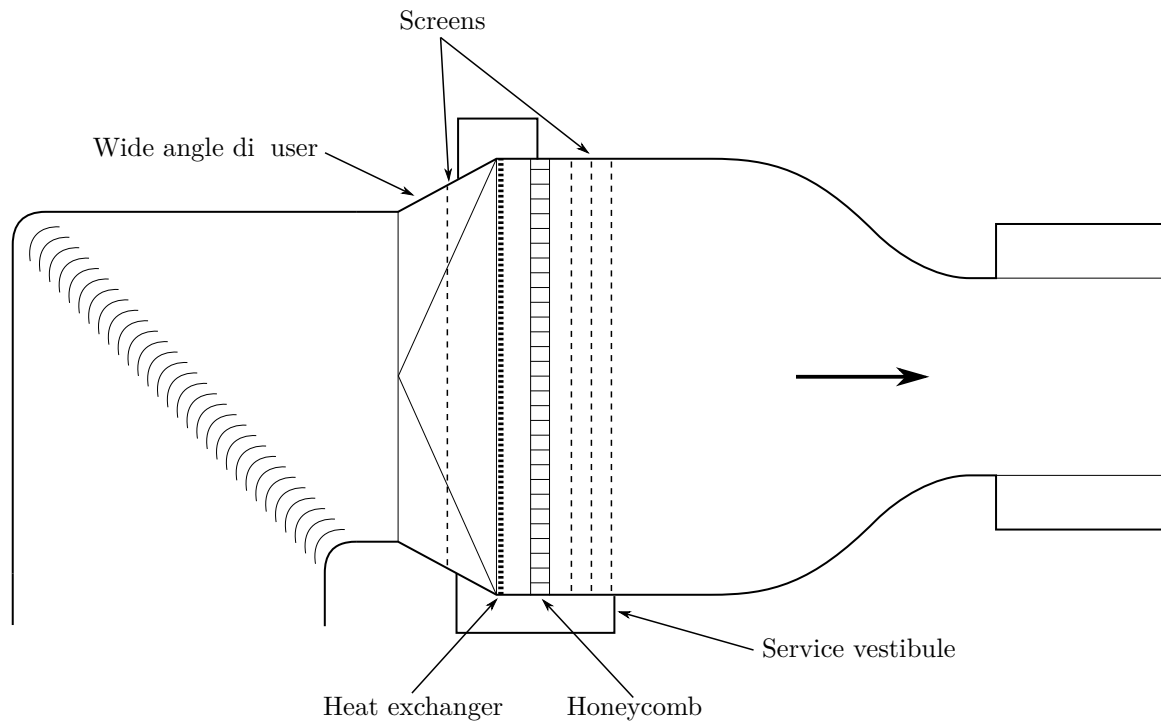
fan not fully eliminated by the flow conditioning devices. However, it has been hypothesized that the flow angularity might be caused by two insufficiencies of the flow conditioning devices themselves; a leakage flow path around the heat exchanger, and the welds of the turbulence screens. Both these alternative causes are investigated in this paper.

Figure 3. Sketch in top view showing the installation of the heat exchanger and other flow conditioning devices in the settling chamber.

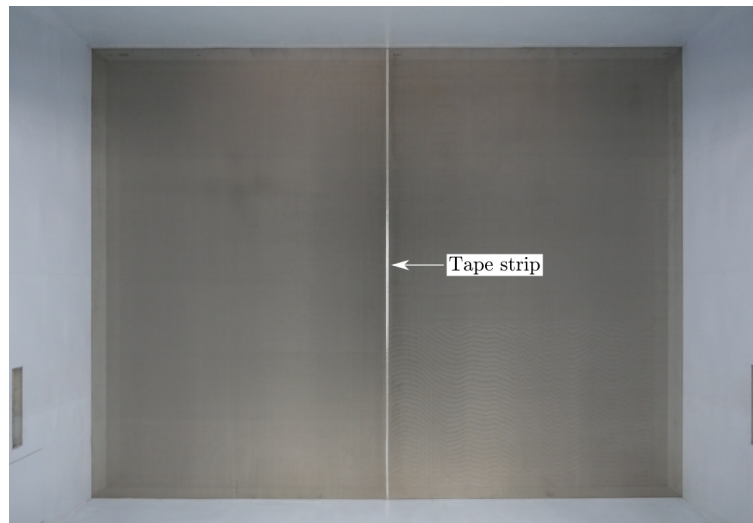
As described, each turbulence screen consisted of two sheets welded together vertically at the centerline. This was done thread-by-thread as shown in Figure 7 in order to minimize the blockage. Despite this precaution, it has been hypothesized that these welds might have had an impact on the test section flow, especially since they lined up for the three screens. This was tested by exaggerating the width of the weld by adding a strip of 40 mm-wide tape to the upstream side of the downstream screen, as shown in Figure 8, and then measuring the flow angularity.

Figure 8. Tape strip added to the upstream side of the most downstream turbulence screen.

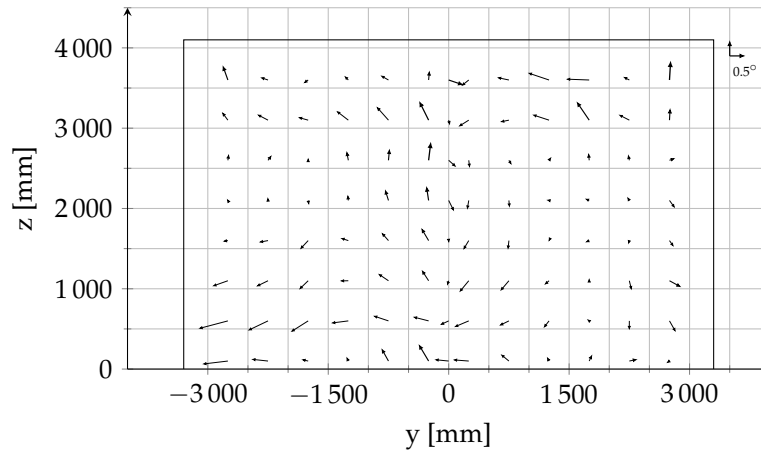
(a) Baseline, standard operating conditions.

The flow angularity for standard operating conditions is shown in Figure 10a. Since the airpath has not been altered in any major way after the moving ground upgrade, Figures 4b and 10a should be very similar. However, a significant difference can be seen in the upper half of the right side of the test section, where the inward and downward flow seen in 2006 is not visible in the present data. A similar flow pattern is visible in all of the measurement planes for the 2006 data [22]; for the most upstream planes the whole right hand side has a strong in- and downwash. The clear difference between the two lateral halves for the most upstream plane does not appear to be physical, and it is believed that this was caused by issues with the references used for the optical measurements of the probe mounting angles. These measurements were performed using a total station, which was likely mounted on different sides of the test section depending on the lateral position of the vertical strut. Hence, it is plausible that different reference points were used for the two lateral halves, thus causing the observed offset of the angles if one set of reference points were misplaced.

Comparing to the 1986 data in Figure 4, it can be seen that the present flow pattern in Figure 10a is not as symmetric between the lateral halves as the old data. The recent measurements indicate a flow that was more directed to the left in the lower part of both the left and the right side. Furthermore, much of the outwash seen in the upper part of the left hand side in the 1986 data was absent already in 2006 and is still so here. It is thereby likely that this change occurred during the upgrade, which means

that either the fan or the boundary layer control system was the cause. It is not plausible that any of the sub-systems in the boundary layer control system and moving ground, which are all located at the floor, had such an impact in this part of the measurement region, which indicates that at least some of the flow angularity was caused by the fan.

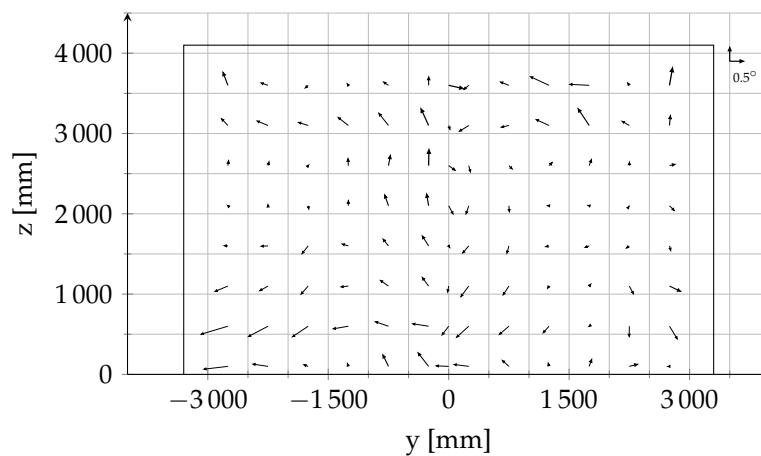
(b) After sealing leakages around the heat exchanger.

The influence on flow angularity from the performed modifications to the flow conditioning devices in the settling chamber can be seen in Figure 10. Comparing Figure 10a and Figure 10b, it can be seen that sealing the heat exchanger leakage does not impact the flow angularity in the test section. It is likely that the disturbance from the leakage flow is small enough to be dampened out by the three turbulence screens mounted downstream of the heat exchanger, and thus not result in any measurable impact on the test section flow field.

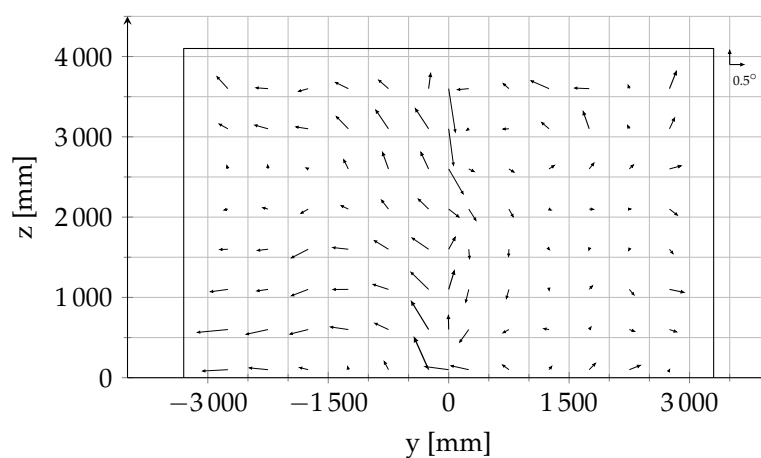
(c) With tape on turbulence screen seam.

Turning to Figure 10c, it can be seen that adding the tape to the turbulence screen had a clear influence on the flow angularity at and around $y = 0$, but did not change the overall behavior of the flow pattern in a major way. Since the tape was significantly wider than the screen weld, the flow influence from the weld itself was much smaller than that caused by the tape. Thus, given that the overall influence from the tape was relatively small, it is concluded that the weld might have a minor influence on the flow angles at the lateral center, but that it is not a significant contributor to the swirling flow pattern in the test section. This is expected, since the weld is very small compared to the total size of the settling chamber.

Since both the heat exchanger leakage flow and the screen welds have been ruled out as the cause of the rotating flow angularity pattern in the test section, the reason has to be found elsewhere. The fact that the rotation of the observed pattern corresponded to the rotational direction of the fan, and that the flow pattern changed slightly when the fan was changed during the moving ground upgrade, indicates that the rotation stemmed from residual swirl from the fan. This corresponds well to the statement by Barlow et al. [17], saying that vortex-like flow patterns could be caused by non-uniform flow upstream of the third corner. In order to confirm this, measurements would have to be performed throughout the airpath of the tunnel.
