# Deterioration in brick buildings: hygrothermal performance and measures to save them

Pär Johansson<sup>1,\*</sup> and Paula Wahlgren<sup>1</sup>

<sup>1</sup>Chalmers University of Technology, Department of Architecture and Civil Engineering, SE-412 96 Gothenburg, Sweden

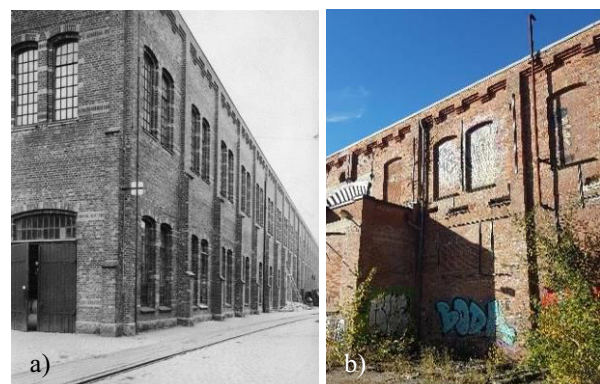
**Fig. 1.** (a) The building from 1896 in south of Gothenburg, photo from 1918, (b) The exterior of the tested external wall.

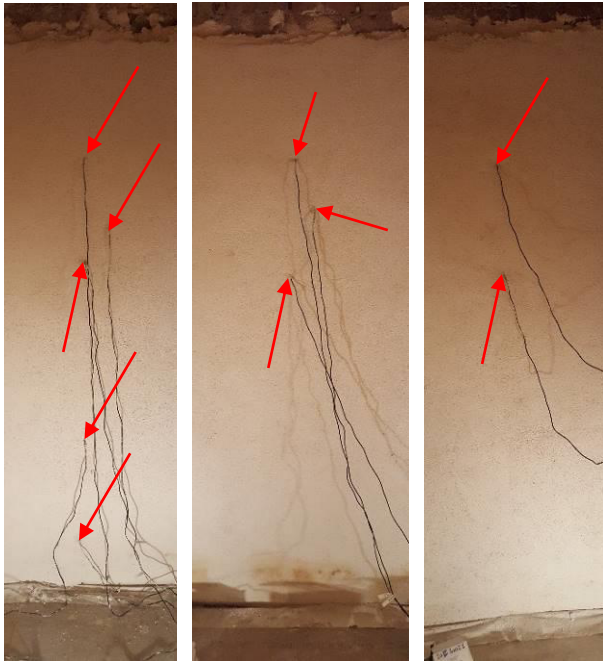
**Fig. 3.** Hygrothermal sensors (marked with arrows) in the middle of the bricks and surface of the plastered brick wall.

Prior to the installation of the sensors, the existing plaster was removed from the interior brick surface. There was substantial capillary suction from the ground and from the exposure to driving rain from south-west, which is the dominant wind direction. The old plaster was loose up to approximately 1 meter above the concrete slab and came down easily, without applying force, while the upper part of the wall required demolition hammer to remove the plaster. The initial estimations showed that the rate of water flow in the

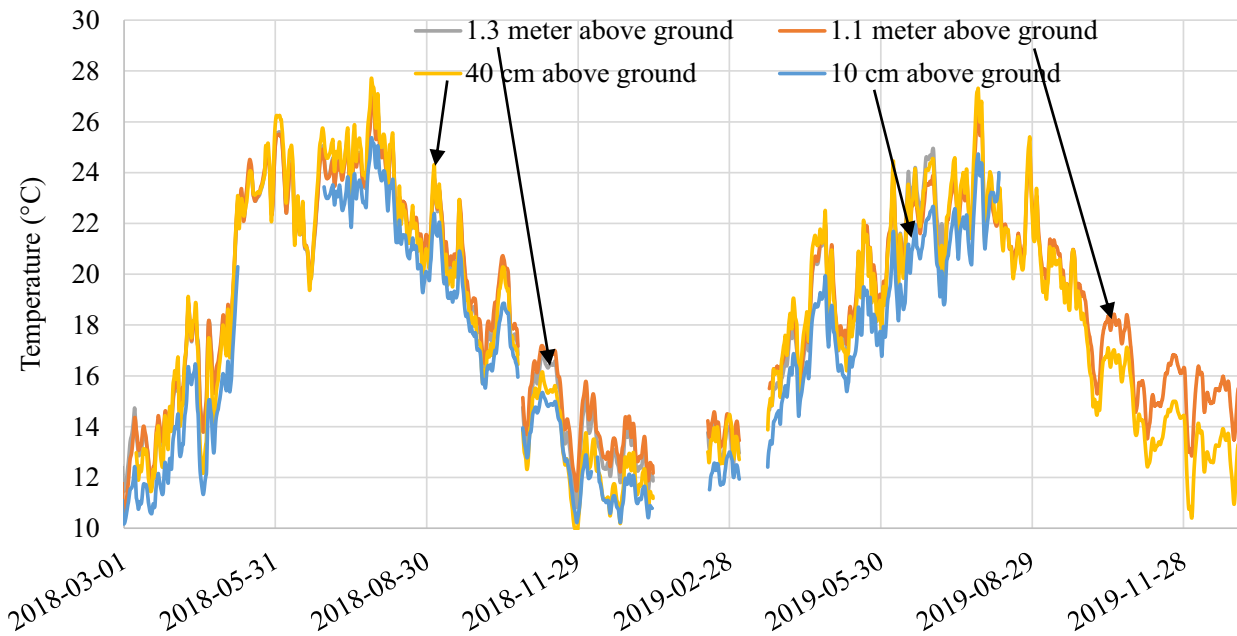
**Fig. 6.** Temperatures in the middle of the wall on different heights, from March 2018 to January 2020, sliding 24-hour average.

According to the measurements, the temperature is highest further up in the wall, where it can be expected that the impact of the surrounding ground is smaller. The relative humidity is above 100% in the measurements. This is due to the interpretation of the measurement results in the sensor itself. The relative humidity is highest close to the slab while it varies between the measurement positions in the upper part of the wall. This could be caused by a crack in the mortar or bricks, as well as whether the sensor is in contact with brick or mortar inside the wall.

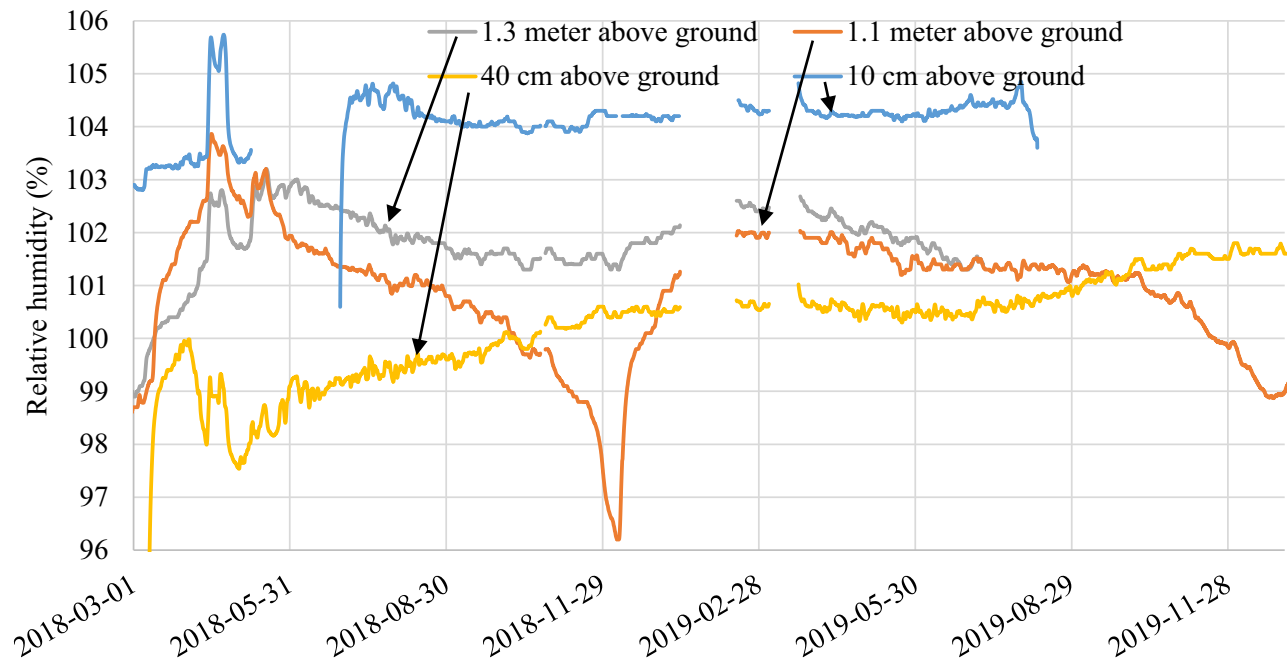
**Fig. 7.** Relative humidity in the middle of the wall at different heights, from March 2018 to January 2020, sliding 24-hour average.

Due to the detrimental effects by the salt efflorescence on the brick masonry, the decision was made to install a layer of lime-based mortar on the interior of the wall. This was performed in the beginning of May 2018, which is visible as an increased relative humidity in Fig. 7. The mortar acts sacrificially to prevent the brick from deteriorating but does not stop efflorescence. Consequently, after the mortar was applied, the efflorescence continued, along with the degradation of the interior surface by the salt deposition. The salt crystals are continuously brushed off the wall and the mortar need to be regularly inspected to not deteriorate and expose the brick masonry. It is also important to make sure that the mortar is attached to the load-bearing part of the brick masonry so that no pockets of air can be formed between the layers where the salt efflorescence can continue to deteriorate the brick masonry.

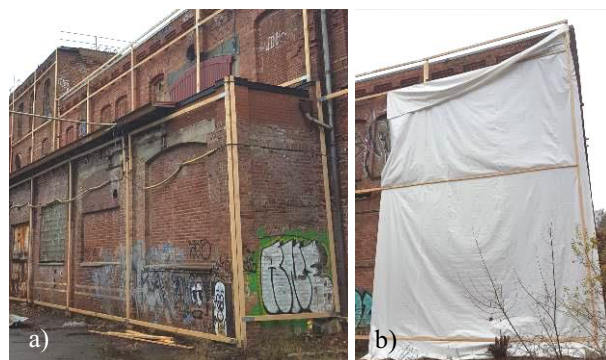
**Fig. 8.** (a) Exterior of the building prepared to be covered in plastic wrapping. (b) Part of the building covered in plastic, from November 2019.

The long-term durability of the building and the load-bearing structure need to be secured. As the heating in the buildings is detrimental to the brick mortar, and the cold and humid climate is as well, measures are needed. A solution that was implemented in November 2019, was to add a plastic wrapping around the entire building, see Fig. 8. The roof was already, from the start of the study, covered by a weather protection tent to prevent water leakage from rain into the building. The measurements will continue also after the plastic wrapping has been installed and the hygrothermal performance of the brick masonry is continuously monitored.
