A material degradation study of novel FeCrAl alloys, stainless steels and nickel base alloy in fluidized bed heat exchangers of a waste-fired CFB

Lindmark, H., Phother Simon, J., Olausson, M. et al (2023). A material degradation study of novel FeCrAl alloys, stainless steels and nickel base alloy in fluidized bed heat exchangers of a waste-fired CFB boiler. *Fuel*, 338. <http://dx.doi.org/10.1016/j.fuel.2022.127299>

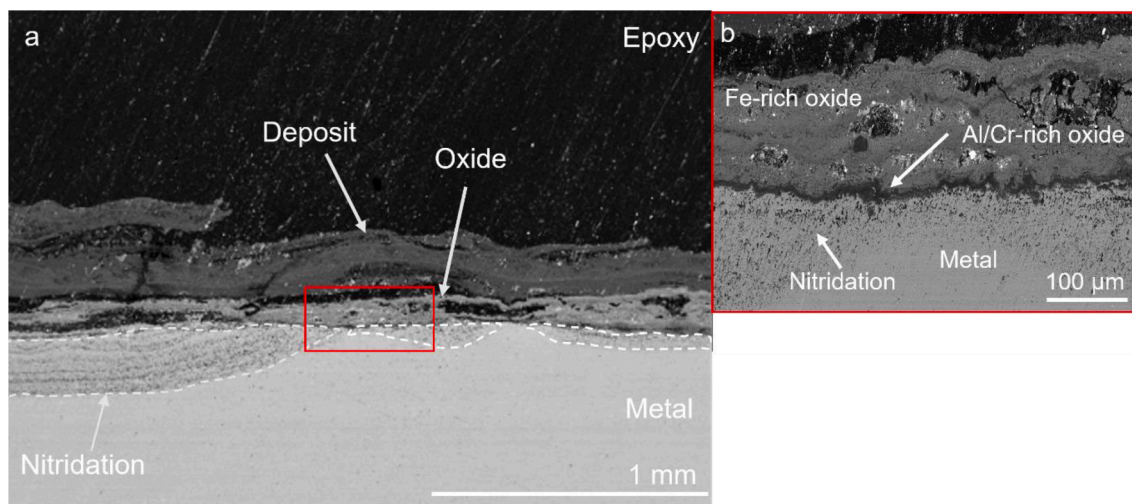
A SEM cross-sectional view of the EF100 sample exposed for 6 months is shown in Fig. 6a. An approximately 250 μm thick deposit was observed, consisting primarily of S, Ca, and O. Beneath the deposited layer, an approximately 100 μm thick iron oxide had formed. The oxide contained small cracks and displayed void formations, whereas it was difficult to distinguish regions of inward and outward oxide layer formation. A roughly 10 μm Al/Cr-rich thin oxide layer was detected across the metal/oxide interphase (see Fig. 6b). The SEM analysis revealed no indications of internal oxidation for this material. However, a nitridation zone could be seen below the metal/oxide interphase. The thickness of the region varied greatly (between 0 and 200 μm) and was observed in a patch-wise fashion throughout the cross-section of the sample.

Fig. 6. (a) SEM BSE cross-section image of EF100 after 6 months of exposure. (b) Higher magnification of the marked area in (a).

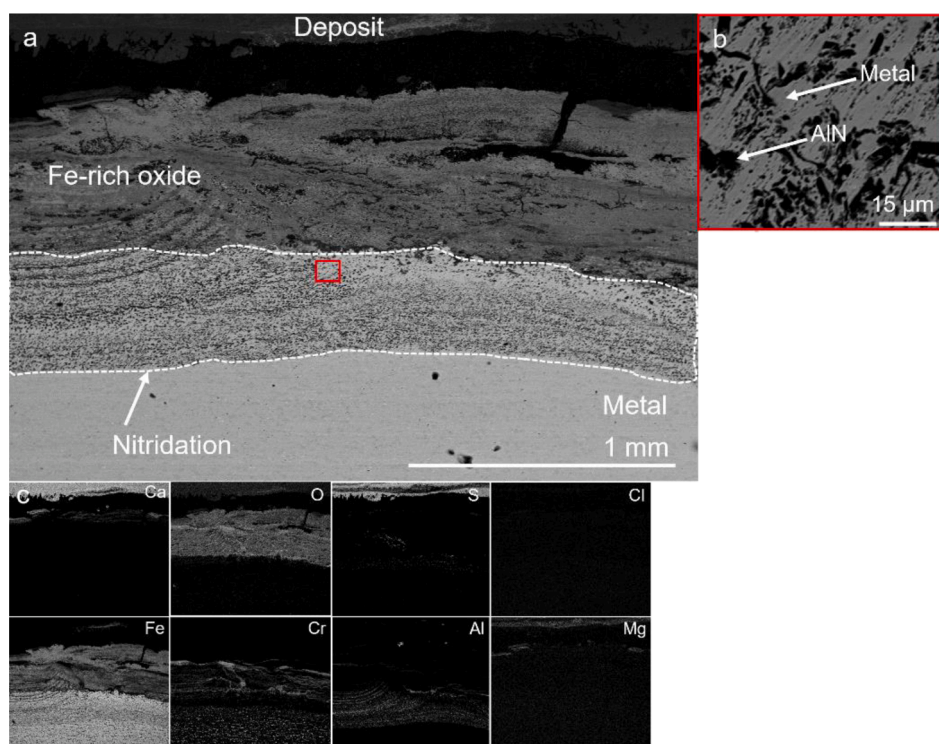
EF100 displayed similar features after 6 and 12 months of exposure

(compare Fig. 6a and Fig. 7a). However, for the sample exposed for 12 months, most of the deposited layer had spalled off. This may however be an effect of sample outtake and subsequent sample preparation for post-analysis measurements. A Fe-rich oxide was observed (about 600 μm in thickness) containing voids and cracks as well as traces of Cr and Al (see Fig. 7a and c). The nitridation zone had also grown larger compared to after 6 months of exposure (about 400 μm in thickness) and was observed throughout the cross-section of the sample in a homogeneous fashion. The EDX analysis confirmed that the dark particles shown in the nitridation zone consisted of Alumina Nitrides (AlN) precipitates embedded in a Fe-rich alloy matrix (see Fig. 7b). The observed microstructures and corrosion attacks agree well with the measured material losses. The material loss for EF100 after 6 and 12 months was 0.13 and 0.19 mm, respectively. The SEM/EDX analysis after 12 months of exposure also shows that a region (roughly 125 μm thick) depleted in Cr was detected at the nitridation/metal interphase (see Fig. 7c). This Cr-depletion zone was homogeneous and observed throughout the sample. No Cl was detected in the corrosion front or the deposit. Regardless of exposure time, the sample was covered by corrosion products and, for the 6-month exposed sample, deposit. Thus, it is suggested that the material loss is primarily driven by a corrosion process rather than erosion.

Fig. 7. SEM BSE cross-section image of EF100 (a) after 12 months of exposure. (b) Higher magnification of the marked area in (a). (c) EDX mapping of (a).

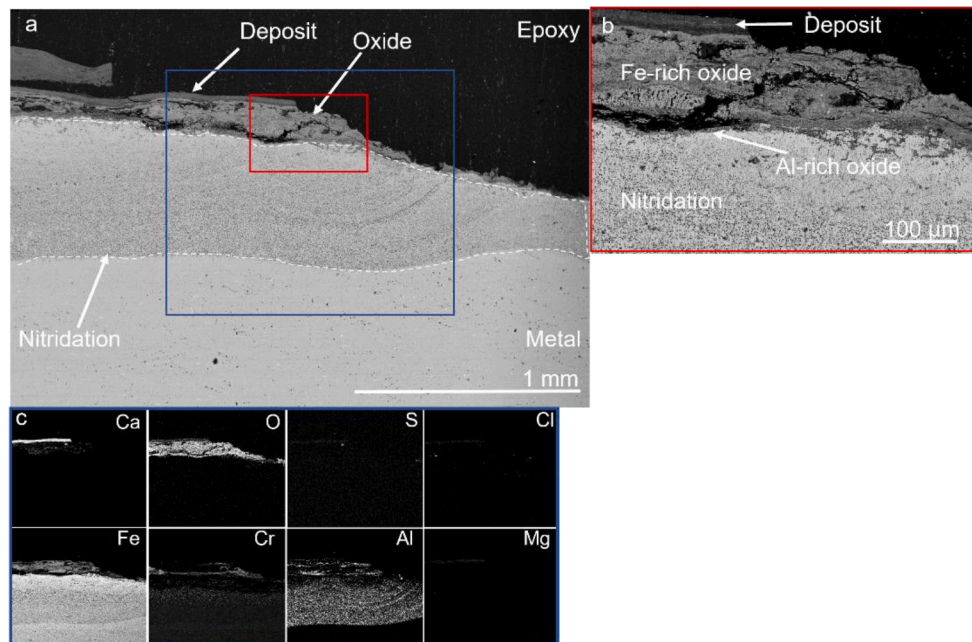
EF101 displayed similar features as EF100 after 6 months of exposure (see Fig. 8a). The EDX map analysis of EF101 shows that a thin deposit layer (about 25 μm in thickness) had formed above the oxide layer containing large amounts of Ca (see Fig. 8c). The oxide scale was composed of a Fe-rich oxide containing cracks and voids (see Fig. 8b). Traces of a Cr rich oxide were also observed but to a lower extent. Below the Fe-rich oxide a roughly 8 μm thin Al-rich oxide layer was observed. In addition, below the metal/oxide interface, a Cr-depleted zone of approximately 100 μm was seen. Compared to EF100, the EF101 sample exhibited a more pronounced nitridation zone. The thickness of the nitridation zones was 450 μm and 200 μm for EF101 and EF100, respectively, after 6 months. For EF101, the SEM analysis revealed no or small amounts of deposit components. In addition, no traces of chlorine-containing species were observed in the cross-section (see Fig. 8c).

Fig. 8. SEM BSE cross-section image of (a) EF101 after 6 months of exposure. (b) Higher magnification of the small marked red area in (a). (c) EDX mapping of the sizeable, marked area in (a). (For interpretation of the references to colour in this figure legend, the reader is referred to the web version of this article.)

The EF101 obtained a thicker nitridation zone after 6 months of exposure compared to EF100 (compare Fig. 6a and 8a). The resistance towards nitridation can be due to several factors, such as the concentration of Cr in the alloy, the integrity of the alumina scale including micro defects in the oxide, which allows the nitrogen to diffuse through the deposit and oxide scale. The nitridation is, from a corrosion point of view, not desirable as the aluminum in the alloy is tied up locally in the formation of AlN rather than forming a protective alumina scale. Despite this, the newly developed FeCrAl alloys showed good material performance in this environment, and the material losses of the investigated materials were rather low.
