Concluding destructive investigation of a nine-year-old marine-exposed cracked concrete panel

Mette Geiker^{a,*}, Samanta Robuschi^b, Karin Lundgren^b, Charilaos Paraskevoulakos^c, Carsten Gundlach^d, Tobias Danner^e, Ulla Hjorth Jakobsen^f, Alexander Michel^c

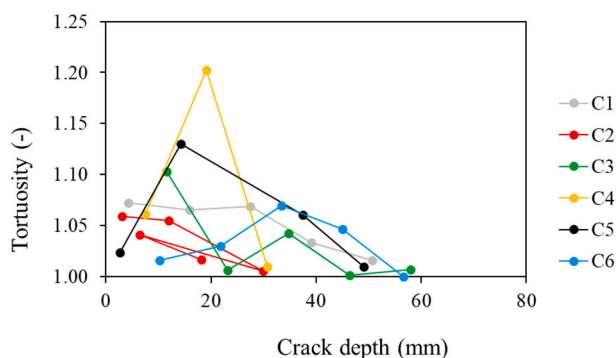
Finally, crack tortuosity was also investigated using the available μ -CT image dataset. Representative 2D XY plane projections (five per core) were used to calculate the effective and the nominal crack length (Section 2.4) in the XY plane. The results are illustrated in Fig. 9. Numbers close to 1.00 might be explained by self-healing, closing part of the crack and reducing the effective crack length.

Fig. 9. Crack tortuosity distribution across crack depth for all six cores investigated using μ -CT. (For interpretation of the references to colour in this figure legend, the reader is referred to the web version of this article.)

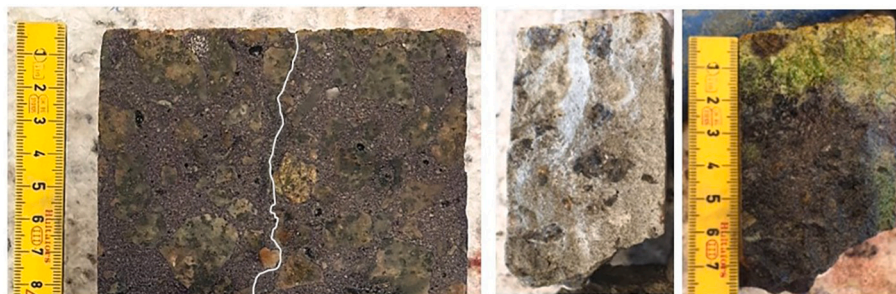
At the cut surface, the concrete did not show visual/macroscopic signs of carbonation (Fig. 10, left), which is similar to the petrographic analysis showing only shallow (1–2 mm) carbonation. The concrete surface colour was violet to blue, indicating a pH between 11 and 13. However, a carbonation front of about 20–30 mm was detected when the concrete was split along the crack face. This is also in line with the observations made in the petrographic analysis that showed carbonation along the crack face to a depth of 20 mm for core C2 (tidal exposure). The colour of the concrete was green in the outer 20–30 mm, indicating a pH of around 9 (Fig. 10, right). Furthermore, the carbonation of the upper part of the crack face coincided with a white precipitate. The carbonation depth appeared deeper along the cylindrical outer surface of the core (Fig. 10, right), suggesting carbonation during storage (approximately six weeks wrapped in plastic and stored at 5 °C). However, this is not in agreement with the lack of/limited carbonation on the exposed surface (Fig. 10, left), so it is assumed to be an artefact. Note that the petrographic analysis showed less carbonation along the crack face (to a depth of 8 mm) for the submerged exposed core (C5) than for the core from tidal exposure (C2). The petrographic analysis also showed shallow carbonation of part of the rebar imprint in core C5 (submerged exposure), which was not observed in the visual/macroscopic investigation. Similar observations were made for core C1 (tidal exposure) and C4 (submerged exposure).

Fig. 10. Carbonation detection on core C1. Left: freshly cut concrete core sprayed with rainbow indicator; Right: crack face sprayed with a rainbow indicator (left side: cut surface; right side: outer cylinder surface). (For interpretation of the references to colour in this figure legend, the reader is referred to the web version of this article.)
