Yuan, M., Karamchedu, S., Fan, Y. et al (2023). A Case Study for a Worn Tool Steel in the Hot Stamping Process. *Journal of Materials Research and Technology*, 22: 1065-1075.

# A case study for a worn tool steel in the hot stamping process

A good understanding of failure mechanisms can help us improve the lifetime of the dies. This paper presents a case study investigating the wear behaviour of a QRO90 die insert utilized for stamping uncoated boron-alloyed high-strength steel sheets. Topography and microstructure were characterized by means of scanning electron microscopy (SEM), energy-dispersive X-ray spectroscopy (EDS), hardness measurement and X-ray photoelectron spectroscopy (XPS). Severe galling due to accumulated layers transferred from the boron-alloyed steel workpieces occurred on the die surface. Material softening was detected in the sublayer of the tool steel (up to ~200  $\mu\text{m}$ ). In addition, white layers with a thickness of 1–2  $\mu\text{m}$  were frequently observed on the surface of the round corner of the tool. The main wear mechanisms are discussed. Galling caused by surface softening and the spallation of white layers are considered to be the primary w

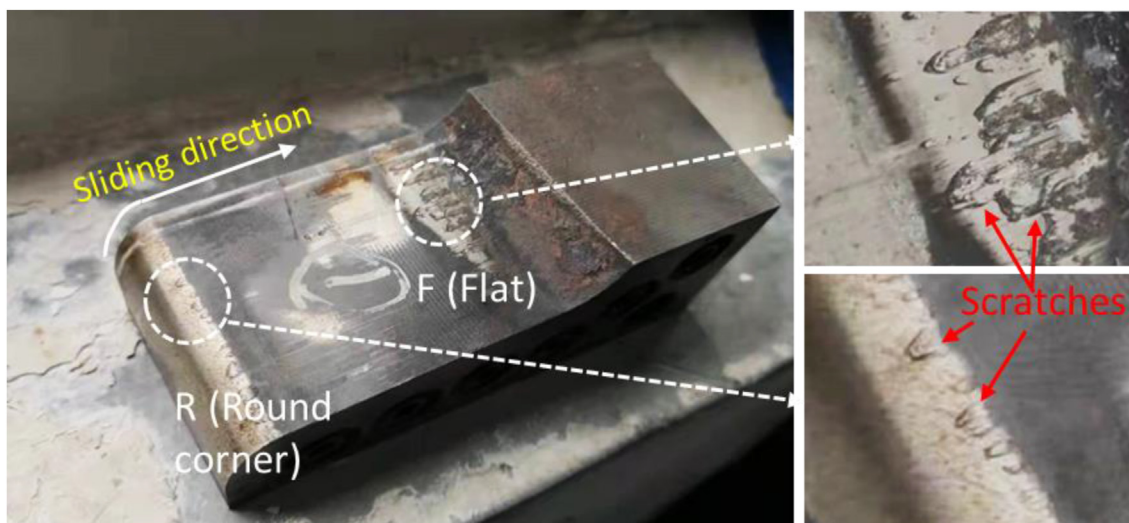
A failed die insert for hot stamping, as shown in Fig. 1, was considered for analysis. The main worn areas on the die insert are displayed in Fig. 1. The area on the round corner is marked

**Fig. 1 – The main worn areas on the die insert.**

as “R” and the flat part is marked as “F”. Specimens were extracted from these two areas for investigation.

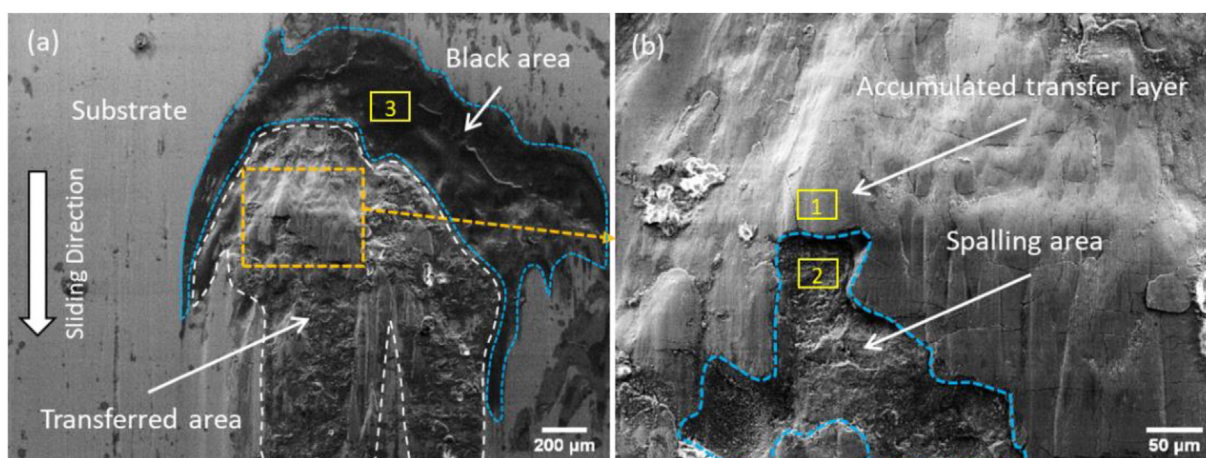
**Fig. 2 – SEM images showing the transferred materials on the flat part. The sliding direction (S.D.) is marked in the figure.**

a scratches was thoroughly examined by SEM, as shown in Fig. 2. A large area of transferred materials was found on the top of the scratch. The transferred material showed a glazed surface. The extremely low concentration of Cr and Mo and high concentration of O at Site 1 (see Fig. 2b), as revealed by EDS analysis in Table 2 indicated that this transferred material was from the workpiece which was oxidized with a remarkable oxide layer thickness in the micrometer level. The oxide was mainly iron oxide. A spalling area was found on the top of the transferred material, implying that the transferred material was accumulated during the stamping process. EDS analysis conducted on the spalling area (Site 2) showed a relatively lower O concentration compared to the un-spalled zone (Fig. 2b and Table 2), indicating less oxidation of the transferred material in this region. In addition, a black/dark area (upper area indicated in Fig. 2a) was also observed in front of this big scratch. The EDS (Site 3 in Table 2) result shows that this area has an even higher O content than that of Site 1. The material in this area was suspected to be mainly iron oxides with some contamination.

The adjacent protrusion prevented this black area in Fig. 2a from being in contact with the hot workpieces, and thereby its surface was exposed to a high temperature for a relatively long time and was thus heavily oxidized. Notice a significant amount of Si was observed in this region. It could be resulted from the selective oxidation of Si from the steel at high temperatures during processing due to the high affinity of Si with oxygen or the residue from the coolant. The observation of Mo here is a surprise. On the other hand, the protrusion can scrape the hot workpiece, and therefore the transferred layer could be accumulated on the top, as observed in Fig. 2.

In order to further characterize the chemistry of the oxide, XPS was conducted on the black area (BA), transferred area (TA) and substrate (SB), as indicated in Fig. 2a. The surface was slightly etched by argon ions prior to the measurement to remove some contamination and the native oxide. As shown in Fig. 3, the substrate possessed strong peaks of Fe, Cr and Mo in metallic form. However, Fe was identified to be present as  $Fe_2O_3$  in both the black area and transferred material area, indicating significantly thicker oxide compared to the substrate. This was consistent with the EDS results in Table 2. Molybdenum was not observed at the surface of BA and TA regions. High silicon content in BA and TA regions is also agree with the EDS results in Table 2. The area with transferred material had the strongest oxidized Fe peak, indicating that  $Fe_2O_3$  was dominant on the surface of this area.

During the hot stamping process, transferred material with a top oxide layer was stacked on the tool steel layer by layer in an accumulated manner. This type of accumulated and compacted layer has commonly been observed in other high-temperature reciprocating sliding systems [9,15]. An interesting phenomenon observed was the varied bonding strength at different locations. At the head of scratches (Fig. 4a), there was a strong bonding between the transferred materials and the slopy surface of tool steel. It was attributed to the high partial normal load  $F_1$  on the local surface (the slopy region) of the tool steel, as schematically drawn in Fig. 4a. Meanwhile, the transferred material was at high temperatures with high ductility. Consequently, it could form a good bonding with the underlying tool steel. On the other hand, at the tail of scratches (Fig. 4a and b), much lower normal stress led to a weak bonding between the transferred materials and the tool steel. As a result, the spalling of transferred materials could happen in such region, as shown in Fig. 2b.

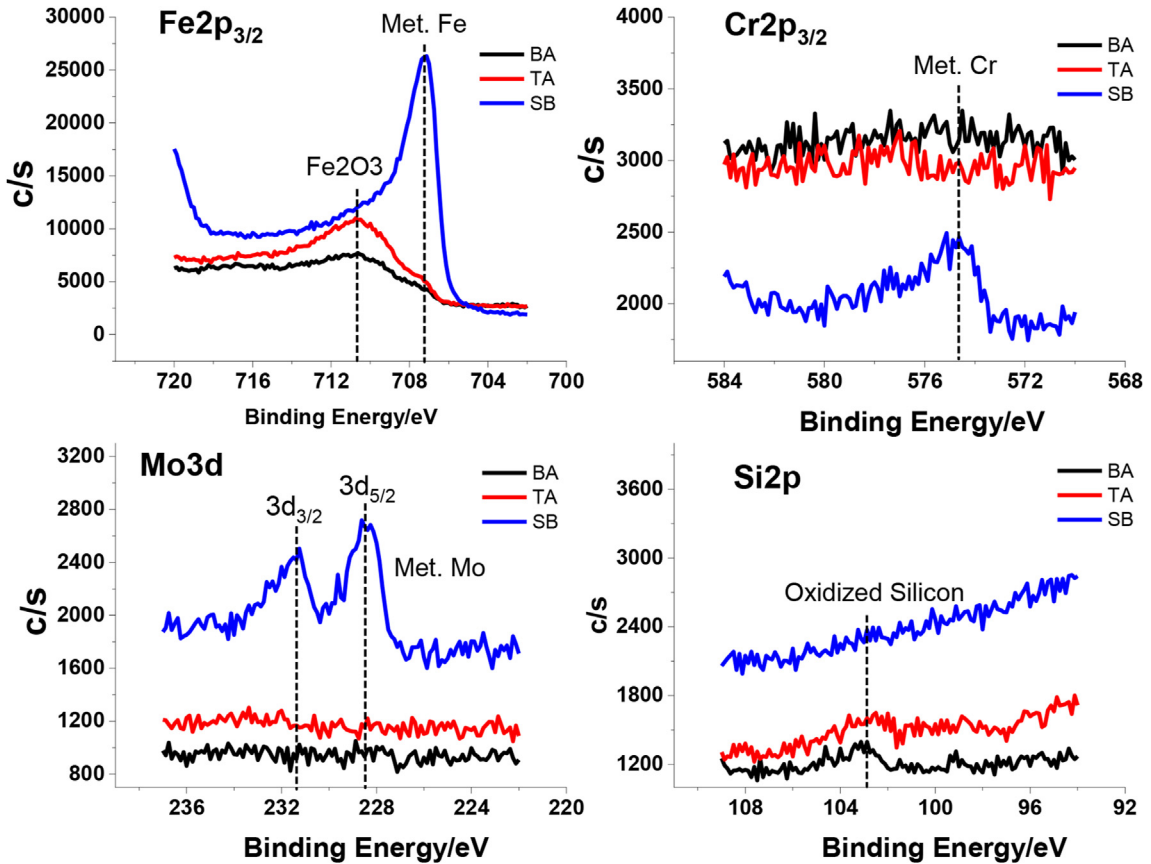
Fig. 3 – The XPS spectra of the concerned elements on the scratch in Fig. 2. BA: black area, TA: transferred area, SB: substrate.

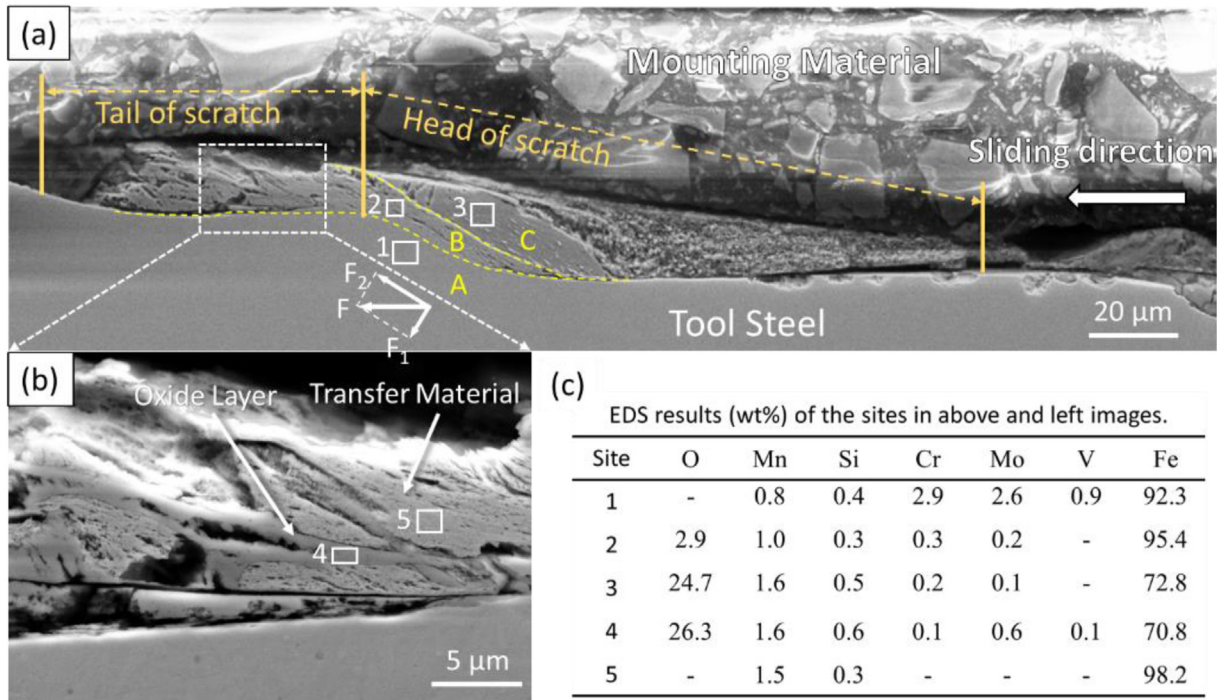
Fig. 4a shows the morphology of the polished longitudinal cross-section from the flat region (see Fig. 1) with some

transferred materials on the top. EDS analysis was carried out on different areas, and the results are presented in Fig. 4c. Here “A” (Site 1 in Fig. 4a) represents the tool steel and shows a typical composition of die material (QRO 90 tool steel). The regions “B” and “C” should be material that differ from the tool steel considering their unique morphology. According to the EDS results shown in Fig. 4c, the “C” layer (Site 3) reveals a much higher O content, and the composition is similar to that of Site 1 in Fig. 2, indicating that the material in this layer is the  $Fe_2O_3$ .

The composition of site 2 in the “B” layer was consistent with the nominal composition of the boron steel, indicating it was the transferred material from the boron steel workpiece. The small content of O (2.9 wt%) in the “B” layer suggests that the material was slightly oxidized. In another location of the “B” layer, as shown in Fig. 4b, multi-layers consisting of alternating denser layers (Site 4) and the ones with some black pores (Site 5) were observed. EDS (Fig. 4c) conducted on these different layers shows that the composition of the more porous layers (e.g., Site 5) was consistent with that from site 2 of the “B” layer, while the denser layers (Site 4) had almost the same composition as the “C” layer, suggesting the formation of  $Fe_2O_3$  due to oxidation of the transferred material. However, Mo was detected in both “B” and “C” layers. It was not expected because Mo is not present in the workpieces of the boron steel. One possible reason for this could be that the smearing of the tool steel might occur, which introduces some material from the tool steel into the transferred layer. The mixture of tool steel and transferred materials was also observed in other sliding wear tests [9]. This occurs at the surface of the workpiece, which explains why Mo was only found in the oxide but not the bulk transferred boron steel bulk in the “B” layer.

Fig. 4 – (a) SEM image from the longitudinal cross-section (parallel to the sliding direction) of the flat part, (b) Magnified image presenting transferred material in a multilayer form, (c) The corresponding EDS analysis results.

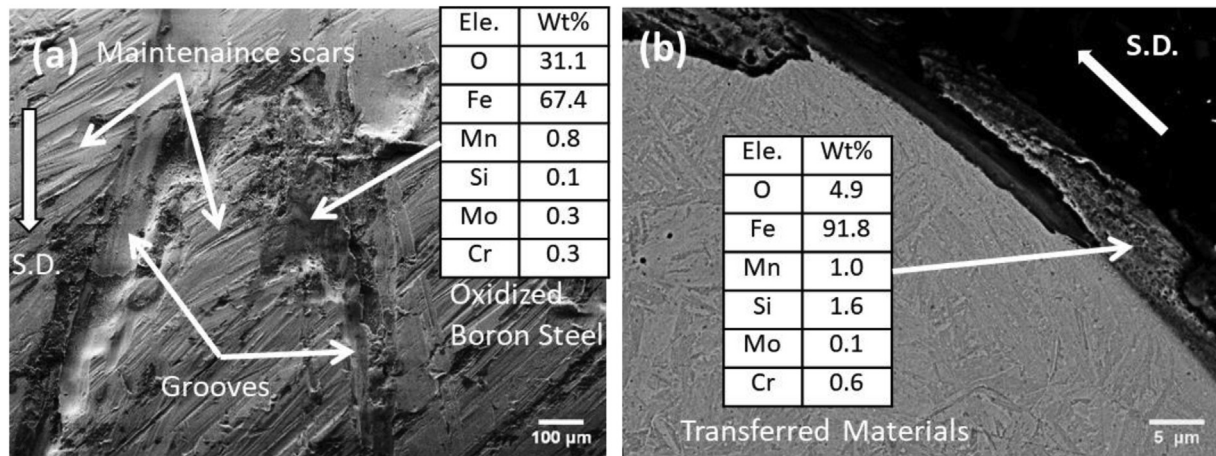
**Fig. 5 – Material transfer observed at the round corner: (a) the micrograph of worn surface, (b) cross-section illustrating the transferred material.**

(31.1 wt%). This meant the oxide layer on the surface was nearly pure  $\text{Fe}_2\text{O}_3$  with a remarkable thickness ( $>1 \mu\text{m}$ ). In the central area of the round corner surface, transferred materials were found as well by cross-section observation (Fig. 5b).

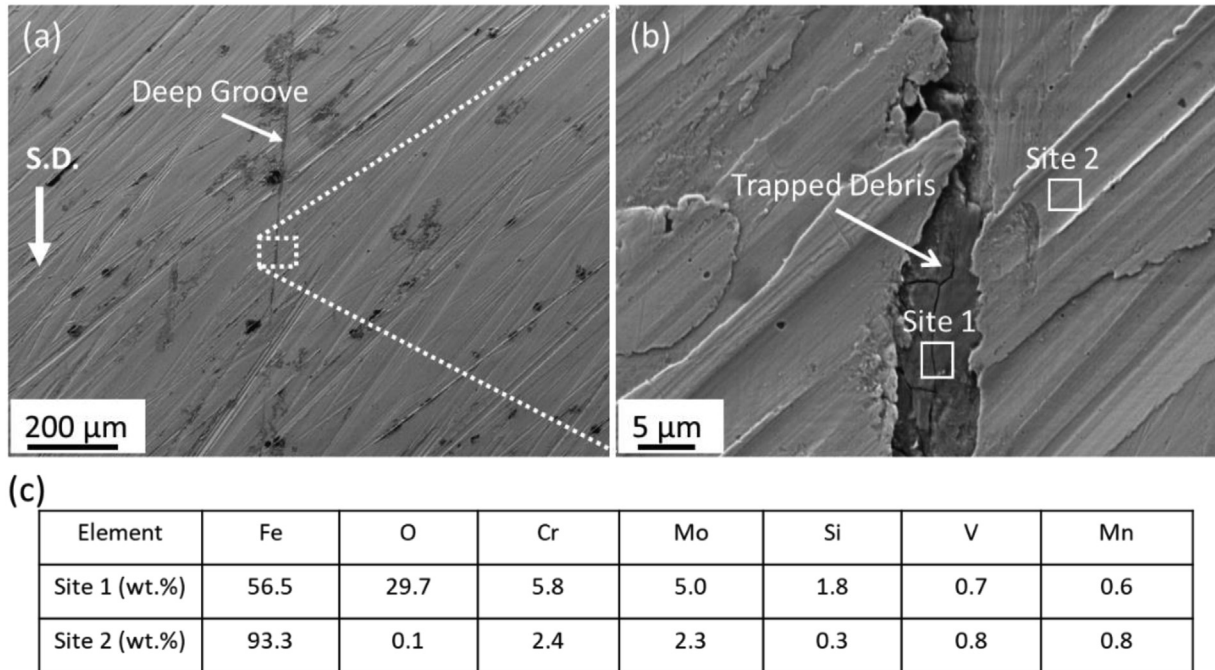
Fig. 6 – (a) Deep groove was found on the round corner surface. (b) Trapped debris found in magnified SEM image. (c) EDS analysis shows the trapped material is the oxidized debris from the tool steel.

could be easily oxidized due to their relatively high specific area and develop into debris consisting of a mixture of metal and oxides. The trapped materials in Fig. 6 are suspected to be this kind of debris.

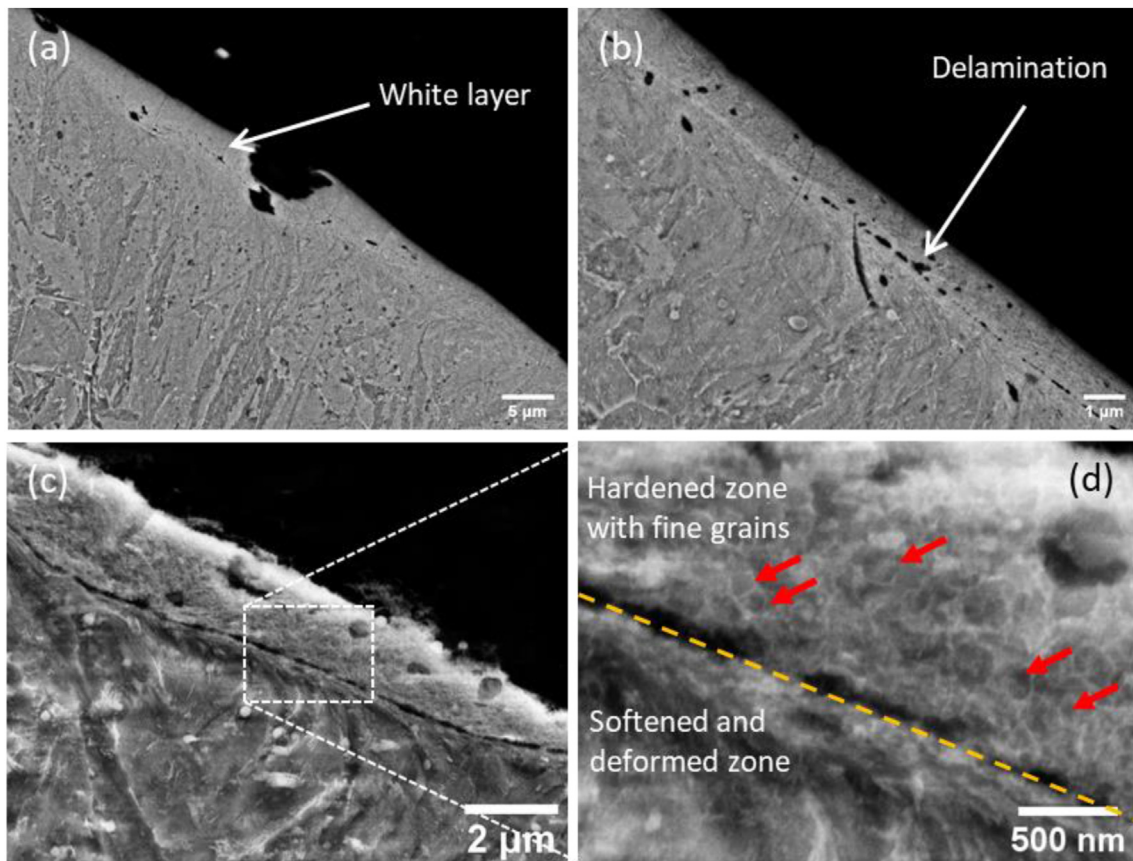
Fig. 7 shows SEM images from the cross-section at the center of round corner. Delamination was found in some local areas near the surface of the round corner. The thickness of these layers is about  $1\text{--}5 \mu\text{m}$ . A discontinuous line (Fig. 7b) appeared between the surface layer and substrate. Above the line, in the SEM image, the layer was brighter than that of the substrate and it was thus named as “white layer” in this paper. EDS analysis conducted on the white layer showed a similar composition to the substrate. At some places, as revealed in Fig. 7a, fracture found in the white layer suggested that it had experienced remarkable tensile stress during the hot stamping service. In addition, the delamination implied a weak bonding between this white layer and substrate, which could probably lead to spallation under a load of shear stress.

Secondary electron imaging SEM having high-resolution was used to reveal some detailed features. As shown in Fig. 7c and d, the white layer (above the delamination line) had an ultra-fine structure, implying that it probably had higher hardness than the region below the line. As can be seen in these images, the region below the line had severe plastic deformation caused by shear stress while no distinct deformation was found in the white layer, although the regions below and above the line were subjected to similar shear stress. This suggested that the hardness of the white layer may be much higher than that of the substrate. The formation of the white layer will be discussed further in Section 4.2.

Fig. 7 – Back scattered SEM images from the cross-section reveal the microstructure of the round corner center, (a) fractured “white” layer, and (b) delamination below the white layer. Secondary electron SEM images (c) and (d) detailed features near the surface.

The formation of the white layer shown in Fig. 7 is the consequence of thermal cycles experienced by the tool steel. During hot stamping, the top surface of the die will be heated up to a peak temperature above 800 °C by the hot workpiece. According to Ref. [14], the austenitizing start temperature of the die material, i.e., QRO 90 tool steel, is about 800 °C. Therefore, partial austenitizing of tool steel occurs within a shallow depth (1–3 μm). The subsequent rapid cooling caused by the water-cooling channels in the die results in the hardening of this surface region owing to martensite formation. During the service, it is expected that the top surface layer of the tool steel is subjected to a repeated austenitizing and quenching, leading to the formation of a layer with ultra-fine grains on the top surface. Hosseini [20] reported a similar white layer on high carbon 100Cr6 steel after fast turning. This layer would have a relatively high hardness due to the quenching process and will not be easily deformed. However, the substrate material, whose peak temperature was below the austenitizing temperature, will not experience austenitizing and just be softened. Hence, plastic deformation could take place easily in these regions, as can be seen in Fig. 7. Different deformation capability makes the white layer and substrate incompatible. This could be one of the reasons for delamination.

Another observation in Fig. 7b is that the black voids near the delamination line have been elongated. The assumption proposed by Suh [19] can interpret it properly. During the deformation, massive dislocations could be accumulated around the hard particles and voids develop. With the growth of the voids, they could be elongated and linked together to form a discontinuous line, as shown in Fig. 7. Further growth of the voids leads to the delamination.

expansion. However, as the temperature of the die decreases by the cooling channels, the surface layer tends to contract, and the substrate opposes it. The internal stresses change direction and turn to tensile stress. Beside this, austenitizing process in the white layer could also be one of the reasons causing tensile stresses. When the temperature in the white layer exceeds the austenitizing temperature, there is a volume contraction, because austenite ( $\gamma$ -Fe) with fcc structure has a higher atomic packing density than that of the martensite/ferrite phase. Hence, austenitizing will cause a sudden increase in density. The resultant volume contraction will also produce tensile stress in the white layer. As mentioned previously, the white layer with a high hardness has limited ductility. Therefore, fracture could happen in the white layer, as shown in Fig. 7a.

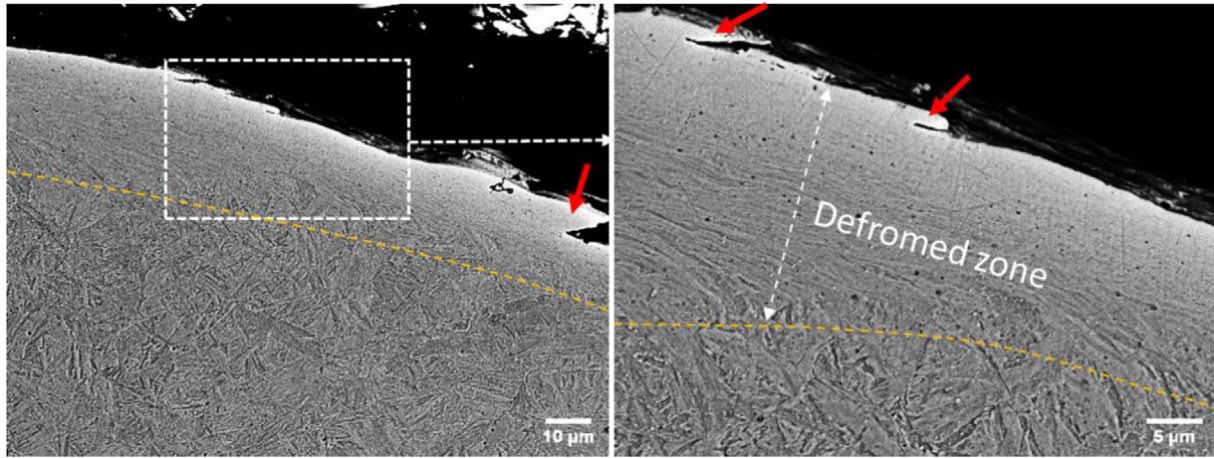
At the die exit of the round corner, severe shear deformation was also found in the region close to the surface (Fig. 8). The sites of exit refer to Fig. 9a. In the lower part of Fig. 8a, a typical tempered martensitic structure was observed. In the deformation zone having a depth of  $10\text{--}20 \mu\text{m}$ , this structure was stretched along the sliding direction. In Fig. 8b, the grain size reduction was seen in the severe deformed zone. In hot stamping, the die was repeatedly subjected to the shear and normal load at high temperatures. High shear stress can lead to not only the elongation of the grain but also break down the original grains into extremely fine size. As a consequence, the deformed zone showed a different microstructure from the matrix. For other sub-surface regions, the deformation depth

**Fig. 8** – Back scattered SEM images from the cross-section of the round corner exit (refer to Fig. 9a), showing severe plastic deformation of the sub-surface of die material. Solid arrows in the images indicate the initiation of wear fragments.

was only about 2–3  $\mu\text{m}$  due to lower shear stress (Fig. 7). Another interesting observation was the initiation of fragments from the uneven surface (marked as red arrows in Fig. 8), which also contributed to the wear in the current study. These fragments could be evolved as well into the third body particles that caused abrasive wear.

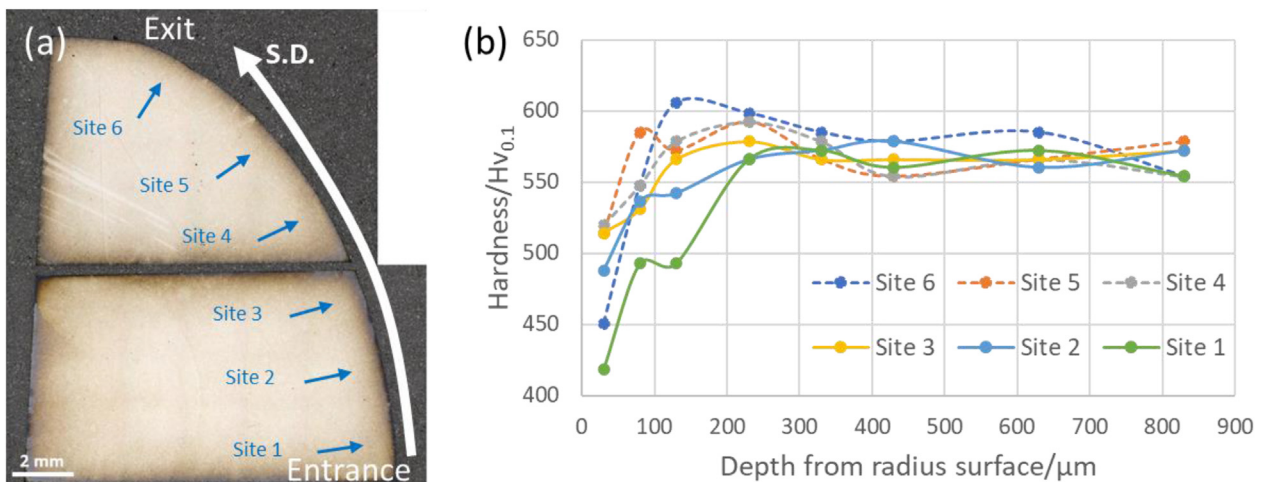
Hardness measurements of the sub-surface on the cross section of the round corner revealed the softening phenomenon of QRO 90 tool steel during the hot stamping process, as shown in Fig. 9. Microhardness test ( $\text{HV}_{0.1}$ ) was chosen in order to reduce the size of indentation and reveal the trend of hardness variation with the distance to the surface. As we can see, the hardness of the sub-surface was significantly lower than that of the bulk ( $\sim 570 \text{HV}_{0.1}$ ). The softening of the sub-surface was believed to be related to the heating effect from the hot workpieces. The heat transferred from the workpieces decomposed the martensite into ferrite and carbides. With

time, the carbides were coarsened at high temperatures and the dislocation density in the material would be decreased greatly, leading to the softening of tool steel. As shown in Fig. 9b, the softening phenomenon became weaker and weaker from the entrance (Site 1) to exit (Site 6) of the round corner. Moreover, the softening depth of the sub-surface also decreased from  $\sim 250 \mu\text{m}$  to  $\sim 150 \mu\text{m}$ . This could be explained by the decrease in temperature when the boron steel workpieces travelled from the entrance to the exit of the round corner.

**Fig. 9** – The hardness on the cross-section of the round corner shows the softening of the sub-surface, (a) test sites, and (b) hardness profiles of various sites.

- (3) Surface softening of the tool steel was found in a depth of about 200  $\mu\text{m}$  by microhardness profiling. It is considered as the reason not only for galling but also for the formation of the ploughing grooves. Hence, the softening resistance should be considered as an essential criterion in the selection of tool steel for hot stamping dies.

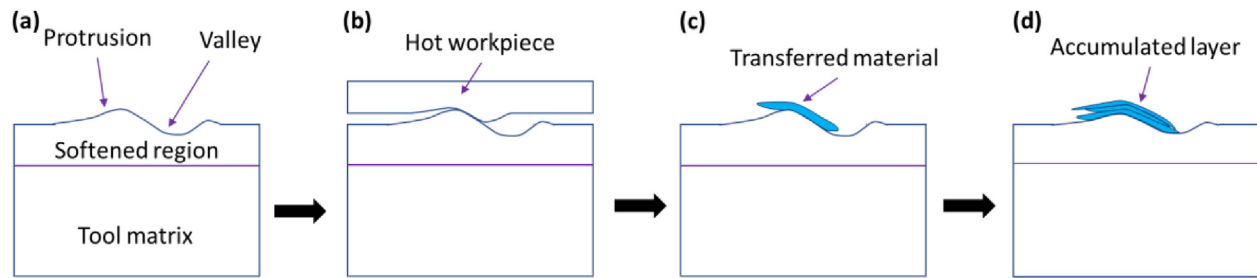
**Fig. 10** – The schematic diagram of the galling phenomenon. (a) Formation of protrusion, (b) Scratching the hot workpiece, (c) Transferred material stuck on the tool surface, (d) Accumulated layer (galling) on the tool surface.

The galling process is schematically shown in Fig. 10. During the initial period, the working condition of the tool is good due to the unsoftened substrate and smooth surface. With the ongoing service (few thousands of cycles), the sub-surface of the tool is softened, as shown in Fig. 9. On the other hand, the already formed workpieces generally have a high hardness (around 500 HV) due to quenching in hot stamping. During the process of unloading, the hardened workpiece could generate some scratches (the valley in Fig. 10a) on the softened tool surface, leaving some protrusions at the edge of the scratches. In the next cycle of forming, these protrusions could scratch the hot and soft workpiece surface of boron steel (Fig. 10b). Consequently, some material could be transferred from the boron steel workpieces to the tool surface (Fig. 10c). Under the forming force and high temperature from the hot workpiece, the adhesive force between the transfer material and tool steel would be high. According to Ref. [17], the adhesive force is largely dependent on the real contact area (atomic level) of two solid materials. The adhesive force between ductile materials will be enhanced with the increased contact area by plastic deformation. In addition, a large adhesive force is often the case when combining similar materials. In the present study, the workpiece and tool are both made of steels. Considering the possible austenitizing at the surface of tool due to heating from the hot workpieces, both types of steel would have an fcc structure in the surface region when forming. This would further enhance the adhesive force. Hence, the transferred material can easily stick to the tool. Notably, this process can be repeated in the stamping processes, which results in the formation of accumulated layers (galling, Fig. 10d) until they are removed as part of daily maintenance. However, the root cause for galling is the softening of the sub-surface, which could lead to the easy formation of scratches and consequently the initiation of material transfer. This is consistent with Heinrichs' work [18]. From the perspective of this investigation, increasing the softening resistance of tool steel or performing hard facing on

the tool could be potential ways to mitigate the galling that happens in the hot stamping process.
