## **Investigation on Pollution-Induced Flashovers of In-Service Insulators in Ethiopian Power Transmission Lines**

Zelalem Desta, B., Wogari, M., Gubanski, S. (2024). Investigation on Pollution-Induced Flashovers of In-Service Insulators in Ethiopian Power Transmission Lines. *Energies*, 17(9). <http://dx.doi.org/10.3390/en17092007>

**Abstract:** Power transmission lines in Ethiopia are experiencing an alarmingly high frequency of unexplained outages triggered by environmental factors, which significantly undermine the reliability of the country's power system. This paper presents investigations aiming to identify those among the unexplained fault records that have been caused by pollution induced flashovers. An identification method is developed, which associates the contextual fault features, such as information about the characteristics of the fault, fault location, and time of day, as well as month of its occurrence with local meteorological/climatic and environmental conditions. A total number of 4231 unexplained faults, recorded between 2015 and 2022, were analyzed. Among them, 1045 faults (24.7%) were identified as being most likely caused by pollution induced flashovers.

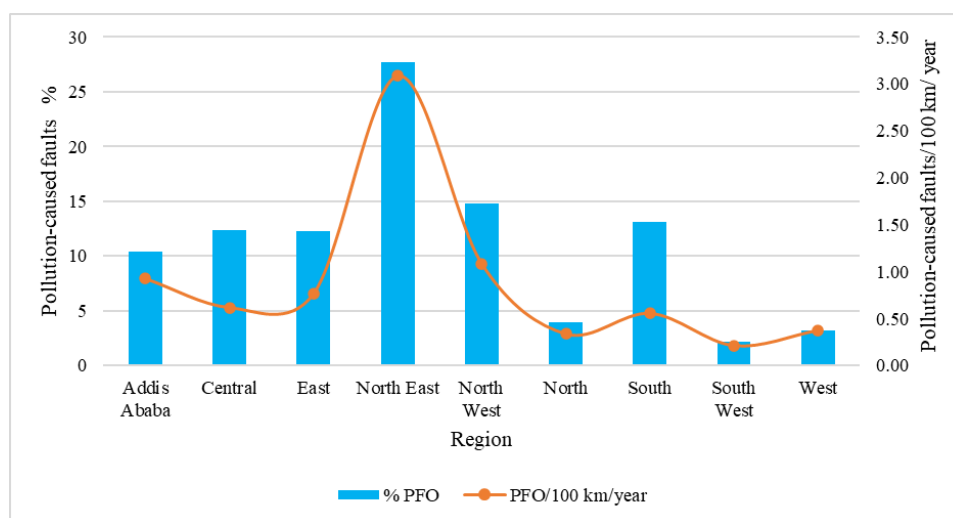
The distribution of pollution-induced faults in each grid region of EEP between 2015 and 2022 is presented in Figure 4. Among these regions, the Northeast region suffered 290 (27.8%) faults, the highest frequency of interruptions with 3.1 faults/100 km/year, followed by the Northwest region which endured 155 (14.8%) faults and 1.1 faults/100 km/year. The Addis Ababa, East, Central and South grid regions also experienced a higher number of interruptions during this period with more than 100 faults and 0.55 faults/100 km/year each. The Southwest region suffered 23 (2.2%) faults, the lowest number of incidents with 0.2 faults/100 km/year.

**Figure 4.** Distribution of pollution-induced flashover faults across EEP grid regions from 2015–2022.

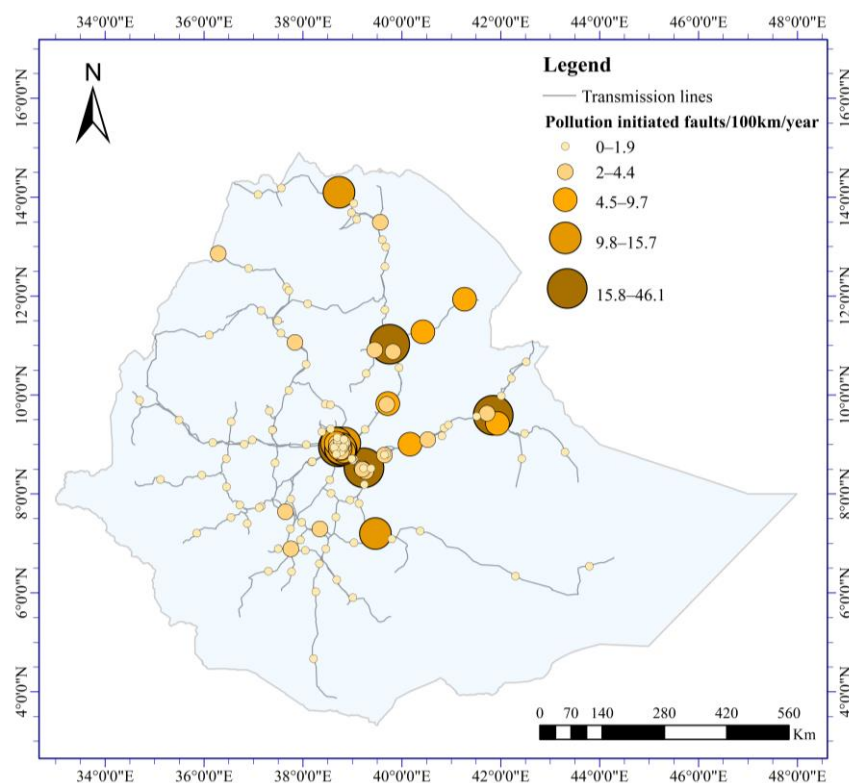
**Figure 5.** Geographical distribution of pollution induced faults across Ethiopia from 2015–2022.

Pollution flashover faults were found in 152 circuits, with an average of 3.0 faults per 100 km per year. In terms of geographical variations, the majority of these circuits were concentrated in the Northeast, Eastern, and Central part of Ethiopia as shown in Figure 5.

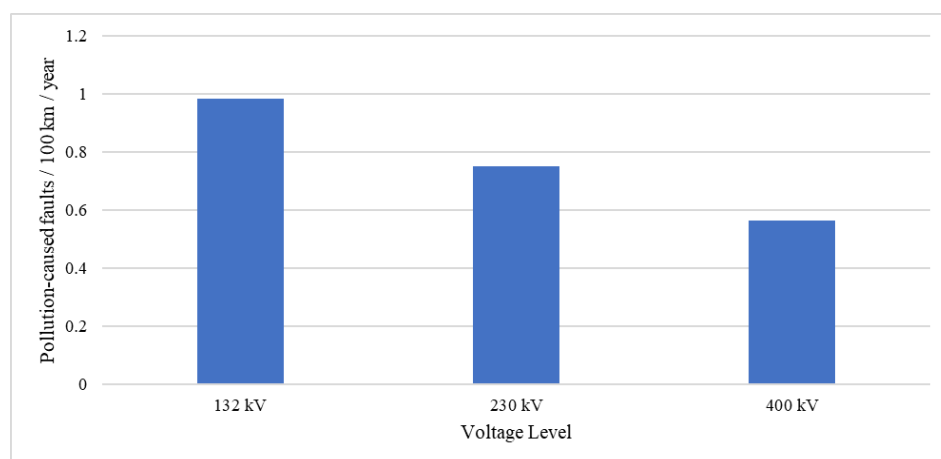
**Figure 6.** Frequency of pollution-induced faults for 132 kV, 230 kV, and 400 kV lines.

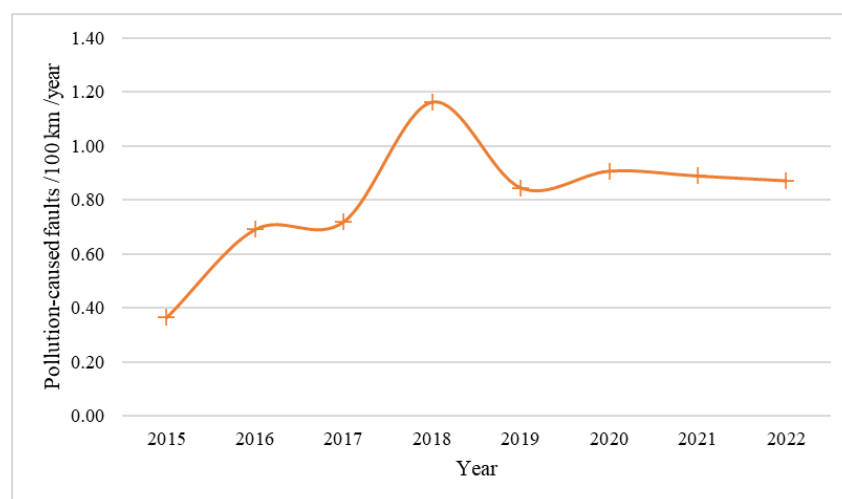
Scrutiny of the identified pollution-induced faults revealed that yearly trends in their appearance varied from one year to another—it had an increasing trend, peaking in 2018, as shown in Figure 7. Since 2019, it has become constant due to pollution saturation (an equilibrium condition between the pollution deposit rate and insulator cleaning rate) [1]. The reason for the increasing trend could be attributed to changes in environmental and meteorological conditions, issues related to the selection and dimensioning of insulators, infrastructure aging, and ineffective maintenance procedures. Further study is required to elucidate the reason for this trend and develop strategies to mitigate future fault occurrences.

**Figure 7.** Annual variation in pollution-induced faults in Ethiopian power grid.

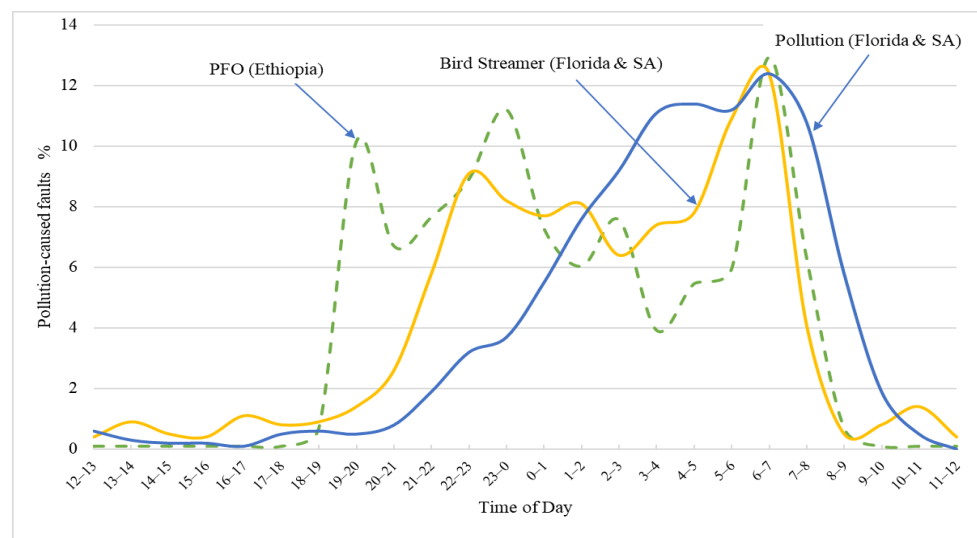
The time-of-the-day curve of pollution induced faults (PFO) is shown in Figure 8. It exhibits a pattern characterized by three peaks. The number of faults rises quickly after sunset between 19:00–20:00, and after showing a decrease, it again rises around midnight, mainly due to pollution wetting that can be associated with light precipitation, dew formation, and moisture adsorption during the night. At around 06:00 in the early morning, there is again a rapid increase in the fault number, likely due to a combination of wetting and bird steamers, the latter usually occurring during the spring season in areas populated by large birds. Thereafter, the number of faults drops close to zero and remains at this level practically for the whole day. This pattern has a good correlation with the

**Figure 8.** Pollution-induced faults within the Ethiopian network, in comparison with the typical time-of-day fault profiles attributed to pollution and bird streamers observed in Florida, USA, and South Africa [2,19].

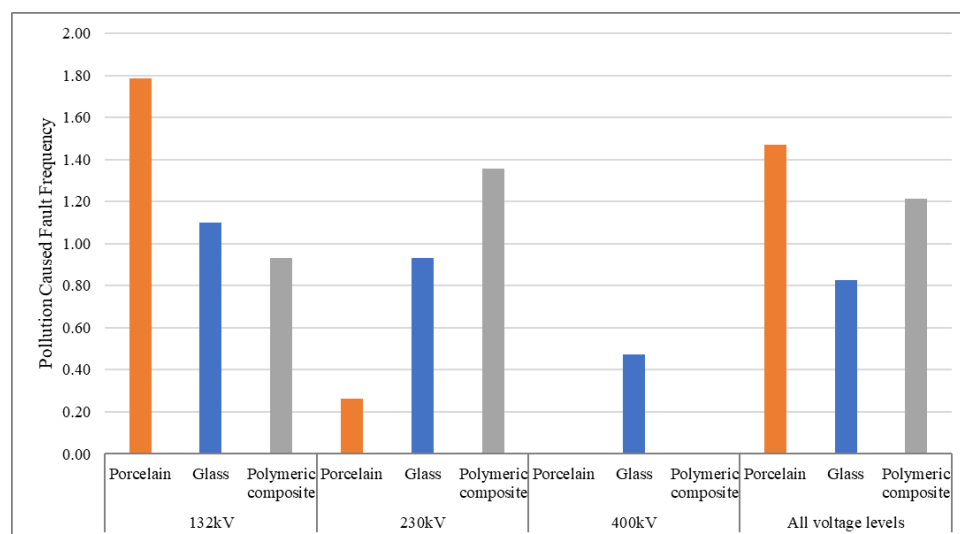
The analysis result indicates that, out of the total 1045 pollution-induced faults, 77 (7.3%) occurred on porcelain strings, 542 (51.9%) on glass strings, and the remaining 426 (40.8%) occurred on polymeric composite long rods. Most of the faults occurred on glass and polymeric insulators which, respectively, represent 61% and 34% of the total insulators installed in the system, while porcelain insulators strings represent only 5%. Figure 10 compares the pollution flashover intensity for each voltage level and for insulator types, covering eight consecutive years from 2015 to 2022. For 132 kV lines, the intensity of pollution-induced flashovers was highest on strings assembled from porcelain cap-and-pin insulators, with the intensity of 1.79 faults/year/1000 units, followed by glass insulator strings with 1.10 faults/year/1000 units and polymeric long rod insulator, which suffered the least number of faults with less than 0.93 faults/year/1000 units. For 230 kV lines, the intensity of pollution-induced flashovers was highest on strings of polymeric composite insulators with the intensity of 1.36 faults/year/1000 units and followed by glass insulator strings with 0.93 faults/year/1000 units. Here, porcelain insulators had the lowest intensity of faults with less than 0.26 faults/year/1000 units. In 400 kV lines, glass insulator strings are exclusively used and experienced the fault intensity of 0.47 faults/year/1000 units.

**Figure 10.** Distribution of PFO intensity by type of insulator (2015 to 2022).

For the three voltage levels, porcelain insulator strings had the highest pollution-induced flashover intensity of 1.47 faults/year/1000 units, followed by polymeric composite long rod insulators with an intensity of 1.21 faults/year/1000 units and glass insulator strings with the lowest fault intensity of 0.83 faults/year/1000 units. The percentage distributions of individual insulator types and a comparison to the intensities of pollution-induced flashovers for all voltage levels are summarized in Table 3.

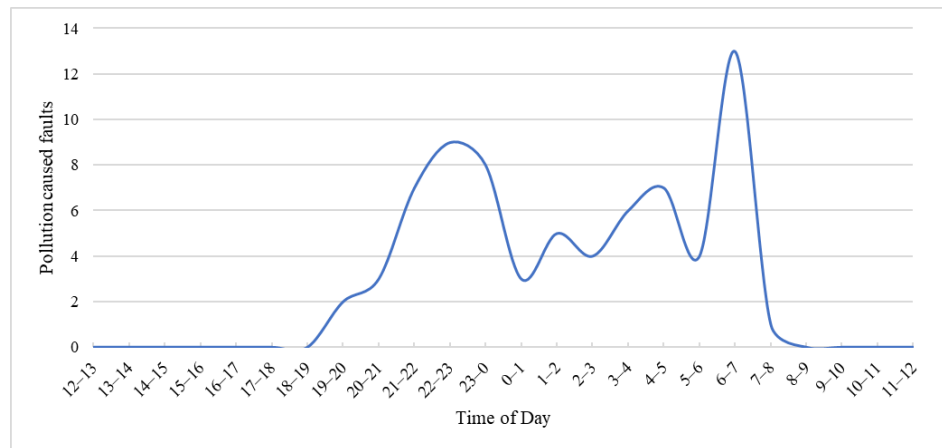
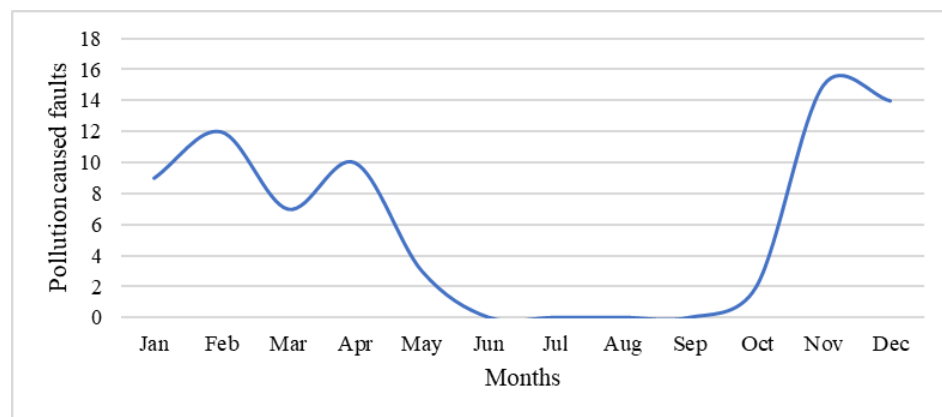
The time-of-the-day curve depicted in Figure 15 reveals that most of these faults occurred close to midnight, from 22:00 to 23:00, and early in the morning, between 6:00 to 7:00. Figure 16 indicates that the majority of faults occurred between November and February, attributed to dew formation on the glass insulator surface, and from March to May (due to light precipitation), respectively, corresponding to the dry and light rainfall seasons in the area. Most faults were concentrated during spring ploughing, winter crop harvesting, and burning. The bird streamer mechanism may contribute to the faults occurring in October and November, during the autumn season. The described conditions are consistent with type A and type B pollution-flashover mechanisms.

**Figure 15.** Daily distribution of pollution-induced faults of the Bahir Dar II—Debre Markos—Sululta 400 kV line.

**Figure 16.** Monthly distribution of pollution-induced faults of the Bahir Dar II—Debre Markos—Sululta 400 kV line.
