Results from laboratory tests of wind driven rain tightness in more than 100 facades and weather barriers

Lars Olsson, M.Sc.

SP Technical Research Institute of Sweden

KEYWORDS: *façade, wall, weather barrier, rain tightness, moisture, ETICS, EN 12865*

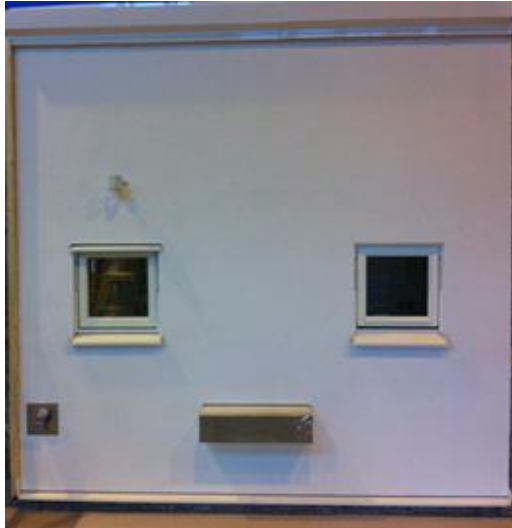
FIG 1. Example of test object, rendered stud wall with façade details.

The test objects were mainly mounted by the client in a steel test frame with the size of 3x3 meters in SP's laboratory. An airtight barrier of plastic film was attached to the inside of the frame walls. This film was perforated to create an air leakage of 1,6 l/s m² at 50 Pa pressure difference, which represents the maximum allowable air leakage through the climate envelope according to Swedish building regulations 2002 (Boverket 2002). Before the testing started, each façade detail (except the movement joint) was subjected to between 5 - 10 blows (represented by a flat piece of wood hit with a hammer) to simulate the mechanical loading, which they would be subjected to in reality during nailing/construction.

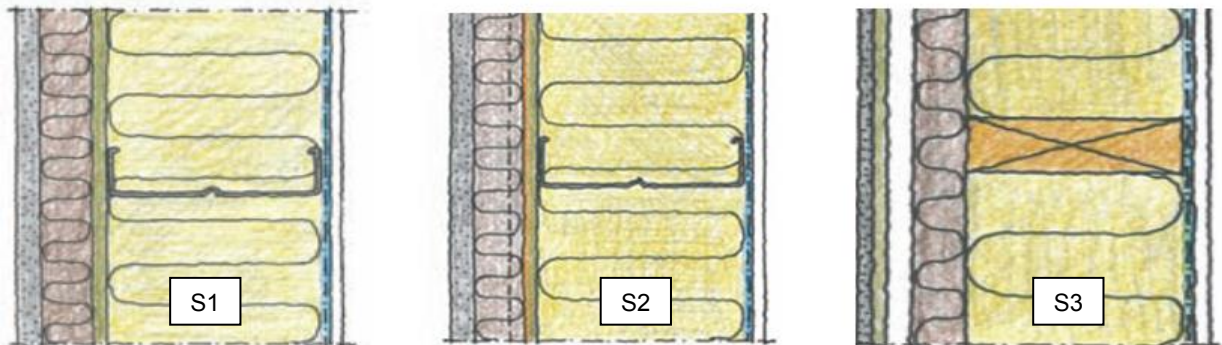
FIG 2. S1=Undrained (ETICS), S2=Drained, S3=Ventilated and drained

Various types of facades systems and weather barriers systems have been tested. Objects are divided with regard to function as undrained, drained or ventilated facades, sandwich elements of metal or concrete and second rain barriers (weather barriers) of fabric, board, or slab, see examples of designs in FIG 2 and FIG 3.

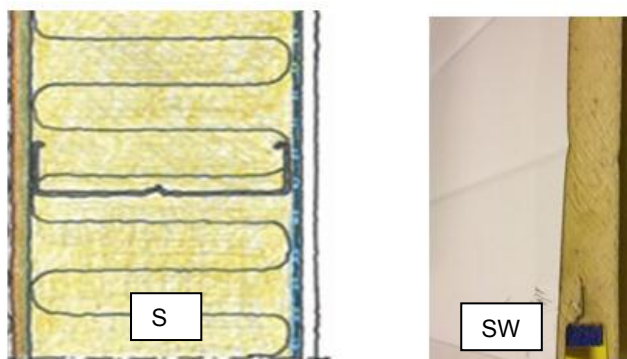
FIG 3. S=Second rain barrier, SW=Sandwich elements of metal or concrete.

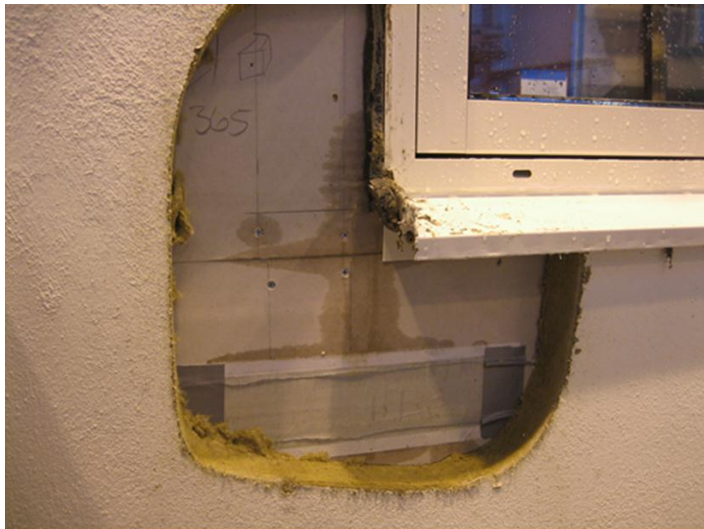
FIG 4. Indicators were placed just below all details behind the façade or exposed surface. The photo was taken after the rain test.

Verification was carried out both visually and with moisture indicators which were attached underneath these details, see FIG 4. The moisture indicators were checked after each pressure level. Indicators consisted of absorption paper with thin electrodes for resistance measurement. At the end of the test, the wall was opened in order to investigate any further leakage and to estimate the leakage rate of each leak.

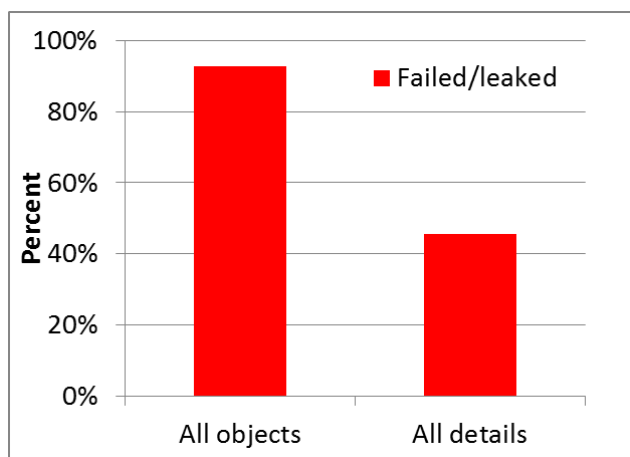
FIG 5. Percentage of objects and details that leaked or failed. 110 objects and 471 details were tested.

More than 90 % of all tested objects failed and nearly 50 % of all details failed. Connections to windows got the worst results overall, despite windows being the most common details in facades. It is difficult to achieve good results in ETICS or undrained facades. It is not quite as difficult to achieve good results with ventilated façades that provide almost no pressure difference over the façade cladding, compared to unventilated solutions where there is a pressure difference across the façade. The weather barrier would be particularly important for the facades of multi-storey buildings, as leakages are added together downwards. If there are also flaws in the weather barrier there is an increased risk of leakage within the structure. Results from the tests of the weather barriers exposed to rain are similar to conclusions derived for facades.

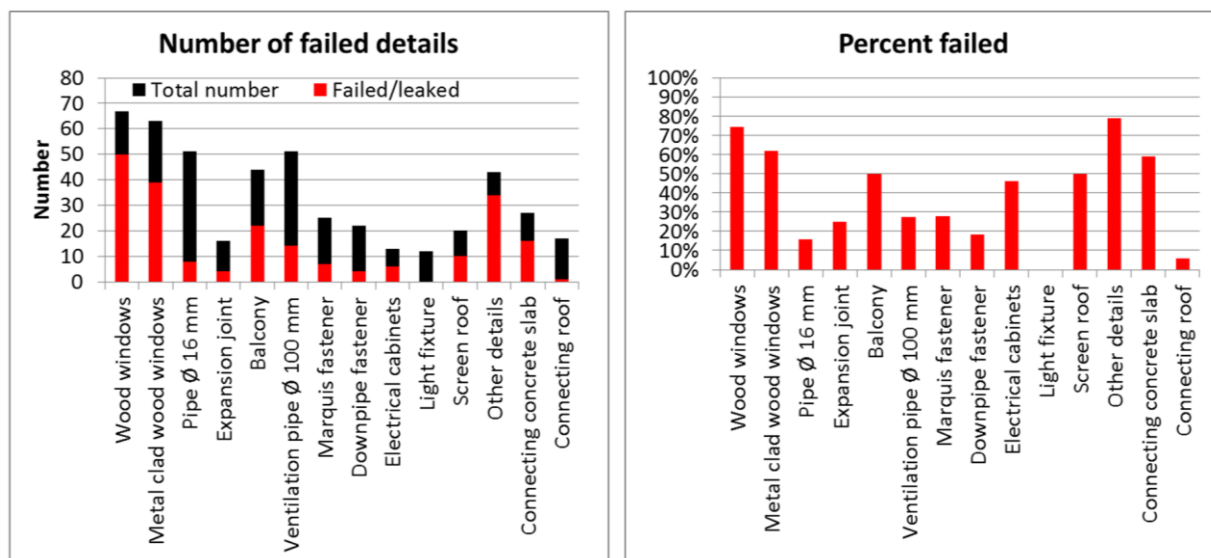
FIG 6. Number of failed details and total number tested (left). Percent of details that failed (right)

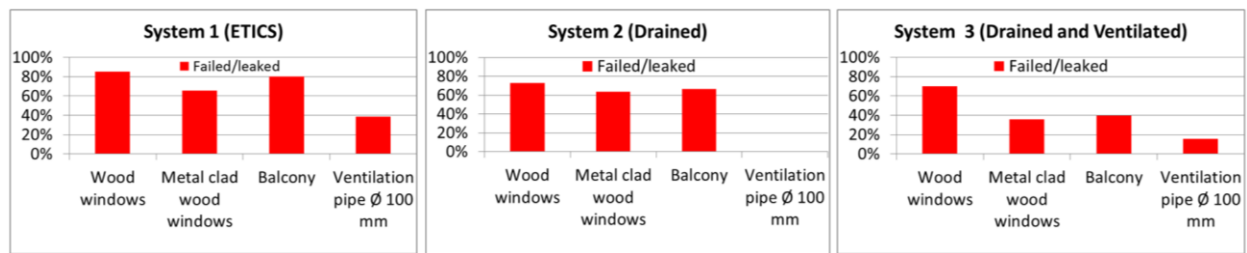
FIG 7. Comparison between system 1, 2 and 3 of failed details of common details.

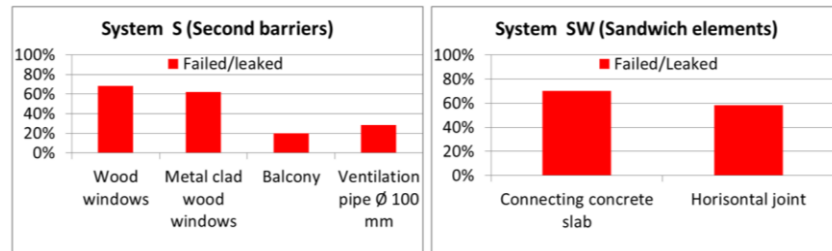
FIG 8. Comparison between system S, SW (and system 1-3, see FIG 7) of failed details of common details.
