Department of Architecture and Civil Engineering  
Division of Building Technology  
CHALMERS UNIVERSITY OF TECHNOLOGY  
Gothenburg Sweden 2018

Driving Rain Tightness, Intrusion Rates and Phenomenology of Leakages in Defects of  
Façades: A New Calculation Algorithm

LARS OLSSON

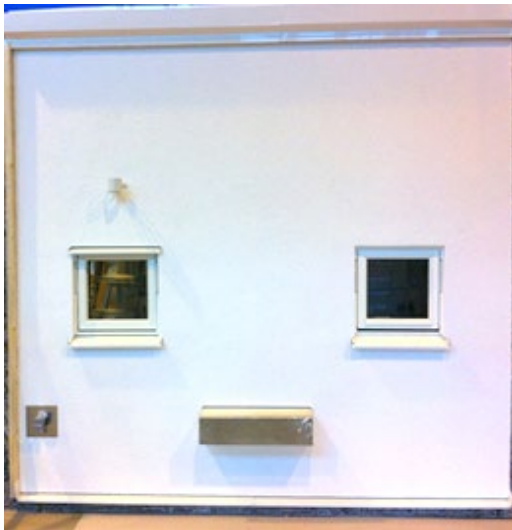
*Figure 3. Example of a commercial test wall (size 3 x 3 m) with façade details; windows, balcony, and two fixings (marquis and downpipe fastener).*

Rain leakage was detected by using indicators that consisted of absorption paper and thin electrodes for resistance measurement, in the study of compilation of over 100 commercial tests. As façades usually consist of multiple façade details, the façade details are important in the testing of commercial façades, see Figure 3 and **Paper I**.

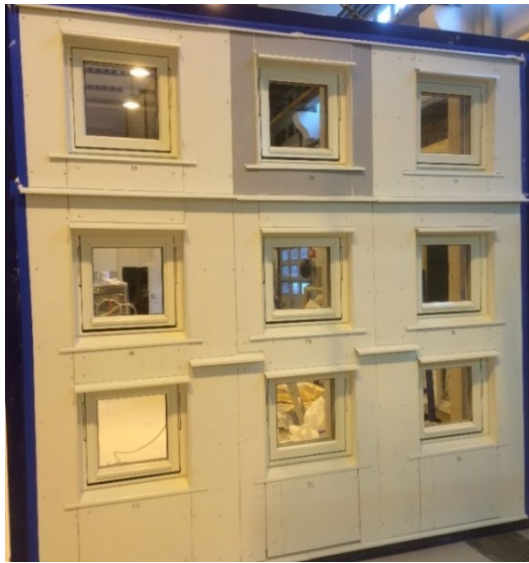
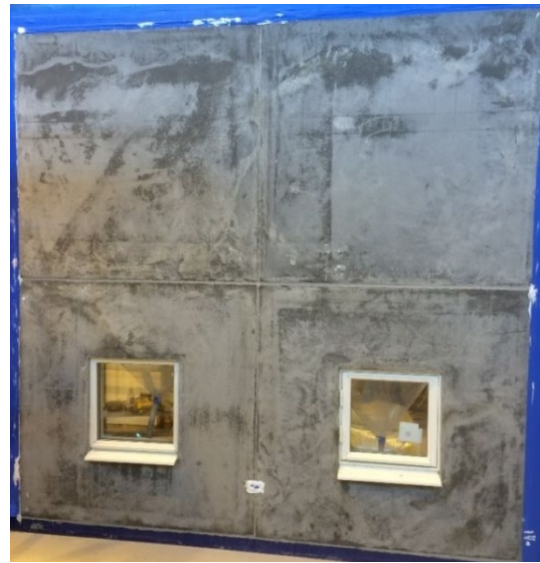
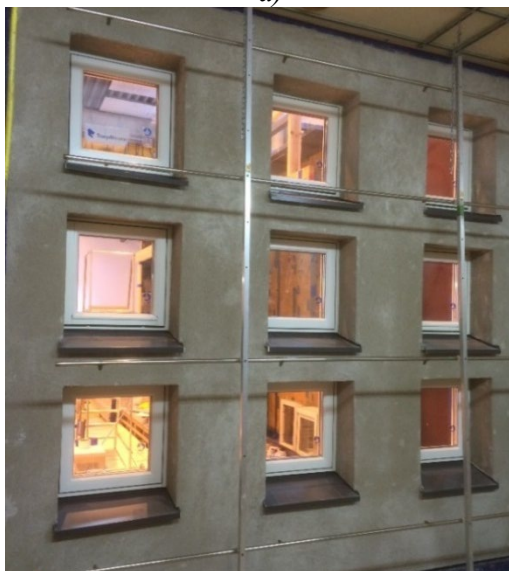
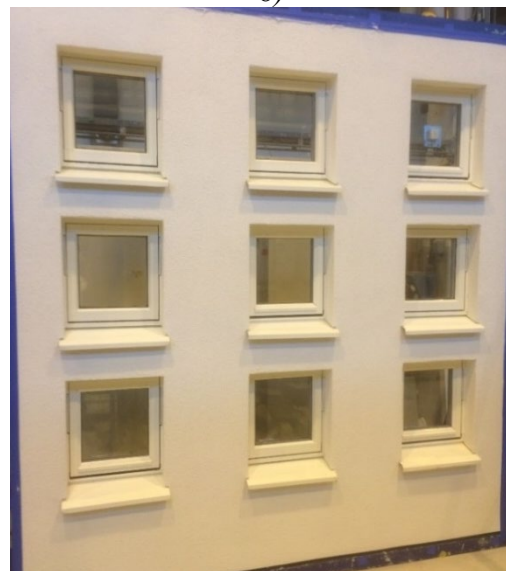
Figure 4. (a) Ventilated façade with polymer composite boards, (b) 15 mm thin prefabricated high-performance concrete sandwich element with elastic joints, (c) 20 mm plaster façade with 200 mm mineral wool with drainage possibility and weather barrier (second line of defence), (d) 8 mm plaster on 100 mm EPS with drainage possibility and weather barrier. Water spray racks are shown in (c).

The additional tests on windows in four different types of façades with 29 window connections, see Figure 4, showed similar results. Window-wall interfaces leakage occurred in around 60 % of the windows connections (window-wall interfaces), see **Paper III**. The three largest point water leakages were within 0.01-0.03 l/min, with the water load as set out

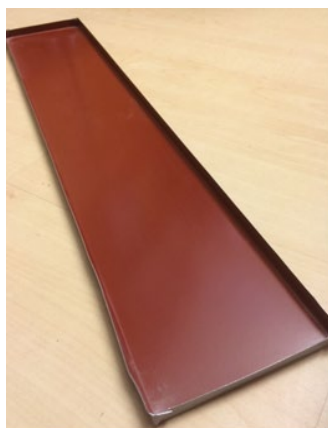
Figure 5. (a) Photo of a collection tray that was placed in the gap under the window frame (the gap was air sealed on inside with transparent tape). (b) Photo of catchment chutes positioned on the outside of the weather barrier, between the façade (to be mounted) and the weather barrier, the smaller just below the exterior window sill and the larger placed approximately 30 cm above the bottom of the wall. To the right of the image, you can see the installation of EPS-insulation in progress.

Within the walls, under the bottom of window frame, collecting trays were installed for measuring the water leakage amount and a little further down, collecting chutes were installed under the details etc. and led with a hose to a closed collecting container, to measure the water leakage flows, see Figure 5.

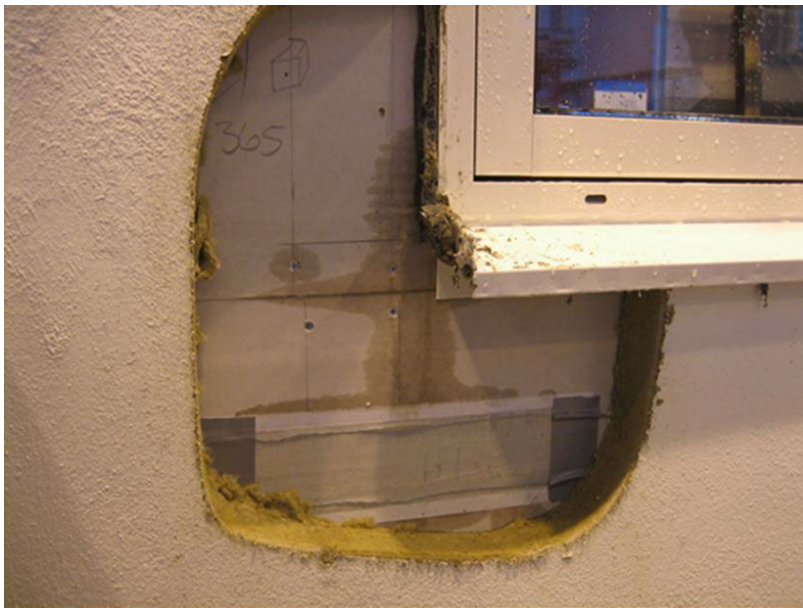
Figure 11. Rain leakage at the corner of the window-wall interface in an ETICS façade (photo from after the measurements were finished and the wall was opened). The material behind the plaster and insulation board is in this case moisture retaining, which should be avoided.

The windows-wall interfaces were particularly difficult to get raintight despite the fact that they are one of the most common details in façades, see Figure 11.
