THESIS FOR THE DEGREE OF LICENTIATE OF ENGINEERING

Anchorage of naturally-corroded, plain bars in  
Reinforced Concrete structures

Department of Architecture and Civil Engineering

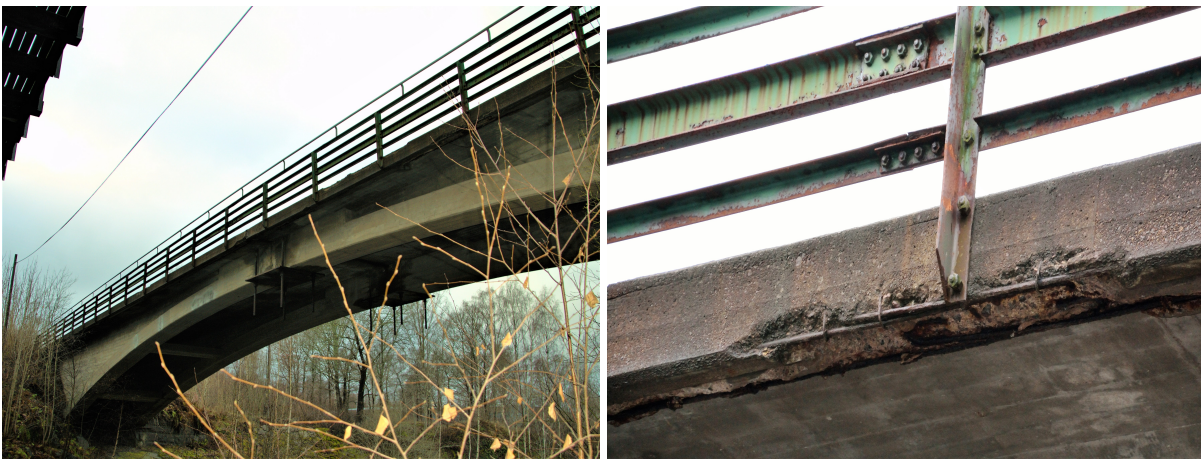
**Figure 3.2:** *Gullspång bridge: view of the bridge before demolition (left) and exposed tensile reinforcement bars and spalling in an edge beam (right).*

Gullspång bridge (Fig.3.2) was built in 1935 and torn down in 2016 due to heavy corrosion damages. The edge beams were carefully taken out, cut in segments and designated to be used for research. Having been exposed for 81 years to weather conditions that include snow, freezing-thawing cycles and wind, as well as to de-icing salts and traffic loads, the beams presented different cracks on their surface, and spalling strongly affected the geometry in some locations (Fig.3.2). Signs of corrosion were clearly visible, but not uniformly distributed.

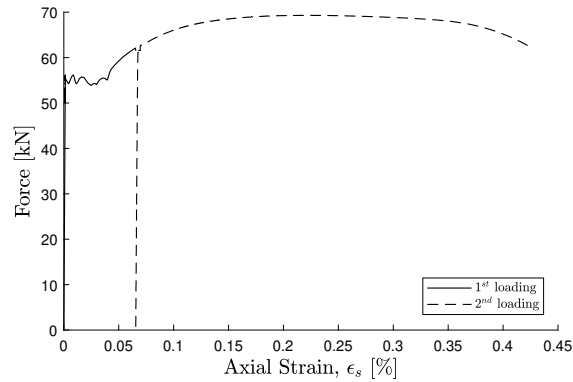
**Figure 3.4:** Example of tensile test of an uncorroded reinforcement bar from Gullspång bridge: the same bar was loaded in two different stages to better capture the mechanical properties of the steel.

Two bars were subjected to additional tests so as to characterize the material properties of the steel. The bars were uncorroded and extracted from an untested segment of the bridge. Each bar was loaded first in tension until indication of strain hardening and then unloaded. The bars were then reloaded until rupture. Fig. 3.4 shows good agreement with the hypothesis of isotropic hardening, meaning that, by testing the already hardened bar in tension, it was possible to estimate, with good confidence, the force reached in the bar when the first test was interrupted.

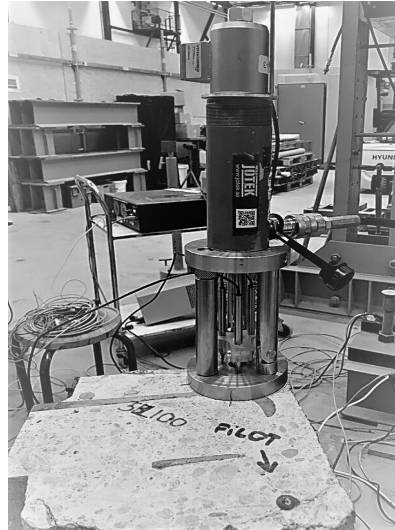
**Figure 3.8:** *Pull-out test set-up*

The third series of tests was designed to avoid the situation of reinforcement reaching the yield point. Direct pull-out tests were performed using cut sections (50, 75 and 100 mm in thickness ) from untested segments of the edge beams from Gullspång bridge. The test set-up required drilling, threading, and inserting a threaded rod in the individual rebars. Thereafter, each individual rebar was pulled out using a hydraulic load cell. A special rig was designed and produced (See Fig.3.8). This consisted of three legs, two of which could be length-adjusted to account for any skew angle between bar and cut concrete surface. The need of avoiding yielding of bars gave an upper limit of 100 mm embedment length. The lower limit was set to 50 mm, for feasible cutting of concrete slices and drilling (20 mm deep) not to affect the major part of the length. Based on these arguments,

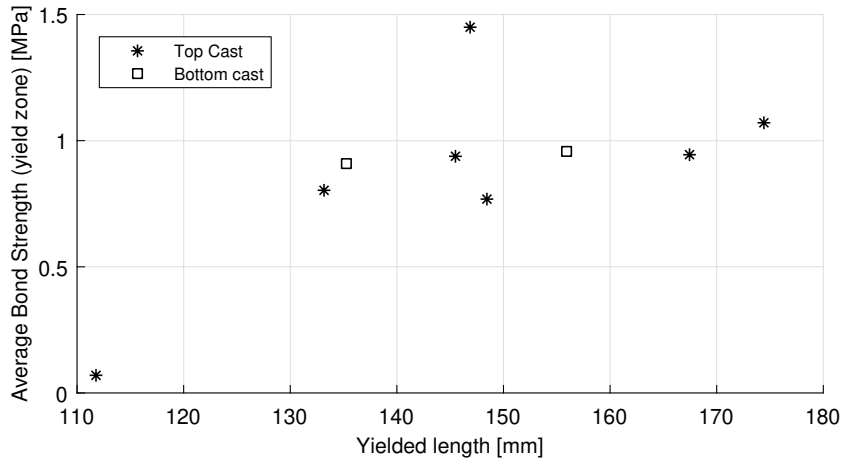
**Figure 4.3:** The average bond strength in the yielded zone is plotted against the length of the yielded zone in the tested bar. The influence of the cast position is shown by asterisk for top-cast and squares for bottom-cast bars.

In Fig. 4.3, the average corrosion level of the bars is presented and plotted against the calculated bond strength in the yielded area. The results presented a rather small scatter, with an average of about 1 MPa. They also show a noticeable

loss of bond strength after yielding (about 90% loss compared to the bond strength in the unyielded zone of the same rebar). However, less data were available due to damages in the extraction process of the bars.

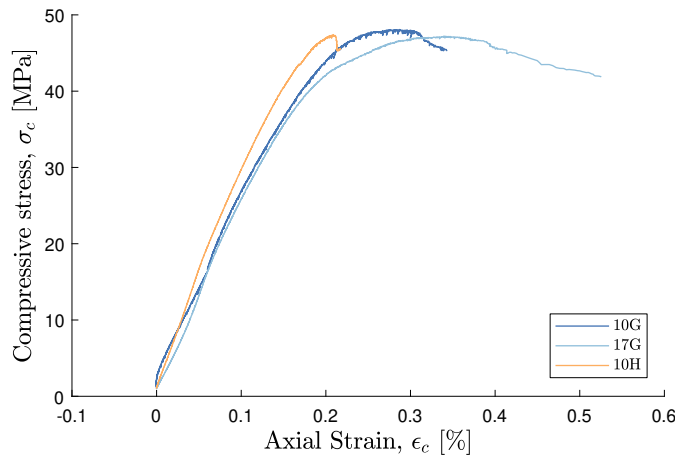
**Figure A.1:** *Stress-strain curves of tested cores 17G, 10H, and 10G.*

Two of the three tested cores showed a change in the elastic slope at low stresses. This is not usual, however, there are two possible explanations to this behaviour. A change of stiffness in the ascending branch of the stress-strain curve often indicates frost-damage in the concrete sample [18]. This is likely linked to the presence of randomly oriented micro-cracks prior testing, resulting from freeze-thaw cycles. Large strains at peak stresses and a more ductile behavior are generally as well
