8th Swedish Production Symposium, SPS 2018, 16-18 May 2018, Stockholm, Sweden

# Measurement of the thermal cycle in the base metal heat affected zone of cast ATI<sup>®</sup>718Plus<sup>™</sup> during manual multi-pass TIG welding

## Abstract

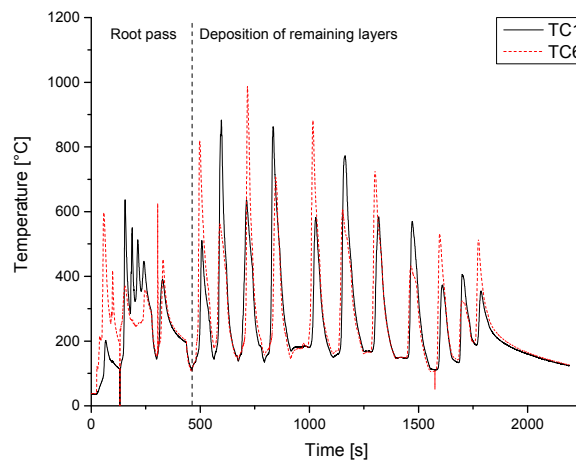
Fig. 4. Thermal profile recorded for TC1 and 6 (25% of groove height) at groove 2

Thermal cycles recorded at position 1 and 6 (25% of groove height, 1.34 and 1.37mm horizontal distance from fusion line, respectively) are exemplarily shown for groove 2 in Fig. 4. All temperature recordings show diffuse (i.e. not continuously cycling as during linear torch movement) thermal cycling in the beginning resulting from the deposition of a root bead in the grooves, as indicated in the figure. Peak analysis revealed that the maximum temperature rarely exceeded 1000°C. For groove 1 the temperature maxima were recorded during root pass deposition, while for groove 3 and 4 the maximum temperature was reached during the first 2 weld passes after the root bead had been deposited. No thermocouple in groove 2 recorded values exceeding 1000°C.

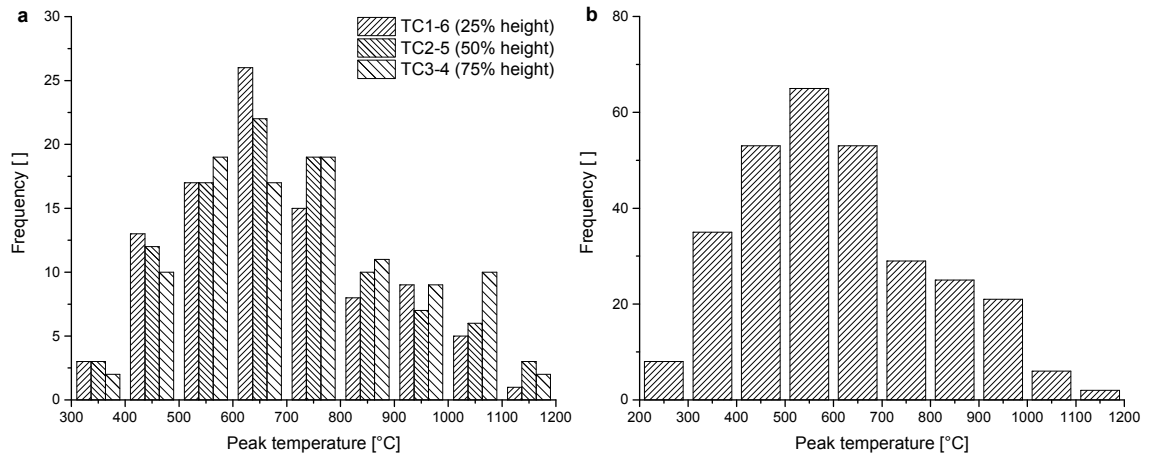
Fig. 5. Distribution of peak temperature during welding (a) grouped by position relative to groove height, (b) all thermocouples combined.

While it is not necessary to represent hard-to-weld conditions for recording thermal cycles, this study was aimed to provide additional temperature data for a previously carried out repair welding study [5] by using identical welding conditions. The frequency of observed peak temperatures during the complete welding operation is shown in Fig 5 a for thermocouples grouped by their location along the groove side walls. The small difference as compared to the distribution considering all thermocouples (Fig. 5 b) indicates that the location alongside the groove side walls has a very limited influence on the thermal cycle. The use of averaged values for exposure time should hence give a reasonable indication for the exposure time that could be expected for comparable repair welding operations. However, to be useful to explain HAZ liquation cracks commonly observed in the base metal HAZ, temperature data recorded more closely to the fusion line is necessary. With the used thermocouple placement it is not possible to obtain such data in a reliable way.
