Methodology for Testing Rebar-Concrete Bond in Specimens from Decommissioned Structures

Lundgren, K., Robuschi, S., Zandi, K. (2019). Methodology for Testing Rebar-Concrete Bond in Specimens from Decommissioned Structures. *International Journal of Concrete Structures and Materials*, 13(1). <http://dx.doi.org/10.1186/s40069-019-0350-3>

Karin Lundgren^{*} , Samanta Robuschi and Kamyab Zandi

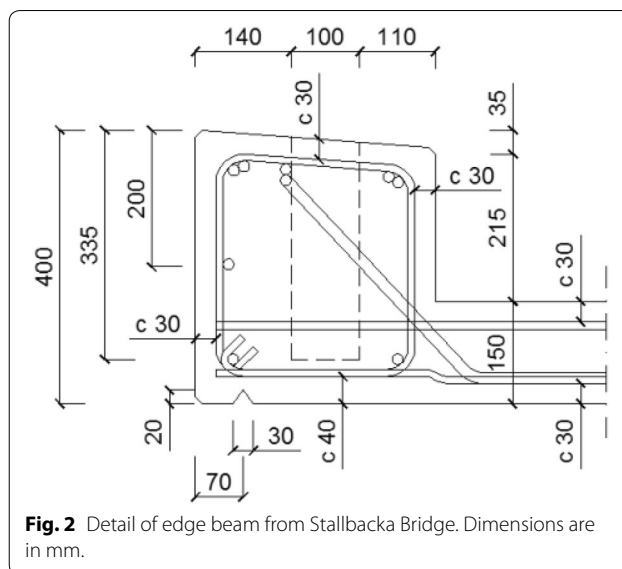
The edge beams contained main reinforcement in bundles of two, see Fig. 2. It was therefore considered very difficult to grab a bar, or bundle, for direct pull-out. However, the geometry of the edge beams was suitable for bending tests. This allowed evaluation of the anchorage behaviour at a structural level and so beam tests were chosen. Suspended supports were chosen

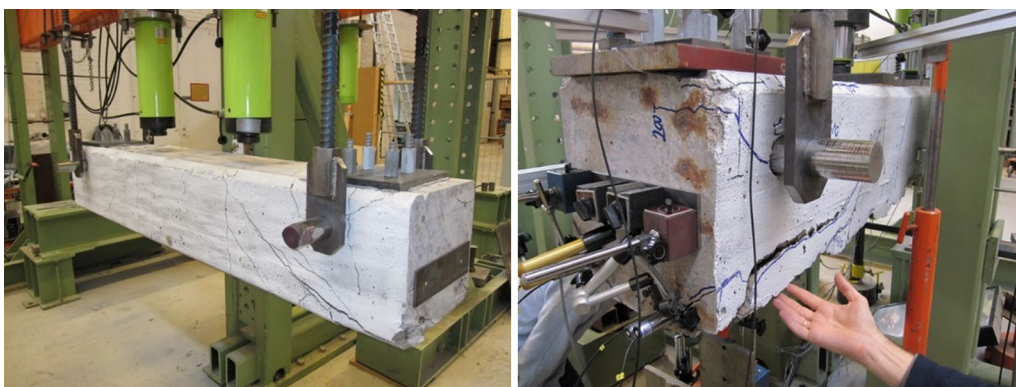
Fig. 4 Pilot tests with improved strengthening method at the suspension holes. Left: specimen without initial damage, after structural testing. Right: specimen with initial corrosion damage including cover spalling, upon failure.

Two beams with the improved strengthening method were tested, one almost undamaged and one with severe corrosion damage including cover spalling. They were selected to investigate whether the developed test method will result in anchorage failure for all corrosion levels of interest. These pilot tests succeeded well, both resulting in anchorage failure as intended. Upon loading, the first cracks were flexural-type and occurred between the two concentrated loads. With increased load, flexural and inclined shear cracks developed in the shear spans. When the cracks propagated towards the supports, the anchorage became critical. In other words, failure occurred (as intended) due to insufficient anchorage of the tensile reinforcement. Photos of the crack patterns after the tests are shown in Fig. 4.

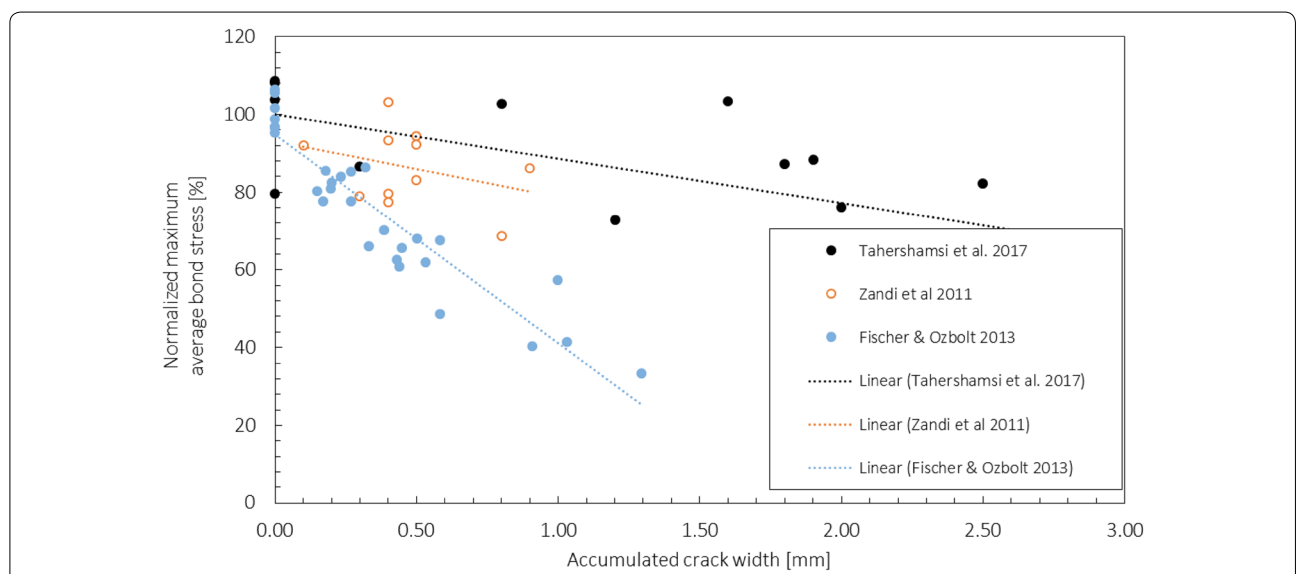
Fig. 5 Comparison between test results from naturally corroded specimens and results from artificially corroded tests in terms of bond strength, normalized with respect to the average maximum bond strength obtained from reference samples, versus maximum crack width of splitting cracks.

The results were compared to others in literature with artificially induced corrosion; all with rebars of 16 mm diameter: (Berra et al. 1997; Rodriguez et al. 1994; Fang et al. 2004; Zandi et al. 2011; Fischer and Ozbolt 2013). It was observed that for the same crack widths, the specimens with natural corrosion had slightly higher bond capacity compared to other studies found in literature with artificially induced corrosion, see Fig. 5. On the other hand, for the same corrosion level, it was the opposite; i.e. the specimens with natural corrosion had slightly lower bond capacity compared to most other studies found in literature with artificially induced corrosion, see Fig. 6. These conclusions may seem contradictory, but are due to that for the same crack widths, the specimens in this study had much less corrosion level compared to other studies found in literature with artificially induced corrosion. This is most likely due to different effects of artificial corrosion and natural deterioration including corrosion taking place over a very long period, combined with e.g. freezing–thawing.

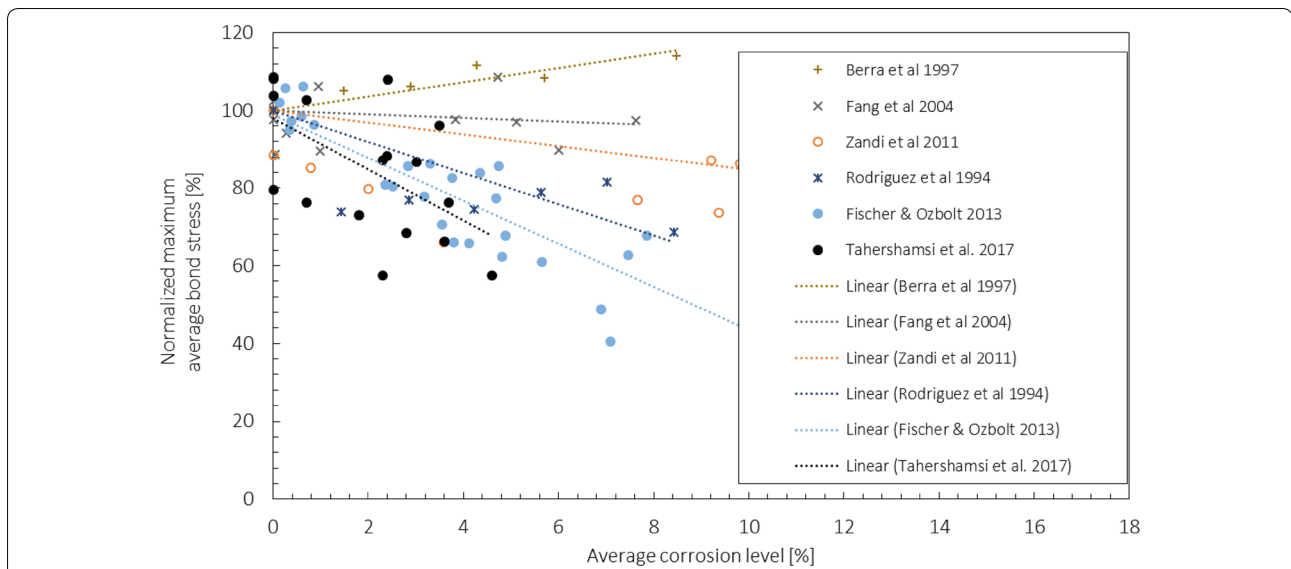
Fig. 6 Bond strength normalized with respect to the average bond strength obtained from reference samples versus average corrosion levels. Comparison between test results from naturally corroded specimens and results from artificially corroded tests from literature.

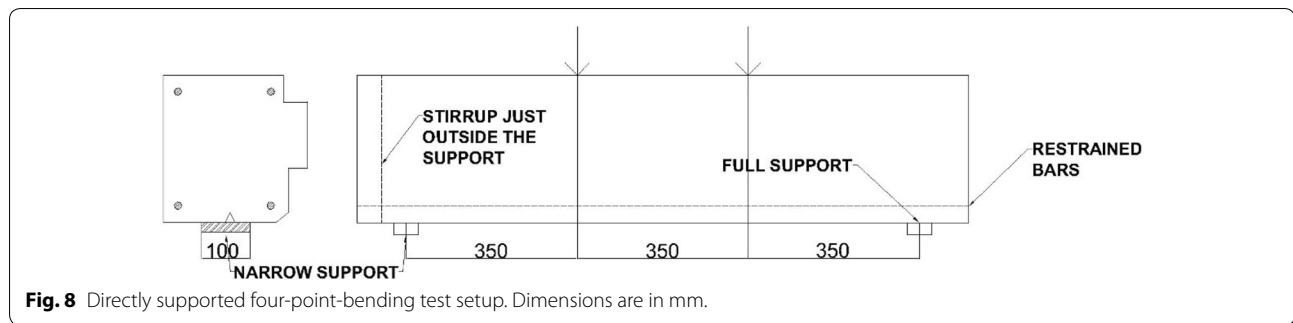
The next test setup considered was therefore a directly supported four-point-bending beam test (Fig. 8). To directly support the beam while minimising support pressure on the reinforcement bars, a narrow support was introduced. This was positioned in between the bars on one side of the beam where anchorage failure was expected. The specimen was designed to have a stirrup (external to the narrow support) to help redistribute the more highly concentrated, support-generated stresses. On the other side, where a full-width support was used, the bar ends were restrained by washers and bolts, to avoid end slips. The aim was to design a test setup which could achieve anchorage failure when a major shear crack opened. Nonlinear 3D FE analysis was adopted as a tool to investigate the crack pattern (Robuschi et al. 2018). In these analyses, the bond-slip relationship was assumed to be constant along the entire bar, with a maximum bond stress of 1–7 MPa in different analyses. From the results, it was noted that rebar yielding followed shortly after bending cracks appeared. Furthermore, the low bond capacity [which, according to literature, is likely for smooth bars (Cairns et al. 2006)], low reinforcement ratio (0.54%) and low reinforcement yield strength, made it difficult for the beam to redistribute stresses once the first bending cracks opened. Thus, no shear crack was observed in the analyses; only bending cracks, either beneath the loading plates or at mid-span. Finally, the

- Test 3 was an asymmetrically supported four-point-bending test (Fig. 8). This had no bars restrained and was tested as positioned on the bridge, resulting in anchorage failure on the full-support side. This test was characterised by the development of two cracks underneath the load plates. The use of digital image correlation made it possible to observe a third-strain concentration zone in the mid-span, but a visual inspection did not show any crack. Yielding of the bars followed, with the bars on the full-support side eventually starting to slip one at a time.

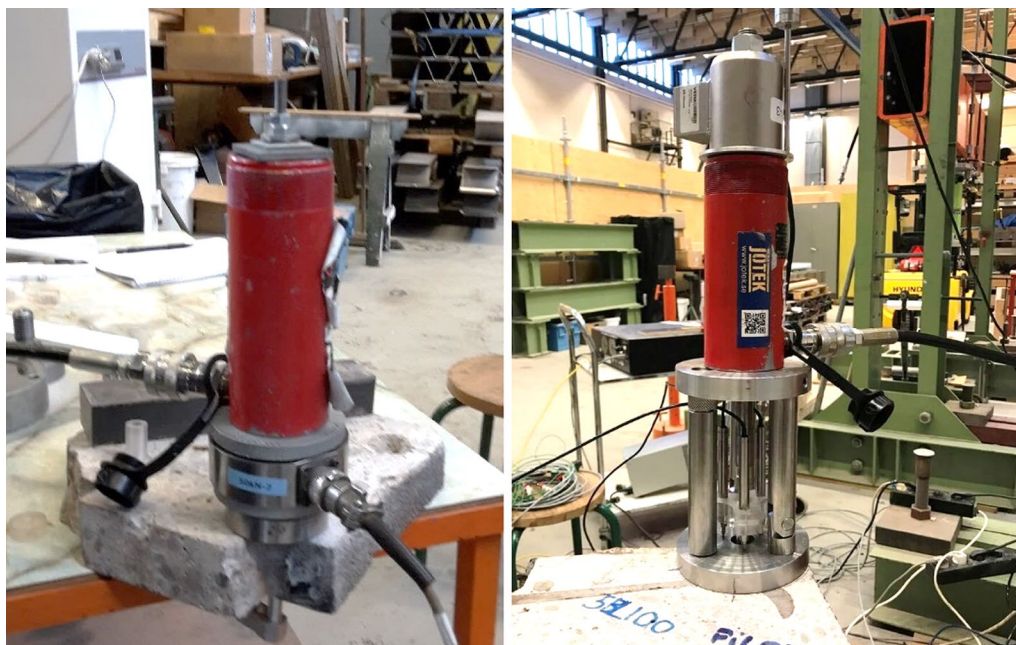
Fig. 11 Pull-out test setup, (left) in pilot test and (right) with developed rig.

This test methodology ensured straight pulling-out of the bar and made it possible to obtain stable measurements of load and passive and active slip. Cone failure was still observed in some of the tests, but with dimensions of only a few millimetres. Thus, the effect on embedment length could be considered negligible.
