Tool wear by dissolution during machining of alloy 718 and Waspaloy: a comparative study using diffusion couples

Hoier, P., Surreddi, K., Klement, U. (2020). Tool wear by dissolution during machining of alloy 718 and Waspaloy: a comparative study using diffusion couples. *International Journal of Advanced Manufacturing Technology*, 106(3-4): 1431-1440. <http://dx.doi.org/10.1007/s00170-019-04805-9>

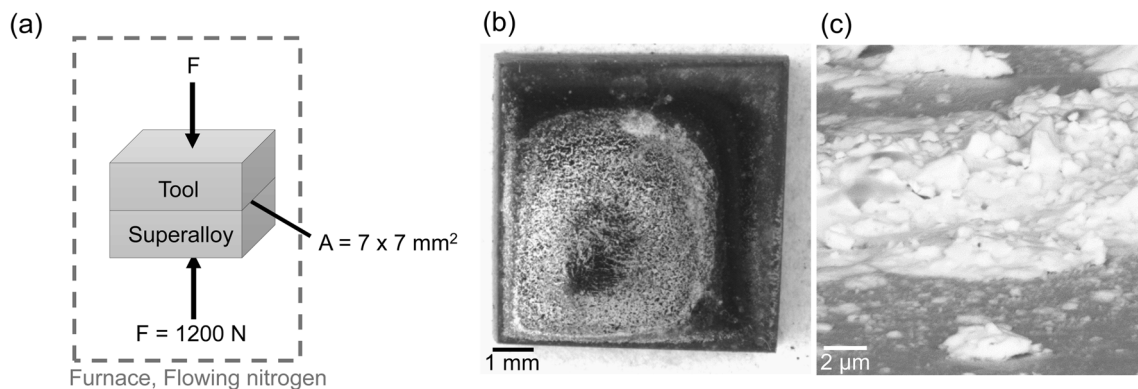
Fig. 1 Schematic setup of the diffusion couple tests with contact surface (“A”) and applied force (“F”) indicated (a); separated diffusion couple of Waspaloy after testing at 1000 °C shown in top-view (b), and tilted view

using SEM (c). Locally, several micrometer thick layers of tool material (bright particles are WC) are bonded to the Waspaloy sample

For each experiment, one diffusion couple comprising one of the two superalloys and a sample of the tool material was tested under controlled conditions. Tool and superalloy were brought in contact so that the mating surfaces were square-shaped with 7 mm side length. Furthermore, to achieve good contact during the tests, the contact surfaces were ground and polished with 1 μm diamond suspension as the final step. In that way, a total of four samples were prepared (two for each superalloy) and tested in accordance with Table 2. For each test, the sample was held together by applying a force of 1200 N corresponding to a pressure of ~ 24.5 MPa in compression for 90 min at two test temperatures. Flowing nitrogen was used as protective gas to prevent oxidation of the samples during the tests. A schematic of the experimental setup can be seen in Fig. 1a.

After testing for the set time and subsequent cooling to room temperature, the contact pressure was released from the samples. It was found that firm bonding between the tool material and the corresponding superalloy samples had occurred in all cases except for Waspaloy tested at 1000 $^{\circ}\text{C}$. Here the vast majority of the tool material had broken off. It is believed that during cooling down, differences between the thermal expansion coefficients of the tool material and the respective superalloys lead to build-up of stresses which resulted in the debonding. However, closer examination by optical microscopy and SEM revealed that pieces of tool material were left adherent to the Waspaloy surface in contact with the tool during the test (Fig. 1b and c). Therefore, bonding had occurred during the test.

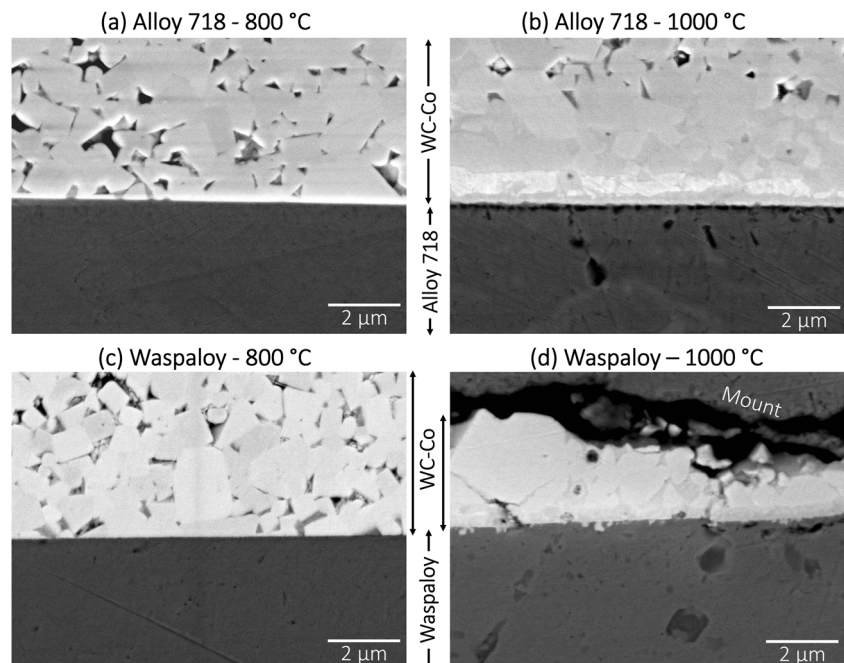
Fig. 2 Cross-sectional SEM micrographs of the tool–superalloy interfaces for the diffusion couples containing Alloy 718 (a, b) and Waspaloy (c, d) tested at the two temperatures. Note the parts of sample mounting resin in the upper part of d

In Fig. 2, the general appearances of the bonded workpiece–tool interfaces are presented for the four tests. When looking at the interface after exposure to 800 $^{\circ}\text{C}$, see Fig. 2a and c, no obvious microstructural changes of either the superalloy or of the tool are visible close to the interface. The WC skeleton (bright) is clearly distinguishable. The holes appearing in-between the WC skeleton are areas of the Co-binder, subjected to preferential removal during metallographic sample preparation.

After the tests at 1000 $^{\circ}\text{C}$ however (Fig. 2b and d), the WC–Co microstructure within the area of about 3.5 μm from the interface appears to have changed. Both the WC skeleton and Co-binder are not clearly distinguishable any more. Instead, there are zones of slightly darker contrast in-between the bright appearing WC grains. Furthermore, it can be observed that a band has formed consisting of interrupted bright areas in very close proximity to the diffusion interfaces of the alloy 718 sample tested at 1000 $^{\circ}\text{C}$ (Fig. 2b). The band is approximately 0.5 to 1 μm thick and stretches all along the investigated interface.

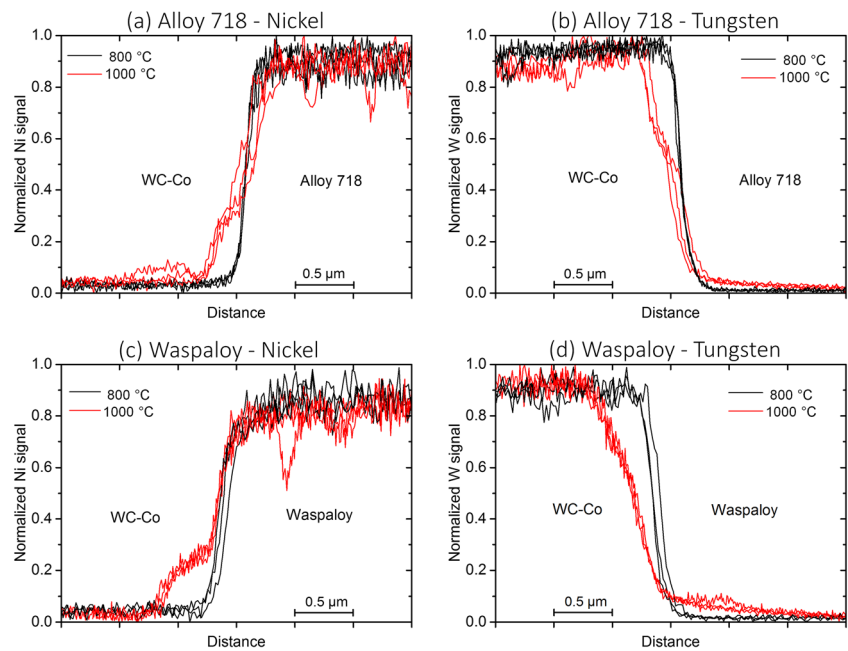
Fig. 3 Qualitative comparison of EDS line scans across the workpiece–tool interfaces after the four tests. Shown are normalized signals of Ni (a, c) and W (b, d)

For qualitative comparison of interdiffusion between the materials, at least five EDS line scans were taken across each tool–workpiece interface. Three of these line scans from each sample are presented in Fig. 3. Shown are the normalized

signal intensities of nickel and tungsten across the diffusion couple interfaces after the tests. In all graphs, a steep decrease or increase of X-rays originating from tungsten and nickel, respectively, can be seen in close vicinity of the tool–superalloy interface (the interface is approximately at the center of the x -axis). When comparing the line scans corresponding to the tests at 800 °C with the ones obtained after 1000 °C, a clear difference can be observed. The higher test temperature yielded in a more shallow increase and decay of tungsten and nickel, respectively. This can be connected to increased interdiffusion between the tool and superalloys which increased the respective element's X-ray signals within about 0.5 μm distance from the interface. This is the case for both the alloy 718 and the Waspaloy containing sample and no significant differences can be observed between the two alloys. Furthermore and as can be seen in Fig. 3a and b, it should be noted that the EDS line scans of the alloy 718 diffusion couple tested at 1000 °C show no significant change in the X-ray intensities at the location of the bright phase.

Concerning the diffusion of workpiece atoms into the tool, it was observed that superalloy elements are present in a narrow region of the tool after the diffusion couple tests conducted at $1000 \text{ }^\circ\text{C}$ (see Figs. 3 and 4). Additionally, significant carbon depletion and formation of tungsten within the tool material were observed in the diffusion couple containing alloy 718 (see Figs. 2 and 5). In the corresponding Waspaloy containing diffusion couple, these phenomena were less pronounced and no significant carbon depletion and formation of tungsten were observable using the employed characterization techniques. A possible explanation for the different responses of the tool material during the diffusion couple tests is that the two superalloys contain different types and quantities of carbide forming elements. Of the present alloying elements, niobium has the strongest tendency to form carbides, followed by titanium [34]. Alloy 718 contains about 5.5 wt% niobium and about 0.9 wt% titanium, whereas Waspaloy contains no niobium and about 3.1 wt% titanium (see Table 1). Due to its chemical composition, alloy 718 should therefore have higher affinity to carbon which could explain the observed carbon depletion of the tool material in close vicinity to the diffusion interface.

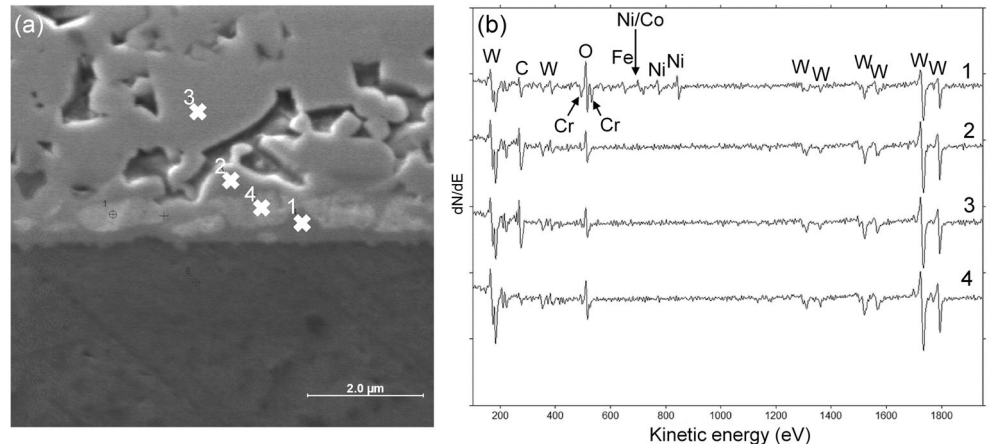
Fig. 4 AES survey scans taken in close vicinity of the interface of the alloy 718 diffusion couple tested at 1000 °C. **a** SEM image with points of analysis. **b** Differentiated AES spectra with peak designations

Complementary to EDS, additional analysis by means of AES was carried out for the samples tested at 1000 °C. As compared with EDS, AES offers higher spatial resolution and higher sensitivity on the orders of 10 nm and 0.1 at.%, respectively [31]. Figure 4 shows derivatives of AES survey spectra obtained for the diffusion couple which contains alloy 718. Characteristic Auger peaks are marked with the corresponding elements. Spectrum 1 shows presence of nickel, iron, and chromium in the tool, confirming diffusion of elements from the superalloy into the tool. At further distance from the

interface (spectra 2 and 3), no elements from the superalloy were detected, which can be seen by the absence of the corresponding peaks in the AES spectra. Spectrum 4 was obtained on the bright phase formed in close vicinity to the diffusion interface (see also Fig. 2b). As can be seen, solely tungsten, carbon, and oxygen are present in the spectrum. The presence of oxygen in all spectra is likely to be the result of air which was entrapped between the mating sample surfaces. Even though these surfaces were polished for improved contact during the tests, remaining small-scale surface roughness can lead to small gaps between the mating surfaces. The entrapped air then caused diffusion of oxygen into the diffusion couples and can explain the oxygen peaks in the shown spectra. Similar to the alloy 718 sample tested at 1000 °C, diffusion of elements of the superalloy into a narrow region of the tool adjacent to the diffusion interface was also confirmed for the corresponding Waspaloy sample.

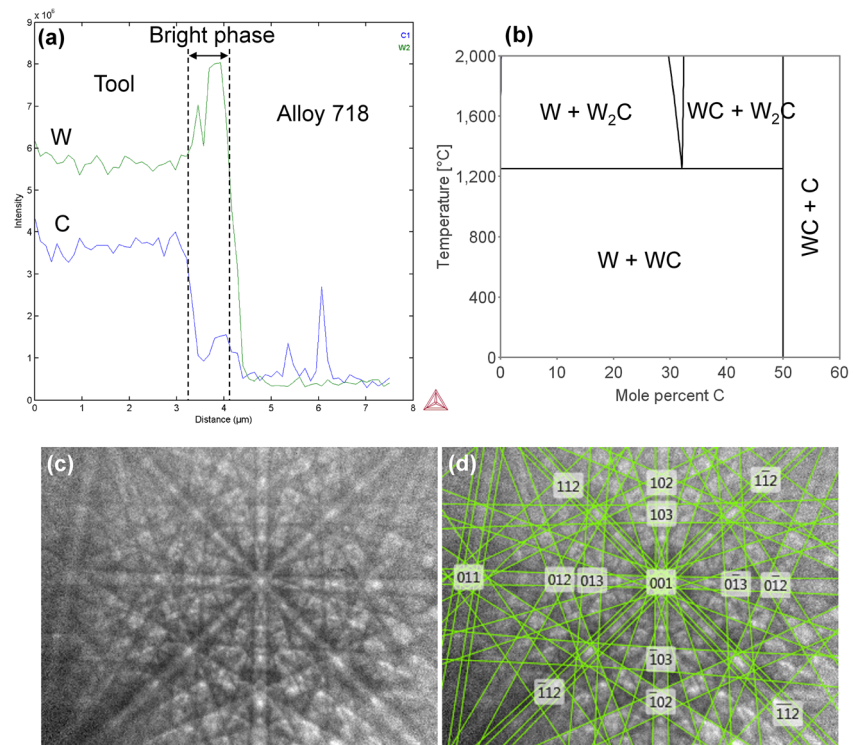
Fig. 5 Analysis of bright phase formed in diffusion couple containing alloy 718. AES line scan showing peak intensities of tungsten and carbon across bright phase (a); part of binary tungsten-carbon phase diagram (b); EBSD pattern obtained on bright phase (c) and with overlaid reference pattern of tungsten (d)

Results of detailed analysis of the bright phase formed in the diffusion couple containing alloy 718 which was tested at 1000 °C are shown in Fig. 5. AES peak intensities of tungsten and carbon across the bright phase are shown in Fig. 5a. The relative peak intensities are a measure of the relative concentration of the respective elements at the locations. As compared with WC (left side of graph), the bright phase is depleted in carbon, shown by the low intensity of the corresponding peak at this position. The bright phase was found to be mainly tungsten. This was done by identifying candidate compounds from the carbon-deficient part of the tungsten-carbon binary phase diagram (Fig. 5b) followed by analysis of EBSD

patterns acquired on the bright phase (Fig. 5c). Figure 5d shows the match of the EBSD pattern of the bright phase with the reference pattern of tungsten. The bright phase also contains some carbon, which could be explained by the fact that small amounts of WC remain within the bright zones which were not resolved by the EBSD analysis.

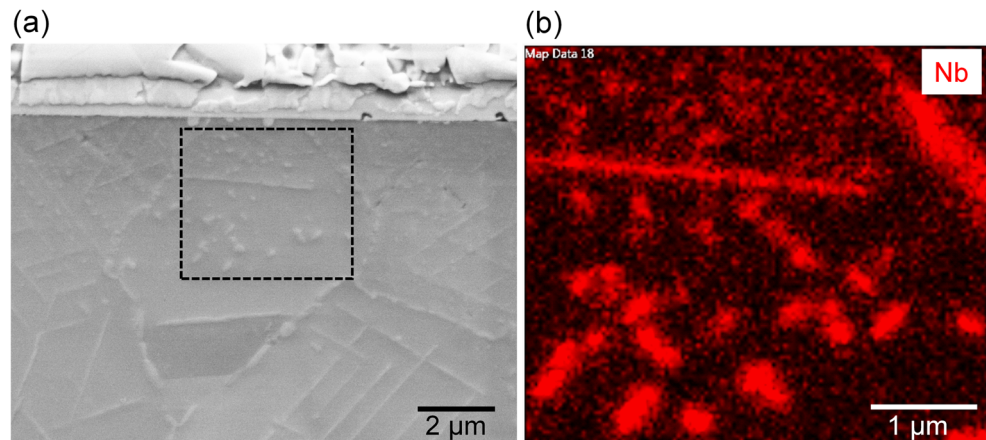
Fig. 6 Niobium-rich precipitates in alloy 718 in close vicinity to the diffusion interface after testing at 1000 °C. **a** SEM micrograph. **b** EDS map showing the distribution of niobium

Furthermore, niobium-rich phases were found to form in alloy 718 in close proximity to the diffusion interface (see Fig. 6). The shown appearance is characteristic for the entire length of the diffusion interface for the alloy 718 diffusion couple tested at 1000 °C.

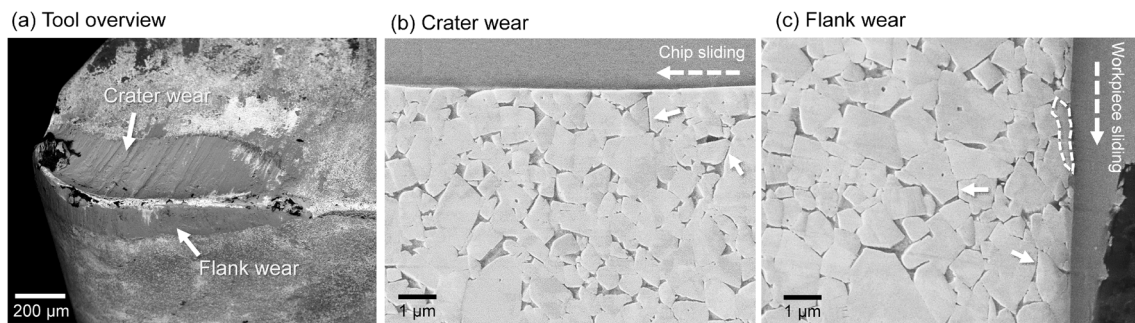
Fig. 7 Characteristics of tool wear after turning alloy 718. Overview micrograph showing the worn cutting edge ($\sim 230 \mu\text{m}$ maximum flank wear width) (a); cross-sectional view of tool microstructure beneath the

crater (b) and the flank wear land (c). Arrows indicate signs of deformation of the WC network and a deformed/elongated WC grain is encircled

Figure 7a provides a SEM micrograph showing the worn tool surfaces after turning alloy 718. Additional micrographs in

Fig. 7 b and c show the subsurface of the worn tool on the rake and flank face, respectively. In both micrographs, adhered layers of workpiece material can be seen covering the worn tool surface. When comparing the WC-Co microstructure beneath the worn tool surfaces on both the rake (Fig. 7b) and flank face (Fig. 7c), no signs of microstructural changes similar to the one observed for the static diffusion couple tested at 1000 °C can be observed. In contrast to the static diffusion couple (Fig. 2b), the individual WC grains are still clearly distinguishable and no areas of brighter contrast corresponding to carbon depletion and formation of tungsten (see Fig. 5) can be seen.

However, the tool microstructure beneath the worn surface shows signs of plastic deformation of individual WC grains and the network of WC grains (see highlighted examples in Fig. 7b and c). Similar wear characteristics have been reported previously for turning of alloy 718 with the same tool grade [32].

Based on the SEM examination in Fig. 7, it is likely that plastic deformation of the network of WC grains and of individual WC grains plays a role in addition to the previously reported abrasive wear mechanism [15] when cutting alloy 718 under the investigated conditions.
