Bond of naturally corroded, plain reinforcing bars in concrete

Robuschi, S., Sumearll, J., Fernandez, I. et al (2021). Bond of naturally corroded, plain reinforcing bars in concrete. *Structure and Infrastructure Engineering*, 17(6): 792-808.

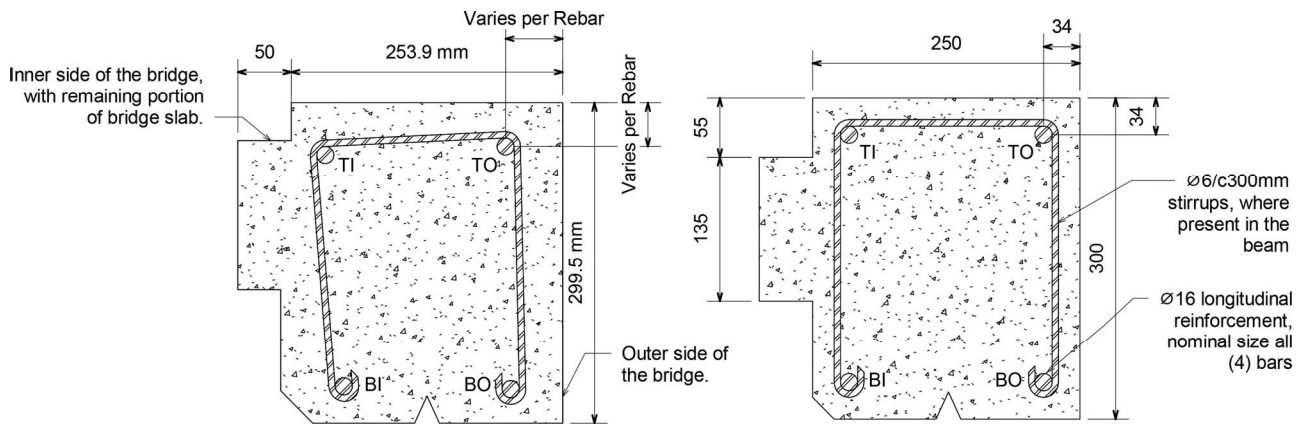
Figure 1. Drafted reference of RC specimen (dimensions in mm). The left image shows width, height, and bar positioning based on average measurements of all specimens. The right image shows nominal dimensions from original drawings of the bridge. Bars are labelled as follows: TO = top-outer, TI = top-inner, BO = bottom-outer, and BI = bottom-inner. The remaining part of cut-off bridge slab is clearly visible on the left.

The test specimens were taken from edge beams at the decommissioning of an existing bridge in Gullspång, Sweden. The bridge was built in 1935 and torn down in 2016 owing to heavy corrosion damage. As is common for bridges of the time, the concrete used was characterised by large aggregates, and the production of the edge beams was cast in place by tamping instead of vibrating. The type of reinforcing steel used was plain steel bars. Specifically, the edge beams, which were chosen as the subject of this study, featured $\phi 6$ stirrups open on the bottom side with respect to the original position on the bridge, and $2\phi 16$ plain reinforcement bars on the top and bottom. Figure 1 shows a representation of a general specimen, including marked locations of bars.

(BI) (see Figure 1). ‘Top’ and ‘bottom’ refer to top-cast and bottom-cast bars, and ‘outside’ and ‘inside’ denote the exterior and interior sides of the edge beams as positioned on the bridge, respectively. The specimens were inspected for external damage before testing. Inspections considered both sides of each specimen and tracked information relevant to individual bars: concrete dimensions, concrete cover, and visible cracks (see Figure 3). Each bar was classified based on the extent of visible deterioration of the concrete cover around the bar location. The ‘reference’ (R) state corresponds to the absence of visible damage. Moderate damage, i.e. cracking without loss of the concrete cover, is defined a ‘cracked’ state (C). Substantial damage, i.e. cracking and spalling of the concrete cover, is defined a ‘spalled’ state (S). Figure 4 shows a tabulation of the dataset sorted by bar position, section thickness, minimum concrete cover, presence of a stirrup and classification. Note that measurements of the minimum concrete cover were conducted on the specimens as received after the demolition of the bridge. A concrete cover equal to zero indicates spalling of the concrete and does not represent the minimum concrete cover in the original design of the structure.

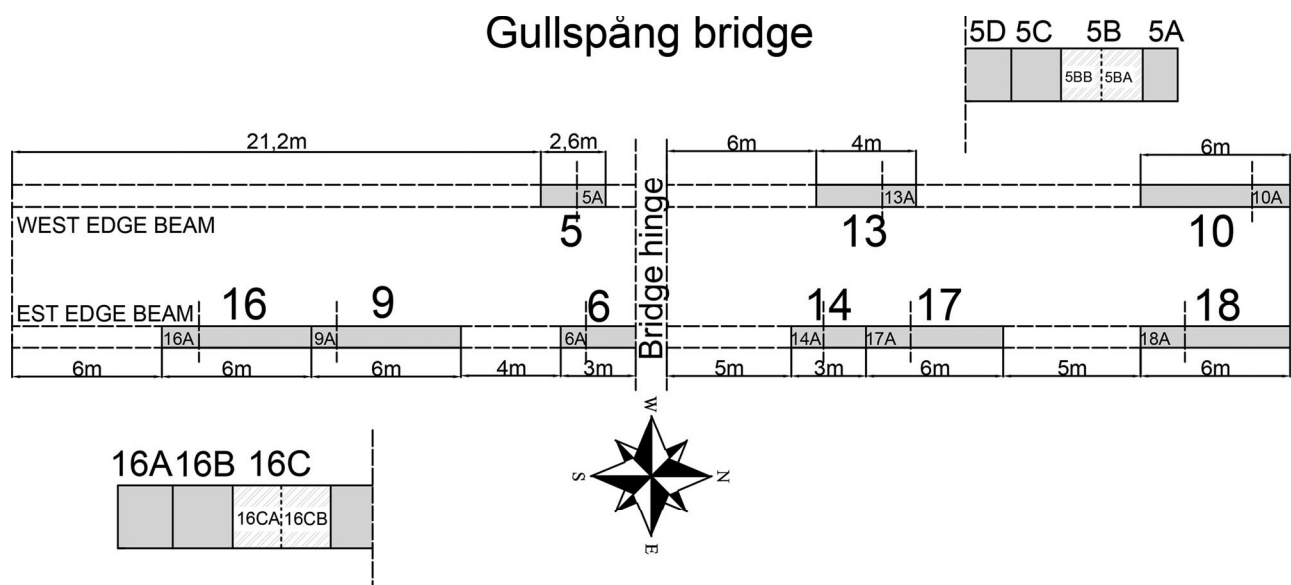
Figure 2. Original position of the segments extracted from Gullspång bridge. A number was assigned to each segment of the edge beams as received after the demolition of the bridge. Letters were used to denote later cuttings, carried out in the laboratory. The cutting was carried out with all the segment oriented in the same direction: this implies that the specimens from the west edge beams were named in alphabetical order from north to south, while the specimens from the east edge beam followed the alphabetical order from south to north (see above). Please note that the drawing is not in scale.

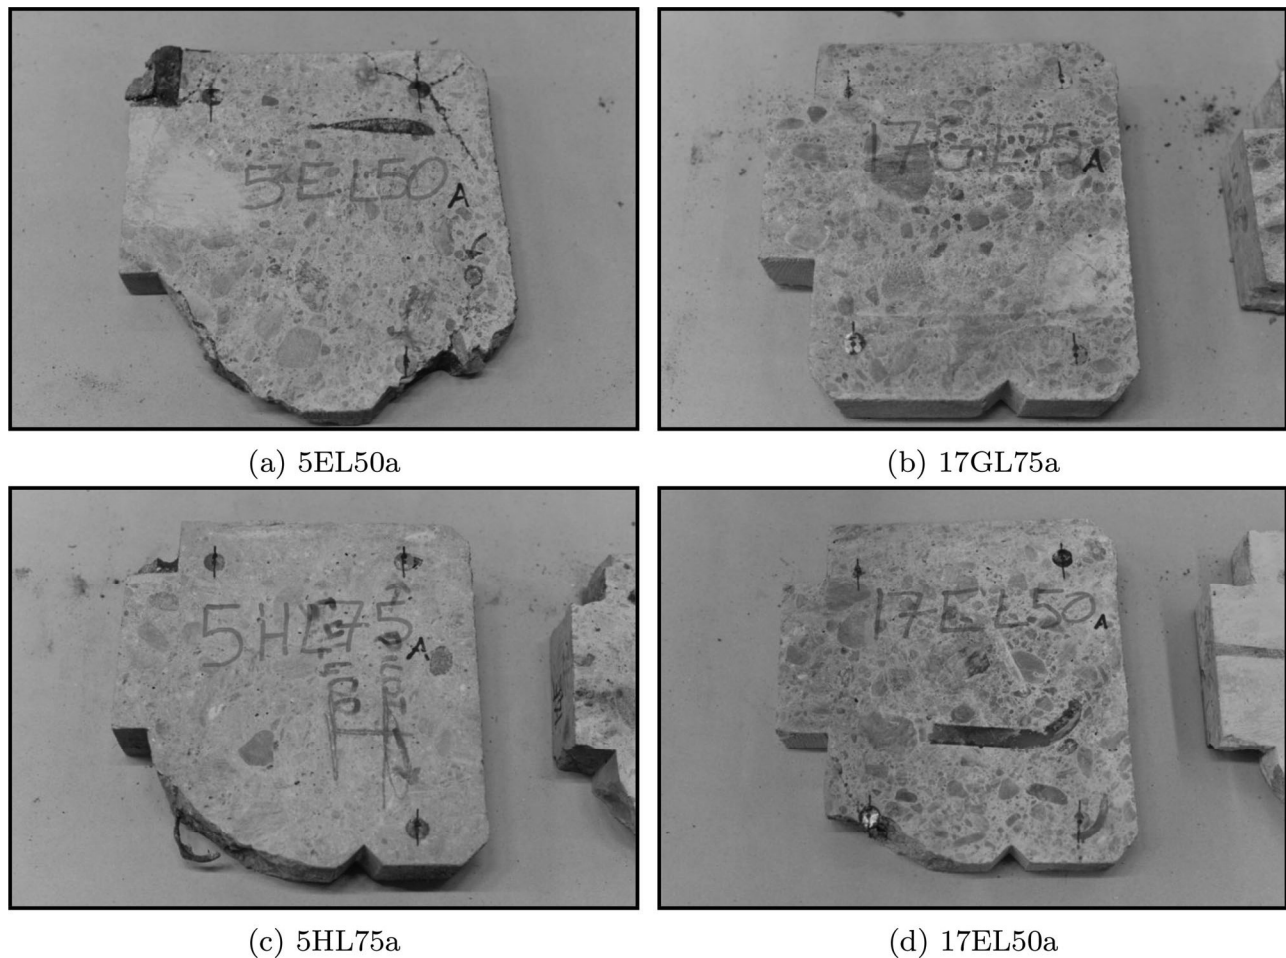
Figure 3. Examples of test specimens with varying deterioration states.

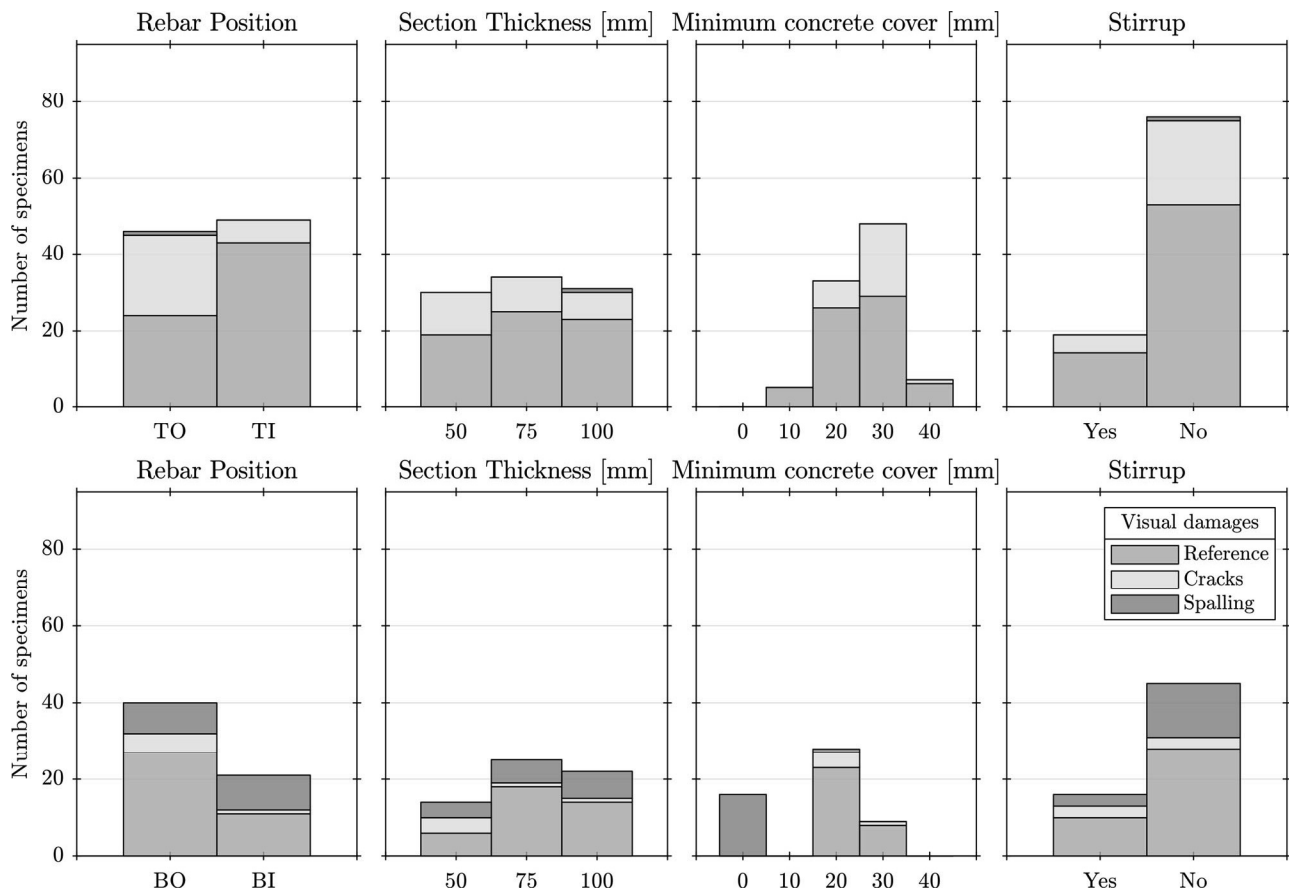
Figure 4. Inventory of tested samples, divided by category (Reference, Cracks, and Spalling).

In Figure 11, spalled specimens are shown to maintain relatively high peak bond stresses. Such observation needs to take into account the absence of data on missing bars in the figure. Many bars had, in fact, approximately 0 MPa bond stress and fell off during test preparation as a result of severe spalling. These results were not included in the figure, but the presence of missing specimens is highlighted by the difference in the number of tested specimens between bottom-cast and top-cast bars (see Figure 4). In total, 32 of the 34 missing bottom-cast specimens were a consequence

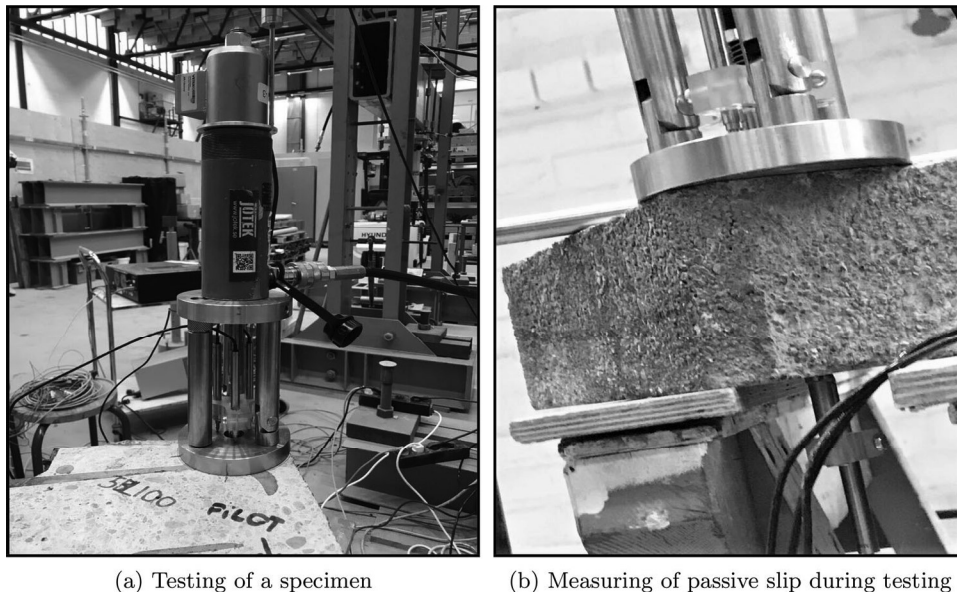
Figure 5. Photographs of pull-out rig assembly and slip measurements during testing of a specimen.

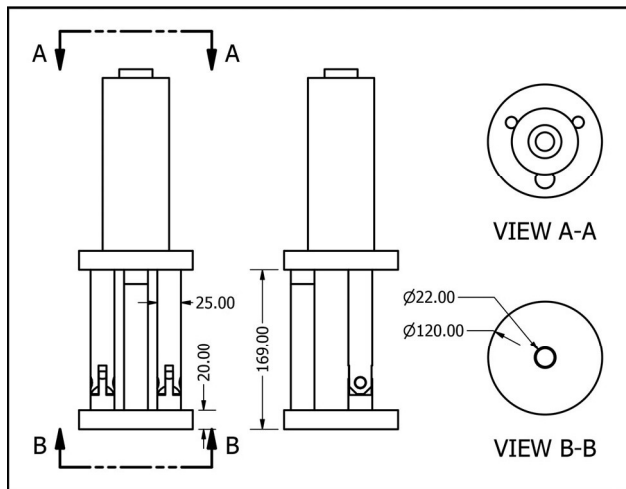
Figure 6. Pullout rig (dimensions in mm), designed by Laboratory Engineer Sebastian Almfeldt.

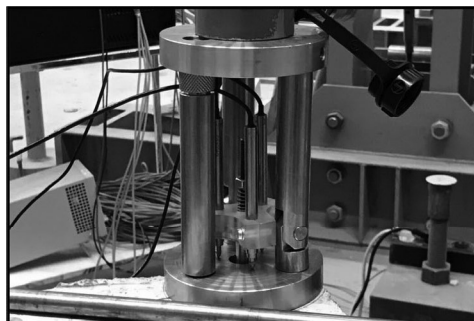
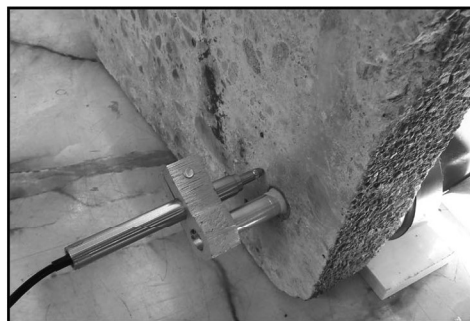
(a) Active slip displacement transducers

(b) Passive slip displacement transducer

Figure 7. Photographs of pull-out rig and slip measurement devices. Note that specimen (b) is tilted with respect to normal testing position to better show the measurement device.

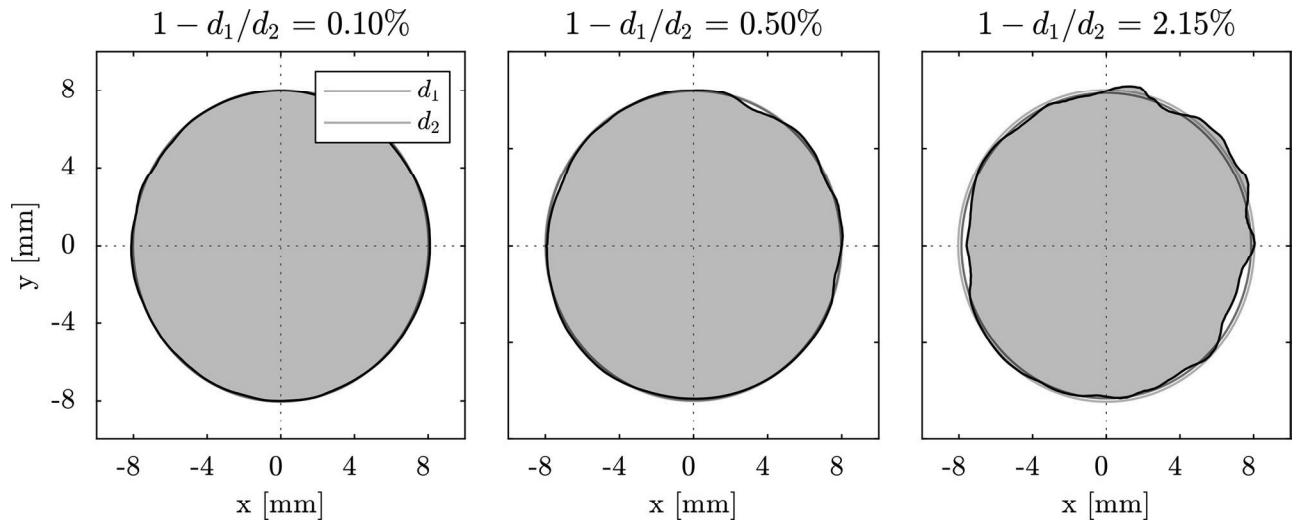
Figure 8. Example of cross-sectional circularity evaluation.

The bar nominal area A_n , i.e. the cross-sectional area of the bar before the corrosion process, was calculated according to Robuschi et al. (2020) based on the assumption that an uncorroded cross section could be idealised as circular. The circularity of each cross section was evaluated based on the ratio between two idealised circular diameters d_1 and d_2 , with d_1 the diameter of the idealised circle having an area equal to the cross-sectional area A_i , and d_2 the diameter of the idealised circle having the same perimeter as the cross-sectional perimeter p_i . For the case of a circular cross section, these values were identical, while d_2 increased for noncircular bars. The tolerance was set to be equal to 0.1%. Figure 8 provides a visual reference of the calculated circularity against the cross-sectional appearance.

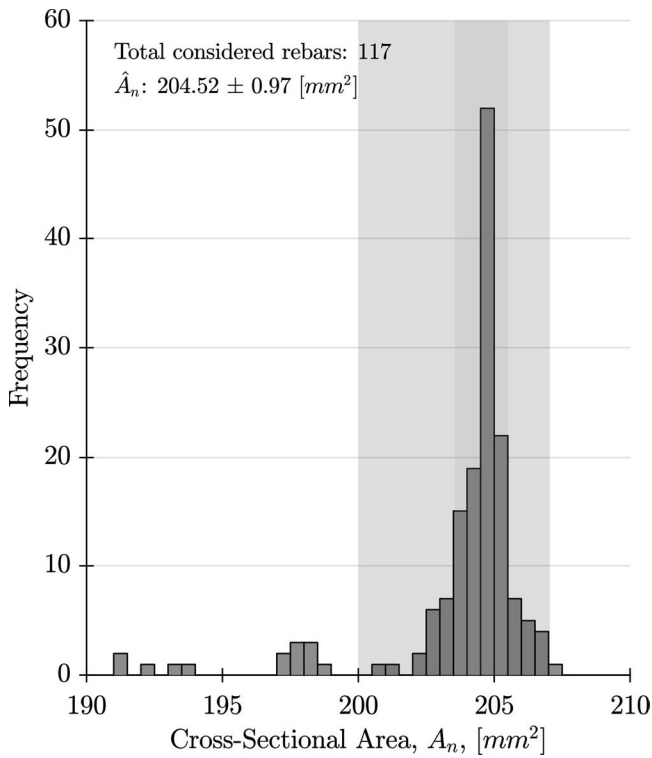
Figure 9. Calculated nominal bar area \hat{A}_n assigned to bars without any circular cross section. The grey shaded region denotes the range over which bar areas were averaged in assigning \hat{A}_n for 'noncircular' bars, and the yellow shaded region indicates associated standard deviation in area assignment.

When no cross sections within an individual bar met the circularity limit, i.e. no uncorroded section was found, A_n and p_n were assigned as the average calculated from all ‘acceptable’ cross sections across the entire dataset: \hat{A}_n and \hat{p}_n , respectively. Figure 9 indicates that three distinct bar sizes were present in the dataset. However, only the range of bars describing the most populous size was considered in assigning \hat{A}_n for the ‘non-circular’ bars. Data suggesting the existence of two other possible sizes were considered negligible given the small amount of samples

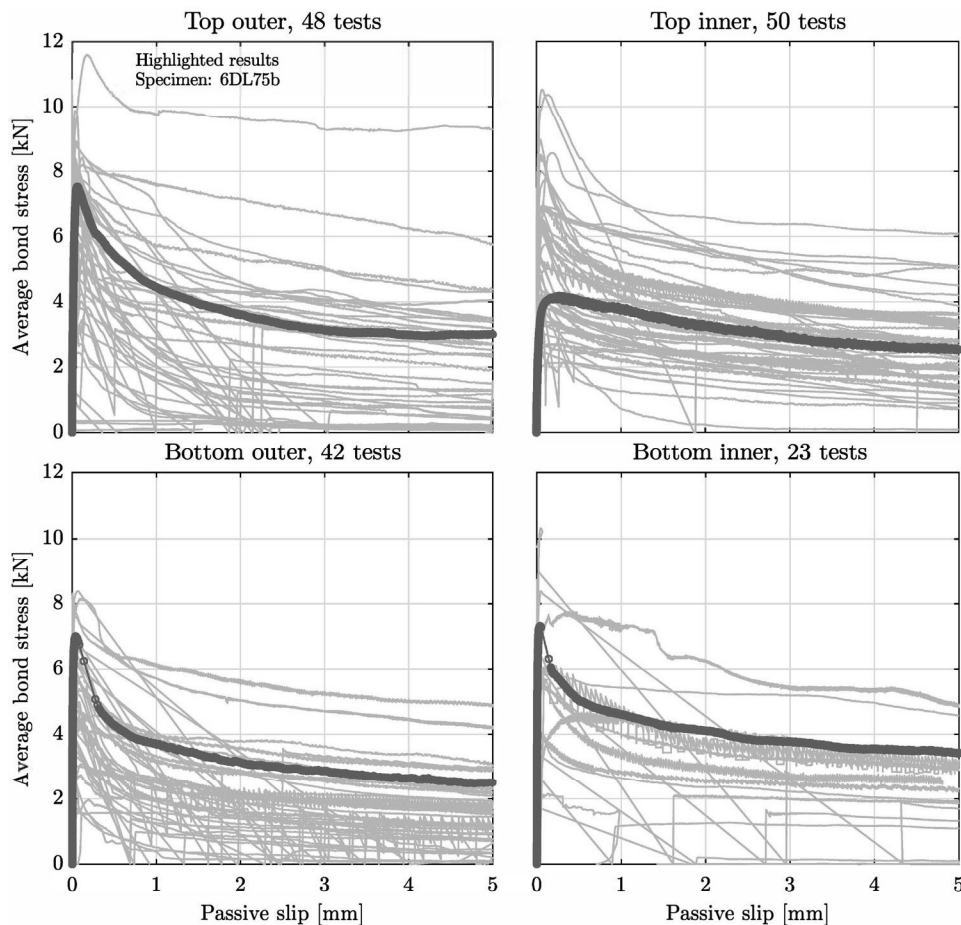
Figure 10. Average bond stress vs. passive slip for entire dataset. Bars from the same sample with different cross-section locations are highlighted as an example.

This chapter presents the outcomes from the experimental test regime. Figure 10 shows an overlay plot of all pullout records with results separated by bar position. The average bond stress is plotted against the passive slip. Curves from the bars of one specific concrete sample (four bars, each with a different position in the cross section of the edge beams) are highlighted for illustration purposes. A high scatter in the results was observed in the same specimen as well as between bars sharing the same location in the cross

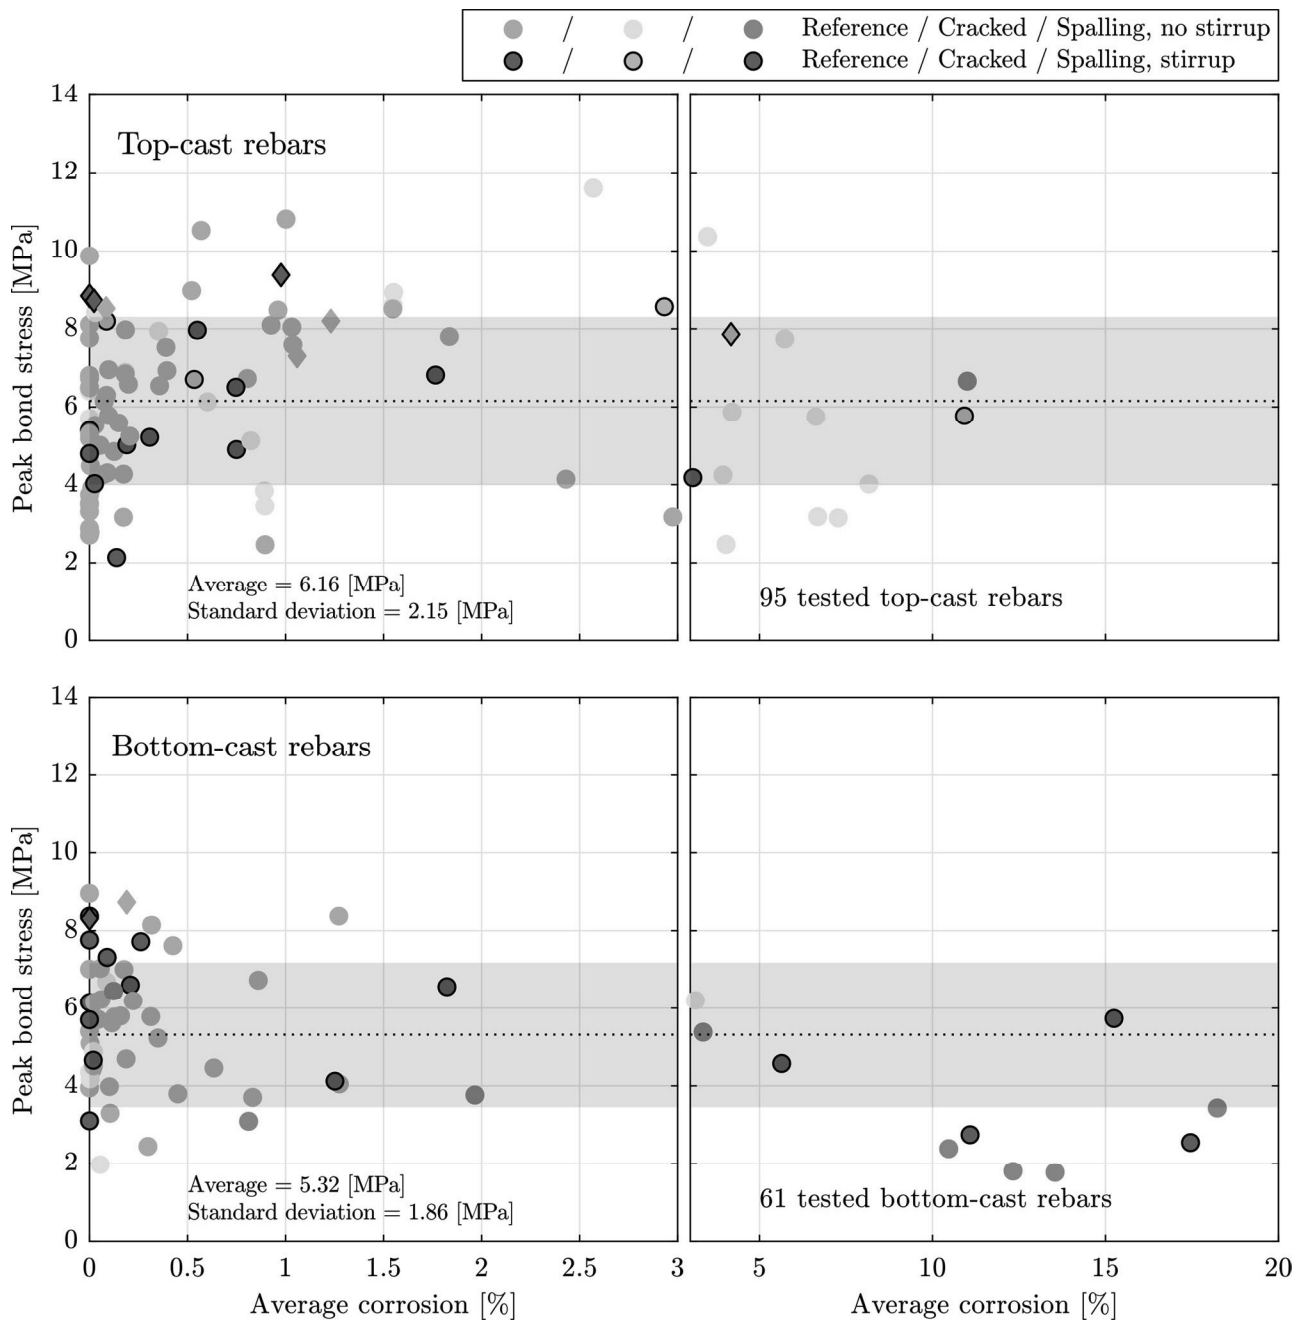
Figure 11. Peak bond stress vs. average corrosion across entire dataset, divided by casting position. Deterioration classification is designated by colour. Dashed black lines mark average value of peak bond stress, and grey colour patches indicate plus/minus one standard deviation. Specimens which exceeded rig capacity are marked with diamond markers.

In Figure 11, the average bond stress at peak of each bar is plotted against the average corrosion level for all tested specimens. On the x-axis, corrosion is presented on two different scales: (from 0 to 3% and from 3 to 20%). This was done to allow the reader to focus on the area with the highest concentration of data, namely, below 3% of corrosion, while still having a full overview of the dataset in the same figure. The grey shaded area corresponds to the average bond stress across the displayed dataset, and the corresponding standard deviation. Successful tests are included in the presented results, together with tests that exceeded the rig capacity, which are marked with a separate marker. Few tests, all 100 mm long, exceeded the rig capacity; possible causes were the overloading of the connecting rod or the yielding of the tested bar. The tests were included by assuming the peak bond stress equal to the maximum bond stress reached during testing.

In Figure 11, different behaviours and characteristics of bottom-cast and top-cast specimens are shown. For top-cast bars, the peak bond stress initially increases with increasing corrosion levels. Loss of bond capacity follows, in connection with the opening of cracks in the surrounding concrete. Bottom-cast bars, instead, show a constant decrease in bond capacity with increasing corrosion level. Spalling damage in the concrete surrounding the bars is already present at relatively low levels of corrosion. Uncorroded bars, however, present highly scattered results for both casting positions.

of severe spalling. However, of the 20 bottom-cast specimens with a stirrup that were tested, 15 resulted in successful testing despite the presence of splitting cracks in the surrounding concrete (see Figure 11). Thus, the presence of a stirrup helped to maintain bond capacity in the presence of spalling of the concrete cover.

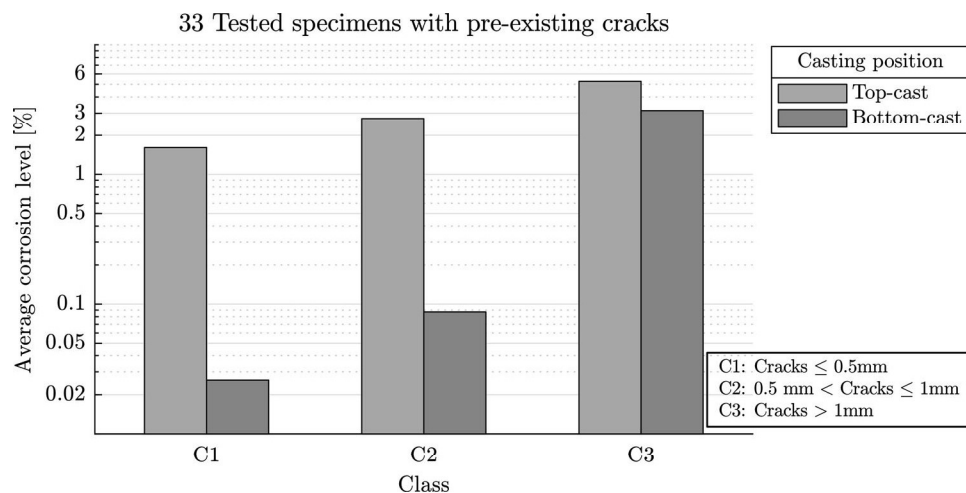
Figure 12. Average corrosion level of specimens with cracks in the surrounding concrete, sorted by crack width. Note that the y-axis is in logarithmic scale.

The average corrosion level of top-cast bars is shown to be significantly higher than the one of bottom-cast bars with similar measured crack width in the surrounding concrete. Such behaviour can be explained by considering different densities of the concrete surrounding the bars. For the case of top-cast bars, the presence of larger voids in the concrete around the bar allows for the corrosion product to expand freely to a higher corrosion level before generating stresses high enough to crack the surrounding concrete. This process, at the same time, increases the confinement on the bar and consequently the bond. Accordingly, an initial increase in the peak bond strength with the corrosion level of top-cast bars can be observed in Figure 11. This observation does not hold true for bottom-cast specimens, where a higher concrete density leads to the opening of splitting cracks at lower corrosion levels and, consequently, to a loss of bond strength.

corrosion levels corresponding to a certain crack width between top-cast and bottom-cast bars (see Figure 12), a general trend showing increasing number of cracks and increasing crack width with increasing corrosion level can still be observed.

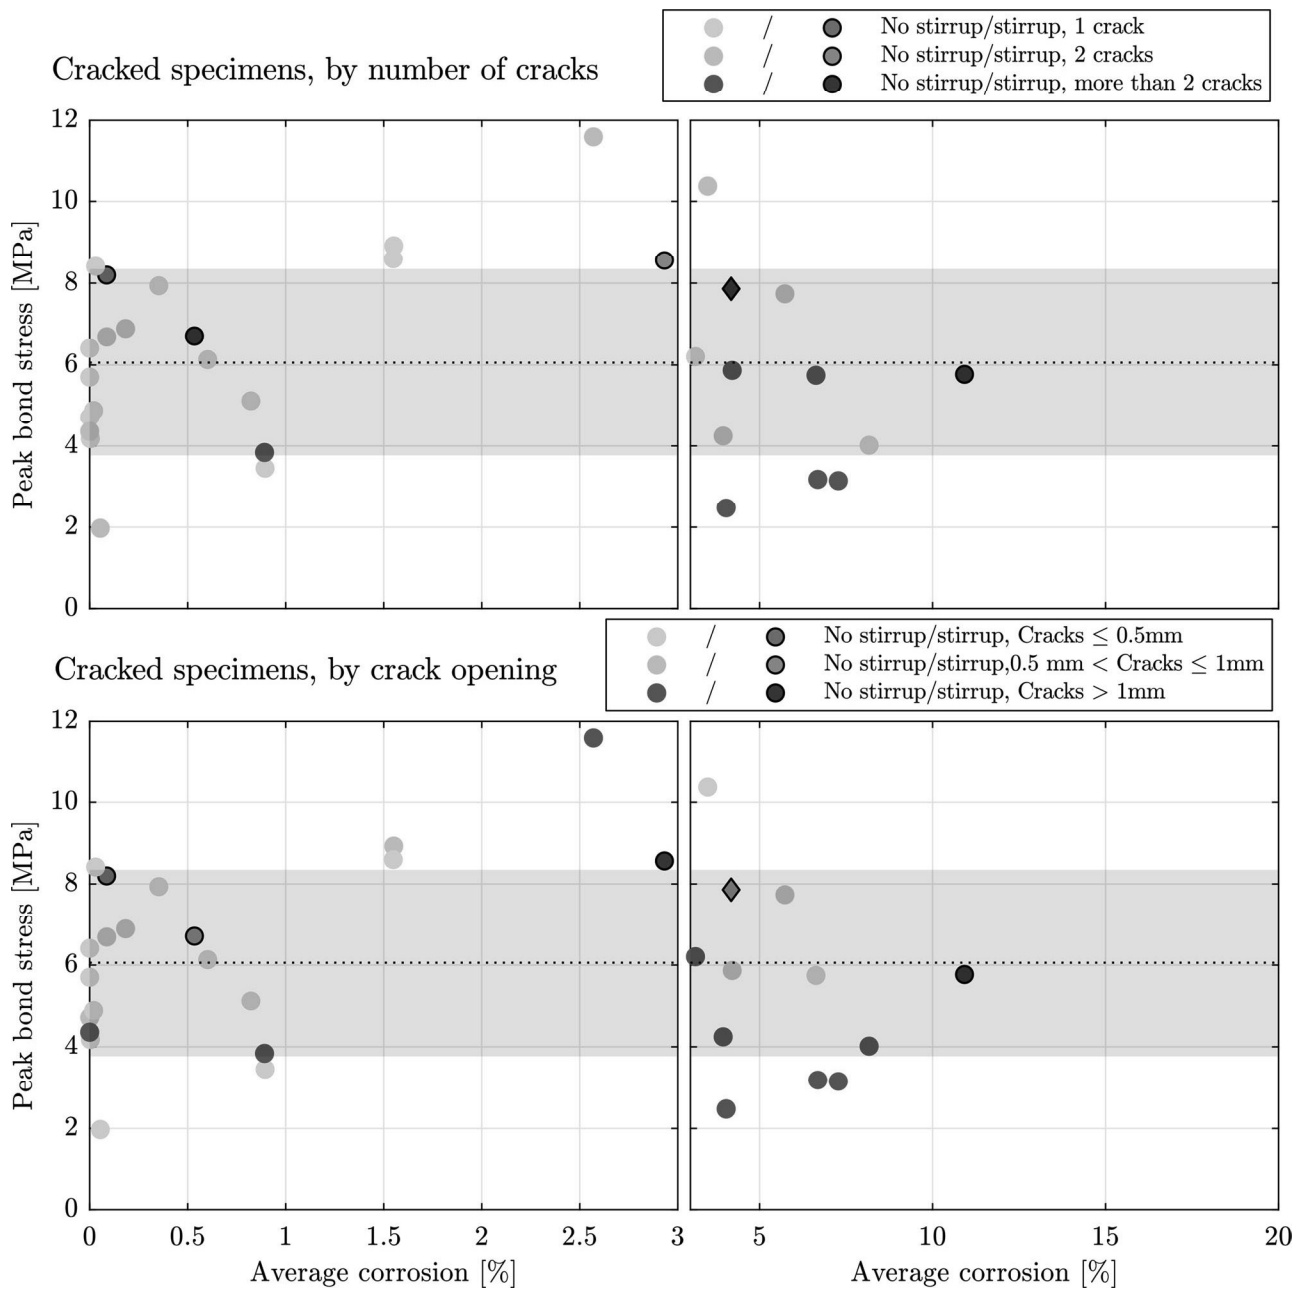
Figure 13. Peak bond stress vs. average corrosion for cracked specimens. In the upper figure, the number of cracks surrounding the bar is designated by colour. In the lower figure, colour indicates different maximum crack width openings. Dashed black lines mark the average value of peak bond stress, and grey colour patches indicate plus/minus one standard deviation.

In Figure 13, data from specimens of category "C" are plotted against the corresponding corrosion level. Two different colour classifications are presented: in the top plot, specimens with cracks are classified based on the number of cracks in the surrounding concrete. In the bottom plot, bars are classified based on the maximum crack width. Both the crack width and number of cracks are observed to increase with the corrosion level. On the other hand, specimens with a stirrup were observed to be less affected by the presence of cracks and maintained higher bond stresses in the presence of large and multiple cracks.

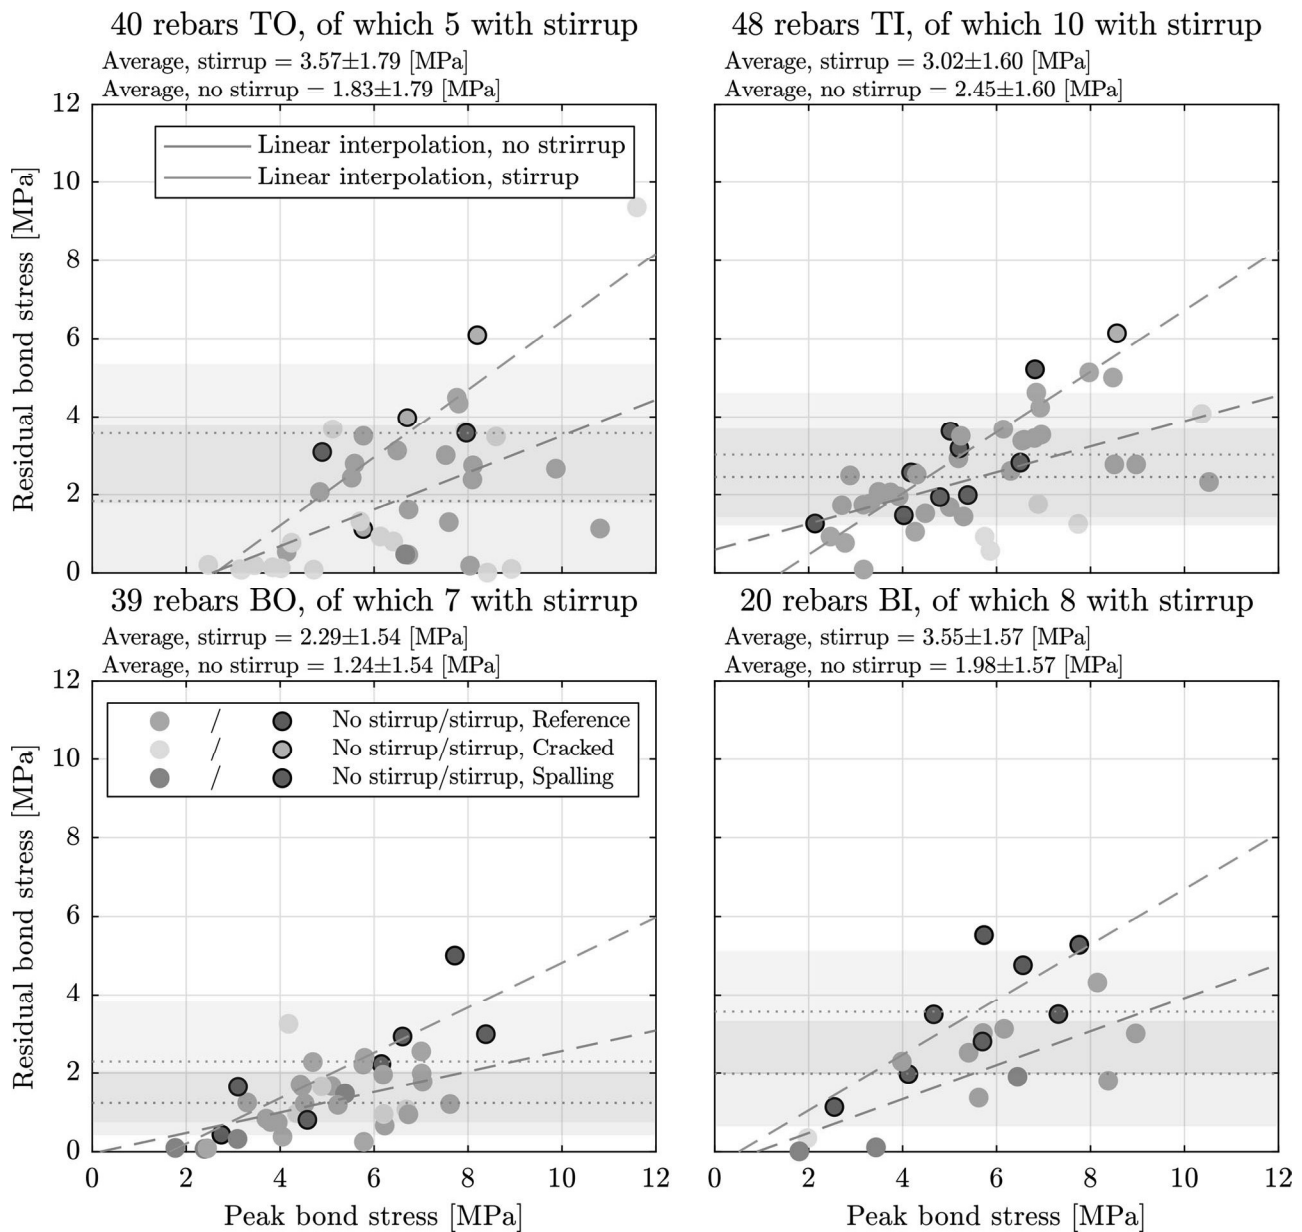
Figure 14. Residual bond stress vs. peak bond stress. Specimens are divided by casting position. Two different linear fits are presented per graph: in blue, specimens with a stirrup, in red, specimens without a stirrup.

In Figure 14, the residual bond stress is plotted against the peak bond stress for each tested specimen. The residual bond stress is defined in this work as the bond stress at 4.5 mm of passive slip (see Section 3.4). Data are divided by bar position in the cross section, and conventions similar to those in previous figures are used.

The average residual bond stress is evaluated separately for bars belonging to specimens with and without a stirrup. The same applies to the linear interpolation of the data, represented in figure with a dotted line. Three main observations are made: 1) the residual bond stress increases with increasing peak bond stress, 2) the residual bond stress is higher for specimens with a stirrup, and 3) the residual bond stress is higher for reference specimens and lower for spalled specimens if no stirrup is present. The latter implies that the presence of corrosion decreases the residual bond strength of the bar.

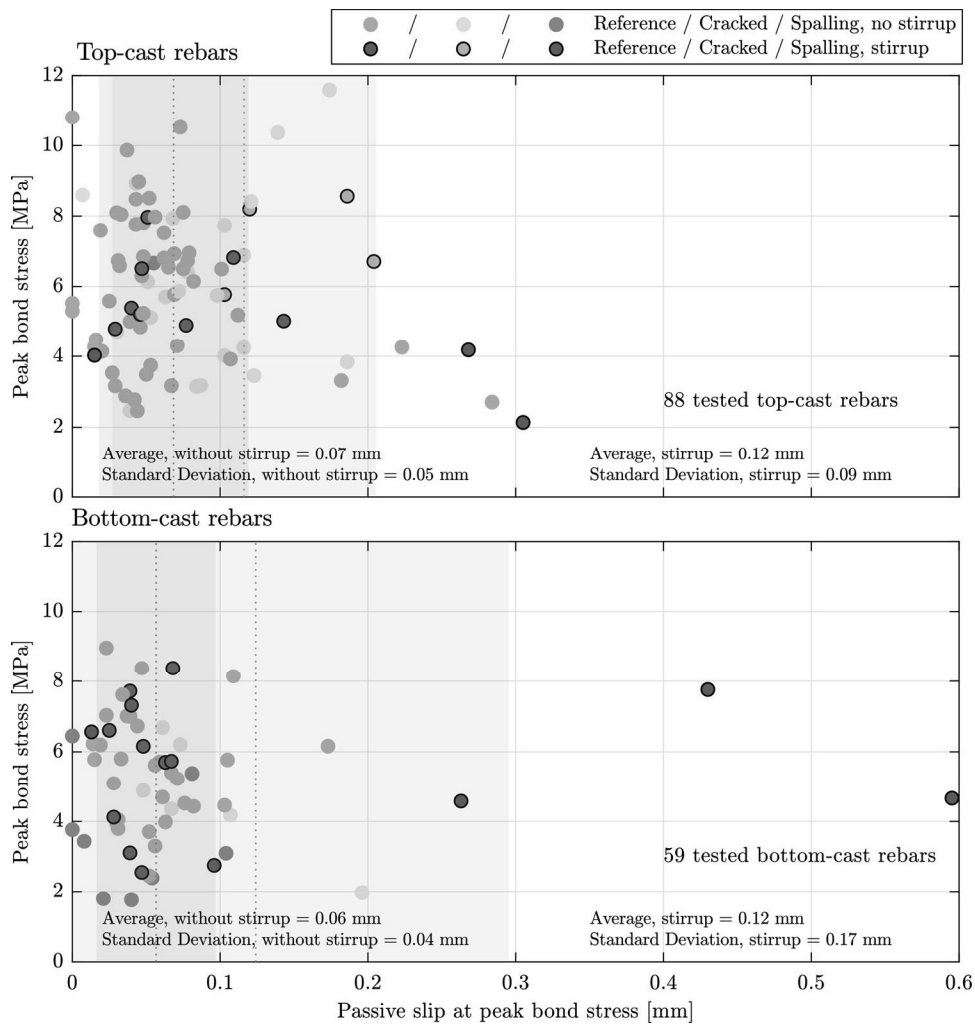
Figure 15. Peak bond stress and corresponding passive slip across entire dataset. Deterioration classification is designated by colour. Dashed lines mark the average value of slip at peak bond stress with and without stirrups, and patches of same colour indicate plus/minus one standard deviation.
