Distributed optical fiber sensing bonding techniques performance for embedment inside reinforced concrete structures

Bado, M., Casas, J., Dey, A. et al (2020). Distributed optical fiber sensing bonding techniques performance for embedment inside reinforced concrete structures. *Sensors*, 20(20): 1-23. <http://dx.doi.org/10.3390/s20205788>

Distributed Optical Fiber Sensing Bonding Techniques Performance for Embedment inside Reinforced Concrete Structures

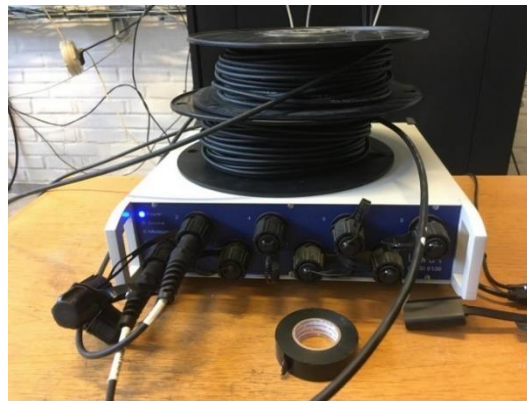
Figure 1. LUNA's ODiSI 6000 Optical Backscatter Reflectometer.

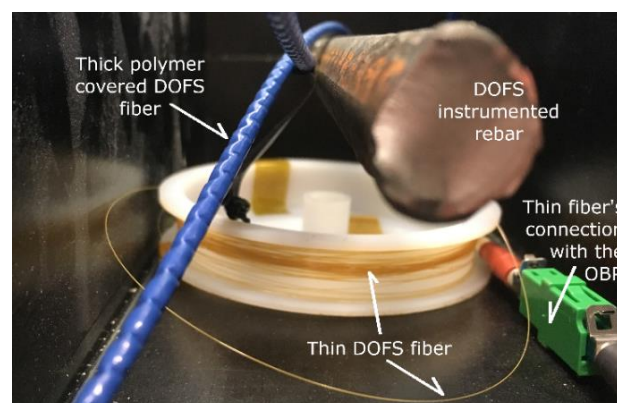
The simplest DOFS sensor is a polyamide clad glass wire which boasts a $125 \mu\text{m}$ diameter (see Figure 2). Multiple commercially available variations cover the latter with differently sized coating layers which span from rigid and deformed polymeric coatings (blue thick fiber in Figure 2) to thin fabric-like covers that consent a large amount of fiber winding.

Figure 2. Thin polyamide clad distributed optical fiber sensors (DOFS) (yellow) and thick polymer coated DOFS (blue).

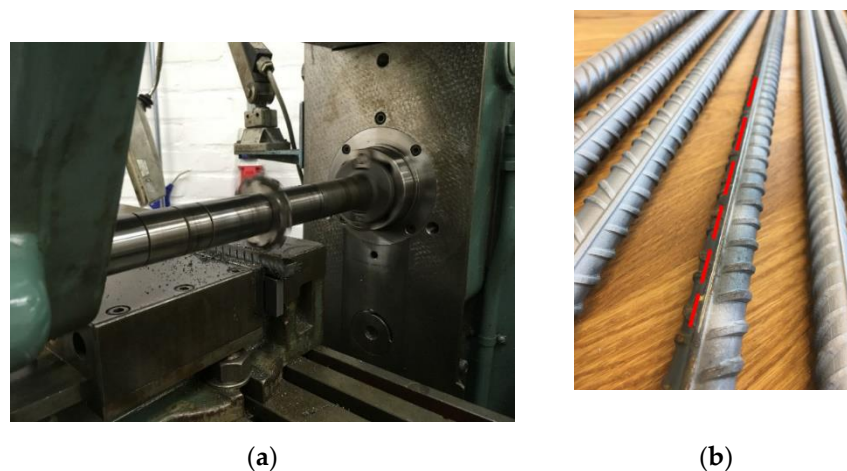
A rather novel and advanced DOFS protection technique establishes the incision of a groove on a rebar's surface (usually on the longitudinal rib as in Figure 3) which later welcomes the DOFS inside it. As will be visible in the following publications, this is believed to provide further protection compared to simply gluing the fiber to the rebar's surface (Quiertant et al. [24]). Yet, it is quite surprising that, despite this technique's non-negligible financial and time costs, a comprehensive study on the potential improvement that it brings to the table (in terms of DOFS reading quality) has yet to be performed. The present paper intends to perform such analysis.

Figure 3. (a) Milling of the groove along the rebar's longitudinal rib and its (b) resulting incision marked with a dashed red line.

It is worth mentioning that, in Figure 5c, the groove is hardly visible due to its small size (as evident in Figure 3b) and color similarity with the background. Additionally, hereafter rebars with an incised groove will be referred to as (w/groove) whilst the ones without it as (w/o groove).

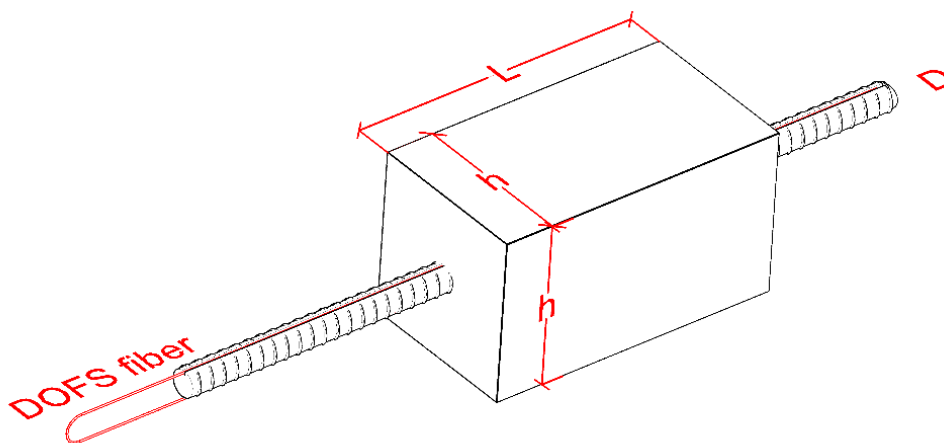
The present paper displays the results of an experimental campaign developed on multiple squared RC ties with DOFS-instrumented rebars. Each of the RC members will be indicated with a code such as 15D20_24 that should be interpreted in combination with Figure 4, which provides indications on the geometrical features of each RC member.

Figure 4. Reinforced concrete (RC) ties' general geometrical dimensions.

The first digits of the code are representative of the concrete prism's cross sectional size (h in Figure 4), the digits that follow the letter D are representative of the diameter of the rebars (D in Figure 4) whilst the digits following the underscore symbol ($_$) are representative of the length of the concrete prism (L in Figure 4). The geometrical design of these RC members satisfies the conditions necessary to perform a double pullout test-powered study [29] on the influence of the longitudinal

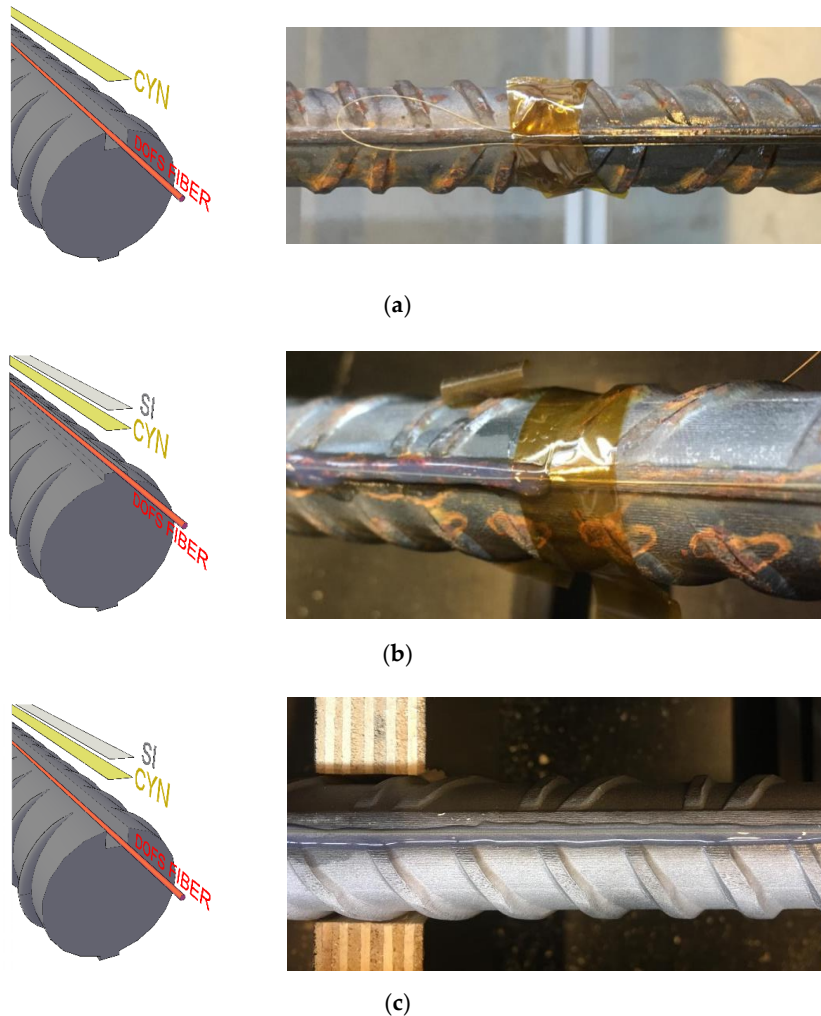
1. DOFS positioned inside a groove and bonded with cyanoacrylate (CYN) as visible in Figure 5a;
2. DOFS glued to the rebar's surface with CYN with a protective layer of silicone (SI) on top, as visible in Figure 5b;
3. DOFS positioned inside a groove, bonded with CYN and further covered with SI. As visible in Figure 5c.

Figure 5. Graphical and photographical representation of the three tested bonding techniques (a) positioning of DOFS in an incised groove and bonding it with CYN (b) bonding it with CYN with an additional protective layer of SI (c) positioning of the DOFS in a groove, bonding through CYN and protection through SI.

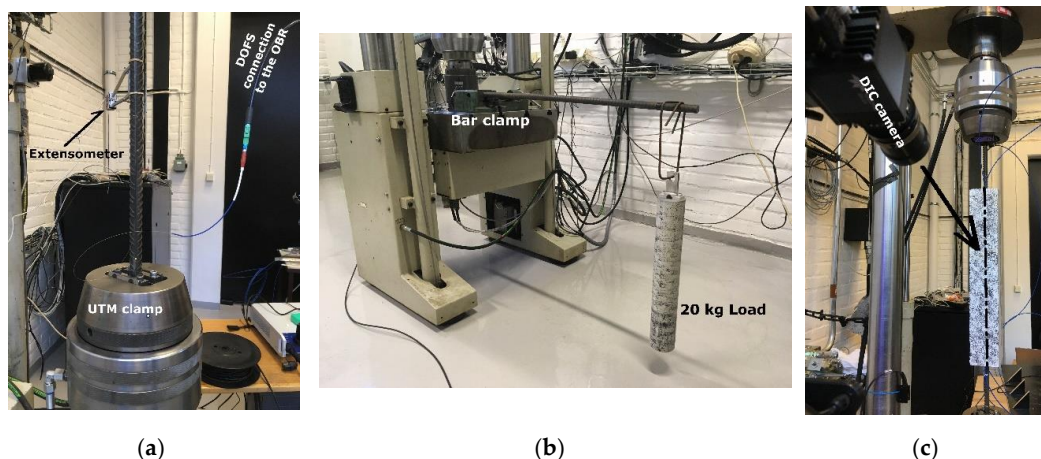
Figure 6. Test setup for the (a) universal testing machine (UTM)-assisted tensile test on a bare rebar (b) bending test (c) UTM and digital image correlation (DIC)-assisted tensile test on a RC tie.

The bending test is instead achieved by clamping one extremity of the rebars and applying on the opposite one (at a fixed distance) a 20 kg load (Figure 6b) in order to create a bending stress and a clearly distinguishable strain profile. Once again, this process is done twice in order to monitor the instrumented rebars strains with a CYN-bonded DOFS and later a CYN+SI bonded DOFS.

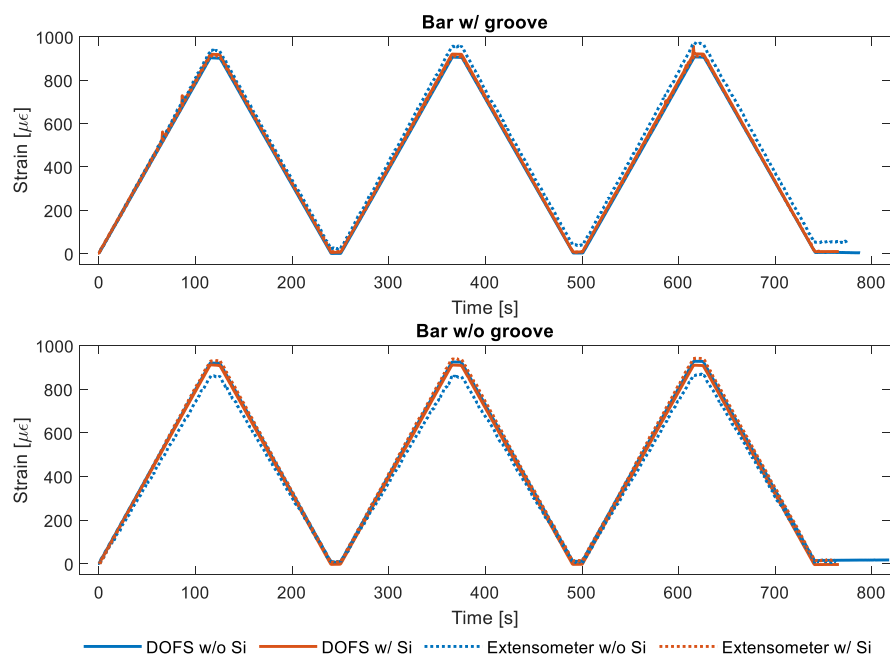
Figure 7 plots the strain measurements performed by the DOFS and by the extensometers connected to the two rebars w/groove and w/o groove. As visible both graphs include two pair of readings, one (in blue) representative of the strains recorded by the DOFS glued with CYN and the other (in red) representative of the strains recorded by the same DOFS glued with CYN and covered with SI. An excellent agreement is present between the DOFS strain curves of both graphs indicative of the small influence that a layer of SI exercises on the tensile readings of a bare bar. Such agreement outshines the ones of the classic extensometer. Moreover, for the case of the bar w/groove, the extensometer even fails to detect that the zeroing of the applied load at the test's end whilst DOFS actually does. The extensometer's lower readings quality is definitely a function of how/where the tool is attached on the rebar compared to its transversal ribs but, then again, it is an uncertainty that is entirely surpassed by DOFS. Figure 8 plots in more detail the strain reading differences of the two rebars when SI is present and when it is not. As DOFS' does not surpass $15 \mu\epsilon$ in either bar (an amount possibly induced simply by a variation of the grip position), it can be safely stated that in tension the presence of SI does not influence the strain readings and thus it is safe to apply it for further protection of the fiber. For the extensometer, instead, the reading variations are expectedly higher for both bars suggesting, once again, the greater reliability of DOFS. Finally, as can be seen in Figure 7, the presence of a groove also does not seem to alter the strain readings suggesting that it too, in tension, can be inserted sans souci as an extra protection for the fiber.

Figure 7. DOFS and extensometer output readings of the tensile test.

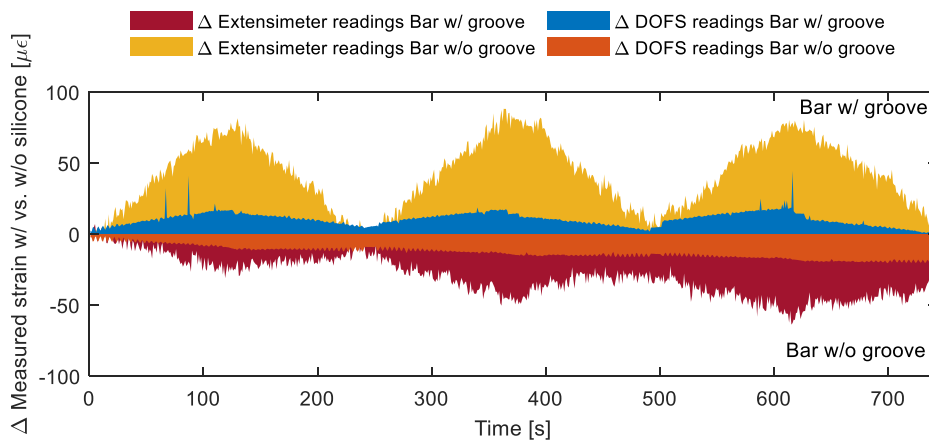
Figure 8. Bar w/groove and w/o groove’s strain reading differences when DOFS + cyanoacrylate (CYN) are or are not covered by silicone (SI).

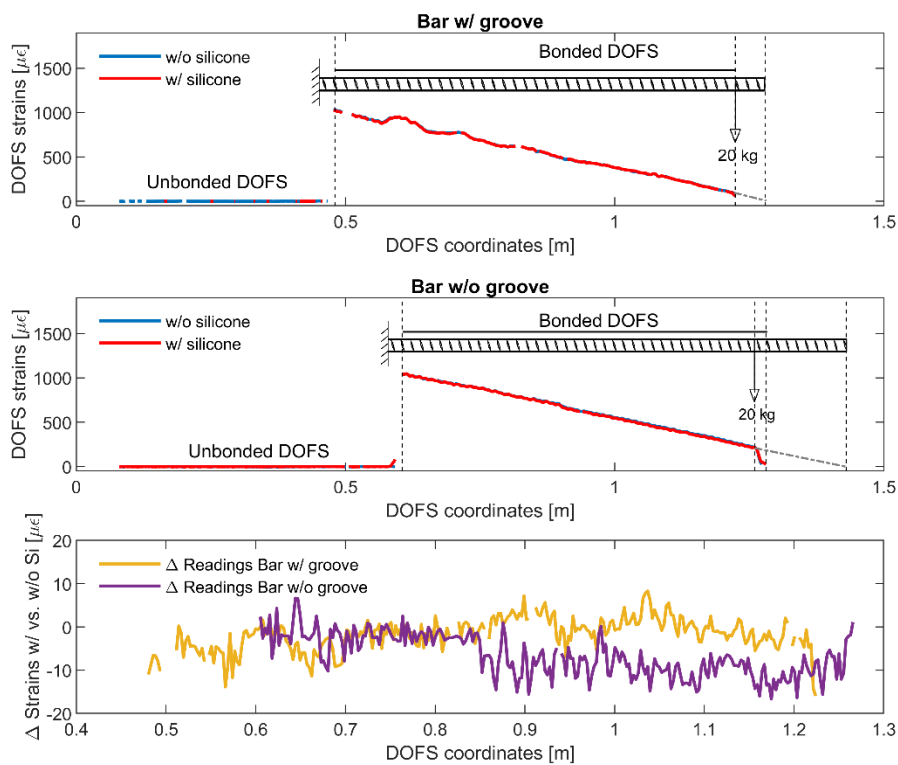
Moving on to the bending test, Figure 9 plots the DOFS strain measured in absence (in blue) and in presence of a SI protection layer for both bars w/and w/o groove. Due to the difference of DOFS bonding length in the two rebars, an illustration of the latter is inserted in both plots in order to help the reader better comprehend the shape of strain profiles.

Figure 9. Strain profiles of the rebars (w/and w/o groove) under bending and the difference of values w/and w/o SI.

It should be kept in mind that the initial segment of the graph, oscillating around the value of $0 \mu\epsilon$, is simply denoting the strains inside the un-bonded and loose section of the DOFS. Only once the first DOFS section of the fiber is bonded, then the profile jumps upwards reporting the rebar’s highest strain. Once again, the presence of silicone is hardly perceptible, as confirmed by Figure 9’s bottom graph, leading to quasi-identical strain profiles. Once again, the largest recorded strain measurement

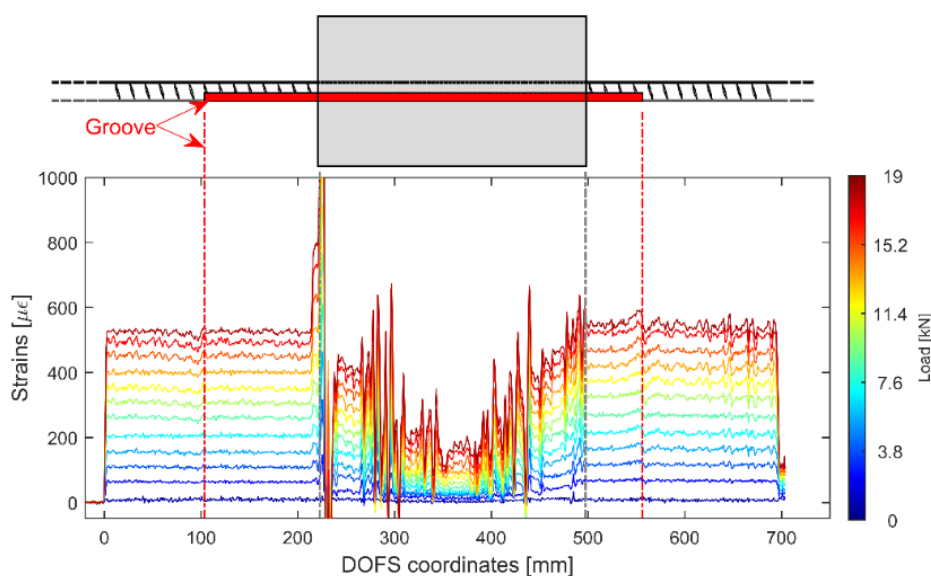
The first tested RC tie was a 15D20_27 member with its DOFS positioned in a groove and bonded with strictly CYN (no protection layer was placed). The test was intended to substantiate whether the mere presence of the groove could guarantee sufficient protection to the DOFS without requiring an extra protective layer. Figure 10 displays some of the strain profiles extracted from the aforementioned test along with an illustration of the member's geometry in order to properly correlate the plot data with the actual physical surface/surrounding in which the DOFS is located. As visible, the profiles' sections corresponding to the segment of the instrumented rebar embedded inside the concrete is full of SRAs (induced by the concrete's friction on the unprotected DOFS) making the actual profile barely readable. This is in line with multiple results reported in the literature review, thus leading to the conclusion that this technique most definitely is not recommended for this kind of DOFS-monitored testing. Yet, it should be mentioned that a possible influencing parameter could be the actual depth of the groove (quite shallow in the present test). It is possible that the deeper it is the better protection it provides to the rebar.

Figure 10. Strain profiles of a 15D20_27 RC tie test with the DOFS bonded with a combination of groove and CYN.

As can be seen in Figure 11 the profiles are much better than Figure 10's as a testament to the higher performance of its bonding technique. Indeed, hardly any SRAs are visible and the strains are monitored all the way to the yielding load (around 167.5 kN) and beyond. The peaks present at the higher loads are not SRAs (as was the case in Figure 10) but rather the physical representation of the rebar's different sections slowly plasticizing one after the other and therefore giving way to drastically higher strains than the non-plasticizing sections.

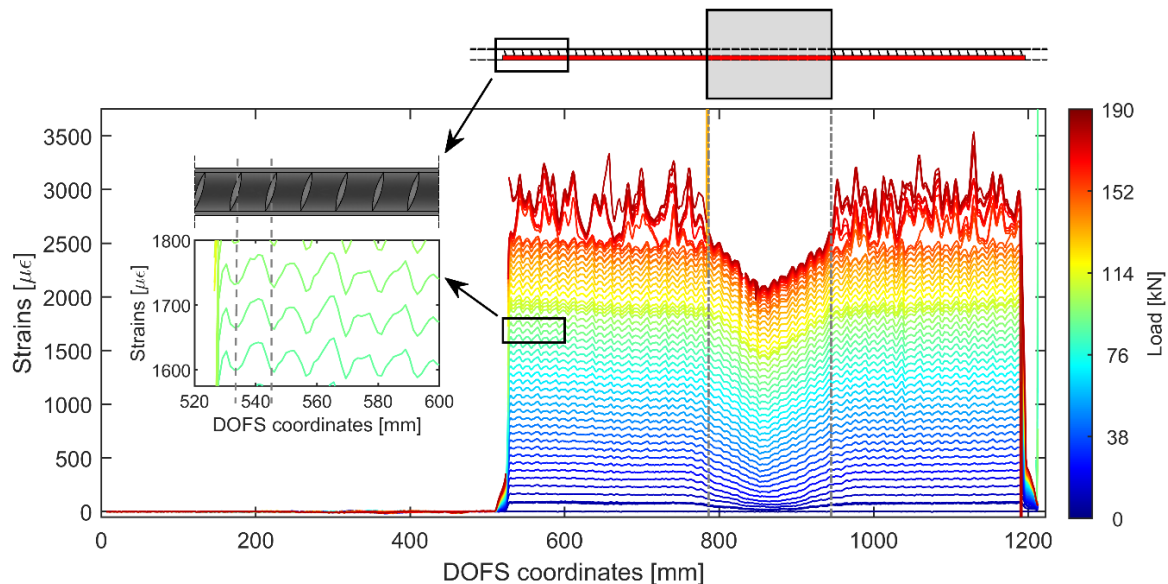
Figure 11 displays the strain profiles of a 15D20_21 RC tie where the DOFS is first positioned in a groove and then bonded with CYN and SI.

Figure 11. Strain profiles of a 15D20_21 RC tie test with the DOFS bonded with a combination of groove, CYN and SI.

Moving back to Figure 11, a small zoom is provided on its left of the rebar's strains profile outside of the concrete as reported by DOFS. An oscillation of the profile is visible which could easily be confused with signal noise. Yet, it is not noise but rather the influence of the transversal rib on the performance of the rebar. As a matter of fact, whenever a rib is present, the cross-section of the bar is automatically larger therefore the carried stress (and consequent steel strains) is inferior. Oppositely, whenever the rib is absent the carried stress is higher. The reiteration of this pattern leads to the abovementioned oscillating profiles. Yet, unless a researcher is interested specifically in the rib's influence on the bar's performance, the latter can be considered signal noise as the useful information signal that is usually pursued is strictly the global profile of the strain curve. As will be visible later on, this particular noise is also a function of the bonding technique in use, thus it is automatically elected as a study parameter for establishing the most performant bonding technique. In order to separate the noise from its original signal (as in Figure 13) a Fourier filtering solution can be used, thus relating a

What is also noticeable in Figure 11, is that the magnitude of such newly defined rib-induced noise becomes increasingly larger with the load thus increasingly disturbing the sought-after signal. Figure 13 shows its occurrence for member 15D20_21's six study case stages along its test. The latest of these stages has average noise peaks of height $27.5 \mu\epsilon$ which, considering its corresponding load of 154 kN, is still very reasonable. As per the bottom graph of Figure 13, the average strain reading noise seems to be increasing at a regular pace with the load suggesting a correlation between the two.

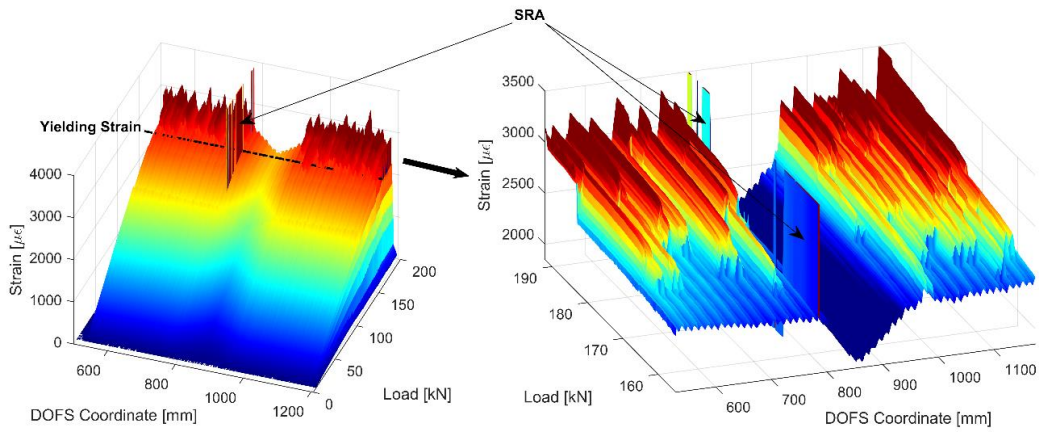
Figure 12. Three-dimensional representation of the strain evolution of member 15D20_21 with a zoom of the higher strains showing the progressive yielding of the different cross-sections of the rebar.

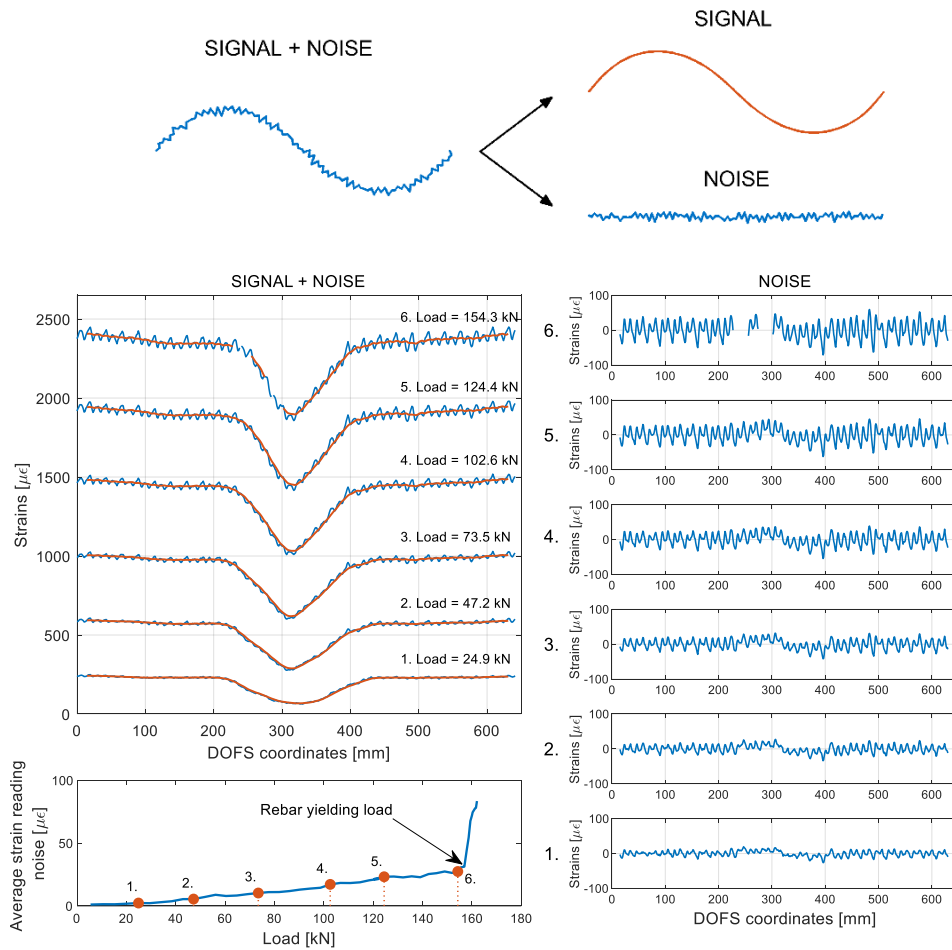
Figure 13. Distinction of signal and noise for an example curve (top) and evolution of the rib-induced noise with the load of member 15D20_21.

This was expected since, being the oscillations caused by the presence of the transverse ribs, the absorbed stress taken by the latter should also increase linearly with the load while in the elastic range. The only moment when the latter is broken is when the steel's yielding stress is reached. Beyond this point, as seen in Figure 12, large peaks start forming wherever the rebar's cross-sections start yielding.

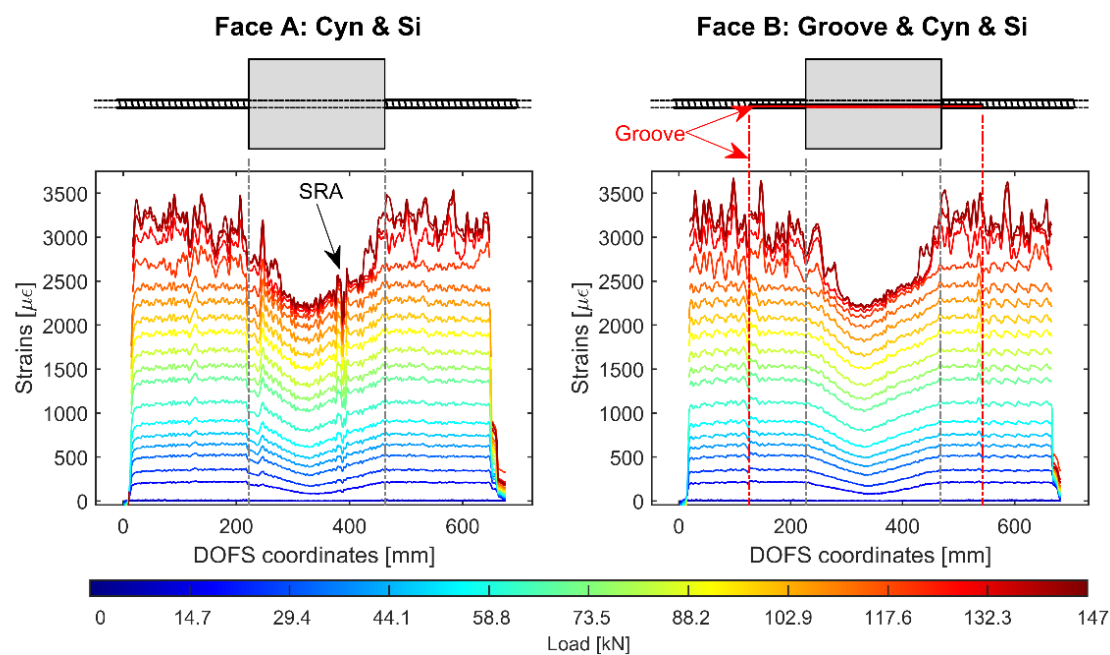
Moving on to the following RC tie, Figure 14 displays the DOFS strain readings of the first of two 15D20_24 members (henceforth referred to as 15D20_24_1) with its DOFS being bonded on its opposite faces. One face (henceforth referred to as Face A) uses CYN and SI whilst the opposite (Face B) adds a groove. The latter, though, is not as long as the rebar itself (see Figure 14's Face B RC tie illustration) therefore allowing to check, on a single face, the DOFS reading performance of two separate bonding techniques. What can be quickly spotted is the larger amount of noise that characterizes Face B's readings when performed outside of the groove versus inside it. Furthermore, along with a higher noise level of the signal, Face A's plots seem to include more SRAs. This is potentially due to the lack of a protective groove on its side.

Figure 14. Strain profiles of 15D20_24_1 RC tie test with the DOFS bonded on both sides of the rebar by means of CYN and SI on one side (Face A—left) and a groove + CYN + SI on the other (Face B—right).

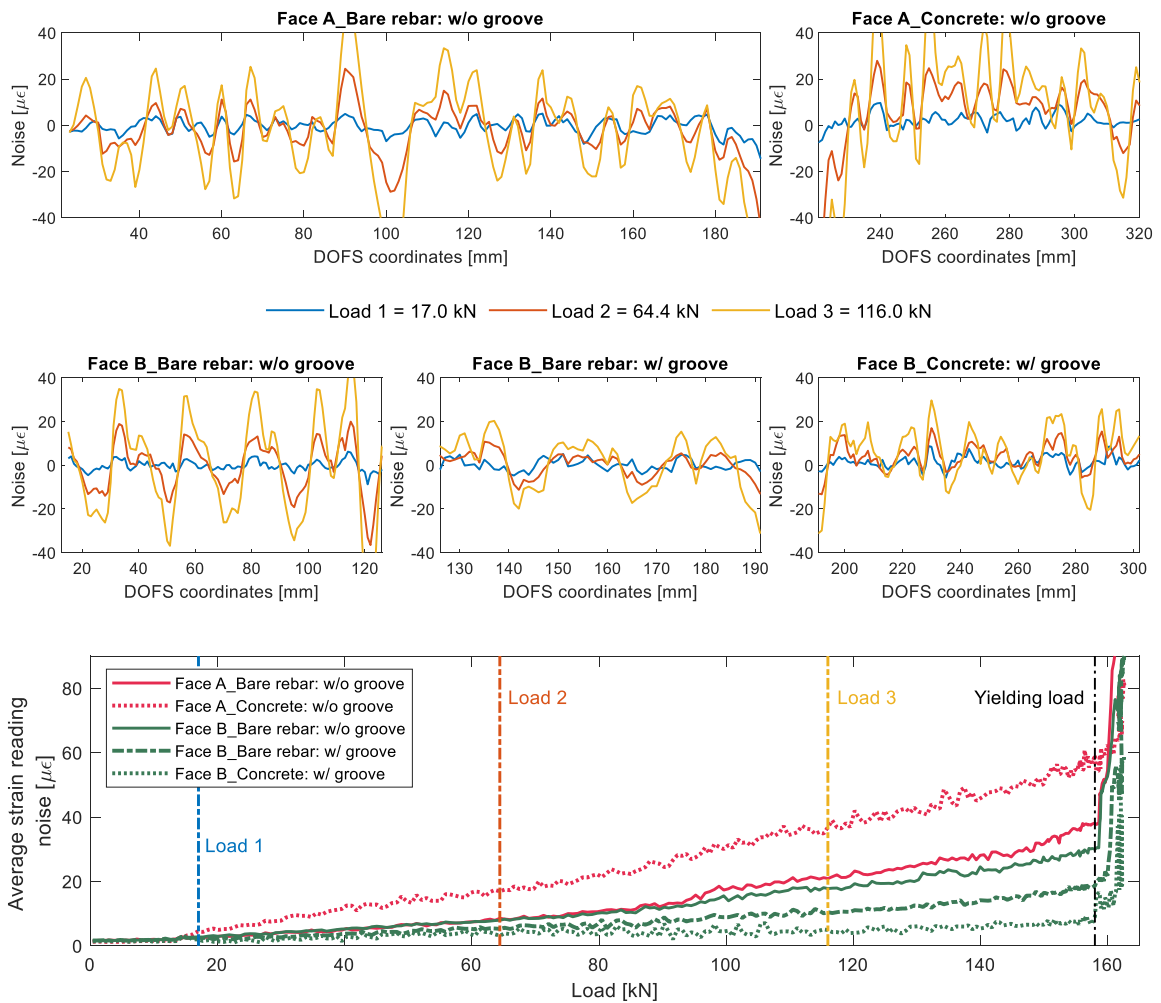
Figure 15 dwells deeper in the DOFS' signal noise, displaying its values under three load levels. A discrete noise magnitude difference is noticeable according to the difference of DOFS/rebar bonding technique and according to the presence or absence of concrete. Figure 15's lower plot summarizes the increasing noise magnitude as a function of the load.

Figure 15. Rib-induced noise analysis of the outputs of member’s 15D20_24’s test (top five subplots) and of their relative average reading noises (bottom subplot).

Both faces of the rebar report similar high noise levels whenever the DOFS is bonded outside of the groove whilst lower levels are consistently reported (both outside and inside the concrete) whenever the DOFS is positioned inside it. Once again it seems that the presence of the groove translates in an improved signal quality both from a noise and anomalous point of view.

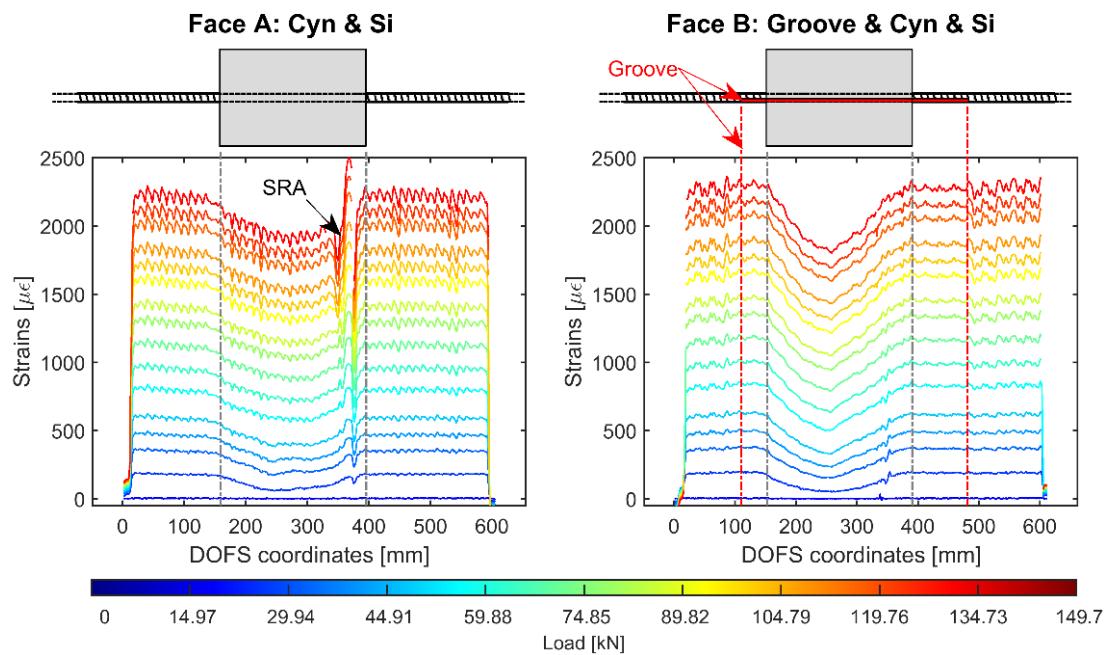
Figure 16 displays the DOFS strain measurement of an identical member, 15D20_24_2, with also identical bonding techniques.

Figure 16. Strain profiles of 15D20_24_2 RC tie test with the DOFS bonded on both sides of the rebar by means of CYN and SI on one side (Face A—left) and a groove + CYN + SI on the other (Face B—right).

The reason behind the testing of such member was the idea of attempting the replication of the previous member's results in order to consolidate them. While most of the above conclusions still apply to the present member (the presence of the groove providing the least noisy and anomalous results both inside and outside the concrete), an unforeseen phenomenon also came up. Indeed, whilst in Figure 14 both faces provide similarly shaped plots, Figure 16's are quite different. Face A's profile inside the concrete loses the central pointy tip (expected in RC tie tests) and appears more curvilinear (instead of the expected pair of crossing linear profiles). Such difference can be attributed to a non-overlookable bending of the RC tie during the test, induced by a lack of straightness of the bar itself. Unfortunately, discrete amounts of bending occur in numerous RC tie tests due to the impossibility of having perfectly straight rebars. Whilst this is an accountable phenomenon, the effect of such bending on the DOFS (or on the adhesives bonding it) is unseen and deserving of further studies. A possible explanation to Face A's profiles could lay in the additional stretching that the bending-induced-tension of the concrete communicates to the adhesives (especially on the very deformable silicone) and thus to the fiber. Additionally, further studying should also be dedicated to assessing the effect of bending-induced-compression. This is in line with other researchers' results [11,16] that suggest a certain "strain relaxing" and "strain redistributing" influence of the silicone when it is used as a DOFS protecting material. Unfortunately, this phenomenon strongly influences the recommendability of the present bonding technique for this particular use. Furthermore, it should be kept in mind that such alteration is truly revealed only when monitoring multiple facets of the same rebar. Indeed, if only a single DOFS deployment is performed, all that is extracted from the test is such altered data is with no way of assessing its correctness.

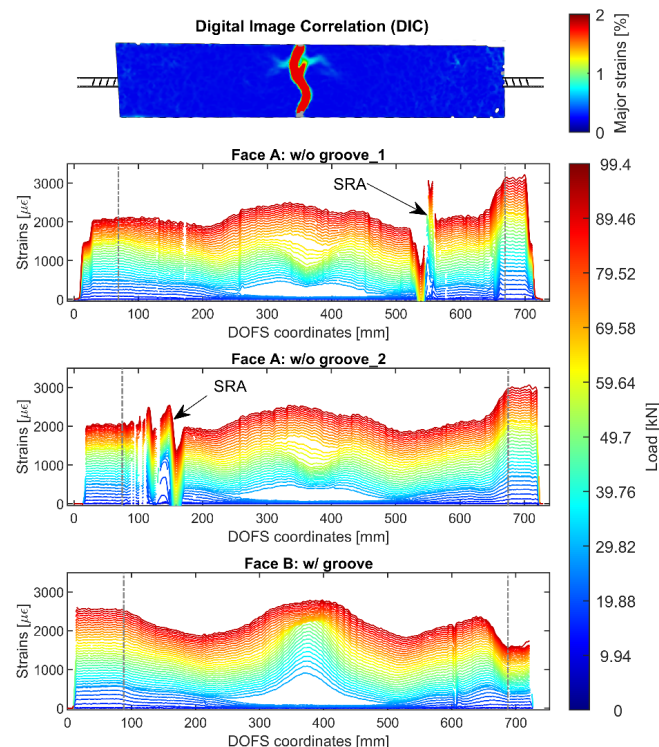
The first RC cracking tie under scrutiny is 12D16_60. The member has the peculiarity of being monitored by three runs of the same fiber (possible thanks to its extended length) achieved through a simple twist, as shown in Figure 5a. Two DOFS runs are performed on Face A, where both bondings are achieved with CYN and SI w/o groove, and one on Face B w/groove (with CYN and SI). Their outputs are plotted in Figure 17 which includes a DIC illustration (on top) of the position of the crack in order to correlate it to the member's rebar strains.

Figure 17. DOFS extracted profiles of member 12D16_60 as monitored by three runs of the same fiber, two on Face A and one on Face B.

Despite a relevant amount of bending is evident in each of three plots, a clear variation of the strain profile can be noticed in correspondence to the formed crack. Indeed, this variation takes the form of a single (Face B) or double pointed (Face A) peak whose axes coincides with the crack displayed in the DIC. Multiple SRAs can be seen in both of Face A's plots whilst only a small un-intrusive one can be spotted in Face B's suggesting the superiority of the latter's bonding technique. In line with what was concluded in the previous sub-section, also the noise produced by the combination of groove, CYN and SI is inferior to the bonding technique using just the last two elements.

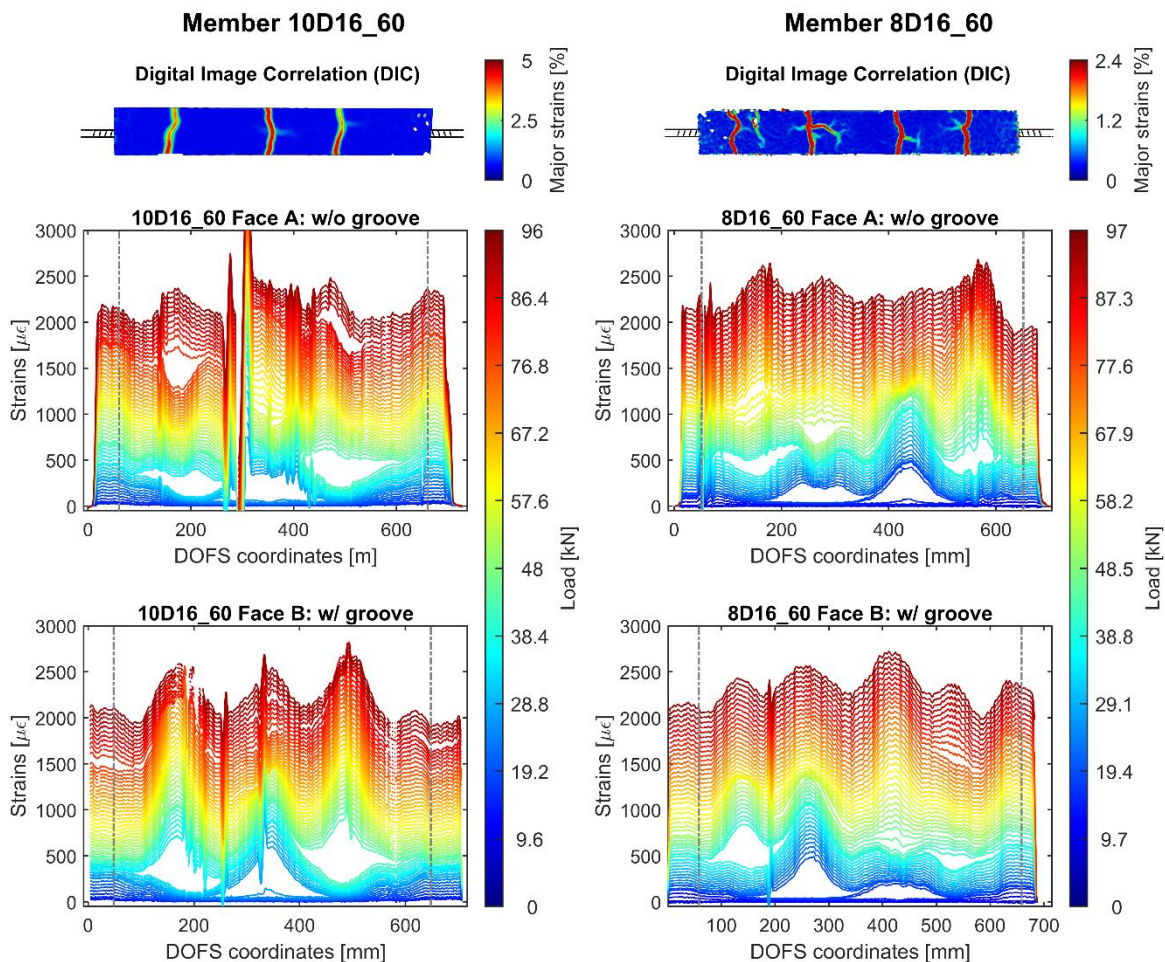
Figure 18 expands on the previous one showing the DOFS and DIC outputs of members 10D16_60 and 8D16_60. Just like before, the members' Faces A use simply CYN and SI whilst Face B adds a groove to the mix. Similar observations to the previous figure's can be performed. Indeed, strain peaks correspond well to DIC's cracks location and the signal noise level is inferior for DOFS positioned inside a groove versus outside one. Interestingly, though, member 10D16_60 displays a consistent amount of SRAs in both faces demonstrating that even the combination of groove, CYN and SI is not completely fail-proof.

Figure 18. Member 10D16_60 (left) and 8D16_60's (right) rebar DOFS strain profiles for the latter's opposite faces, each welcoming different bonding techniques, and their DIC monitoring.

Ideally, the steel rebar's strains in the cracked section (where concrete is absent) should be equivalent to the steel strains present on the bare rebar outside of the concrete prism. Yet, due to the presence of bending in the rebar, this assumption cannot be made. Furthermore, member 10D16_60's two plots display two different crack-induced peak heights, Face A's smaller than Face B's. As mentioned above, it is only through a double DOFS monitoring of member's 10D16_60 rebar

Member's 10D16_60 crack-induced strain peak height difference between Faces A and B, could potentially be attributed to the two following issues; the above mentioned extra-stretching communicated to the DOFS by the bending-induced-tension inside the concrete and/or to the under-performance of SI which fails to properly isolate the DOFS from the concrete's pull whenever the latter's cracks open. Differently so, this issue was less pronounced for both fibers deployed in member 8D16_60 probably due to either a positioning of the DOFS half way between the bending-induced tensile and compressive area or to a thicker and more protective layer of SI. Further research is necessary to comprehend this phenomenon as no sufficient data is available at the present moment.

- An unexpected phenomenon, possibly connected to the under-performance of the above bonding technique, causes an alteration of the DOFS strain readings whenever the fiber is in the presence of extra bending-induced tension (smoothened strain profiles as in Figure 16, Face A) and/or monitoring strains in cracked cross-sections (magnifying their amount as in Figure 18);

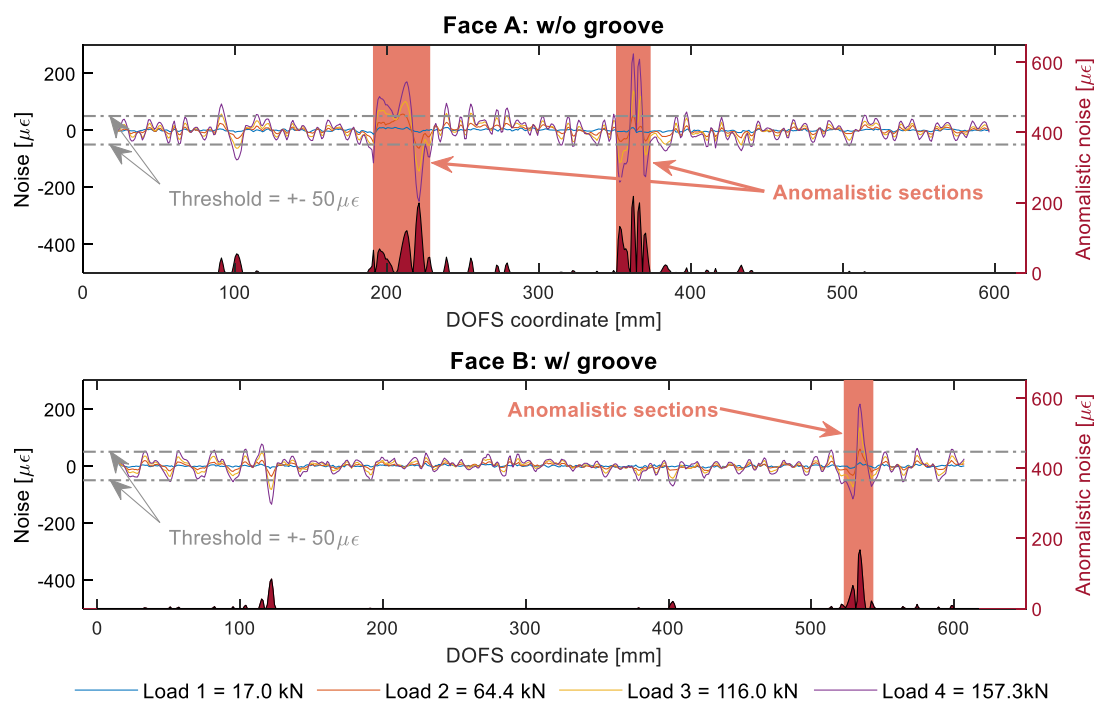
In order to properly diagnose an SRA and clearly distinguish it from the signal's noise, a unique method is here presented. Taking as example member 15D20_24_2, Figure 19 analyses its DOFS signal noise level for four distinct loads.

Figure 19. Member 15D20_24_2 Face A's (top) and B's (bottom) noise level study for SRA analysis.

For clarity purposes, being the noise increasingly larger with the load, only the latter will be studied on the lookout for SRAs. Then, if to assume a customizable threshold of $\pm 50 \mu\epsilon$, any noise

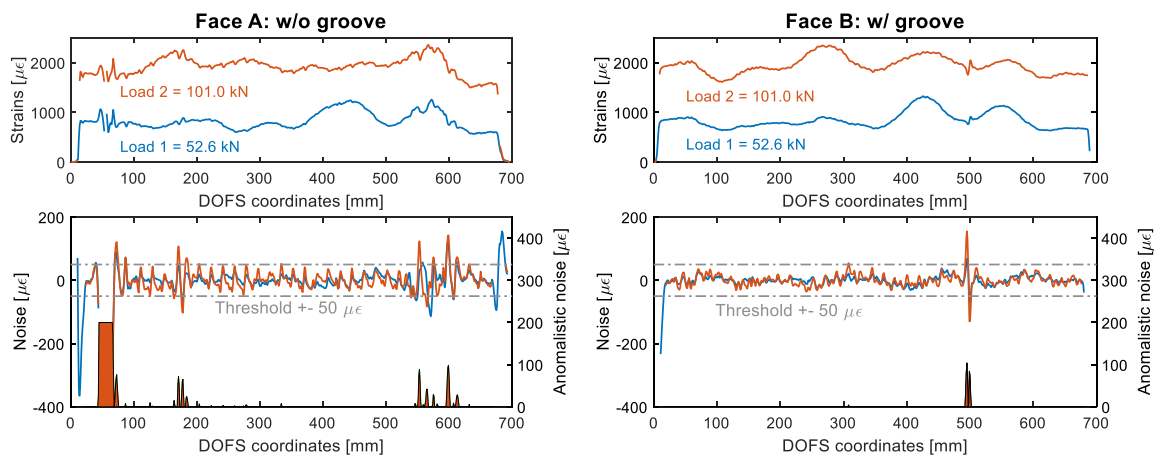
Whenever data is absent it can also be considered an anomaly as the viewer is also missing out on relevant information just like with an SRA. Except that, whilst with small SRAs a trend can still be distinguishable, with absent data no such thing can be done. Therefore, the used SRA detection code was tweaked to attribute an anomalistic noise of $200 \mu\epsilon$ to any DOFS section with missing data (as visible in Figure 20).

Figure 20. Member 8D16's strain profiles (top) and noise level (bottom) study for strain reading anomalies (SRA) analysis.

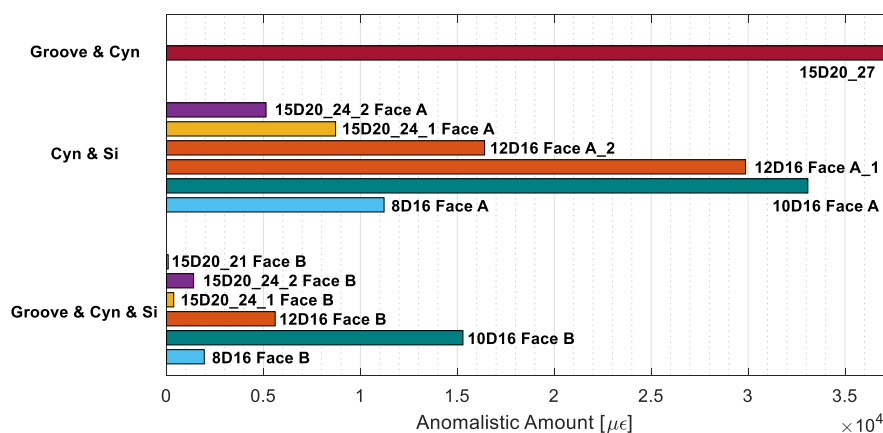
With these observations in mind a final calculation of the total amount of SRAs can be performed per every bonding technique. Its outcome, represented in Figure 21, shows a clear advantage of the groove, CYN and SI technique as it averagely welcomes a distinctly smaller amount of SRAs compared to the other two.

Figure 21. Total amount of anomalistic readings grouped per bonding technique used.
