## **A closer look at corrosion of steel reinforcement bars in concrete using 3D neutron and X-ray computed tomography**

Samanta Robuschi<sup>a,\*</sup>, Alessandro Tengattini<sup>b,c</sup>, Jelke Dijkstra<sup>a</sup>, Ignasi Fernandez<sup>a</sup>, Karin Lundgren<sup>a</sup>

<sup>a</sup> Chalmers University of Technology, Göteborg, Sweden

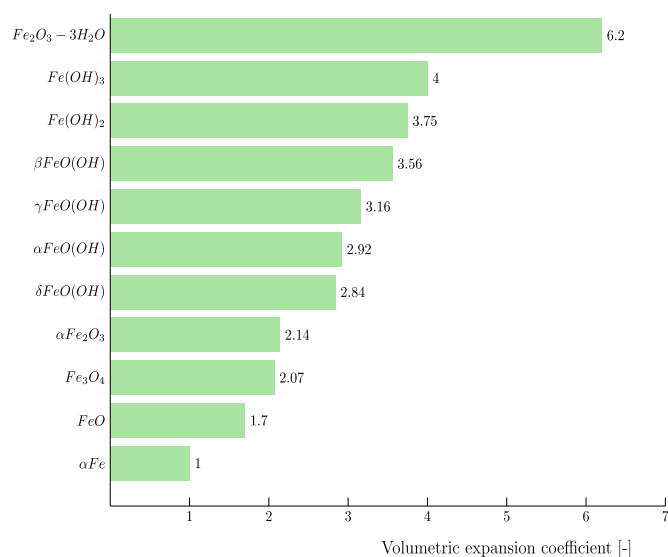
Fig. 1. Relative iron to rust volume for different iron oxides and hydroxides [13,14].

the modelling of corrosion-induced concrete cracking. It is known to vary between 2.2 and 6.4 depending on the availability of oxygen and hydrogen at the time of formation of the corrosion products [13,14]. Fig. 1 summarises different oxides and hydroxides generated in the corrosion process and the corresponding iron-to-rust volume ratio.

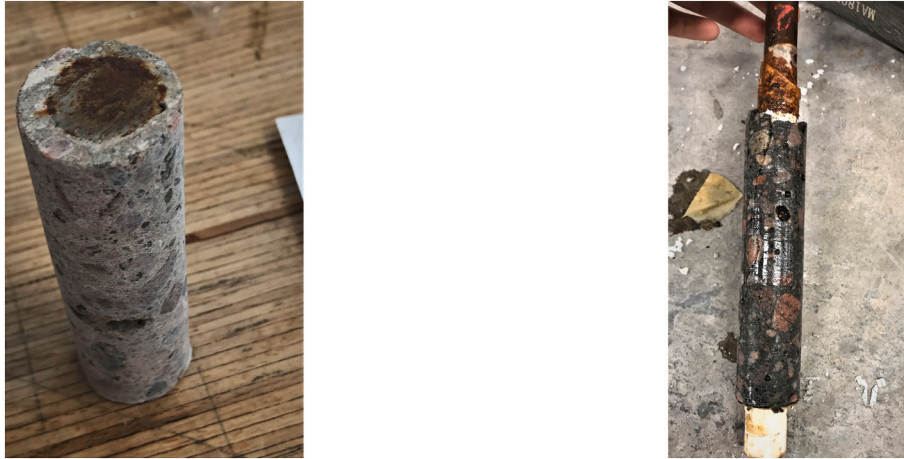
Fig. 2. Samples included in the study, after coring. To the left, naturally corroded sample cored from a decommissioned bridge; to the right, artificially corroded sample with corrosion induced cracks.

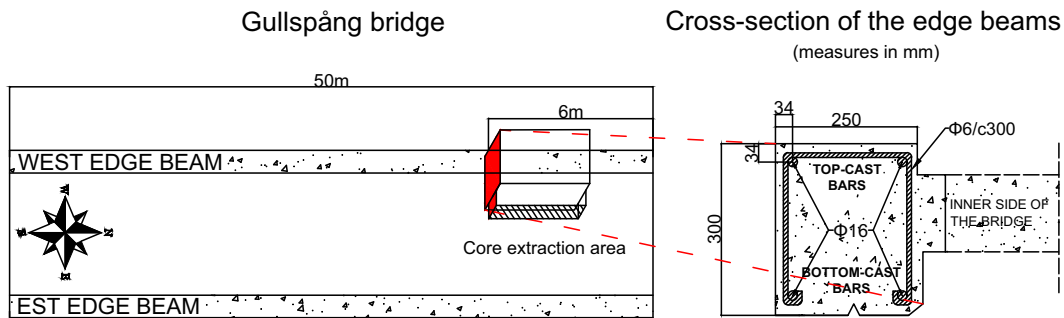
Fig. 3. Original position of the sample cored from Gullspång bridge. On the left, a view of Gullspång bridge where the position of the cored sample is marked. On the right, the nominal cross-section of the edge beams. Note that the drawings are not in the same scale.

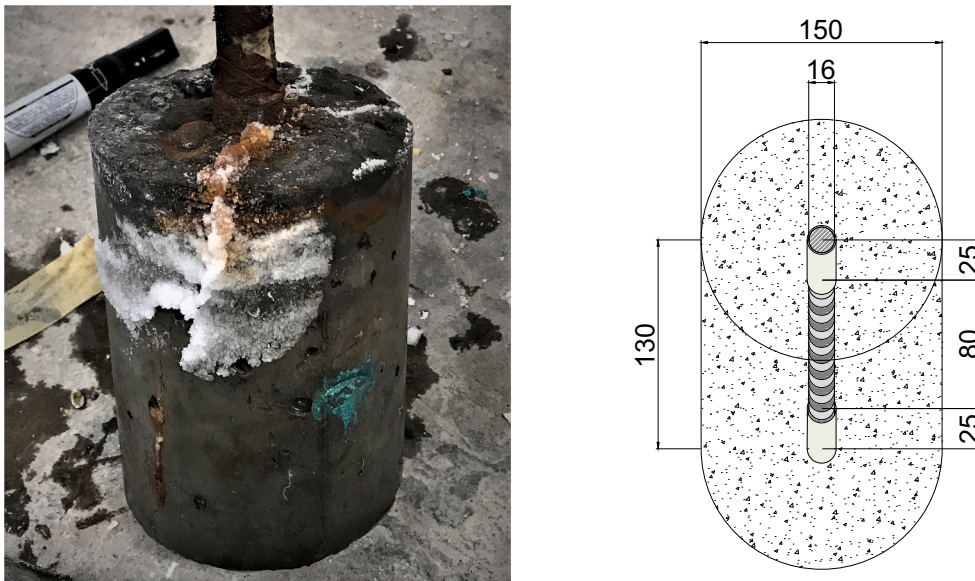
Fig. 4. On the left, artificially corroded sample, before coring. Cracks and corrosion stains are clearly visible on the surface. On the right, the geometry of the artificial sample is shown. All measures in mm.

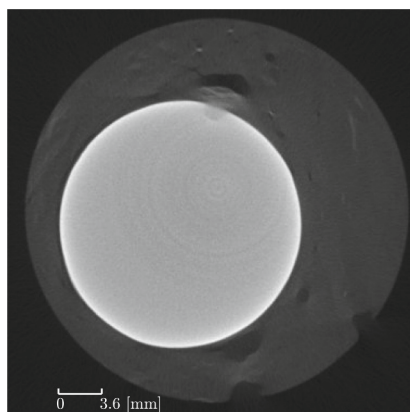
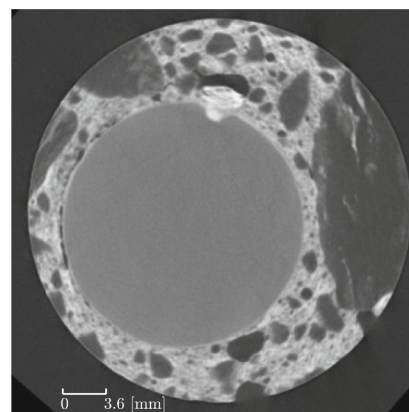
A: X-ray tomography

B: Neutron tomography

Fig. 5. On the left, a view of a cross section with a corrosion pit from the naturally corroded sample obtained with X-ray tomography. On the right, view of the corresponding cross section after alignment, as obtained with neutron imaging. The highest coefficients of attenuation are in white.

This is reflected in Fig. 5, which shows a cross-section from the naturally corroded sample, as captured with X-ray (left) and neutron imaging (right), after the two data sets were aligned. In the X-ray image, the low density pores are easily recognisable but aggregates and the cement paste, having similar densities, are hard to distinguish. In the neutron image, conversely, the cement paste has higher attenuation than quartzitic aggregates, due to the presence of both free and chemically bound water. Nonetheless, pores and voids are hard to distinguish from the aggregates, which can be compensated with the X-ray data. Most importantly, the high hydrogen content of corrosion products makes their presence highly visible, which is key in the present study. Conversely the more commonplace X-rays have difficulties in the presence of the relatively large reinforcing bar (16 mm in diameter), in particular on the boundary between the steel and the concrete (the beam hardening effect highlighted by the large gradient in X-ray attenuation

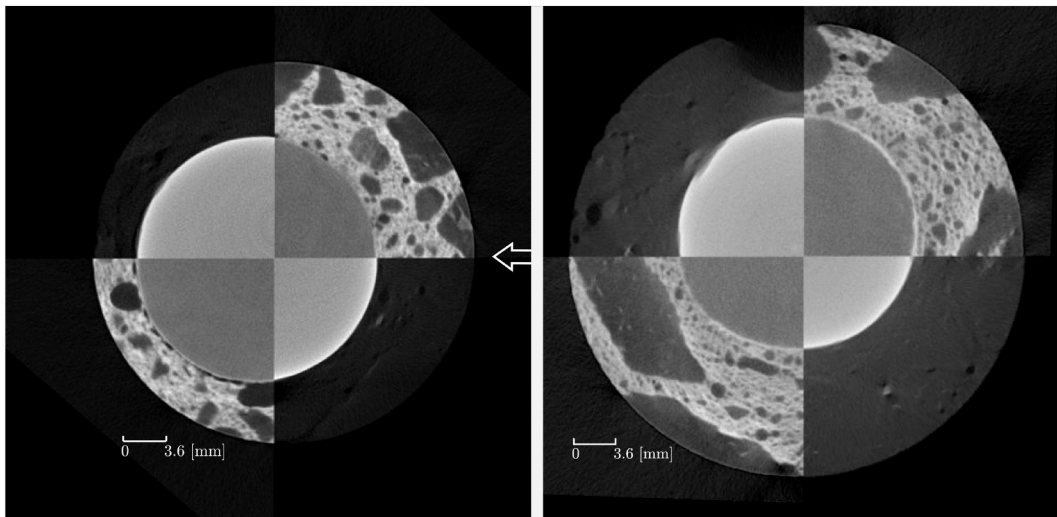
**Fig. 6.** Example of the realigned data-set. Cross sections of the naturally corroded sample (left) and the artificially corroded sample (right) are shown. A white arrow marks the expected casting direction in the naturally corroded sample.

data. An example of the results is shown in Fig. 6, where a horizontal cross-section of each 3D data set is presented. The new aligned data was subsequently used to divide the image in different phases, corresponding to background, cement paste, aggregates, voids, reinforcing bar and corrosion products as detailed in the next section.

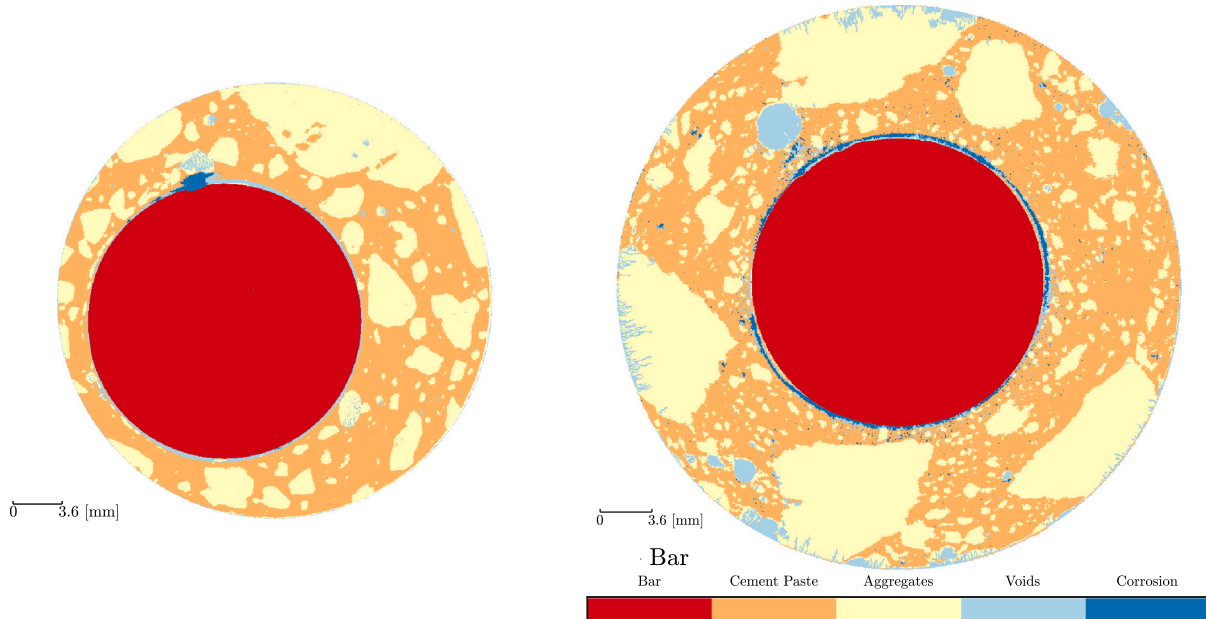
**Fig. 7.** Phase segmentation of the samples. Cross sections of the naturally corroded sample (left) and the artificially corroded sample (right) are shown.

An example of the final result is shown in Fig. 7. It should be observed that the theoretical voxel size of the sample ( $36 \mu\text{m}$ ) did not allow for distinguishing either micro-pores or the interfacial transition zone (ITZ), their size being smaller than the theoretical voxel size.

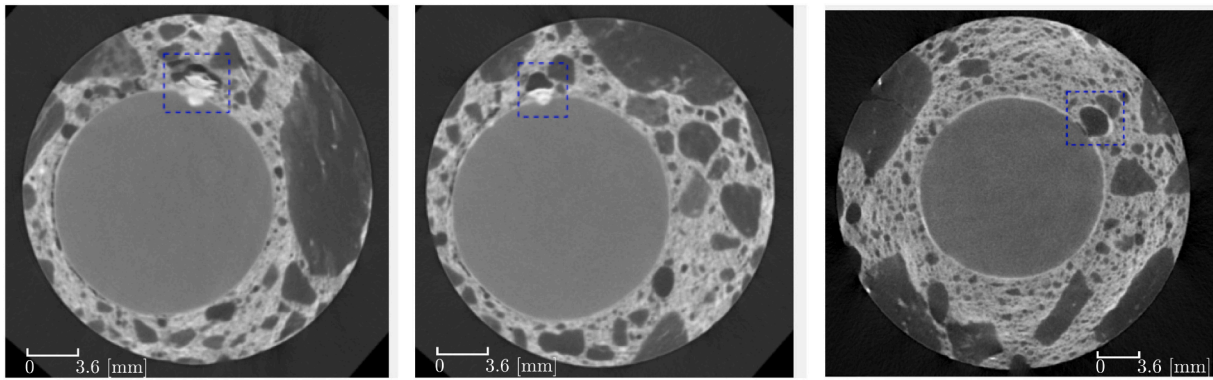
**Fig. 8.** Cross sectional view of the corrosion pits used for the computation of the iron-to-rust ratio (as captured with neutron imaging). Two pits were found in the naturally corroded sample (left and centre), one in the artificially corroded sample (right). In blue, the area of the cross-section considered for the evaluation of the expansion coefficient. (For interpretation of the references to colour in this figure legend, the reader is referred to the web version of this article.)

A total of three pores satisfying these conditions were observed in the samples, of which two were found in the naturally corroded sample and one in the artificially corroded sample (see Fig. 8).

The procedure for the evaluation of the expansion coefficients consisted first in isolating the volume of interest, *i.e.* the pore and the corresponding corroded bar surface (see Fig. 8). Then, the total volume of the corrosion products was calculated starting from the previously isolated corrosion phase.

- For the naturally corroded sample, the average uncorroded area is assumed to be equal to  $203.02 \text{ mm}^2$ , as obtained from 3D scanning of bars from the same edge beams in a previous study [39];
- For the artificially corroded sample, the geometry of the reinforcing bar was evaluated before casting, and therefore the average uncorroded area was known and equal to  $207.92 \text{ mm}^2$ ;
- The loss of steel was equal to the difference between the measured local volume of the bar, and the volume of a perfectly circular bar, centred in the centre of the reinforcing bar and having an area equal to the uncorroded area. The theoretical radius was based on the average uncorroded area. Note that the volumetric difference was evaluated only in the subvolume of interest of the pit, calculated from the theoretical steel area in the marked region in Fig. 8.

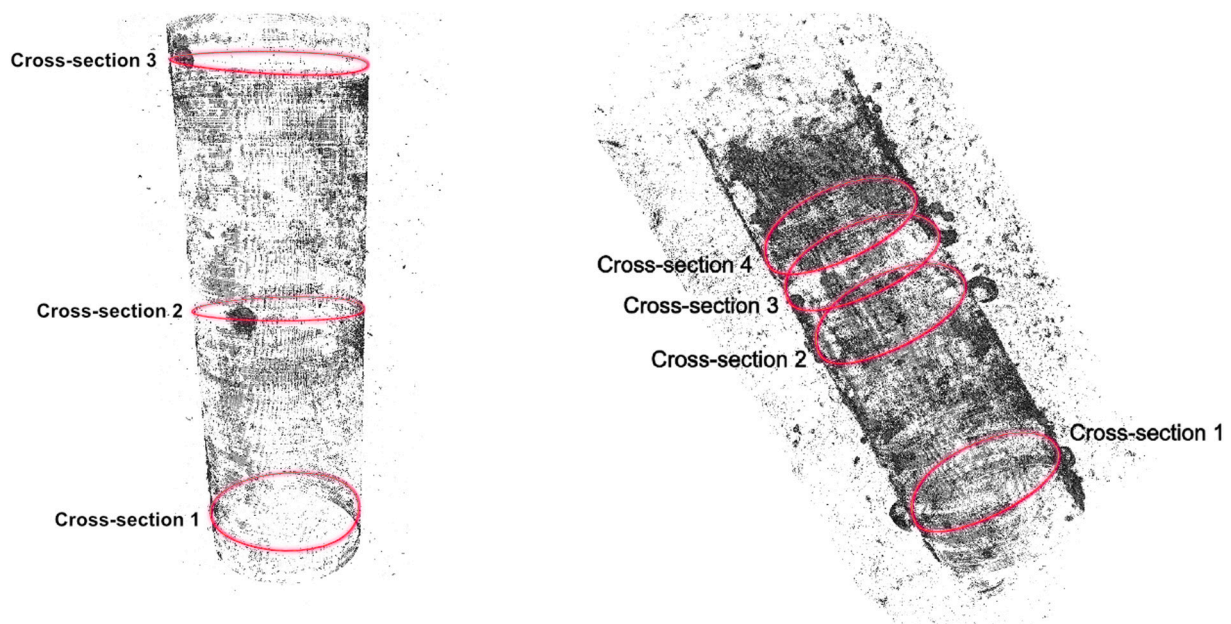
**Fig. 9.** 3D rendering of the corrosion distribution around the bar for the naturally corroded sample (left) and the artificially corroded sample (right). In red, the location of the cross-sectional views presented in Figs. 10 and 11 are shown. (For interpretation of the references to colour in this figure legend, the reader is referred to the web version of this article.)

Fig. 9 shows the distribution of the corrosion products over the length of the bar in the naturally (left) and artificially corroded sample (right), as obtained from the segmentation procedure described in Section 2.3.4. The naturally corroded sample appears almost not corroded, except for two large, visible pits. Those pits are located in correspondence of macro-pores (see Fig. 10). The artificially corroded sample shows, instead, a fairly uniform distribution of the corrosion products along the surface of the bar. Corrosion is also observed to adhere to the surface of macroscopic interfacial pores, and smaller corrosion particles appear to have migrated through the sample.

than other corrosion products with lower iron-to-rust ratios, such as magnetite ( $Fe_3O_4$ ) or haematite ( $\alpha - Fe_2O_3$ ), as highlighted in Table 1. Jaffer et al. [53] observed a dependency between the concrete porosity and the migration of corrosion products through the cement paste, where migration of the products would increase with the concrete porosity. High concrete porosity, and the formation of a more soluble corrosion product under accelerated corrosion conditions, may explain the spatial distribution of corrosion products in the artificially corroded sample shown in Fig. 9.

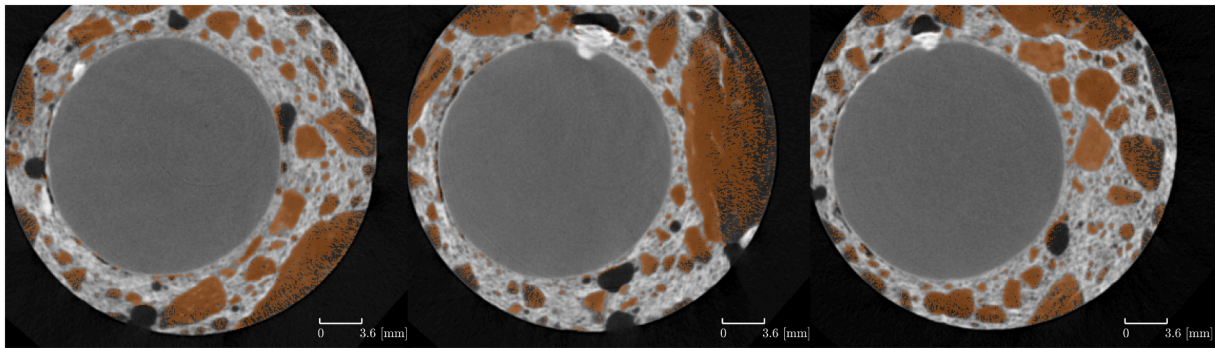
**Fig. 10.** Horizontal slices of the naturally corroded sample, view of three different pits. From left to right: cross-sections 1, 2 and 3, see Fig. 9. Aggregates are highlighted in orange using complementary X-ray data.

Fig. 10 shows different types of macroscopic interfacial concrete voids in the naturally corroded sample. Corrosion products are represented in white, corresponding to higher neutron attenuation. In contrast, voids, having low attenuation coefficients, are shown as dark features in the image. The high contrast between the corrosion products and the pore, and the dry status of the sample at the time of scanning suggest the absence of pore solution.

In all cases, the presence of corrosion products is clearly linked to the presence of a macro-pore adjacent to the bar. However, the presence of a macro-pore does not necessarily result in the formation of corrosion products, as can be observed for example in Fig. 10 (left). Corrosion products are observed to partially occupy the pore, growing directly from the corresponding corrosion pit in the reinforcing bar.

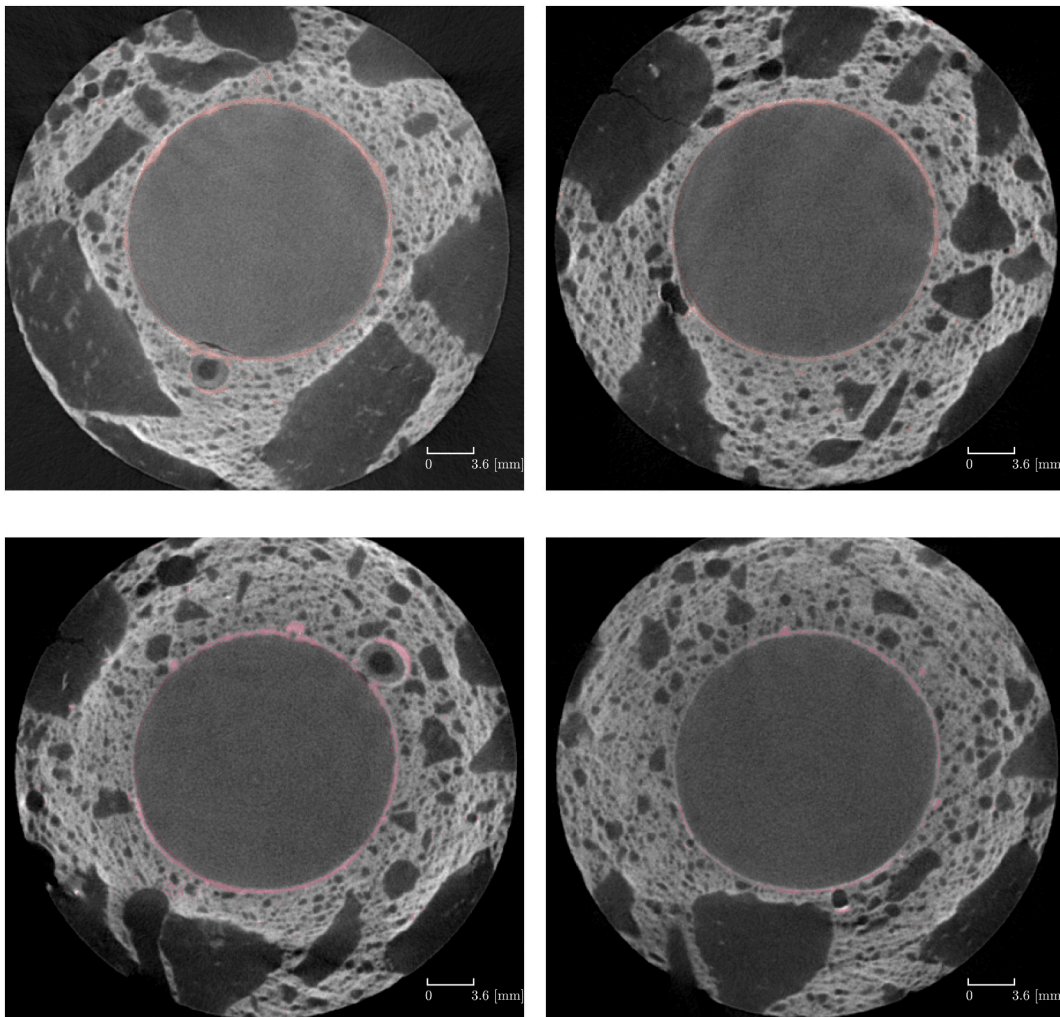
**Fig. 11.** Horizontal slices of the artificially corroded sample, highlighting the distribution of corrosion products (in red) in four different cross sections with pits. From left to right, top to bottom: cross sections 1, 2 3 and 4 in Fig. 9. (For interpretation of the references to colour in this figure legend, the reader is referred to the web version of this article.)

Fig. 11 shows different interfacial macroscopic voids in the artificially corroded sample, highlighting how the bar is surrounded by an almost homogeneous layer of corrosion products. Corrosion products are highlighted in red, using complementary x-ray data. Corrosion products appear to adhere to the cement paste, instead of the bar. This is particularly evident for large pores, where corrosion products are observed to surround the pore perimeter, instead of growing from the pit as in the natural corroded case. A similar distribution was observed by Michel et al. [27], where corrosion products were observed to deposit at the mortar surface of artificially corroded specimens with a w/c ratio of 0.4 and 0.5, while for the case of a w/c ratio equal to 0.3, corrosion products were observed to adhere to the reinforcing bar.

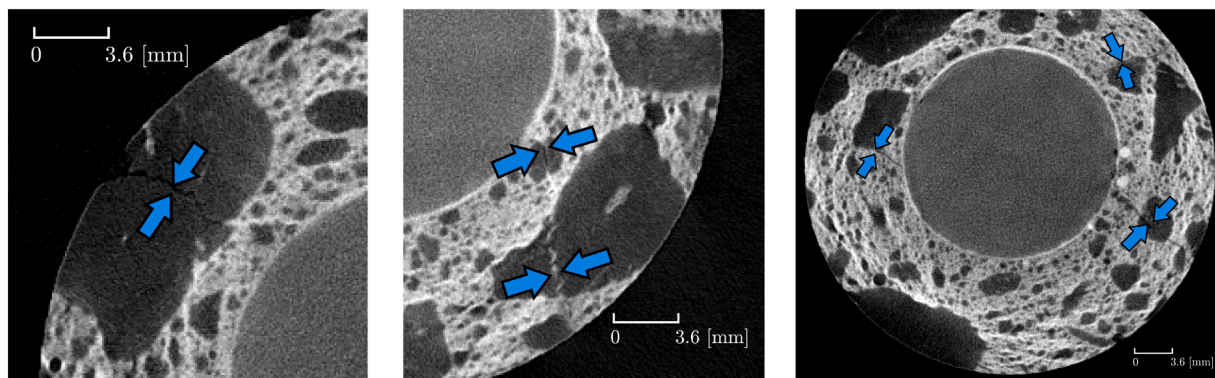
Fig. 12. Cross sectional views of the artificially corroded sample: corrosion products (in white), are observed to migrate towards the external surface of the sample (left and centre). However, not all cracks appear to be filled with corrosion products (right).

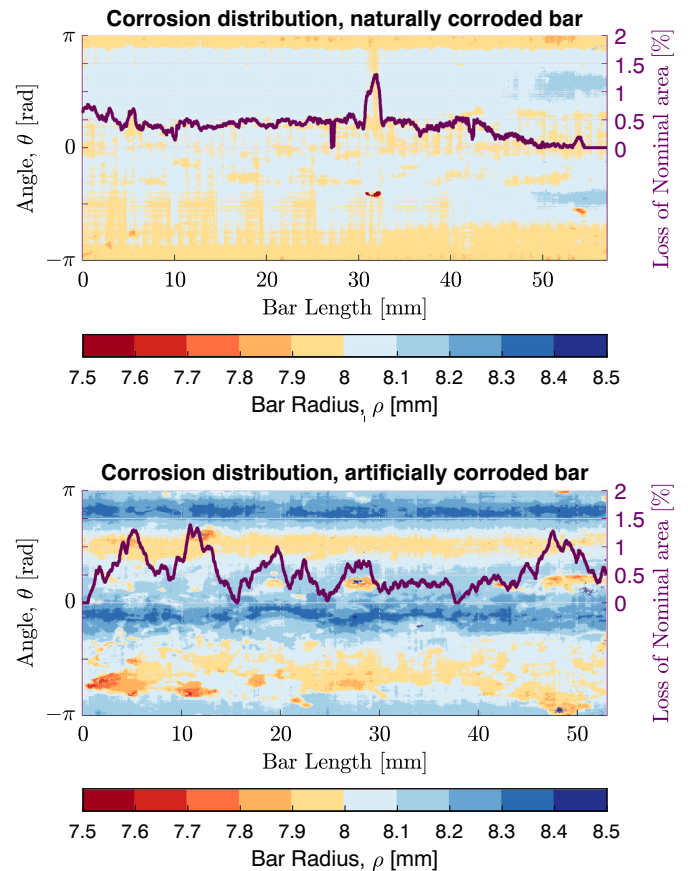
Fig. 14. Corrosion distribution along the length of naturally corroded bar (top) and artificially corroded bar (bottom). The loss of nominal area is represented by the continuous purple line, and refers to the right y-axis. (For interpretation of the references to colour in this figure legend, the reader is referred to the web version of this article.)

The corrosion level of the steel bars was evaluated by comparing the corroded area of the reinforcing bar to its estimated average area prior the corrosion process (see Section 2.3.7). Fig. 14 offers an overview of the corrosion level of the two reinforcing bars embedded in the samples. The average corrosion level of each section is plotted against the length of the bar, while the radius of the bar, with respect to its centre, is shown in a contour plot with the length of the bar and the rotation angle in the  $x - y$  axis, resulting in a complete 2D view of the bar surface.

Differences in corrosion patterns between the two bars can be clearly observed: while the naturally corroded sample is characterised by two large corrosion pits at 33 and 55 mm around a  $-\pi/2$  angle, alongside minor spots of corrosion, corrosion damages are almost uniformly distributed along the length of the artificially corroded bar. Note that the estimation of the corrosion level is more precise for the case of the artificially corroded sample, for which the original geometry of the embedded bar is known *a-priori*.

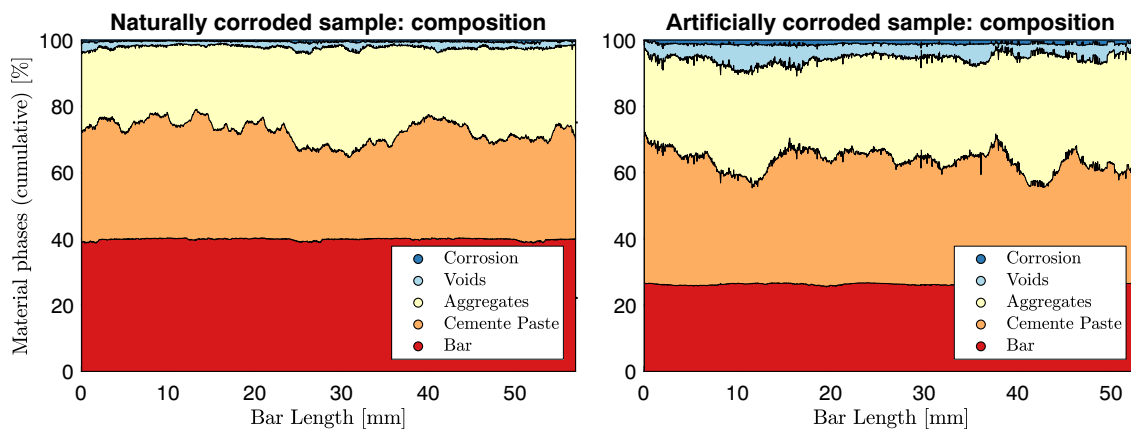
Fig. 13. Composition of the naturally corroded (left) and artificially corroded sample (right), after phase segmentation. Note that the artificially corroded sample had a larger diameter than the naturally corroded one, therefore the bar constitute a lower percentage of the sample composition.

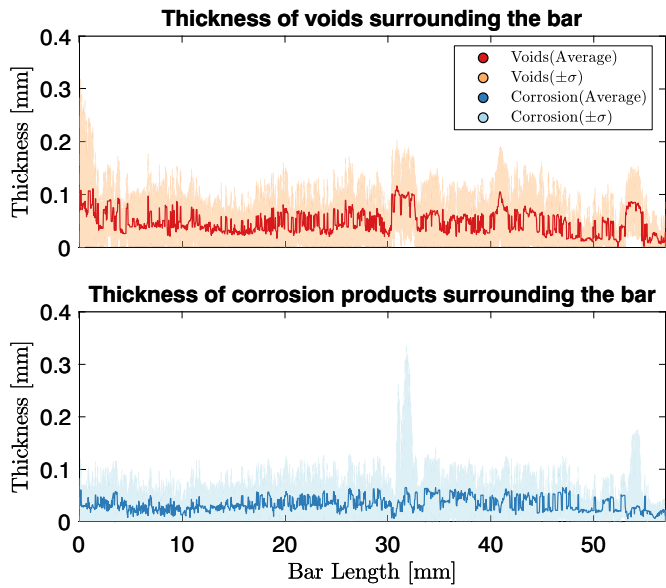
Fig. 15. Thickness of voids and corrosion products along the length of the bar in the naturally corroded sample.

In Figs. 15, 16, 17 and 18, the thickness of voids and corrosion products surrounding the bar is presented (whose evaluation is detailed in Section 2.3.5). Therein, the average thickness is presented along the length and across the perimeter of the bar for each specimen. Each measurement is the average of the maximum thicknesses of voids/corrosion products for a given portion of the specimen, thus, adding the

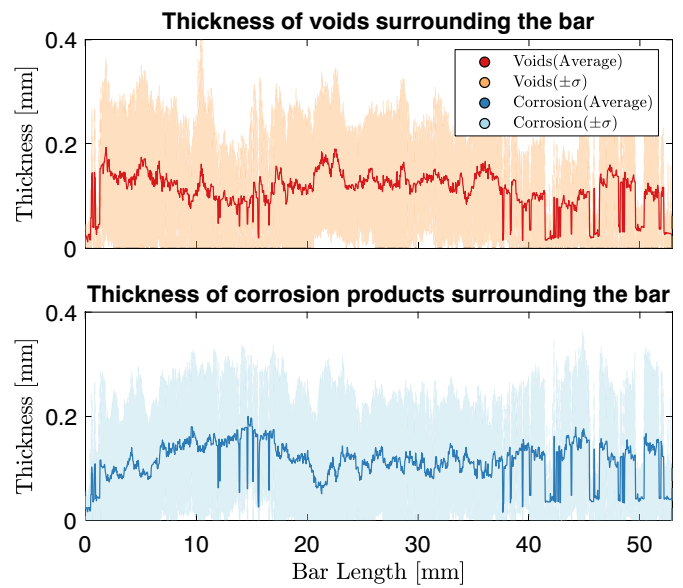
Fig. 17. Thickness of voids and corrosion products along the length of the bar in the artificially corroded sample.

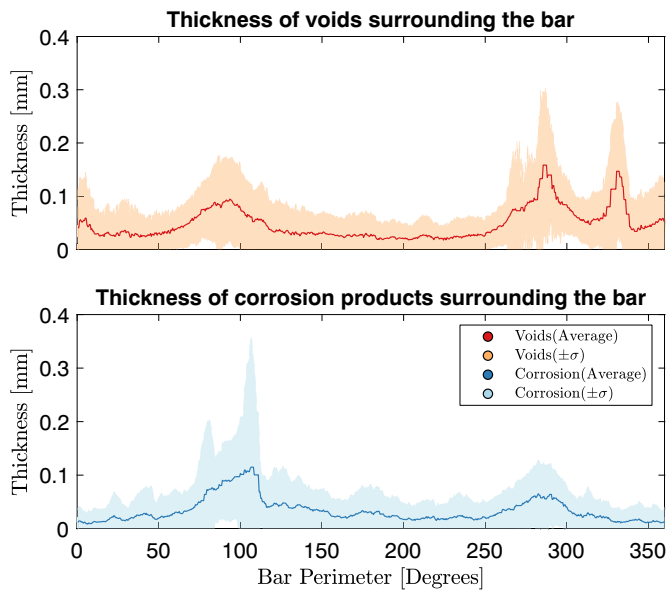
Fig. 16. Thickness of voids and corrosion products along the perimeter of the bar in the naturally corroded sample.

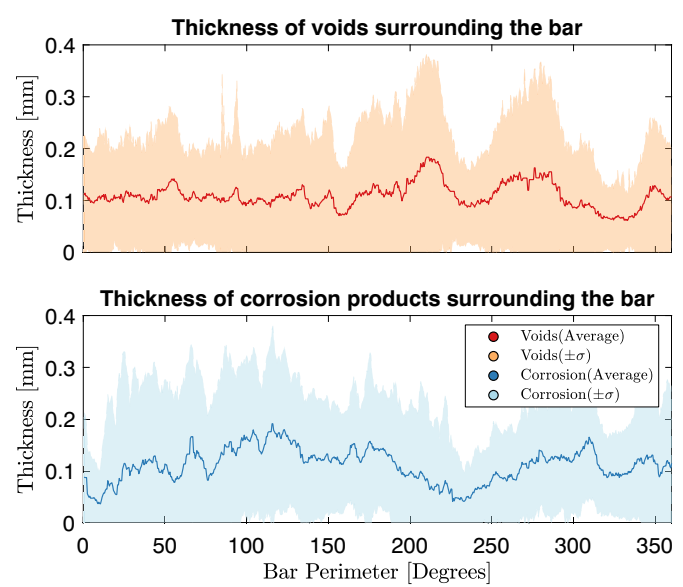
Fig. 18. Thickness of voids and corrosion products along the perimeter of the bar in the artificially corroded sample.
