Experimental investigation of cavitation-induced erosion around a surface-mounted bluff body

Jahangir, S., Ghahramani, E., Neuhauser, M. et al (2021). Experimental investigation of cavitation-induced erosion around a surface-mounted bluff body. *Wear*, 480-481.
<http://dx.doi.org/10.1016/j.wear.2021.203917>

Saad Jahangir^{a,*}, Ebrahim Ghahramani^b, Magdalena Neuhauser^c, Sébastien Bourgeois^c, Rickard E. Bensow^b, Christian Poelma^a

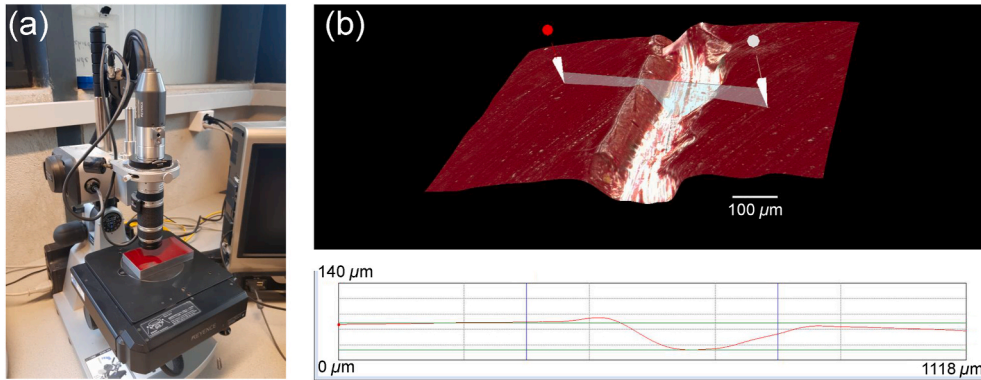
Fig. 4. (a) Paint thickness is measured via a digital microscope (KEYENCE VHX-700F). (b) 3D reconstruction of the paint layer. A scratch (white region) is used to determine the layer thickness. The bottom shows the height profile between the two markers. Thickness of paint is approximately 48 μm. See text for details.

The thickness of the paint is measured by a digital microscope (KEYENCE VHX-700F), as shown in Fig. 4(a). This digital microscope uses fine changes in the texture to calculate height data using multi-focal plane microscopy. This means that a 3D image can be created by compiling images captured at different focal planes. In Fig. 4(b), the thickness (approximately 48 μm) of the paint is shown. The paint removal in Fig. 4(b) is obtained by a simple scratch on the plate before the test. The green curve in the plot shows the reference measurement and the red curve shows the actual measurement.

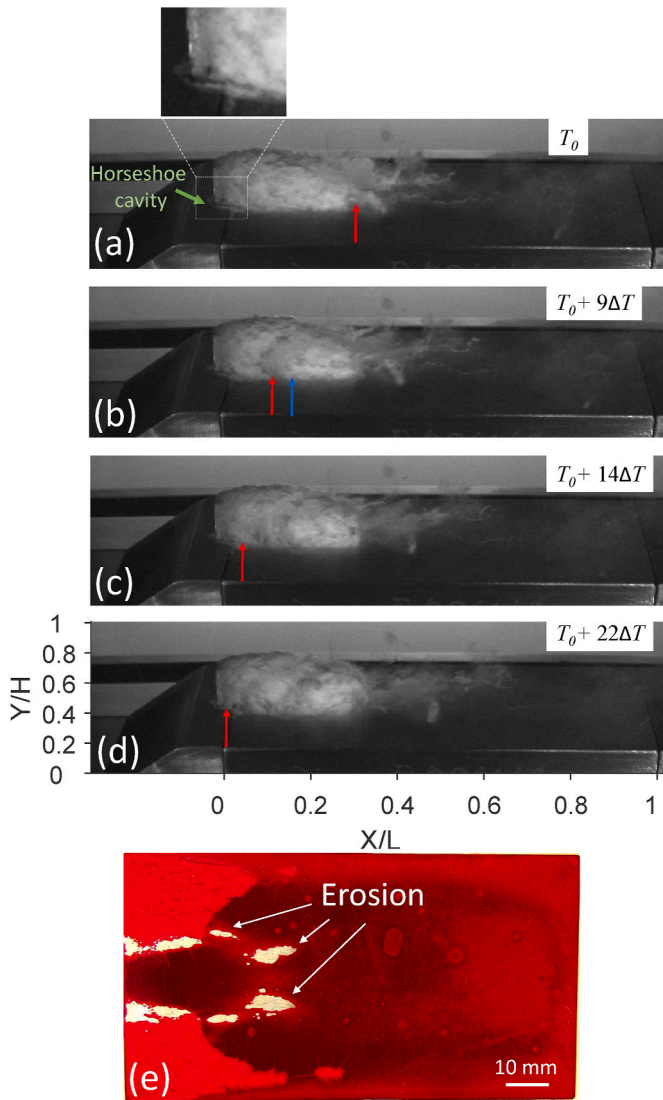
Fig. 10. Case C1, $\sigma = 0.641$. (a–d) A time series of cavity collapse, the red arrow locates the front of the reverse jet. The rolling of the cavity is indicated by the blue arrow. The [supplementary movie 'S4'](#) more clearly shows these features. Flow is from left to right. (e) (Top view of the sample plate) Paint removal after 40 min. (For interpretation of the references to colour in this figure legend, the reader is referred to the web version of this article.)

In Fig. 10, a time series of a test case (C1) with $\sigma = 0.641$ is shown together with the erosion pattern (Fig. 10(e)). It is clear from the snapshots that the shedding and deformation at the closure of the cavity takes place sooner as compared to the cases discussed without the bluff body. In Fig. 10(b) and (c), the development and detachment of a vortex

can be seen at the closure of the cavity (indicated with red arrows). The rest of the cavity is attached to the cylinder. The figure shows a time series of the flow with $\Delta T = 4 \times 10^{-5}$ s. At $T_0 + 9\Delta T$, a reverse flow can be seen together with the rolling of the cavity (indicated by the blue arrow). The front of the reverse jet is depicted by a red arrow. A detailed description of the dynamics of this reverse jet is provided in the earlier study [37]. The reverse flow of the cavity has an angle towards the bottom plate. It moves further upstream ($T_0 + 14\Delta T$) and finally hits the cylinder ($T_0 + 22\Delta T$). Moreover, one more interesting characteristic of this flow is the horseshoe cavity formed just in front of the cylinder base. The horseshoe cavity is indicated by the green inclined arrow and it can be seen more clearly in the enlarged view (Fig. 10(a)). The horseshoe cavity is more clear in motion (supplemental movies). The periodic collapse of this horseshoe cavity causes erosion just downstream of the cylinder and this erosion will also be observed in the cases discussed later. In the erosion pattern (Fig. 10(e)) it can be seen that most of the eroded part is around the perimeter of the cavity, both at the end as well as the sides. In this case, erosion is not just attributed to the collapses at

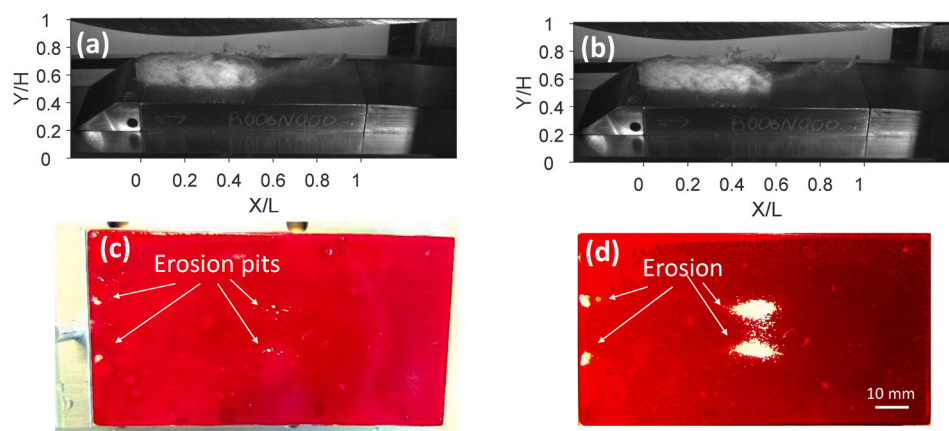
Fig. 11. Case C2, $\sigma = 0.604$. (a–b) Two snapshots of cavity collapse. Flow is from left to right. (c) (Top view of the sample plate) Beginning of erosion development. (d) Paint removal after 40 min.

By reducing the cavitation number to $\sigma = 0.604$ or lower, most of the cavity remains attached to the bluff body. Only small structures are shed downstream from the attached part. In [Fig. 11](#) (a) and (b), two snapshots of the cavity structures of case C2 ($\sigma = 0.604$) are presented to illustrate some features of the flow. The cavity length increases compared to case C1. The shedding area of the vapor bubbles from the trailing edge is relatively smaller than the attached cavity in this case. After 40 min of operation, the main erosion took place at the closure of the cavity. Here the length of the attached cavity increases and the shed vapor clouds also increase in size, which makes their collapse more violent. The more aggressive collapse will in turn result in more erosion. The eroded part is shown in [Fig. 11](#)(d). It can be seen that the downstream area of the eroded part is increased compared with the earlier case. This will be further confirmed in the next case. However, in this case we do not see erosion around the sides of the attached cavity. In [Fig. 11](#)(c), at the start of the sample plate (just downstream of the bluff body), we see two clear erosion spots. After a careful examination of the high-speed movies, we find that a horseshoe cavity is generated in front of the cylinder base and collapses, similar to case C1 ([Fig. 10](#)(a)). That horseshoe cavity extends until this eroded part. This phenomenon is further explained in the next case. It is worth mentioning that the erosion pattern in this case is very similar to the one reported by Escaler et al. [35]; who performed erosion tests on four different materials and at a similar flow speed. They found that the wear is mainly located in two elliptical areas in the first half, nearest to the cylinder, immediately behind the obstacle for all the sample plates of different materials. Cavitation erosion is strongly concentrated in the center of each region and diminishes gradually towards the border. In the downstream half of the samples, a few isolated, relatively large impacts can also be observed. Escaler et al. [35] concluded that the region where collapses take place appears gradually from the first hours and no sudden increase of damage is observed during the run. Qualitatively our erosion patterns are very much similar to those cases, which means that the test times can be significantly reduced from 75 h to 40 min. The tests are compared further in the next section.

In [Fig. 11](#)(c), the beginning of erosion development for this case can

be seen. The sample plate was taken out of the test-rig after approximately 15 min of operation. We can see a few erosion pits developing at the main erosion location together with the erosion just downstream of the bluff body. With time these pits become bigger.

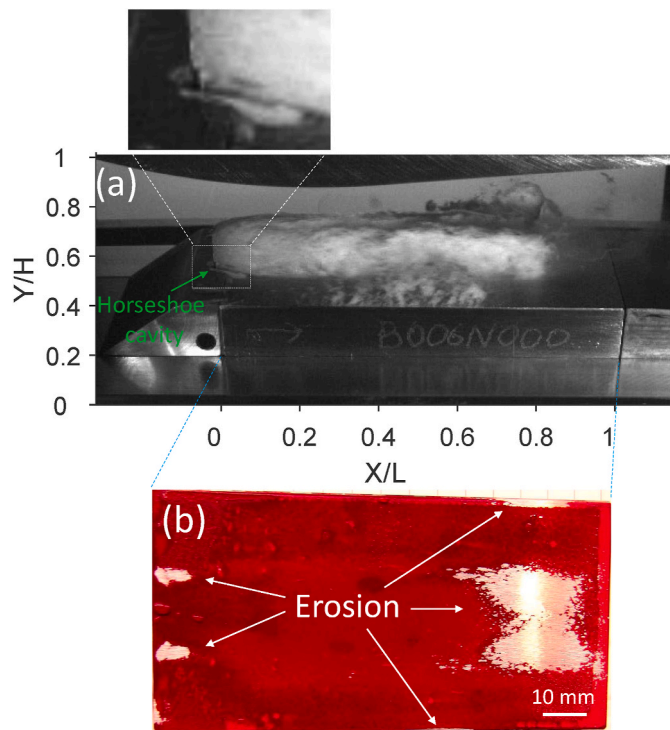
Fig. 12. Case C3, $\sigma = 0.559$. (a) Cavitation pattern. Flow is from left to right. (b) (Top view of the sample plate) Paint removal after 40 min.

A third case C3 is selected by further decreasing the cavitation number to $\sigma = 0.559$. In Fig. 12(a), a snapshot of the cavity can be seen. The cavity region extends almost to the end of the sample plate. The intensity of cavitation increases considerably compared with Cases C1 and C2, and larger vapor structures are shed from the cavity, which makes the collapses very violent. We also see the development of small and intermittent sidewall cavities. Similar to the earlier cases, we have reverse flow inside the attached cavity, but it occurs less frequently as the fixed cavity is longer. In Fig. 12(b), the corresponding erosion pattern for case C3 can be seen. The downstream of the sample plate shows a larger eroded area compared to the earlier cases, as expected. Some paint removal also took place at the start of the sample plate. Similar to the earlier cases, this is assumed to happen due to the horseshoe cavity collapse in front of the cylinder. The horseshoe cavity is indicated by the green inclined arrow and it can be seen more clearly in the enlarged view (Fig. 12(a)). Horseshoe cavity implosion is very important due to its aggressiveness. Dular and Petkovšek [11] also showed the destructive behavior of a horseshoe cavity collapse on a foil. At the sides of the sample plate, some narrow erosion can also be seen due to the unavoidable sidewall cavity (indicated by the white arrows in Fig. 12(b)). This case is the most aggressive and violent compares to the previous cases which ultimately results in more removal of the paint. The largest paint removal at the end of the sample looks similar to the paint removal pattern from no-cylinder case NC3, which is expected, as both of them happen from the violent collapse of large vapor clouds at the same region.
