The effect of boron and zirconium on the microcracking susceptibility of IN-738LC derivatives in laser powder bed fusion

Hans Gruber^a, Eduard Hryha^{a,*}, Kristina Lindgren^b, Yu Cao^a, Masoud Rashidi^a, Lars Nyborg^a

^a Department of Industrial and Materials Science, Chalmers University of Technology, Gothenburg SE-41296, Sweden

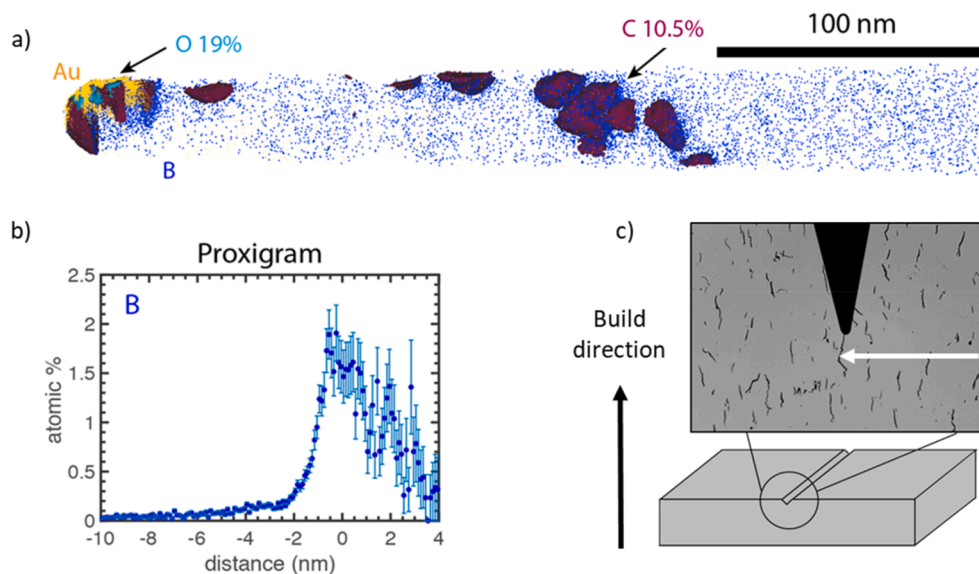
Fig. 9. APT reconstruction of HB-HZr. (a) Isoconcentration surfaces of O (light blue, 19%) and C (burgundy, 10.5%) are shown, as well as B atoms (blue) and Au atoms (yellow); (b) Proxigram of B based on the C isoconcentration surfaces, indicating that B atoms are present at the carbide-metal interfaces; (c) Orientation of the analysed volume in relation to the fracture surface indicated by the white arrow.

APT was used for analysis of the phases present on the microcrack surfaces of a fractured HB-HZr specimen. The reconstruction as well as the orientation of the analysed volume in relation to the fracture surface are shown in Fig. 9. At the surface, a thin layer of oxide is found. The gold from the coating is partly within the analysis region, confirming that the fracture surface is within the APT analysis volume. The oxide is rich in Cr and Al, but also contains a few atomic % of Zr as well as

have a B-rich layer on the carbide-metal interface, see the proximity histogram (proxigram [34]) in Fig. 9. In addition, a boride rich in Cr, Ti, and Mo was found at the surface in another APT analysis (not shown in the figure). A more detailed account of the APT results and additional transmission electron microscopy (TEM) results will be presented in a coming publication by the authors.
