THESIS FOR THE DEGREE OF DOCTOR OF PHILOSOPHY

Natural corrosion in reinforced concrete  
structures

SAMANTA ROBUSCHI

Department of Department of Architecture and Civil Engineering  
Chalmers University of Technology  
Gothenburg, Sweden, 2021

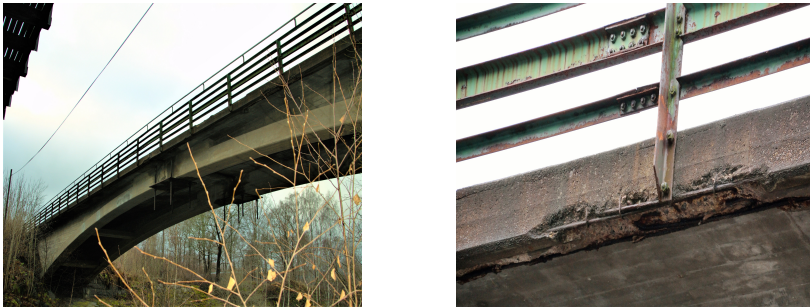
**Figure 3.1:** Gullspång bridge: view of the bridge before demolition (left) and exposed tensile reinforcement bars and spalling in an edge beam (right). Photos courtesy of Ignasi Fernandez

Gullspång bridge (Fig.3.1) was built in 1935 and torn down in 2016 due to heavy corrosion damages. The edge beams were carefully taken out, cut in segments and designated to be used for research. Having been exposed for 81 years to weather conditions that include snow, freezing-thawing cycles and wind, as well as to de-icing salts and traffic loads, the beams presented different cracks on their surface, and spalling strongly affected the geometry in some locations (Fig.3.1). Signs of corrosion were clearly visible, but not uniformly distributed.
