Thesleff, A., Ortiz Catalan, M., Brånemark, R. (2022). Low plasticity burnishing improves fretting fatigue resistance in bone-anchored implants for amputation prostheses. *Medical Engineering and Physics*, 100. <http://dx.doi.org/10.1016/j.medengphy.2022.103755>

# Low plasticity burnishing improves fretting fatigue resistance in bone-anchored implants for amputation prostheses

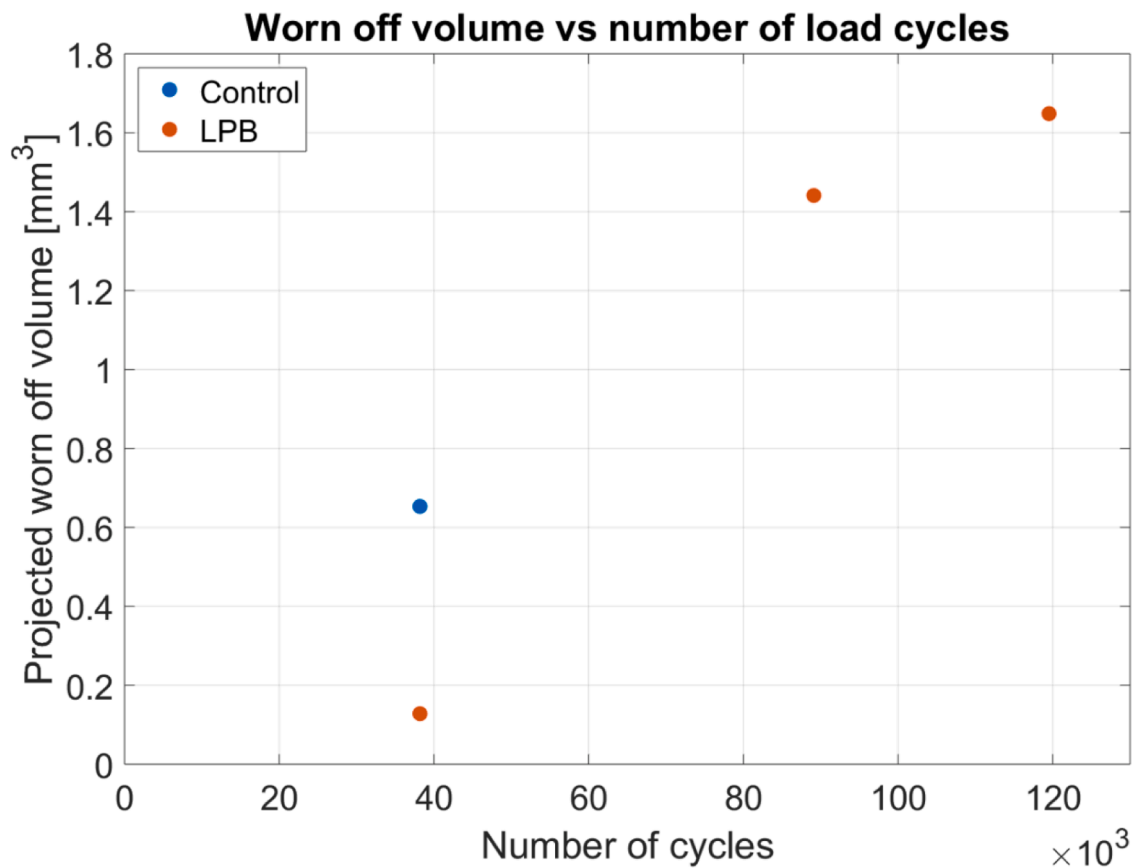
Fig. 11. Mean projected worn off volume and number of load cycles for each of the fixtures that underwent interference profilometry.

The profilometry profiles are shown in Fig. 9, with results presented in Fig. 10, Fig. 11, and Table 2. LPB 8 and Control 4 had undergone the same number of load cycles, but the mean projected volume of worn off material for LPB 8 was approximately one fifth of corresponding value for Control 4. The projected worn off volumes of LPB 1 and LPB 9 were 2.5 and 2.2 times the value of Control 4, respectively.
