The interplay between corrosion and cracks in reinforced concrete beams with non-uniform reinforcement corrosion

Gil Berrocal, C., Fernandez, I., Rempling, R. (2022). The interplay between corrosion and cracks in reinforced concrete beams with non-uniform reinforcement corrosion. *Materials and Structures/Materiaux et Constructions*, 55(4).
<http://dx.doi.org/10.1617/s11527-022-01956-2>

Carlos G. Berrocal · Ignasi Fernandez · Rasmus Rempling

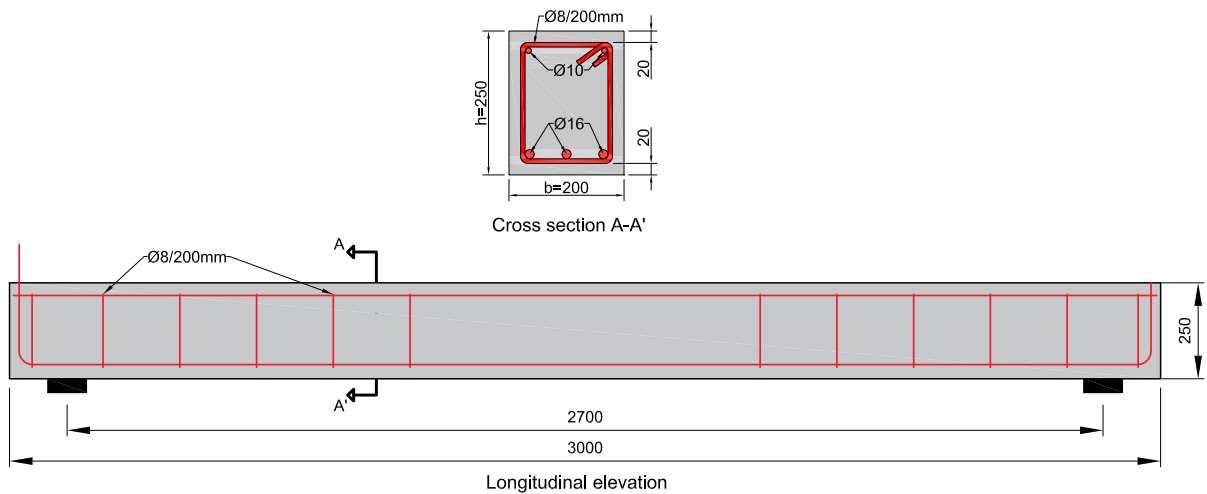
Fig. 1 Geometry of the beam specimen and reinforcement layout (all measurements in mm)

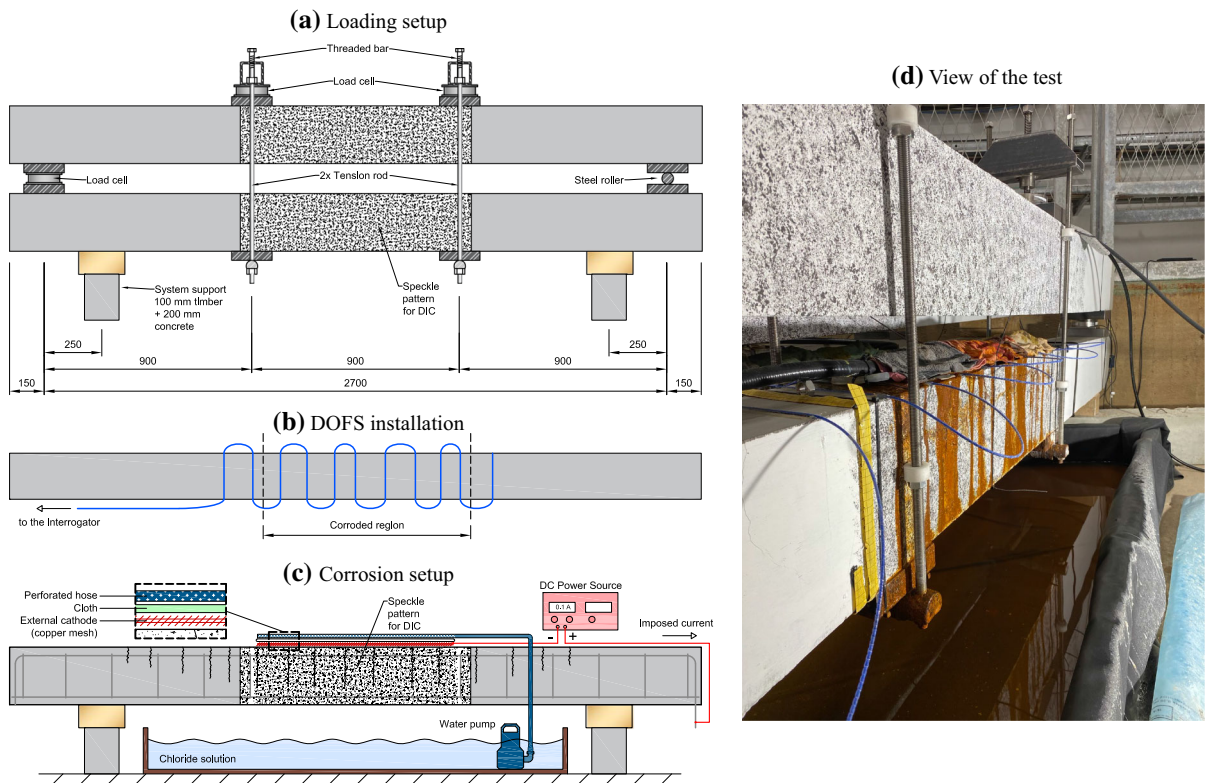
Fig. 2 **a** Loading setup for long-term imposed deformation; **b** schematic representation of the DOFS installation; **c** accelerated corrosion setup with impressed current; **d** view of the test during the accelerated corrosion phase (all measurements are in mm)

For the long-term loading, the beam was clamped together with an identical beam as illustrated in Fig. 2a. In that setup, the bottom beam was turned upside down so that the tensile reinforcement was facing upwards. Then the top beam was positioned onto two sets of support plates resting on the bottom beam, the centres of which were 2700 mm apart. Thereafter, the load was introduced at two loading points where the clamping devices were mounted, dividing the total span into three equal spans of 900 mm. Sustained deflection was applied by imposing a constant deformation between the two beams, which was achieved by tightening a threaded bolt screwed into the clamping device. Two load cells were provisioned at the loading points over the top beam and one additional load cells was placed between the support plates at one of the ends in order to ensure a symmetric distribution of load.

After 96 days of imposed deflection, accelerated corrosion of the bottom beam was promoted through impressed current. The accelerated corrosion setup, schematically illustrated in Fig. 2c, was specifically chosen to promote a non-uniform corrosion

Cracks on the tensile face of the beam were monitored using a distributed optical fiber sensor. In this study, a robust fiber optic cable BRUsens V9 from Solifos with an inner steel tube and an external rugged polyamide cladding was used. The cable, with a diameter of 3.2 mm, was deployed as schematically shown in Fig. 2b by gluing the sensor to the surface of the concrete using epoxy resin. The Optical Distributed Sensor Interrogator (ODiSI) 6000 series from Luna Inc. was used as data acquisition unit. The largest available spatial resolution between measuring points provided by the interrogator was chosen, namely 2.6 mm, whereas the sample rate was set at 1 measurement every 10 min. A general view of the test setup is shown in Fig. 2d.

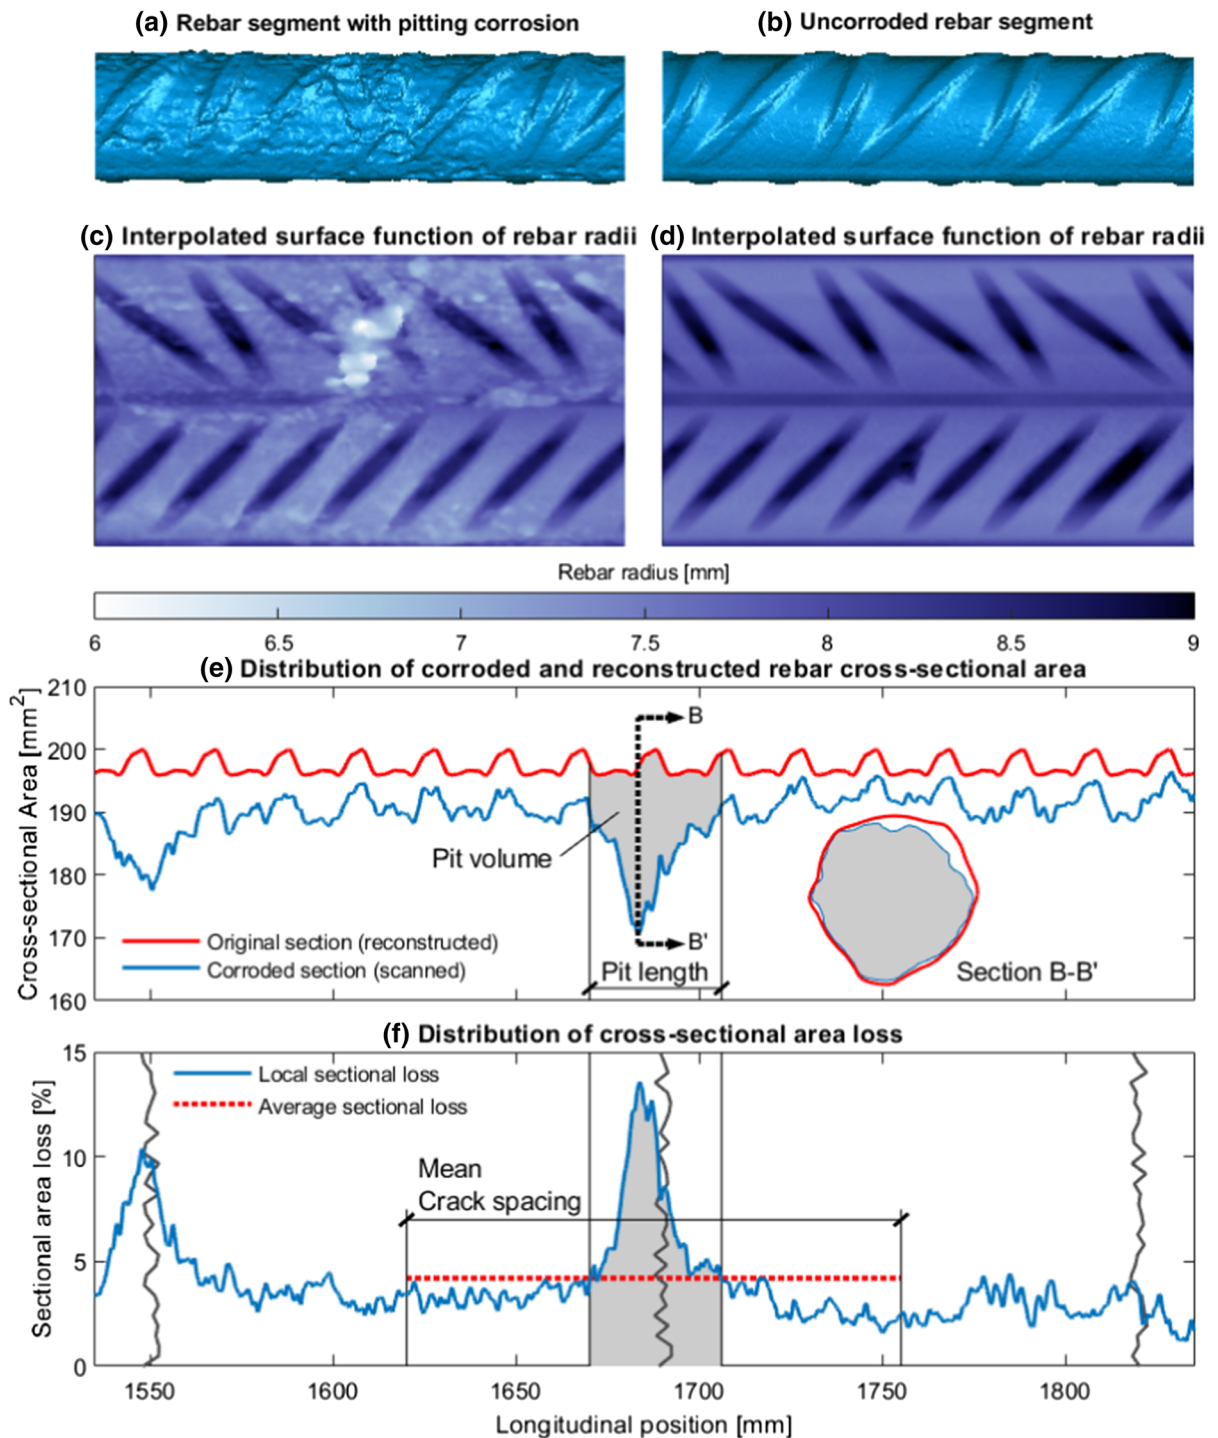
Fig. 3 The resulting triangle mesh from the 3D scanning of **a** a corroded bar section and **b** an uncorroded bar section. Corrosion maps resulting from the interpolated surface function in polar coordinates where the colour indicates the radius for **c** a corroded bar section and **d** an uncorroded bar section. **e** The computed distribution of residual cross-sectional area based on

the interpolated surface from the 3D scanner (blue) and the reconstructed original distribution of cross-sectional areas (red). Section B-B' illustrates the most corroded section for the selected pit. **f** Distribution of focal corrosion level in terms of sectional loss and definition of average corrosion level based on mean crack width and pit length. (Color figure online)

Following the methodology presented in [18], a surface interpolation of the point-cloud was carried out after a change of the coordinate system from cartesian to polar, so that rectangular corrosion penetration maps as the ones depicted in Fig. 3c, d, could be generated. This representation of the data facilitates the identification of the areas more heavily affected by corrosion both along the length and around the perimeter of the bar. Next, a description of the longitudinal variation of cross-sectional area along the bar length was performed as the integration of the area enclosed by the surface points. This representation of the data allowed to clearly identify the position of the critical sections, namely the sections featuring the largest sectional loss, as well as to determine their remaining cross-sectional area, see blue line in Fig. 3e.

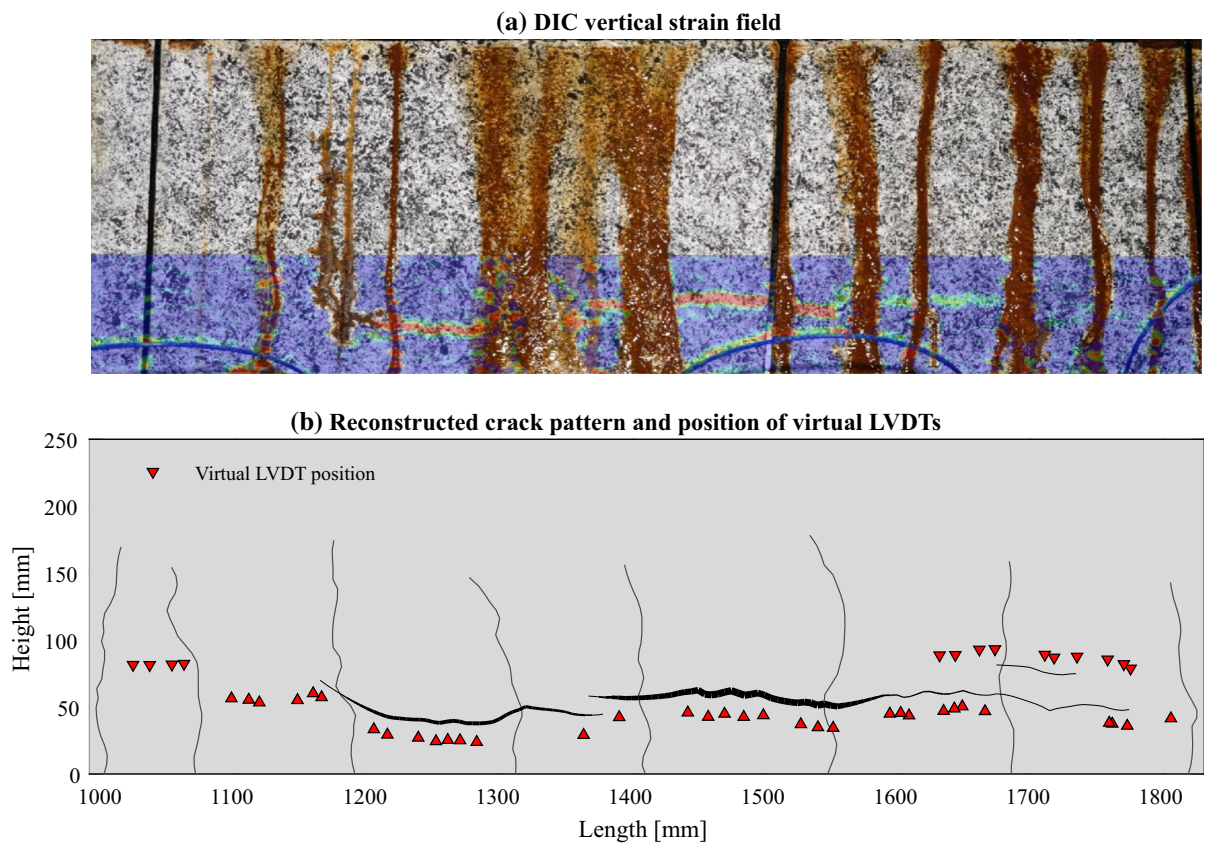
Fig. 4 **a** Example of one of the images used to determine the evolution of corrosion-induced longitudinal cracks with an overlay of DIC postprocessed results showing the field of major principal strains (note that the image is upside down with respect to the testing setup to facilitate the intuitive expectation of the

tensile reinforcement at the bottom of the beam). **b** Reconstruction of the corrosion-induced cracks obtained through interpolation of the discrete measurements carried out at the location of the virtual gauges depicted as red markers

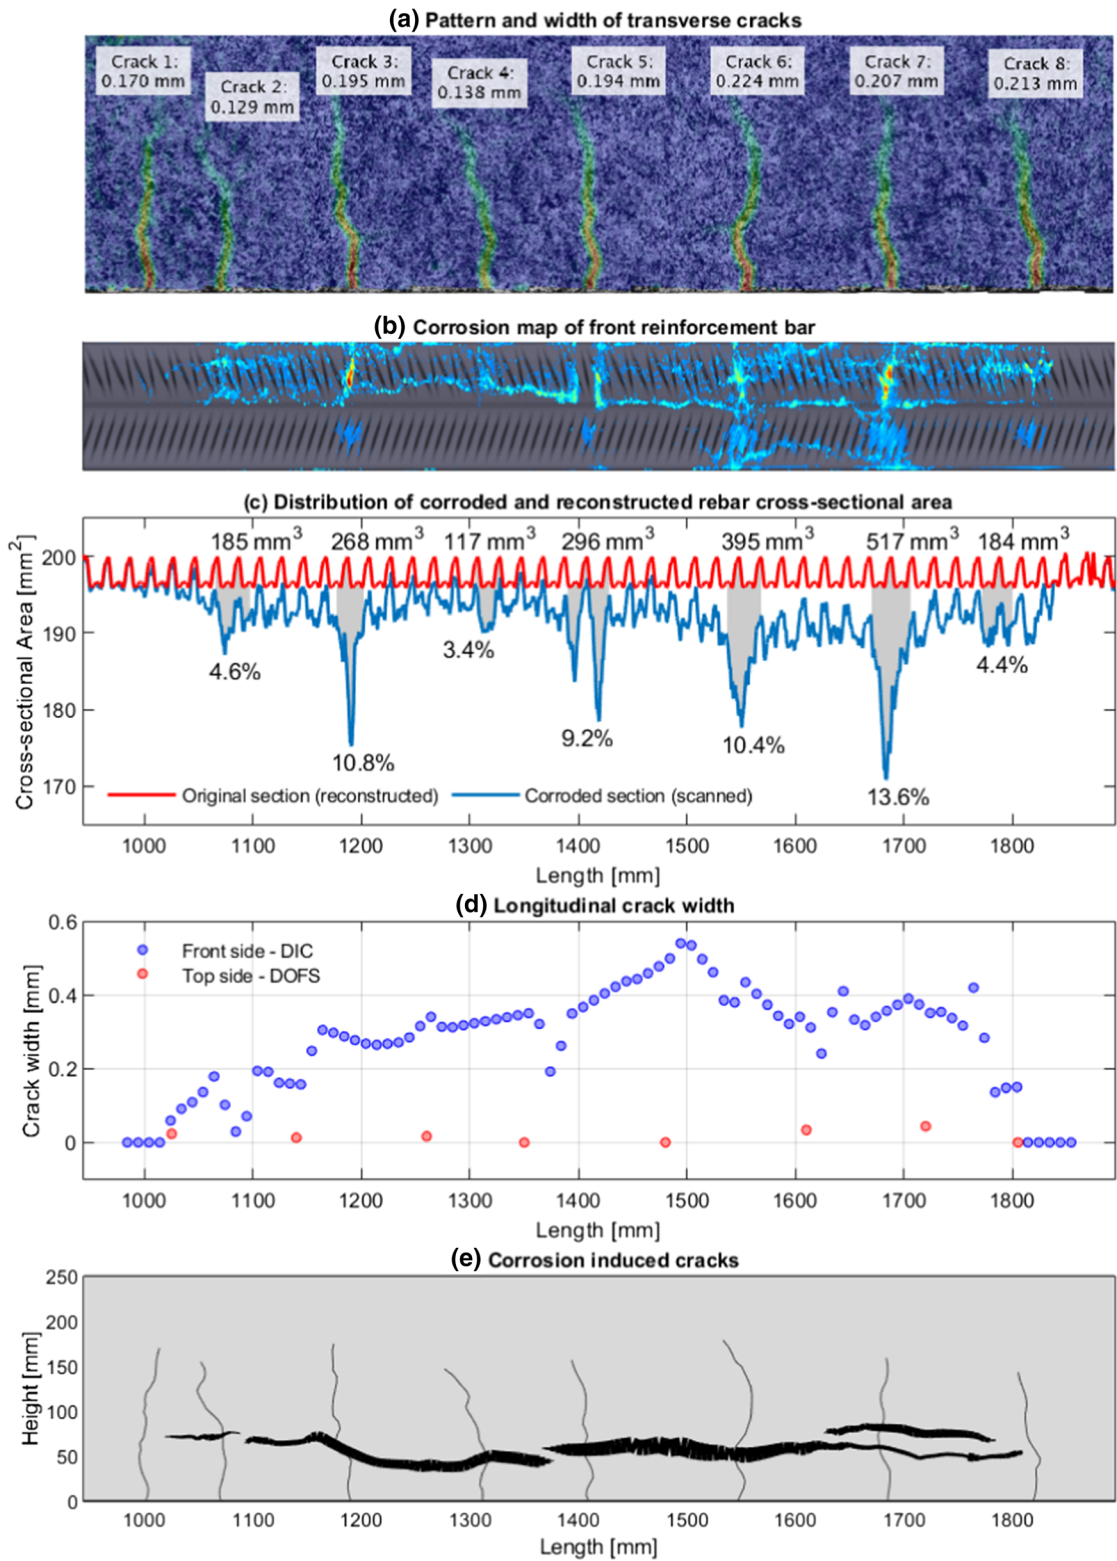
Fig. 5 Overview of results: **a** position and maximum crack width of bending cracks as measured by DIC; **b** corrosion distribution along the surface of the front reinforcement bar based on 3D scanner; **c** variation of original and residual cross-sectional area along the bar and indication of the maximum corrosion level and pit volume of each pit; **d** longitudinal crack width as measured by DOFS and DIC; **e** longitudinal crack pattern at the end of the accelerated corrosion test

In Fig. 5, an overview of the experimental results is presented. Figure 5a shows the principal strain field during the loading procedure where the position of the bending cracks in the central part of the beam is highlighted. A total of eight bending cracks were identified which are numbered from 1 to 8 in Fig. 5a. Information about the maximum crack width reached at the crack mouth (bottom surface) is provided. Figure 5b illustrates the distribution of corrosion over the surface of the reinforcement bar that was closest to the side of the DIC measurements (front bar). The parts of the bar in colour represent the areas with

apparent corrosion, defined as those points on the surface where the corrosion penetration exceeded 0.2 mm with respect to the reconstructed original surface. Figure 5c presents the variation of the original and residual cross-sectional area for the bar displayed in Fig. 5b, where the maximum corrosion level and the volume of each pit have been specified. Figure 5d shows the variation of the accumulated longitudinal

crack width as measured by the DOFS and DIC on the top and lateral sides of the beam, respectively. Finally, Fig. 5e displays a reconstruction of the crack pattern at the end of the test based on DIC measurements for the longitudinal cracks formed on the lateral side of the beam.

Several findings can be observed in Fig. 5. First, the proposed experimental setup for accelerated corrosion could successfully deliver a non-uniform distribution of corrosion along the reinforcement bars. Not only that, but the presence of corrosion pits in the bar was clearly governed by the existence of bending cracks as suggested by the close agreement between their respective positions along the bar. This correlation between the position of cracks and pits in reinforcement bars is in line with previous findings observed in naturally corroded elements for early stages of corrosion [20, 30]. This suggests that the setup put forth can be used to reproduce realistic corrosion distributions, up to moderate corrosion levels, which can be of interests in laboratory studies aimed at investigating the load bearing capacity of corroded structures. It should be noted, however, that when using impressed current the composition of the generated corrosion products may still differ from those generated under

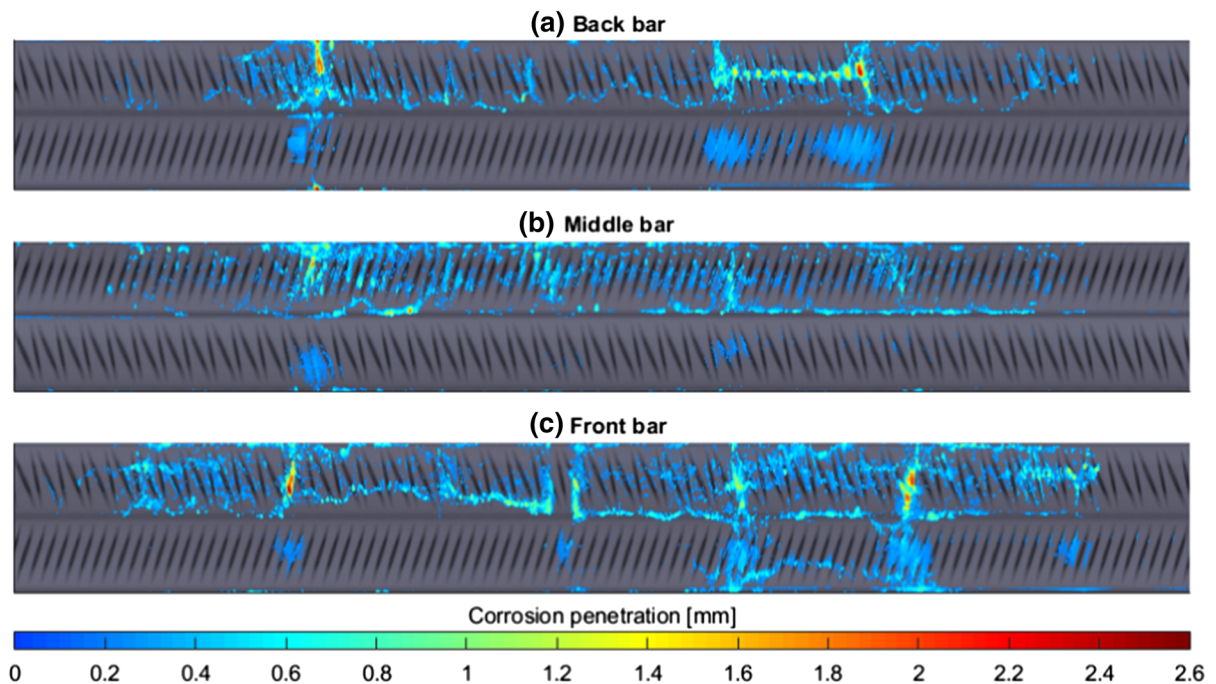
Fig. 6 Corrosion maps displaying the distribution of corrosion penetration for **a** the back reinforcement bar, **b** the middle reinforcement bar and **c** the front reinforcement bar

natural conditions, thereby changing their volumetric ratio and therefore modifying the rate of corrosion-induced degradation. To further support the validity of the observed results, the corrosion distribution on the three reinforcement bars is presented in Fig. 6, where it can be seen that corrosion concentrated at the location of transverse cracks in all bars.

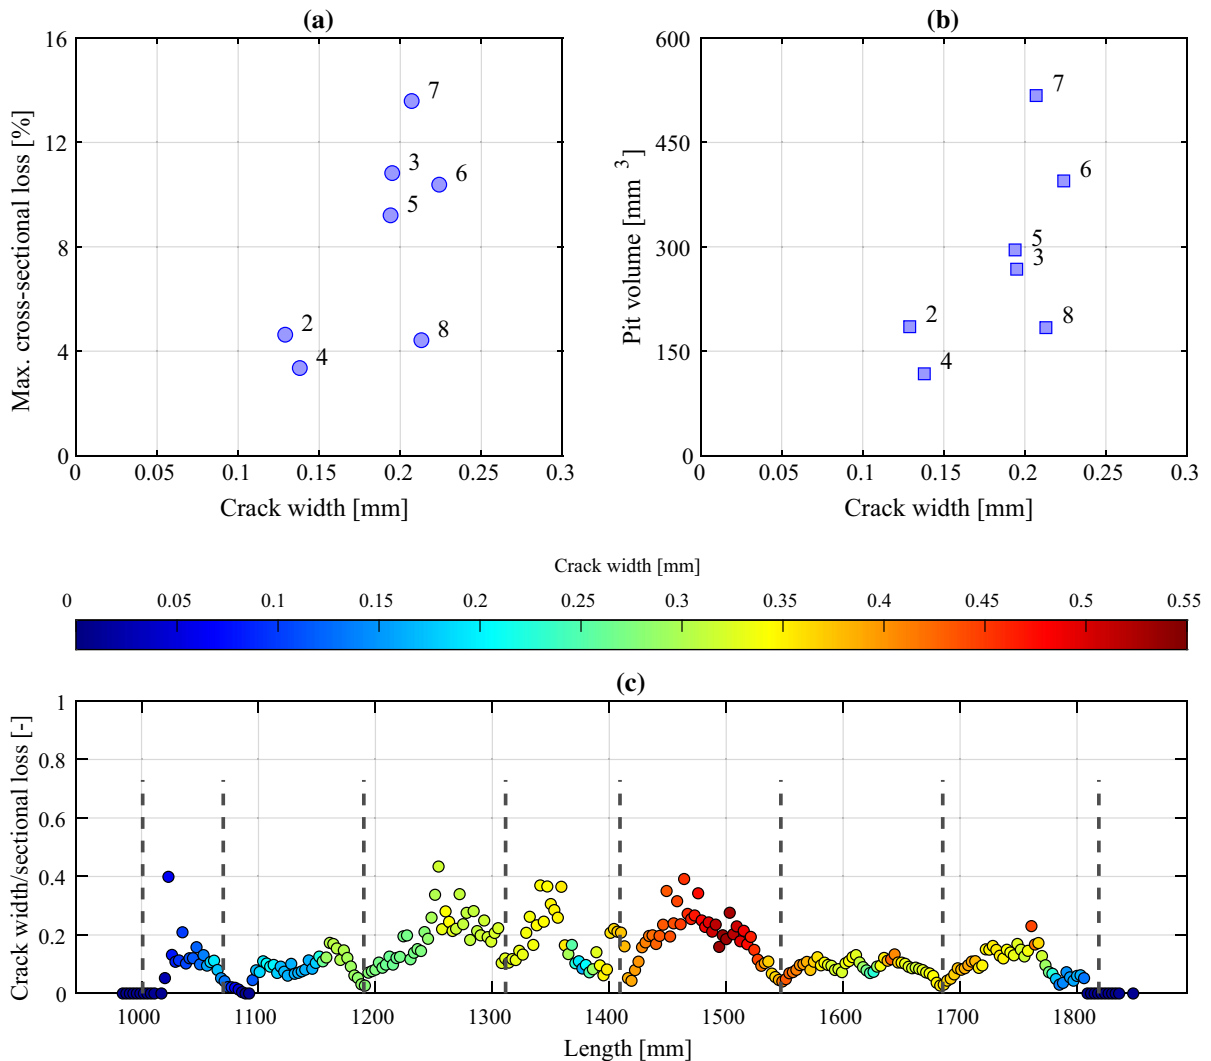
Fig. 7 **a** Relationship between transversal crack width and maximum corrosion level at the pit; **b** relationship between transversal crack width and pit volume; **c** ratio between

longitudinal crack width and corrosion level along the length of the reinforcement bar. Dashed lines indicate the position of transversal cracks and pits

The relationship between the crack width of transversal cracks and the extent of corrosion at the pits in terms of maximum corrosion level and pit volume is explicitly presented in Fig. 7a, b, respectively, where each marker has been numbered

according to the crack number shown in Fig. 5a. Note that crack 1 is not included because no corrosion was found at that location. This is most likely due to the fact that the external cathode did not reach the position of crack 1. For the rest of cracks, it can be observed that both the maximum corrosion level and the pit volume were quite sensitive to the transversal crack width. Indeed, varying the crack width from 0.13 to 0.22 mm had a remarkable effect on the amount of steel loss at the pit, which increased by almost a factor of three. This indicates that crack width played a major

In order to investigate whether a relationship exists between the longitudinal crack width and the distribution of corrosion along the reinforcement, the ratio between the crack width and maximum corrosion level at each section of the bar is presented in Fig. 7c. As observed, the highly variable profile of the plotted ratio suggests that a local relationship does not exist. Indeed, comparing Fig. 5c, d, it can be seen that whereas the longitudinal crack width exhibits a certain continuity along its length, the corrosion level is highly irregular with large spatial gradients. As a result, the crack width-corrosion level ratio becomes very small at the location of the pits where the corrosion level is significantly higher. On the other hand, away from the cracks, the ratio becomes larger due to the significantly lower corrosion levels. These results reveal that unlike in elements with generalized corrosion where the steel loss occurs uniformly along the surface of the bars, the width of longitudinal cracks cannot be directly correlated with the local corrosion level of the reinforcement in cases where non-uniform corrosion prevails. Furthermore, this implies that in elements with transverse cracks where an ongoing corrosion exists, it is not possible to determine the most corroded section solely based on the examination of the crack width of longitudinal cracks, which is in line with the findings by [8]. Conversely, the crack width of corrosion-induced cracks seems to be a function of the accumulated or total corrosion along the corroded region.

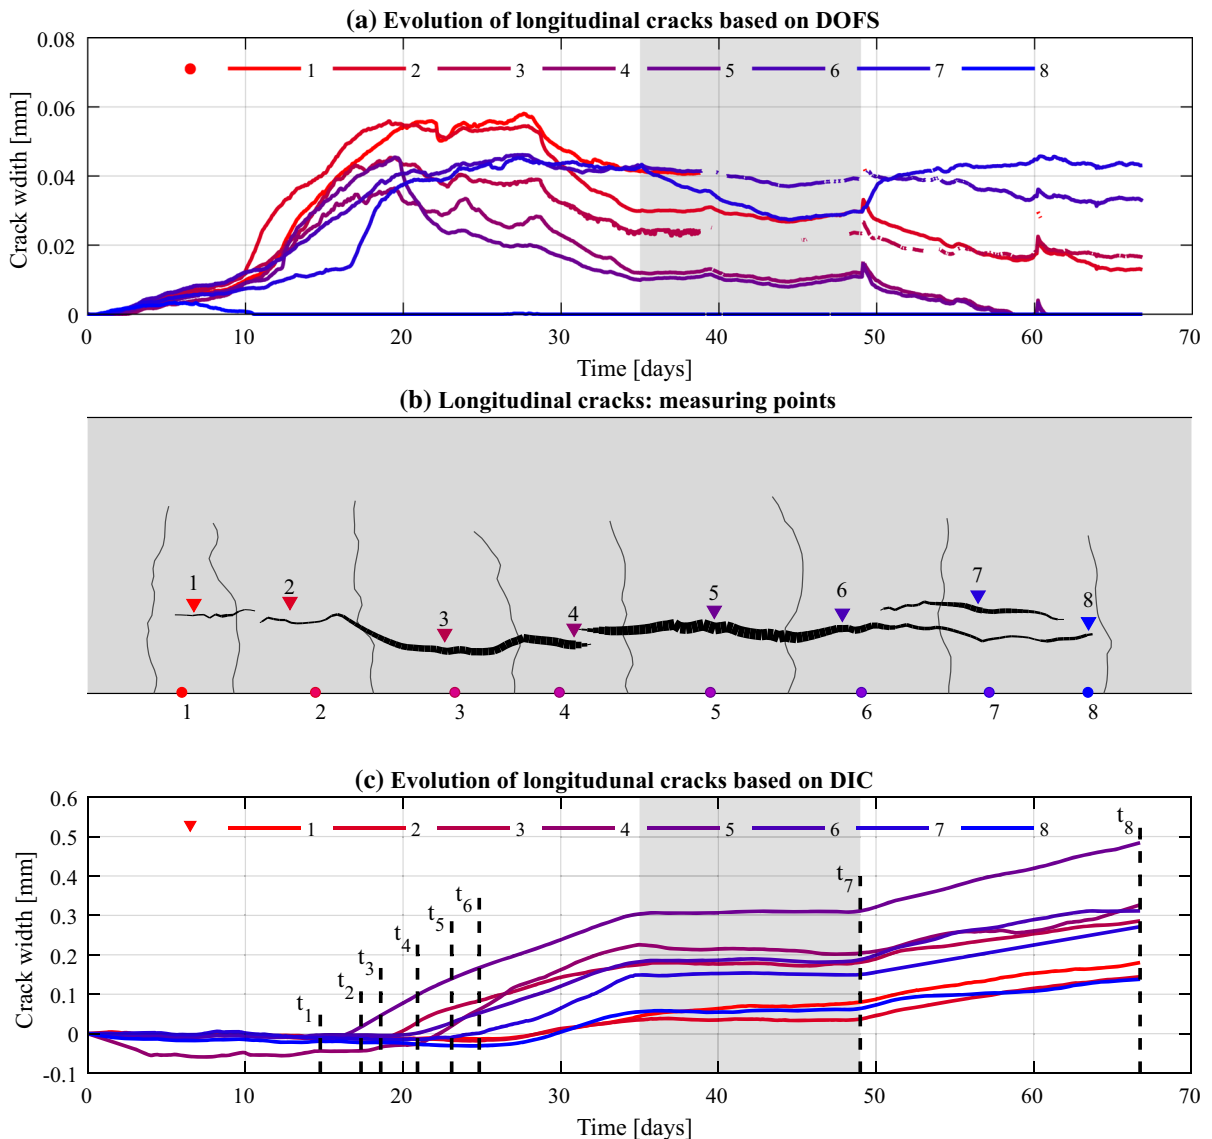
Fig. 8 **a** Crack width evolution of longitudinal cracks formed on the tensile surface of the beam based on DOFS measurements; **b** longitudinal crack pattern on the lateral side of the beam. The markers indicate the position at which cracks have

been measured for the DOFS (●) and DIC (▲); **c** crack width evolution of longitudinal cracks formed on the lateral side of the beam based on DIC measurements

As observed in Fig. 8a, cracking at the bottom surface of the beam occurred approximately 10 days after the initiation of the accelerated corrosion process. It should be noted that the calculated crack width displayed in Fig. 8a up to that point corresponds to the elastic expansion of the concrete before cracking. Subsequently, cracks at the bottom surface grow proportionally with increasing time, although at different rates, up to a period of about 20 days, after which they either stabilize or reclose. This change in the growth rate coincides with the appearance of longitudinal cracks on the lateral side of the beam, as shown in Fig. 8c. Due to the layout of the reinforcement and the corrosion of three tensile reinforcement bars forming a horizontal plane, most of the corrosion-induced damage was concentrated on the longitudinal cracks formed on the lateral side beam, rendering the cracks at the bottom surface almost negligible.

Looking at the evolution of the crack width for the longitudinal cracks on the lateral side, it can be seen that in all cases the crack width increases almost linearly with time while it halts during the period where impressed current ceases. Moreover, after restarting the impressed current, the crack width of longitudinal cracks started to increase again with a similar linear trend. Since the externally applied current was kept constant during the periods of impressed current, and assuming that the distribution of corrosion rates along the bar did not change significantly after the formation of the longitudinal cracks, it can be inferred from the results in Fig. 8c that changes in corrosion-induced crack width are proportional to changes in local corrosion levels. However, the factor of proportionality between crack width and the local corrosion level does not remain constant at different sections and it is most likely influenced by both the local mechanical properties of the concrete as well as the distribution of corrosion in the neighbouring zone of the investigated section. Nevertheless, these results suggest that if the corrosion level could be assessed at two different points in time, then the factor of proportionality between the longitudinal crack width and the corrosion rate could be established. Once the factor of proportionality is

It could already be observed from Fig. 8 that longitudinal cracks on the lateral side of the beam initiated earlier in the central region of the investigated area

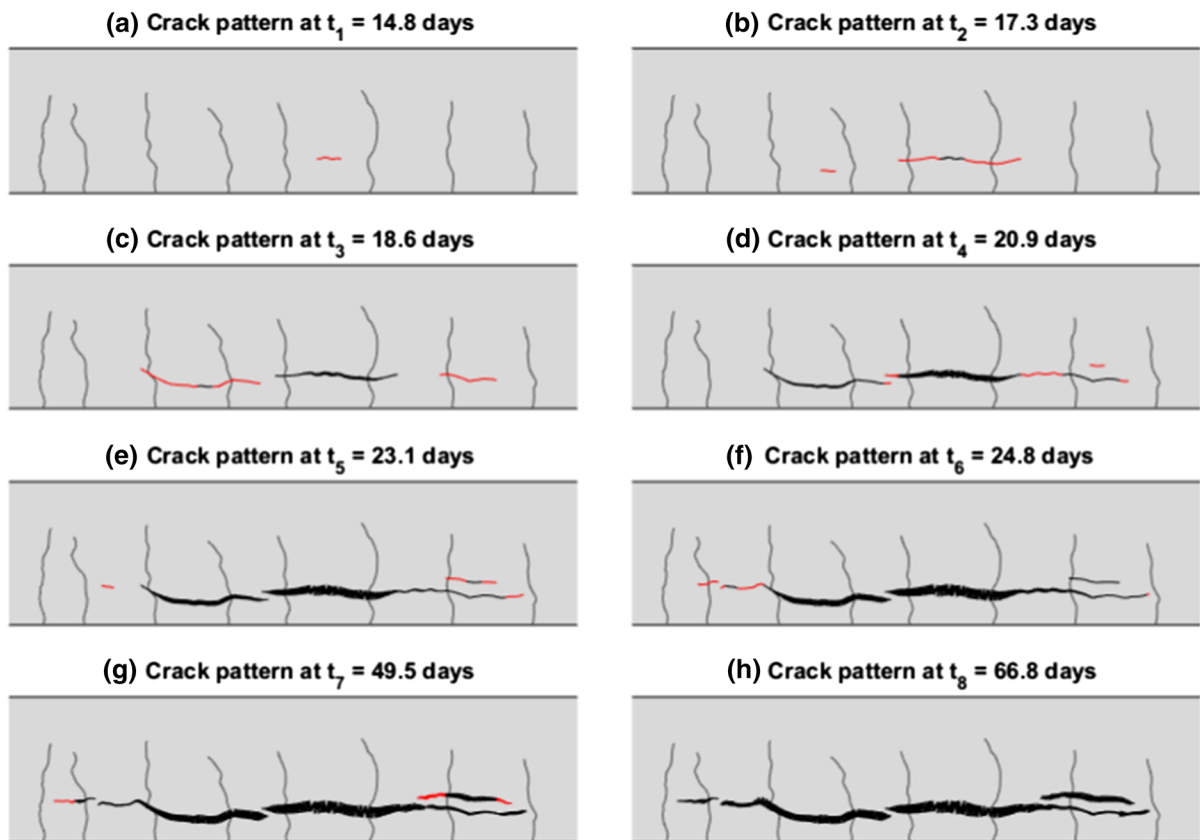
Fig. 9 Evolution of the corrosion-induced longitudinal crack pattern as measured per DIC. Red crack segments indicate new cracks with respect to the previous time step. (Color figure online)

where the crack segments drawn in red represent cracks that were not present in the previous step.

The results in Fig. 9 confirm that longitudinal cracking initiated at the centre of the investigated region. However, it can also be observed that longitudinal cracks initiated at different locations over time and subsequently merged. This could be different from a natural corrosion scenario where corrosion focuses in a smaller region as opposed to the present study where corrosion happened along the entire investigated area.

Another finding from Fig. 9 is the fact that, contrary to what could be anticipated, longitudinal cracks did not initiate at the sections with a greater local corrosion level. Instead, new cracks were in most cases observed to form in the regions between transversal cracks, which as previously discussed, featured relatively low corrosion levels. An explanation for this observation could be found in the transport of corrosion products through transversal cracks,
