Increasing Water Absorptivity of an Aerogel-Based Coating Mortar in Subsequent Wetting and Drying

Karim, A., Johansson, P., Sasic Kalagasidis, A. (2022). Increasing Water Absorptivity of an Aerogel-Based Coating Mortar in Subsequent Wetting and Drying. *Gels*, 8(12). <http://dx.doi.org/10.3390/gels8120764>

Abstract: Aerogel-based coating mortars are energy-efficient composites with thermal conductivities of 30–50 mW/(m·K). They are useful when retrofitting uninsulated building envelopes, particularly in listed masonry buildings, as shown in studies. Meanwhile, the long-term reliability of their hygrothermal properties, typically declared after a single laboratory measurement, is not confirmed. To illustrate the latter and by combining experimental and numerical methods, this study shows that (1) the capillary water absorptivity of a commercially available aerogel-based coating mortar increases after repeated drying and wetting cycles, and (2) leads to a higher moisture content in a masonry wall. After the third cycle, the measured water absorption was more than five times higher than after the first one. Based on numerical simulations, the increasing capillary water absorptivity

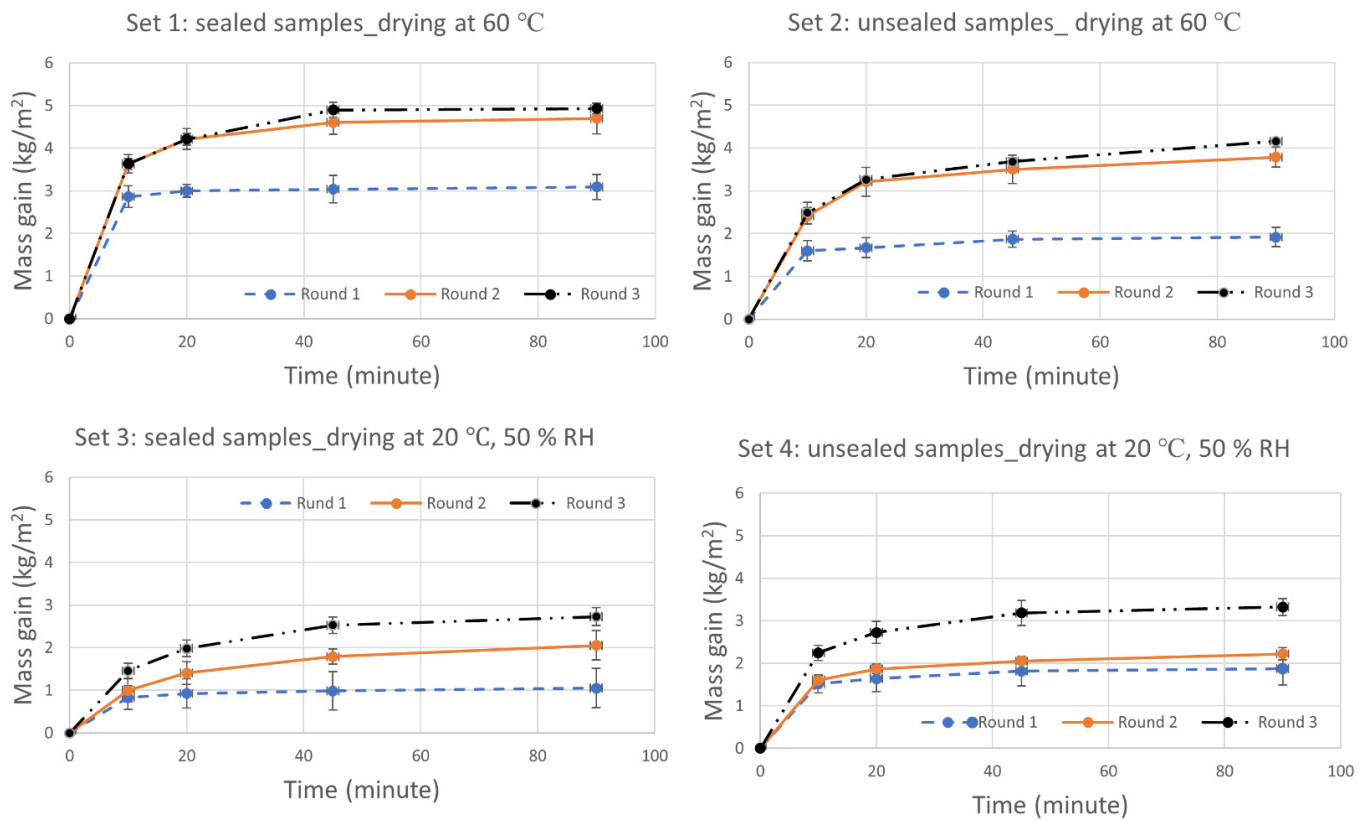
Figure 1. The mass gain (kg/m^2) of all sample sets (1–4) during 90 min of capillary water absorption from free water. Each measurement point represents the mean value of the three samples in each set.

The results showed that the calculated A_{cap} in the first round was $0.04\text{--}0.06\text{ kg}/\text{m}^2\cdot\text{min}^{0.5}$ for all sample sets, i.e., within the lower range of the declared value of less than $0.2\text{ kg}/\text{m}^2\cdot\text{min}^{0.5}$. The value for sample set 1, dried and sealed in accordance with the standard, was $0.04\text{ kg}/\text{m}^2\cdot\text{min}^{0.5}$. In the second and third round of the measurements, the A_{cap} for the same sample set 1 was significantly increased from 0.04 to 0.17 and 0.21 $\text{kg}/\text{m}^2\cdot\text{min}^{0.5}$, respectively. This means that the measured A_{cap} in the third round was more than five times higher than the same after the first round. A similar magnitude of change could be observed for the other sample sets as well, see Figure 2.

presented in this section, it is evident that the mass gain and measured A_{cap} of the ACM samples already increased significantly after one cycle of wetting and drying. The drying condition and sealing of the samples were investigated as two parameters that could potentially affect the measurements. Regardless of the sealing and drying condition, a similar increasing trend was observed in the measurements. For the unsealed samples, a source of error would be the additional vapor exchange via diffusion with the (humid) surrounding air in the containers. The coefficient of variance ($CV = \left(\frac{SD}{\text{mean value}}\right) \cdot 100$) (CV) for the A_{cap} of the sample sets varied between 7–22%. These variations could be due to the uncertainties related to the testing method, such as weighting of the samples. It could also be a sign of heterogeneity of the samples with respect to their capillary water absorptivity.

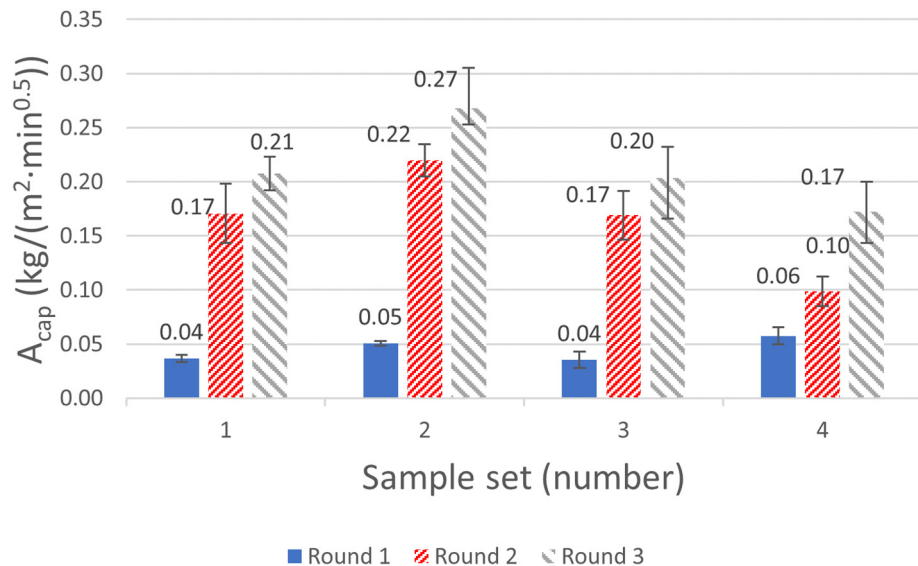
Figure 2. The calculated water absorption coefficient, A_{cap} ($\text{kg}/\text{m}^2 \cdot \text{min}^{0.5}$), for all three rounds of measurement using Equation (1). Each value represents the mean value of three samples in each set. The declared A_{cap} of the ACM is stated to be less than $0.2 \text{ kg}/\text{m}^2 \cdot \text{min}^{0.5}$.

For the calculated A_{cap} presented in Figure 2, it has to be mentioned that according to the standard [16], the A_{cap} should be calculated for the samples dried at elevated temperature ($60\text{ }^\circ\text{C}$). As such, the calculated values for sample sets 2 and 4 (dried at $20\text{ }^\circ\text{C}$ and 50% RH, respectively) are not following this specification. Consequently, for these two sample sets, it is the trend and actual change in the capillary water absorptivity after each cycling that is of interest rather than the absolute value of the calculated A_{cap} . With this reasoning in mind, all sample sets are considered in the analyses.

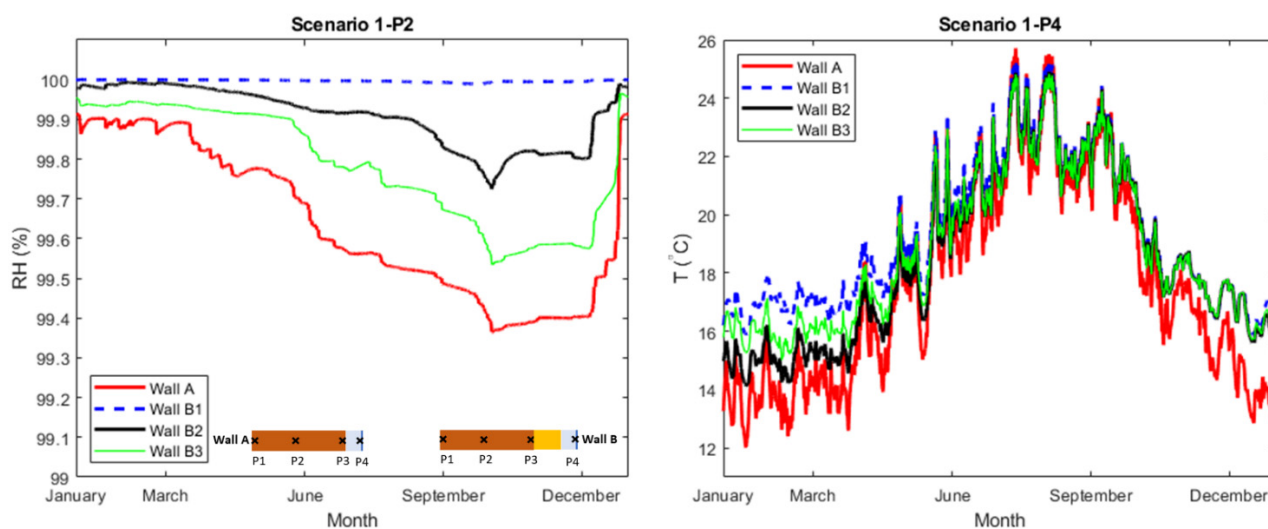
Figure 3. (Left): Relative humidity at checkpoints P2 (middle of brick). (Right): Temperature at checkpoint P4 (interior surface).

In scenario 1, the exterior wall surfaces were exposed to rain (Adhering Fraction of Rain, AFR: 0.7) and the drying towards the exterior was highly limited, simulating a case for the locally denser and low permeable bricks in the moisture-damaged reference building. In Figure 3, the RH at checkpoint P2, in the middle of the brick, and the interior surface T at point P4 are plotted. Table 1 presents the yearly average RH at all checkpoints. Furthermore, additional plots on scenario 1 can be found in Appendix B (Figures A3 and A4).

In summary, the simulated cases in scenario 1 showed high levels of RH in the walls, both for the reference wall but also the walls internally insulated with ACM. The high RH-levels in the reference wall, wall A, could demonstrate an extreme case of the moisture problems that exist today in the walls of the reference building. In the case the drying towards exterior is limited, the interior drying may not be sufficient even for the heated indoor environment as demonstrated in the simulations. The results also showed that for the rain-exposed walls, the existing moisture problems would remain after internal insulation by ACM if drying towards exterior is prevented. The differences between the wall B1 and wall B2–B3 were negligible considering the RH-levels at checkpoints P1–P3. At checkpoint P4 at the interior, the average RH in wall B1 (A_{cap} : $0.04 \text{ kg/m}^2 \cdot \text{min}^{0.5}$) was 21% lower than the same in wall B2 (A_{cap} : $0.2 \text{ kg/m}^2 \cdot \text{min}^{0.5}$) and wall B3 (A_{cap} : $0.3 \text{ kg/m}^2 \cdot \text{min}^{0.5}$). Comparing the interior surface temperature at P4, Figure 3 (right), the average temperature was around $17.6 \text{ }^\circ\text{C}$ in wall A and $19.2 \text{ }^\circ\text{C}$ in wall B1. The same in wall B2–B3 was around $18.5 \text{ }^\circ\text{C}$. This could be an indicator for less transmission heat losses

towards the exterior and better thermal comfort in the interior for the retrofitted walls B1–B3. The higher temperature at P4 in wall B1 compared with wall B2–B3 could be due to the lower moisture content and accordingly lower thermal conductivity of the ACM in wall B1. Considering the risk for freeze-thawing, it only occurred at the exterior of the brick section (P1). A freeze-thaw cycle was defined as one crossing of 0 °C in the respective checkpoint. The number of freeze-thaw cycles was increased from 21 to 25 times (Figure A4) after internal insulation by ACM. Again, this was most likely a consequence of reduced heat losses towards the exterior resulting in lower temperatures in the exterior (P1).

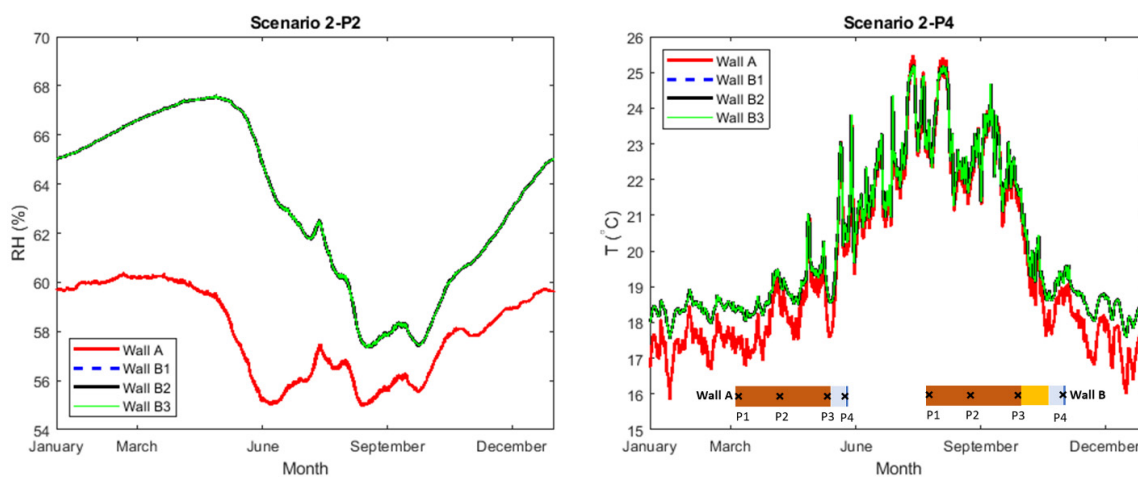
Figure 4. (Left): Relative humidity at checkpoints P2 (middle of brick). (Right): Temperature at checkpoint P4 (interior surface).

The simulations in scenario 2, represented the same cases as in scenario 1 with the only difference of assuming no capillary water absorption (no rain) at the exterior of the brick walls (AFR: 0). In Figure 4, the calculated relative humidity at checkpoint P2, in the middle of the brick, and the interior surface temperature at point P4 are plotted. Table 2 presents the yearly average RH at all checkpoints. Furthermore, additional plots in scenario 2 can be found in Appendix C (Figures A5 and A6).

In general, and compared to scenario 1, the RH-levels in the walls simulated in scenario 2 were lower. Like scenario 1, a less significant difference between the calculated RH-levels in the walls was observed. The results showed that freeze-thaw cycles occurred only at the exterior part of the brick section (Figure A6), as in scenario 1. The number of cycles at checkpoint P1 was 35 in wall A compared to 41–42 for wall B1–B3. Compared with scenario 1, the number of cycles was increased in scenario 2. Unlike the wet construction and wet ACM in scenario 1, the thermal performance of the dryer construction in scenario 2 would be higher. As such, the heat losses towards the exterior would be less, increasing the probability for minus degrees at the exterior. Considering the interior surface temperatures at checkpoint P4, the average temperature of the reference wall (wall A) was 19.6 °C. The temperature at the same position was increased to 20.2 °C after the internal insulation by ACM (wall B1–B3).

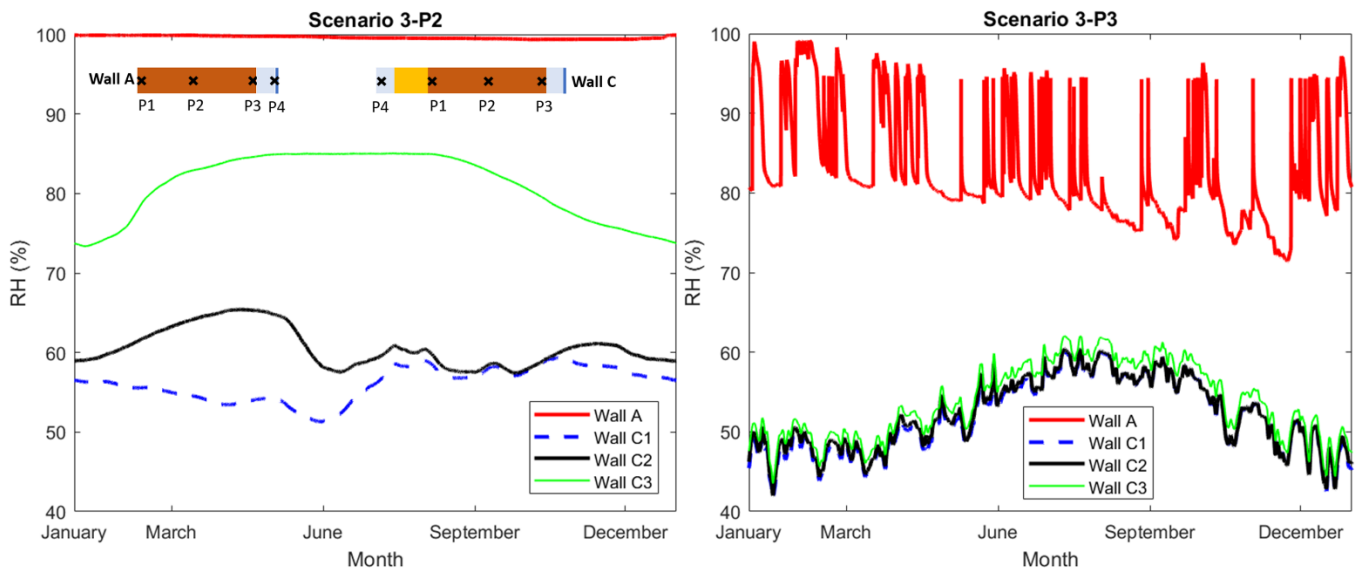
Figure 5. (Left): Relative humidity at checkpoint P2 (middle of brick). (Right): Relative humidity at checkpoint P3 (interior of the brick).

In scenario 3, in contrast to scenario 1 and 2, the reference wall was insulated externally by ACM. Similar to scenario 1, the exterior surface was exposed to rainwater (AFR:0.7). The purpose of the simulations in scenario 3 was to study the impact of varying A_{cap} of ACM on the RH-levels in the walls when the ACM is applied externally. In Figure 5, the calculated RH at checkpoint P2, in the middle of the brick, and at point P3, at the interior side of the brick, are plotted. Table 3 presents the yearly average RH at all checkpoints. Furthermore, additional plots in scenario 3 can be found in Appendix D (Figure A7).

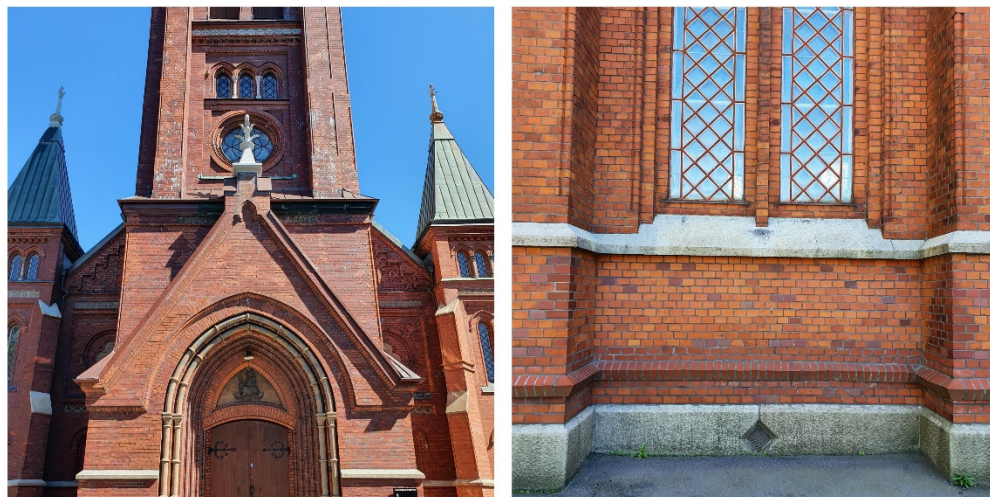
The Örgryte New Church is a listed property from 1890 situated in Gothenburg, on the west coast side of Sweden. This church, located on a hill in Örgryte parish, is oriented with the main tower facing southwest [32]. The façade of the church consists of machine-made red bricks with decorative details in concrete and limestone. Figure 7 shows parts of the exterior of the church.

Figure 7. Parts of the exterior of the Örgryte New Church, selected as a reference building in this study. Photo: the authors.

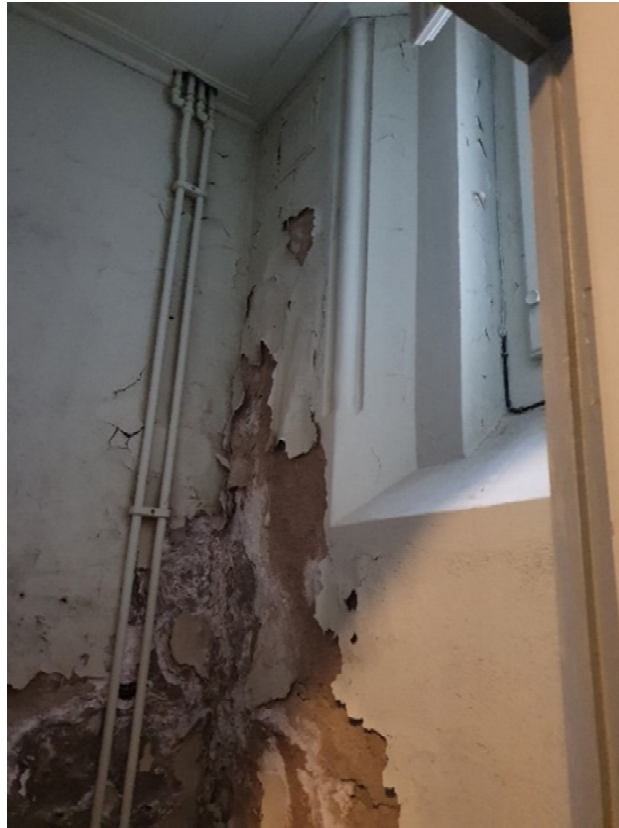
Figure 8. Example of the moisture-related damage at the interior of the Örgryte New Church: weathering of the internal coating mortar (plaster) and paint, and salt efflorescence. Photo: the authors.

There have been multiple cases of moisture-related damage in the church for years [32]. In [32], Balksten et al. delivered a comprehensive investigation report on the historical background, current status, and main reasons causing this damage. The first damage was reported in early 1900, approximately 10–20 years after the inauguration of the church. Since then, several retrofitting attempts have taken place to repair only limited parts of the damaged construction, most likely due to economical limitations and limited resources at the time. Consequently, the façades consist today of several types of bricks with various properties considering their vapor permeability. Also, many grout types, with varying age, binder type and porosity, and thus different moisture properties have been used for the repair work of the construction. According to Balksten et al. [32], the low frost resistance of the originally used bricks was a major contributor to the frost damage in the façades. The issue was more severe for those parts facing south and west, due to higher exposure to driving rain combined with the high frequency of freeze-thawing events. Also, the façades of the unheated areas in the church were more damaged than other parts with an internally heated area. The damage has led to weathering of the bricks from the façades with extensive material loss. Internally, the damage can be recognized locally on the weathered coating layers (plaster). Moreover, clear patterns of salt efflorescence can be observed. Figure 8 shows an example of the damage on the interior side of the church. The walls in the church were internally painted with several layers of organic and dense paints, with low vapor permeability. Consequently, drying towards the interior was rather limited. This issue resulted in moisture accumulation and salt crystallization behind the paint as the salt transportation, in dissolved form, towards the interior surface was highly prevented.

According to [32], the main moisture source for the observed damage in the building envelope of the church is the exterior moisture load mainly from driving rain. The material variations in the exterior façades, combined with high exposure to driving rain and freeze-thawing have resulted in water penetration in several spots. Meanwhile, for the parts with less permeable bricks drying towards the exterior is rather limited. The fact that drying towards the interior was also partly prevented due to the low vapor permeable interior surface coating and paint, increased the magnitude of the observed damage in the building

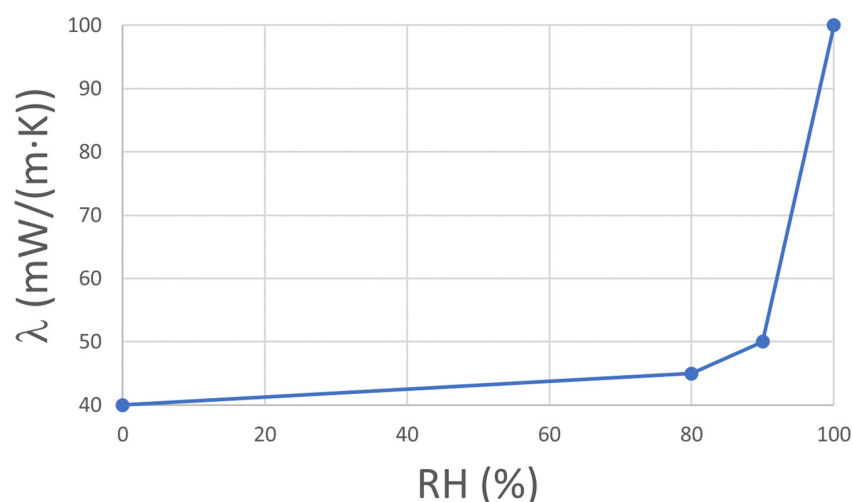
Figure 11. Declared moisture-dependent thermal conductivity of the ACM. The thermal conductivity is increased by less than 13% up to 80% RH and then rises sharply up to 100 mW/(m·K) at saturation [30].

In Table 6, the properties of the materials used in the simulations are presented. Also, the moisture-dependent thermal conductivity of the ACM is illustrated in Figure 11. Because the specific material properties of the brick (machine-made red brick) in the reference building were unknown, the study used available brick types in the WUFI database. Based on the results of the pre-study (scenario 0) summarized in Appendix A (Figures A1 and A2), the extruded brick was selected. For ACM, internal and external coating mortars and paint, the declared material properties of the products were used. For consistency, the same materials were used in all three walls (wall A, B, C). As illustrated in Figure 11, the thermal conductivity of the ACM is increased by less than 13% up to 80% RH. Above this limit, the thermal conductivity is increased by more than two times from 40 to 100 mW/(m·K).

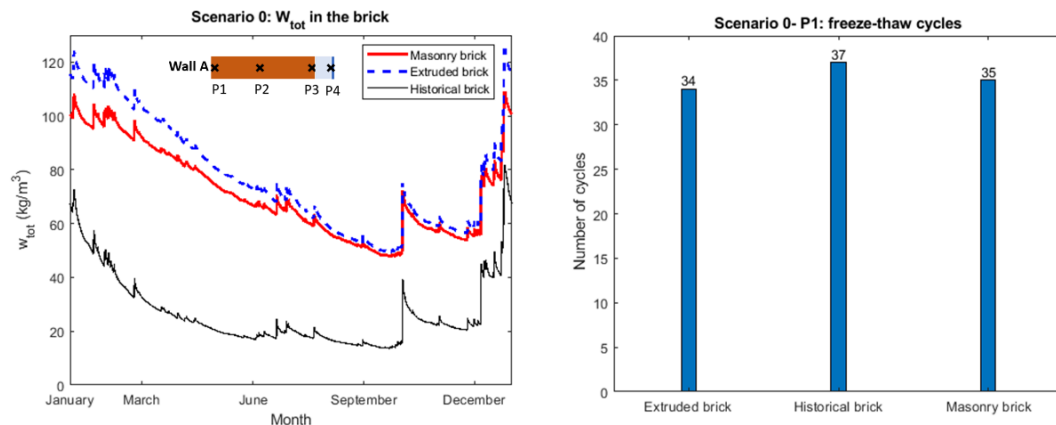
Figure A2. Scenario 0: Total water content in wall A and number of freeze-thaw cycles at checkpoint P1 (exterior surface).

other words, the water content in the brick masonry, extruded brick, and historical brick was around 37, 30, and 11% of the saturated water content, respectively. The number of freeze-thaw cycles varied between 34–37 times at checkpoint P1 during the last year of simulations. No freeze-thaw cycles occurred at checkpoints P2–P4.

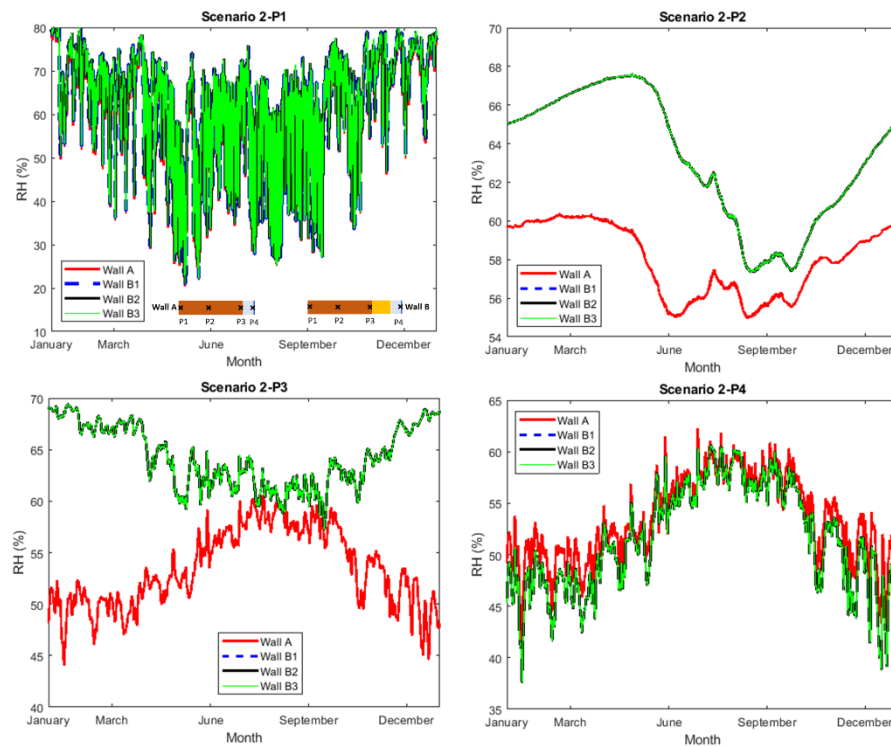
Figure A5. Scenario 2: Relative humidity at checkpoints P1–P4.

Appendix C includes complementary figures on the results of the numerical simulations for scenario 2. In scenario 2, the exterior wall surfaces were not exposed to rain (AFR: 0) and drying towards the exterior was highly limited, simulating a case for the locally denser and low permeable bricks in the reference building. Wall A represented the original wall of the reference building prior to the retrofitting. Wall B1, B2 and B3 represented the internally retrofitted wall with ACM, for which the A_{cap} of the ACM was set to 0.04, 0.2 and 0.3 $\text{kg}/\text{m}^2 \cdot \text{min}^2$, respectively.

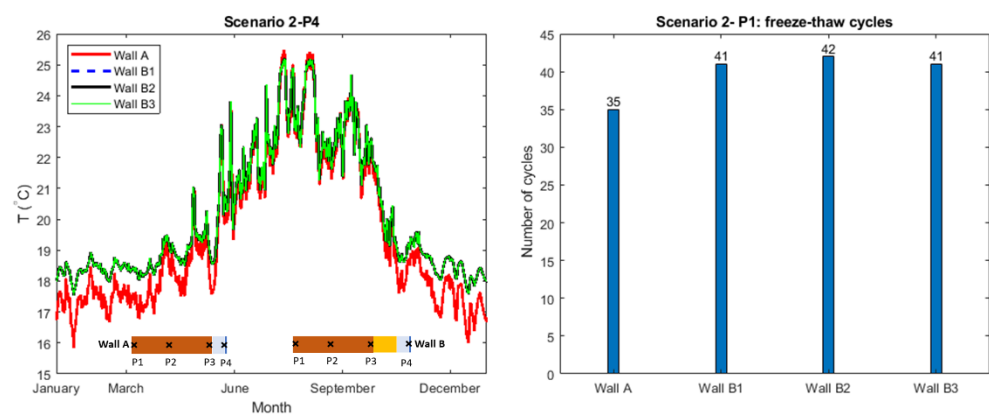
Figure A6. Scenario 2: Temperature at checkpoint P4 (interior surface) and number of freeze-thaw cycles at checkpoint P1 (exterior surface).
