## **Towards an automatized and objective assessment of data from visual inspections of building envelopes**

Mandinec, J., Johansson, P. (2022). Towards an automatized and objective assessment of data from visual inspections of building envelopes. *Acta Polytechnica CTU Proceedings*, 38. <http://dx.doi.org/10.14311/APP.2022.38.0057>

# TOWARDS AN AUTOMATIZED AND OBJECTIVE ASSESSMENT OF DATA FROM VISUAL INSPECTIONS OF BUILDING ENVELOPES

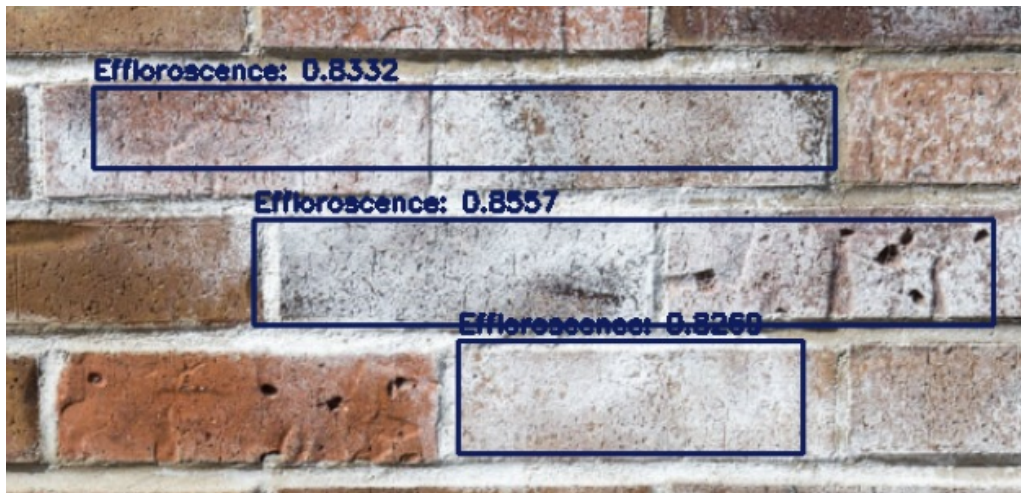
FIGURE 1. Example of output from the Build-Sense model – model draw bounding boxes around damaged area alongside with its level of confidence [18].

The Build-Sense model was originally built for detecting damage on brick walls specializing on drawing bounding boxes around cracks and bricks subjected to spalling and efflorescence. The model is utilizing the concepts of transfer learning and was trained based on 225 images of damaged brick walls (approximately 75 images for each damage type) manually annotated with more than 2000 bounding boxes providing the model with the interpretation of how a damage looks like. Figure 1 shows bounding boxes around efflorescence as they were predicted by Build-Sense model.

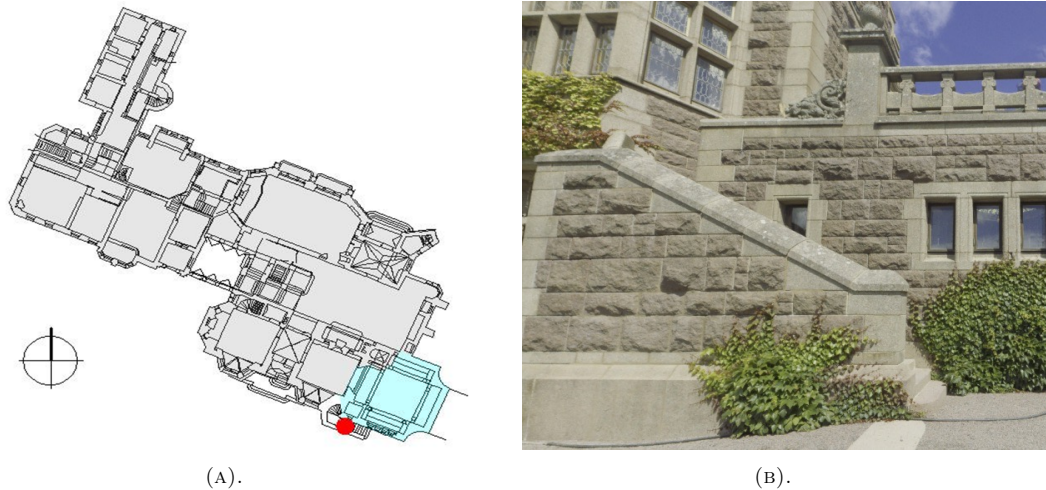
FIGURE 2. (A) Schematic plan on the building's ground floor to the left shows the location where the panoramic photograph was taken (red dot). Gray background indicates multi-storey parts while cyan colour indicates single storey part of the building. (B) Photograph was taken on the stairs leading to the roof of single storey part [19].

Given the fact that joints are continuously disintegrated, mainly on the east side of the south-west façade, the study is limited to the assessment of the Build-Sense model only to one panoramic image which closely depicts the area of interest. The positions of the panoramic image as well as the overall view over the wall of interest is on the Figure 2.

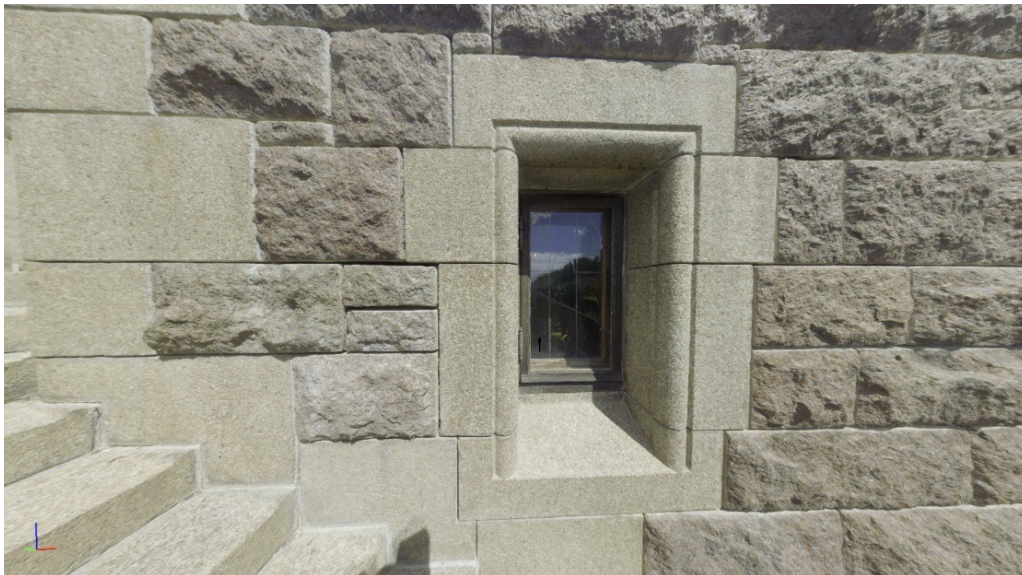
FIGURE 3. Default view from the panoramic image directly facing the area of interest [19].

All images altogether presented in this subchapter were analyzed using retrained Build-Sense model. Figure 3 shows the default (un-zoomed) view from the panoramic image directly facing the building envelope. Note that there are missing joints on the left side of the window. The model there fails to detect any objects of interest.

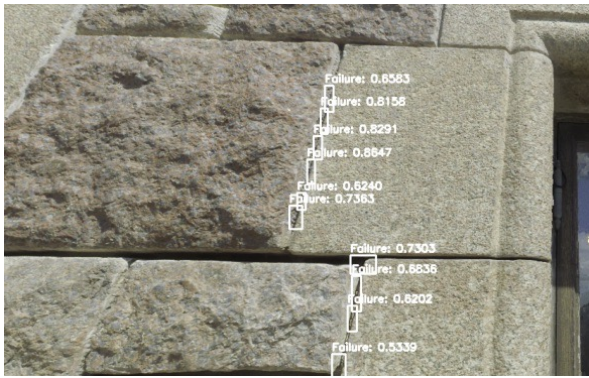
(A). Detailed view 1.

FIGURE 4. Detailed views. Credit: Anders Jansson, all rights reserved.

However, this was not a case for zoomed images. Figure 4a shows missing joints in the vertical direction but the algorithm failed to comprehend damages in the horizontal direction. Observe that the confidence of the model in predicting missing veneer is relatively high i.e., always above 70%. Complete opposite picture gives the Figure 4b where the missing joints were detected mainly in horizontal direction while the model's confidence is in general lower.

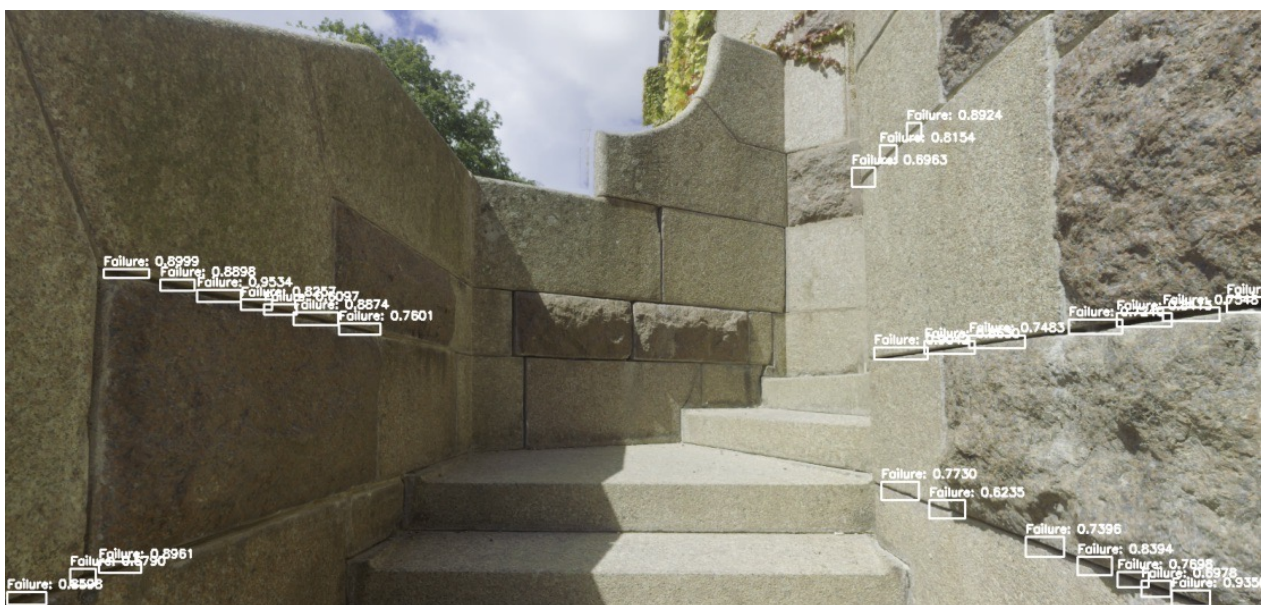
FIGURE 5. Image facing stairs [19].

The presumption that the low confidence in the previous case is caused by the low number of relevant training images is further strengthened by Figure 5 where most missing joints were correctly detected with high level of confidence. The model only fails to grasp missing veneers in the opposite wall in the distance and few parts of the joints on the sides.
