Monitoring corrosion-induced concrete cracking adjacent to the steel-concrete interface

Alhede, A., Dijkstra, J., Lundgren, K. (2023). Monitoring corrosion-induced concrete cracking adjacent to the steel-concrete interface. *Materials and Structures/Materiaux et Constructions*, 56(9). <http://dx.doi.org/10.1617/s11527-023-02252-3>

Andreas Alhede · Jelke Dijkstra · Karin Lundgren

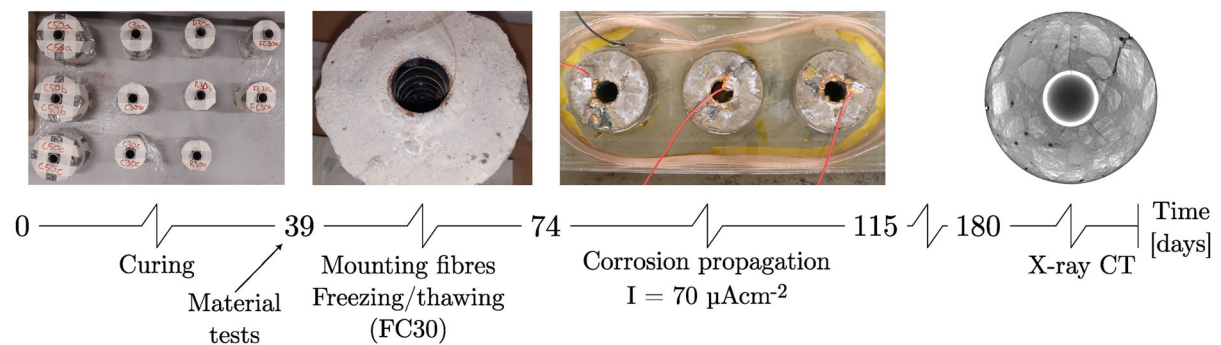
Fig. 1 Timeline of the experiments. Material tests took place 39 days after casting. The corrosion propagation period started 74 days after casting and lasted for 41 days. Specimens of types

C30, FC30 and R30 were scanned using XCT approximately 180 days after casting

corrosion period, most of the specimens were scanned using XCT, from which cracking and corrosion level were evaluated. A timeline of the test procedure is shown in Fig. 1. In the following, the experimental programme, material and methods are elaborated.

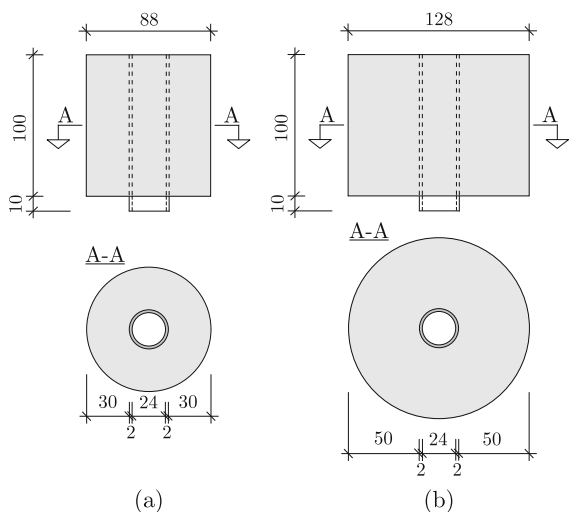
**Fig. 2** Geometry of specimens in series **a** C30, FC30, R30 and **b** C50**Table 2** Concrete mix proportions and mechanical properties measured 28 days after curing

The experimental programme consisted of four different test conditions as listed in Table 1. In addition to the reference tests without accelerated corrosion, the impact of concrete cover thickness and prior freezing damage on the steel corrosion was investigated in additional test types. In total, eleven specimens were included in the experimental programme. The dimensions of the specimens were chosen to ensure a concrete cover thickness of reasonable size compared to the ones used in real structures, while simultaneously achieving a sufficiently high resolution in the XCT scans. Further, the wall thickness and the inner radius of the hollow steel bar were chosen to ensure that the strain on the inside was measurable [19]. All specimens were 100 mm long. The cross-sectional diameter varied from 88 mm for series C30, FC30 and R30, to 128 mm for series C50. A hollow steel bar with outer diameter 28 mm and a wall thickness of 2 mm was cast in the centre of each specimen. The steel bar protruded 10 mm from the bottom surface, see Fig. 2.

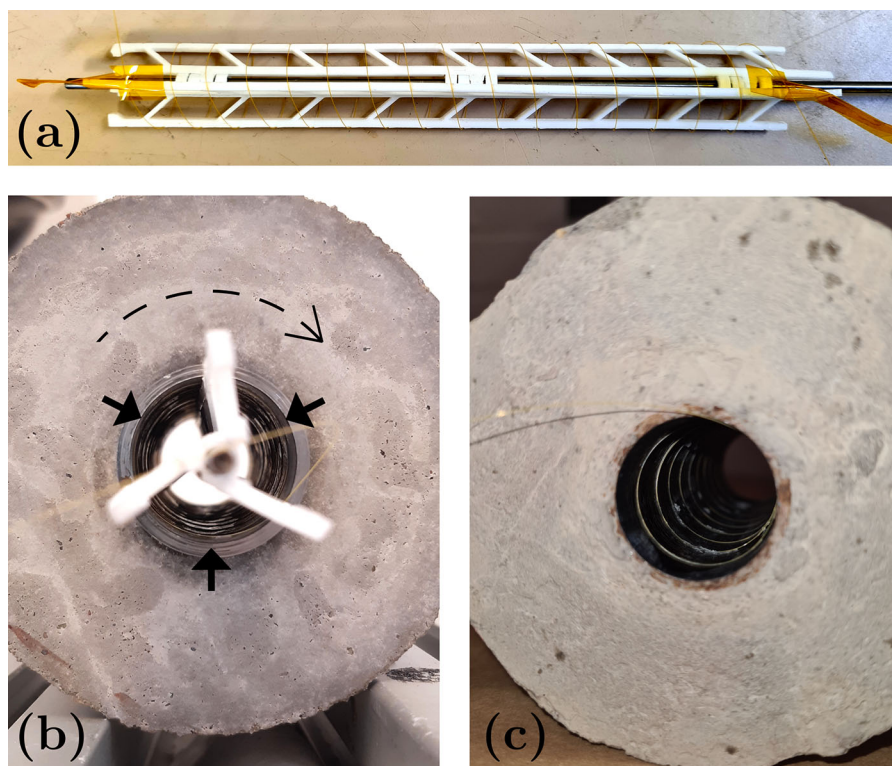
Fig. 5 Process of gluing the fibre on the internal surface of the hollow steel bar. **a** An optical fibre wound around the arms of the tool, restrained with tape. **b** Positioning of the fibre inside the hollow steel bar. The fibre obtained its helical shape by

removing the tape and by rotating the tool around its length, as indicated by the dashed arrow. The fibre was bonded to the steel by gluing the parts in between the plastic arms (solid black arrows). **c** Removal of the tool and additional gluing

challenging, hence the exact spacing between turns varied slightly. The intended spacing between each turn was 10 mm, and for most specimens, 10 turns were made within one specimen. However, some

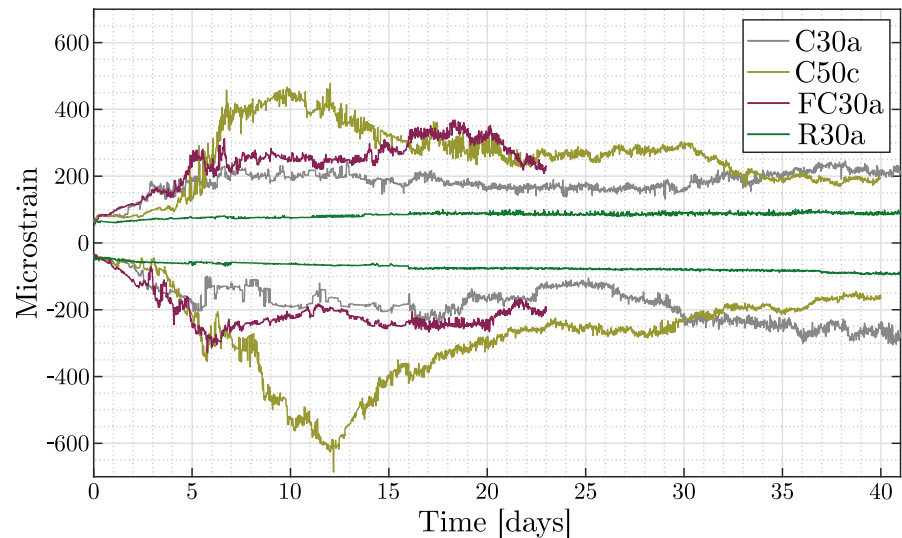
Fig. 8 Average strain of local maxima and minima of each fluctuation cycle (Fig. 7), respectively, along the optical fibre, as a function of time. (R)eferece, (C)orrosion and (F)rost damaged sample with 30 or 50 mm concrete cover thickness

To study the strain development with time, the mean value of local maxima and minima of each fluctuation cycle were studied (Fig. 7). These mean values and its development with time are shown in Fig. 8 for specimens C30a, FC30a, C50c and R30a. The strain showed the smallest peak values in the reference specimen, R30a. The average strain increment evolved slowly, less than ± 50 microstrain, over the entire period in this specimen. For specimen C30a, the average strain increased to approximately ± 200 microstrain after five days of corrosion propagation. After seventeen days, the strain decreased slightly but increased again after twenty-six days. Largest strain magnitudes were obtained for specimen C50c (with a larger cover), with 450 and -650 microstrain measured after 12 days and thereafter reducing values. For FC30a (subjected to freeze-thawing before corrosion), the strain increased in magnitude approximately linearly up to ± 300 microstrain. Thus, FC30a had slightly larger strain values than the corresponding specimen C30a subjected to corrosion only. Unfortunately, at day twenty-three in the experiment, the fibre broke, which is why no measurements were obtained for FC30a after this period.

The thickness of the concrete cover affected the measured strain in the optical fibre (Fig. 8). For C50c, the strains were larger and the peak occurred later compared to the other specimens. Therefore, a larger

radial pressure and more energy was required to crack the larger concrete cover. For specimens C30a and FC30a, small differences were observed, as seen in Fig. 8. However, no consistent difference could be observed when comparing measurements on all specimens of type C30 and FC30. This may be related to the small number of freeze and thaw cycles (5) applied prior to corrosion, thus their limited impact on the capacity of the concrete cover [28, 29].

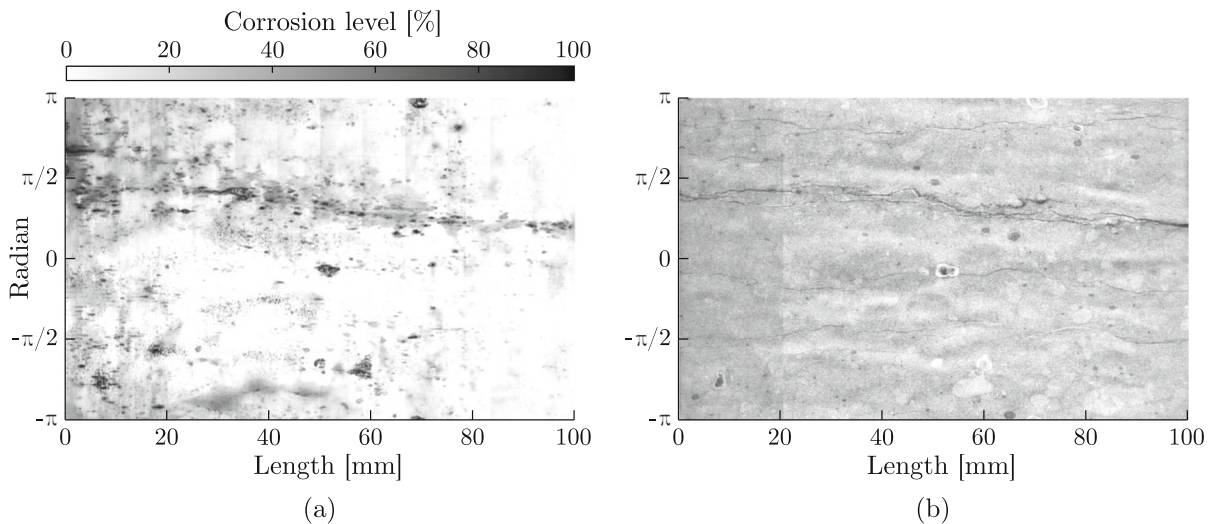
Fig. 10 C30a **a** Corrosion level, and **b** internal cracking as a function of radian and length of the specimen

In Fig. 10, a contour plot of the corrosion level and XCT data revealing internal concrete cracking close to the steel is shown for C30a, over both the radian and length of the specimen. The left and right vertical boundaries of each figure corresponds to the top and bottom side of the specimen, respectively. The internal

cracking in Fig. 10b was evaluated at a radial distance 1.6 mm from the surface of the bar, see circle R1 in Fig. 12a. The evaluation of grey-scale values at the positioning of the circle was done by interpolation of nearest-neighbouring pixels. Note that the corrosion levels are quite large, up to 98%, as they were calculated for the tube, not a solid bar. The corrosion level appears to be non-uniform around the bar, with a

localised band of corrosion along the length. Interestingly, a larger crack (Fig. 10b) can be seen in the same region. In total, five radial cracks can be identified. Some deep corrosion pits can also be observed (Fig. 10a), and it can be noticed that their location agrees with air voids visible in Fig. 10b.
