Influence of railway wheel tread damage on wheel–rail impact loads and the durability of wheelsets

Maglio, M., Vernersson, T., Nielsen, J. et al (2023). Influence of railway wheel tread damage on wheel–rail impact loads and the durability of wheelsets. *Railway Engineering Science*, In Press. <http://dx.doi.org/10.1007/s40534-023-00316-2>

Michele Maglio¹ · Tore Vernersson¹ · Jens C. O. Nielsen¹ · Anders Ekberg¹ · Elena Kabo¹

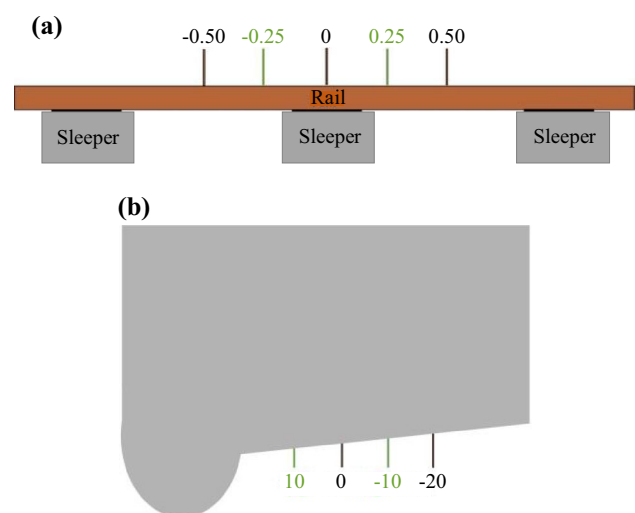
Fig. 6 Schematic descriptions of **a** normalised longitudinal position of wheel–rail impact within a sleeper bay and **b** lateral contact position (in mm) on the wheel tread. The sketches are not to scale

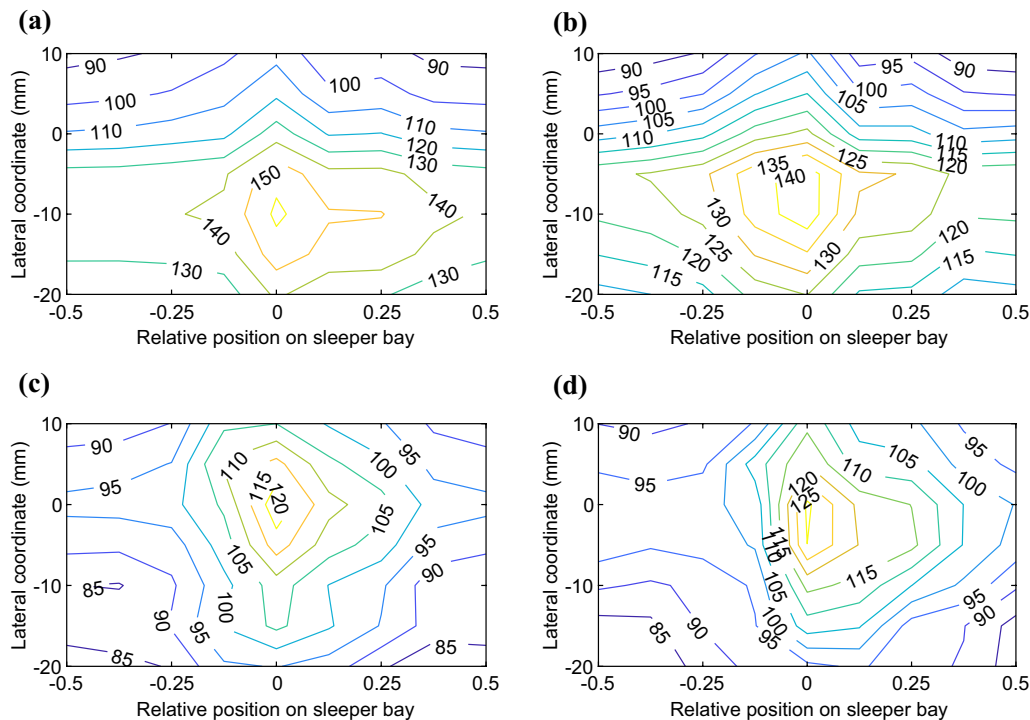
Fig. 10 Contour plot of calculated maximum vertical wheel–rail contact forces (in kN) generated by **a, b** the filtered surface of the long defect shown in Fig. 3, and **c, d** the RCF defects excluding the long defect. For the long defect, see caption to Fig. 7 for interpretation of the coordinates on the horizontal axis. For the RCF defects, the position of the centre of the defect at longitudinal coordinate 0 in Fig. 3b was aligned with different coordinates on the horizontal axis. Vehicle speed 100 km/h on straight track with sleeper bed modulus 100 MN/m³. Travelling **a, c** northbound and **b, d** southbound

To understand the influence of different types of surface damage, the mesh obtained from the 3D scans has been post-processed to separate the long defect from the RCF defects. To obtain the profile of the long defect, a median filter with a window size of 50 mm along the longitudinal coordinate and 10 mm along the lateral coordinate was applied such that the more abrupt variations in geometry (those due to the RCF defects) were filtered out. The geometry of the RCF defects was obtained by taking the difference between the scanned mesh and the filtered one. Calculated impact loads for different prescribed rolling circles and for both travelling directions are presented in Fig. 10. The results for the long defect are shown in Fig. 10a, b, while the corresponding results for the RCF defects are presented in Fig. 10c, d. Note that the approach to prescribe the longitudinal impact position of the RCF defects (Fig. 10c, d) was different compared to the approach used for the long defect (Fig. 10a, b). For the RCF defects, the position of the centre of the defect at

These results can be compared to the corresponding contour plots in Fig. 7c, d for the original scanned surface of the damaged wheel. It is observed that the results for the filtered surface, see Fig. 10a, b, are very similar to those obtained for the original wheel surface, see Fig. 7c, d, although a relatively uniform reduction in impact loads by about 10 kN can be noted. On the other hand, the simulations only involving the RCF defects reached significantly lower impact load magnitudes.

Thus, it can be concluded that the long defect generates the dominating contribution to the high impact loads, whereas the influence of the various local RCF defects on the contact load magnitude is minor. It is observed that the RCF defect with the largest size and depth, which is centred at coordinates $(x', y') = (0, -8)$ mm, generates higher impact loads when the vehicle is travelling southbound, see Fig. 10d, compared to when it is travelling northbound, see Fig. 10c. This can be explained by the geometry of the defect leading to a steeper rise in wheel centre trajectory when travelling southbound, see Fig. 3c.

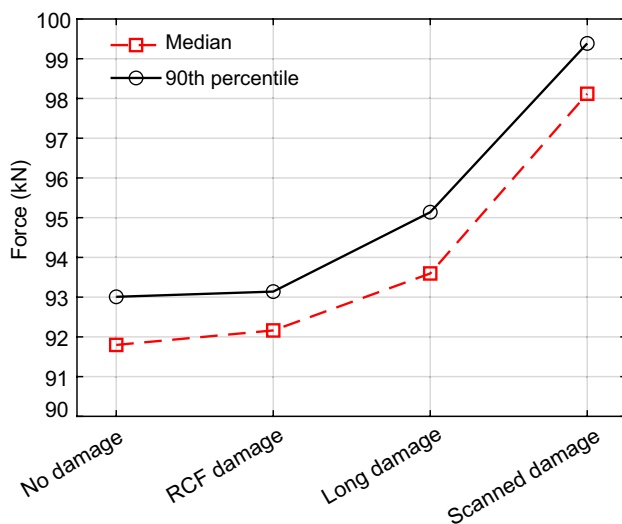
Fig. 14 Median and 90th percentile of the total vertical load acting on the bearing

where k_s and c_d are the stiffness and viscous damping of the primary suspension, respectively, and $y_{\text{axlebox}}(t)$ is the vertical displacement of the axlebox. For the four analysed cases, the median and the 90th percentile of the bearing force are shown in Fig. 14. It can be observed that the relative increase between the cases of no damage and the worst case (“scanned damage”) is only 7%. The increase in bearing force may thus seem less relevant compared to the corresponding increase in wheel–rail contact force. However, as mentioned for the other wheelset components, rather small increases in loading can lead to significant variations in the resulting fatigue life if the conditions are such that the fatigue limit is exceeded.

The results in Fig. 14 have been compared to the calculation procedure in the guidelines from the SKF railway technical handbook [32]. According to that procedure, dynamic bearing loads between 8.3 and 10.9 kN can be expected for bearings of a damaged wheelset similar to the one used in the field test at Sunderbyn (i.e. non-powered wheelset for a passenger coach with 20-t axle load). The results plotted in Fig. 14 for the worst types of damage are found to be in line with the handbook guidelines. The simulation results are in line with the static load acting on the bearings (9.2 t).
