Electrostatic discharge impacts on the main shaft bearings of wind turbines

Zhao, J., Xu, X., Carlson, O. (2023). Electrostatic discharge impacts on the main shaft bearings of wind turbines. *Wind Energy Science*, 8(12): 1809-1819. <http://dx.doi.org/10.5194/wes-8-1809-2023>

Jian Zhao, Xiangdong Xu, and Ola Carlson

Abstract. This paper studies the electrostatic discharge effect in wind turbines, a possible trigger source of the main bearing current. A lab setup with a charge generator and downsized wind turbine was built to verify the impact of electrostatic discharge on the main bearing current. In the test, a fatal amplitude for the bearing current was found at only -93 mV driven voltage on the shaft. Compared with the bearing current driven by the common-mode voltage, the electrostatic discharge effect triggers the bearing breakdown at a lower shaft voltage but much higher bearing current amplitude. The results demonstrate that the electrostatic discharge effect is a pattern of the bearing current in wind turbines and is much more dangerous to the bearing.

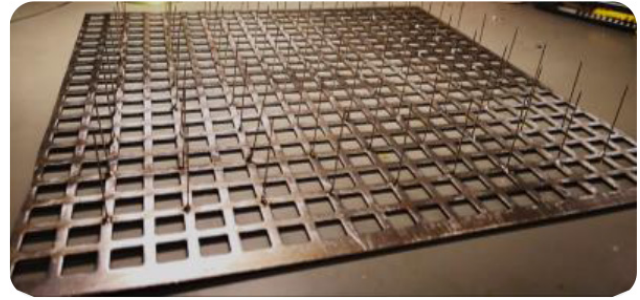
Figure 8. Needle panel used to generate charges in air.

To increase the charge density, a needle panel is used to release charge to the air by means of corona discharges. As shown in Fig. 8, the needle panel is made of a steel net with a number of needles welded onto it and connected to an adjustable negative high-voltage direct current (HV-DC) source. The panel is mounted in front of an electrical fan which provides a controllable airflow across the needle panel,

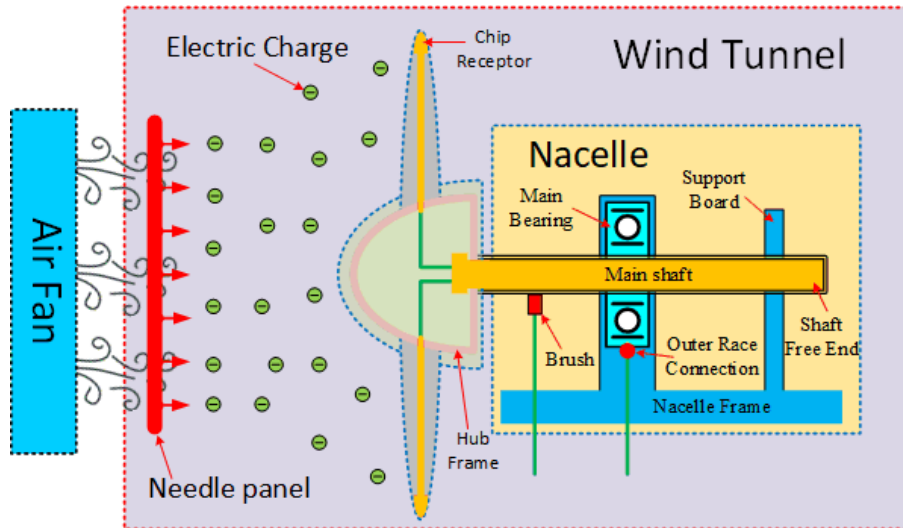
Figure 9. Illustration of the simplified wind turbine configuration utilized in the lab study.

The downsized turbine part indicated in Fig. 9 is located inside the wind tunnel, which is made of wood and plastic sheeting. Its centre height is 1 m with a diameter of 75 cm.

blade's root are electrically connected to the shaft's rear end by three cables. These details are also illustrated in Fig. 9. On the shaft's drive side (see bottom inset in Fig. 12), a carbon brush holder is mounted on the nacelle board, and the carbon brush is forced into contact with the surface of the main shaft by a spring. A conductive cable at the end of the brush connects the brush to the system's ground or test equipment.

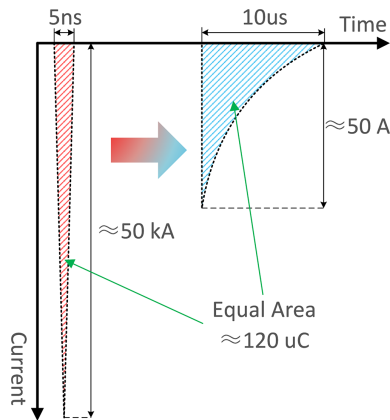
Figure 15. Bearing discharge current test method indication.

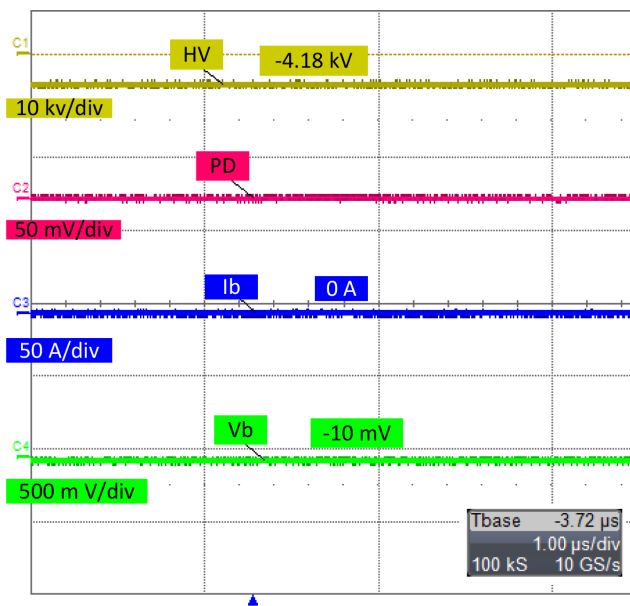
Figure 19. Bearing voltage and current at -4.18 kV needle voltage.

Using the test system connection in Fig. 14, different direct current (DC) voltage levels were applied to the needle panel. In the test, the charge that accumulated or was induced on the blade was conducted to the main shaft via the lightning protection system. The charges accumulated on the main shaft are impeded by the grease in the main bearing to the ground. The electrical properties of the main bearing mean that it acts as a dynamic capacitor, blocking DC but conducting alternating current (AC). The charges from the air are unipolar particles, whose movement generates a negative DC current flow from the blade to the main shaft. These airborne charges are stored on the bearing's inner race and build up a DC electric potential on the main shaft. As shown in Fig. 19, for the needle panel supplied with a voltage of -4 kV in channel 1 and in channel 4, a voltage of -10 mV is induced on the shaft. Because the airborne charges form negative sources, the voltage on the main shaft is also negative. Based on the

Unlike in Test A, in Test B, a DC potential was built up at the shaft by means of charge accumulation via the blades. As shown in Fig. 23 (left panel), the accumulated charges built up a static electric field over the grease. But the amplitude of the electric field on the bearing grease was not strong enough to break down the bearing. Thus, the potential on the main shaft kept at a stable DC value, as shown in Fig. 19.

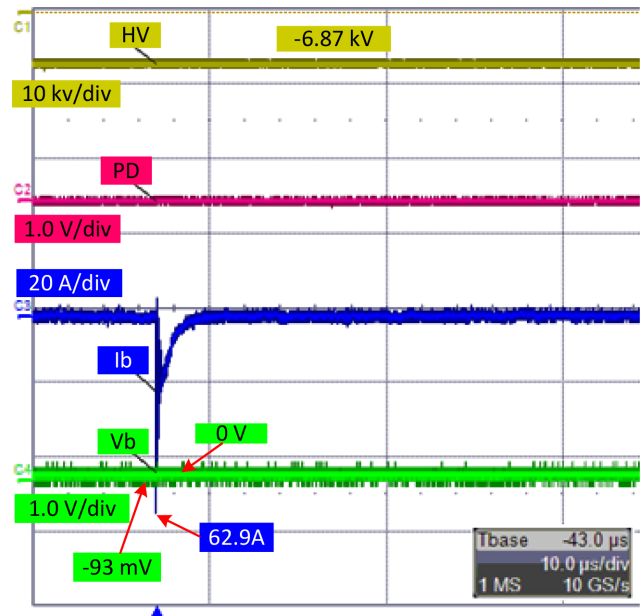
Figure 20. Bearing voltage and current at -6.87 kV needle voltage.

In Fig. 20, with a -6.87 kV DC voltage applied to the needle panel, the voltage build-up on the main shaft reached only -93 mV. From the bearing current curve, a breakdown clearly occurred on the bearing and its amplitude reached 62.9 A. During the breakdown process, the induced voltage on the shaft dipped to zero.

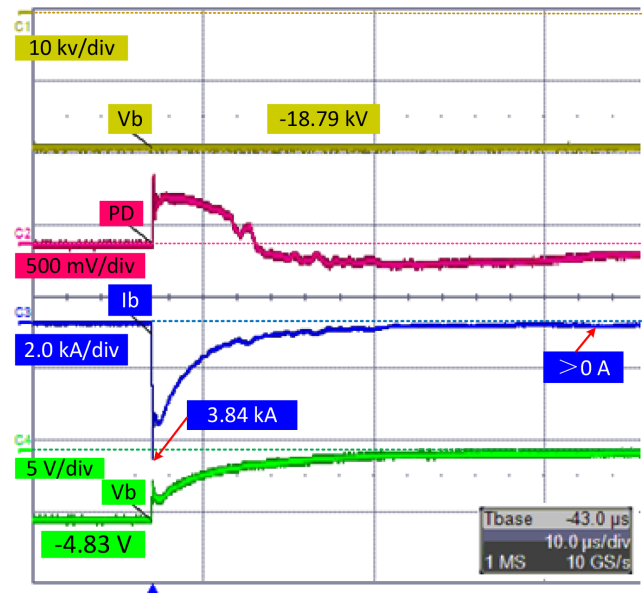
Figure 22. Bearing voltage and current at -18.79 kV needle voltage.

Further increasing the charge density, the applied needle voltage was adjusted to -18.79 kV. As indicated in Fig. 22, the induced shaft voltage reached -4.83 V. The breakdown occurred in the bearing during rotation, with the current flowing through the bearing peaking at 3.84 kA. After the breakdown, the bearing's operating state reverted to a conductive state. There was a continuous current flow through the bearing, even after the voltage had dropped to nearly zero.

channels inside the bearing grease. From the test results shown in Fig. 22, it is obvious that, after the breakdown, the shaft voltage gradually dropped to nearly zero, but the current was maintained at a stable value.
