Mechanical properties of Hastelloy X produced by laser powder bed fusion and affected by spatter redeposition

Claudia Schwerz^{a,*}, Johan Moverare^b, Vishal Sundar^a, Benjamin A. Bircher^c, Alain Küng^c, Dmitri Riabov^{a,d}, Lars Nyborg^a

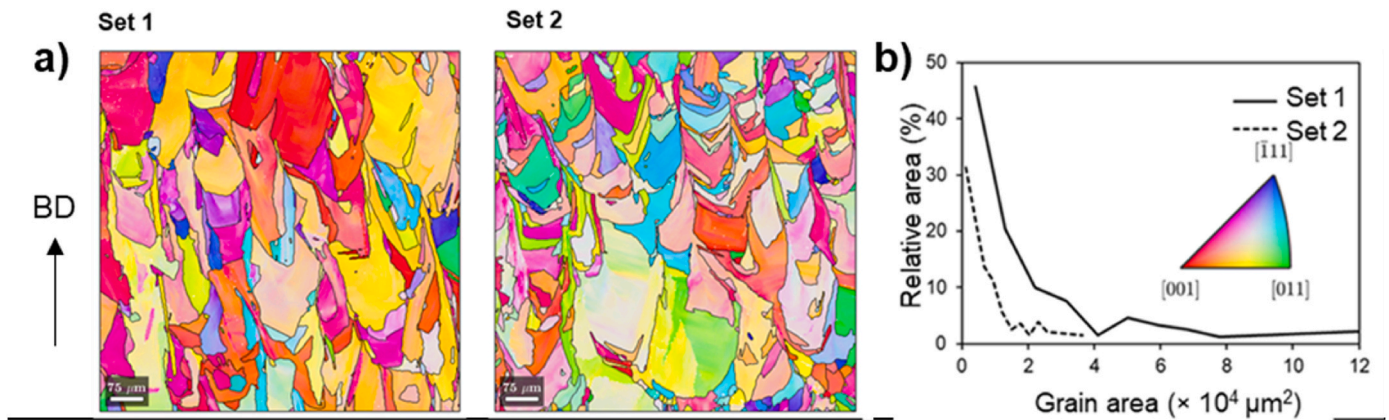
Fig. 2. (a) EBSD orientation maps along the build direction (BD) from the two sets. (b) Grain size distributions.

Electron backscattered diffraction was performed in selected specimens from set 1 and set 2. EBSD orientation maps originating from the two sets are presented below in Fig. 2a. In both maps, the typical appearance of melt pools and elongated grains can be discerned. Grain areas were measured in larger corresponding maps, thus allowing the comparison of grain size distributions, presented in Fig. 2b. It is noticeable that set 2 displayed a shift in the distribution toward finer grains, which is expected based on the process parameters used during manufacturing: the melt pool dimensions are similar in both sets due to the constant laser parameters (energy distribution profile, spot size, power and scan speed) [30]; however, the larger nominal layer thickness in set 2 allows smaller volumes of material to be re-processed, thus restraining the epitaxial grain growth typically observed in additively manufactured materials [18].

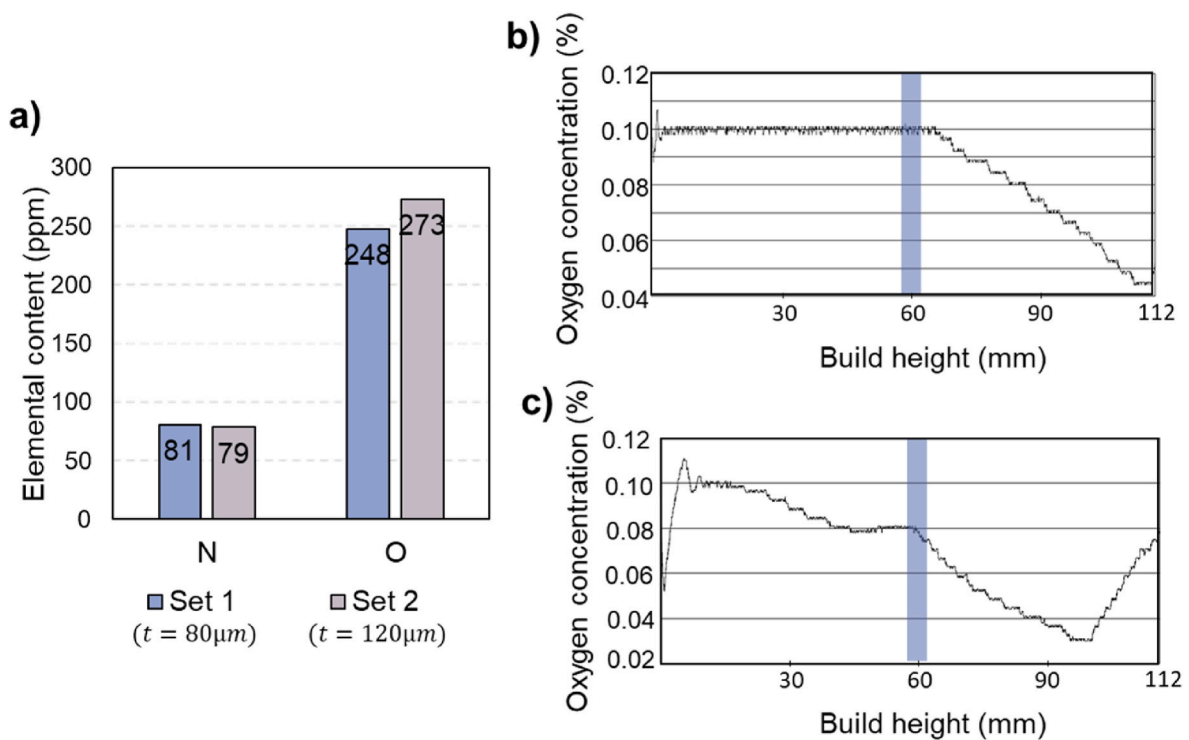
Fig. 3. (a) Bulk nitrogen and oxygen contents in samples of sets 1 and 2. Oxygen concentration in the build chamber during printing of specimens in set 1 (b) and set 2 (c). The sampling location is indicated in the plots (in blue). (For interpretation of the references to color in this figure legend, the reader is referred to the Web version of this article.)

Bulk chemical analysis was performed in chips extracted from tensile specimens at around 60 mm build height. For each set, the averages of two measurements are shown in Fig. 3a. The analysis revealed that

specimens in set 2 contained 10% more oxygen, on average, than those in set 1, despite the slightly lower oxygen content in the build chamber in set 2, in the build height corresponding to the sampling locations, highlighted in Fig. 3b and c.
