Surface integrity of machined electron beam melted Ti6Al4V alloy manufactured with different contour settings and heat treatment

Mallipeddi, D., Hajali, T., Rännar, L. et al (2020). Surface integrity of machined electron beam melted Ti6Al4V alloy manufactured with different contour settings and heat treatment. *Procedia CIRP*, 87(20): 327-332.
<http://dx.doi.org/10.1016/j.procir.2020.02.091>

5th CIRP CSI 2020

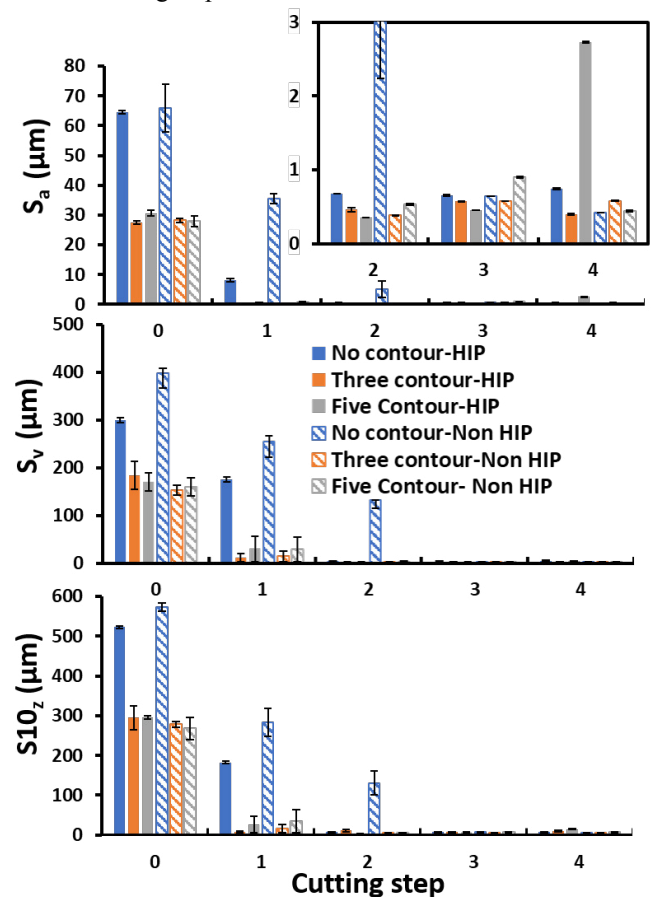
Fig. 2. Surface roughness S_a , S_v , and S_z of as-builds with different contour settings (presented as cutting step 0) and corresponding changes after turning using H13A insert. Note, the error bar indicates the maximum and minimum deviation of the mean value.

The surface finish of a component is of utmost importance as it has a significant influence on its functional performance. In this respect, the roughness of the as-built surfaces with different contour settings and their corresponding changes to subsequent finishing machining operation after each cutting step was examined. Although there are slight variations in the roughness values achieved after machining using two different inserts (H10 and H13A), the overall trends appear to be similar. The slight variations observed can be attributed to the existence of initial roughness variation of the two different builds produced with same contour settings. In other words, the initial surface condition of the same contour setting builds subjected to turning by two different inserts were different. The measured surface roughness values when using H13A insert are presented in Fig. 2. In as-built condition, the no-contour builds have two times higher values of surface roughness for all three analysed surface parameters compared to three and five contour builds. This is of no surprise as builds made with no contours are expected to be the roughest. Interestingly, there is no significant difference in roughness values between three contours and five contours settings. On the other hand, however, avoiding contours is beneficial in terms of production time; up to 20% reduction is attainable. For all the cases, HIP slightly improved the surface finish. For three and five contour setting builds, irrespective of the HIP condition, the S_a parameter which is the most common roughness parameter used for base line comparison has reduced/reached to $\leq 0.5 \mu\text{m}$ already after the first cut (i.e. removing 0.25 mm). Surprisingly, only for five contour-HIP condition, S_a value increased again to around $2 \mu\text{m}$ after cutting step 4 (i.e. cutting down to 2 mm). Further detailed investigation is needed to understand the reason for the observed increase in roughness. Whereas, for no-contour builds, the same level of smoothness, i.e. lower S_a values of around $0.5 \mu\text{m}$ were obtained only after second cutting step for HIP condition and after the third cutting step (i.e. removing 1 mm of material) for non-HIP condition. This clearly demonstrates that HIP has a significant (positive) influence on the no-contour builds. Interestingly, though the

peaks were eliminated, the maximum valley depth, i.e. S_v parameter values, for both the three and five contour builds, remain in the range of tens of microns after the first cutting step. This is in turn reflected on the S_{10z} values which is the summation of the average of the heights of the five peaks and valleys. For no contours, the S_v and S_{10z} parameter follow the same trend as S_a , i.e. the lowest values were obtained only after the third cutting step.

To summarize, the lowest values of (considered) surface roughness parameters (smoother surfaces) for no-contour builds were obtained after third cutting step, while for the three- and five-contours strategy required only two cutting steps. This has a significant implication on future process planning in terms of (required) machining allowance.
