Microstructural Characteristics of Vehicle-Aged Heavy-Duty Diesel Oxidation Catalyst and Natural Gas Three-Way Catalyst

Keywords: catalyst deactivation; diesel; natural gas; SEM; TEM; poisoning

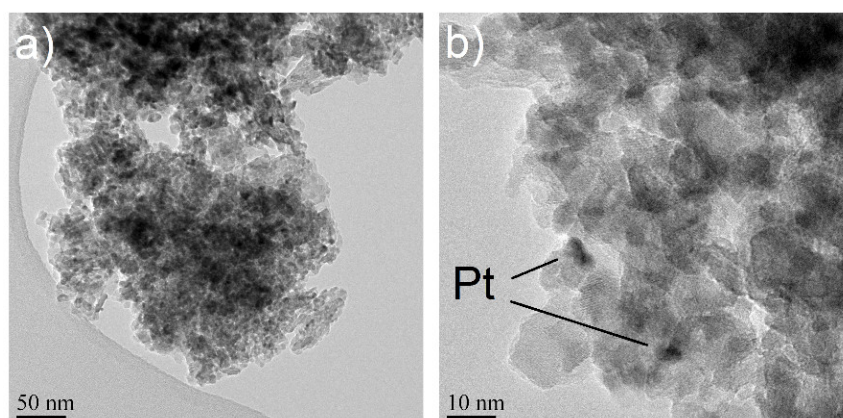
Figure 3. TEM images from the fresh diesel oxidation catalyst with (a) lower and (b) higher magnification.

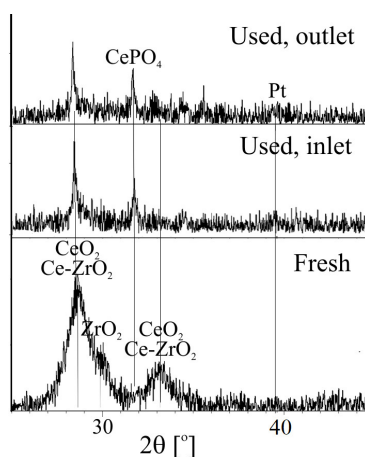
The X-ray diffraction analysis of diesel oxidation catalyst sheets is presented in Figure 7, revealing also an indication of an increase in the platinum particle size. The platinum peak was higher and sharper in the used samples. Differences between inlet and outlet samples were not observed, while both included obscure peaks arising from poisons and their compounds. This indicates that the deactivation has been effective throughout the catalyst from the inlet to the outlet.

Figure 7. XRD patterns of the fresh and used diesel oxidation catalysts.

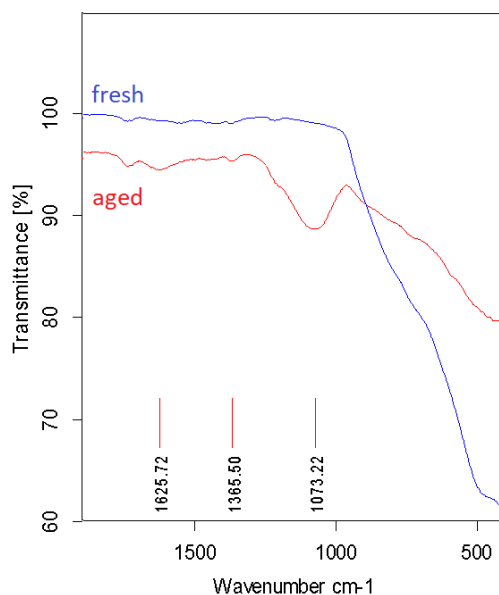
The FTIR-ATR spectra of the vehicle-aged and fresh diesel oxidation catalysts are presented in Figure 9. Only some differences can be found between the fresh and the aged catalyst spectra, from which the three most obvious peaks (1073 , 1365 and 1625 cm^{-1}) are indicated.

The first broad peak at around 1100 cm^{-1} can be assigned to the sulphur species; for example, CeO_2 sulphates are known to give a broad peak at ~ 1200 cm^{-1} and bulk sulphates near to 1160 cm^{-1} . For the gas-phase SO_2 , the major peaks are 1151 cm^{-1} and 1363 cm^{-1} , and for the gas phase, the SO_3 major peaks are 1061 cm^{-1} and 1391 cm^{-1} [19]. An indication of aluminium sulphates can also be found at 1360 cm^{-1} , 1290 cm^{-1} , 1170 cm^{-1} and 1045 cm^{-1} [25]. The presence of phosphorus can also be considered, since the group frequency for the functional group of the phosphate ion is 1100 – 1000 cm^{-1} . The broad peak at 1626 cm^{-1} was not clearly assigned to any of the poisons in the used diesel oxidation catalyst. According to the literature, there is a characteristic group frequency of organic nitrates at 1620 – 1640 cm^{-1} [26].

Figure 9. FTIR-ATR spectra of the vehicle-aged and fresh diesel oxidation catalysts.

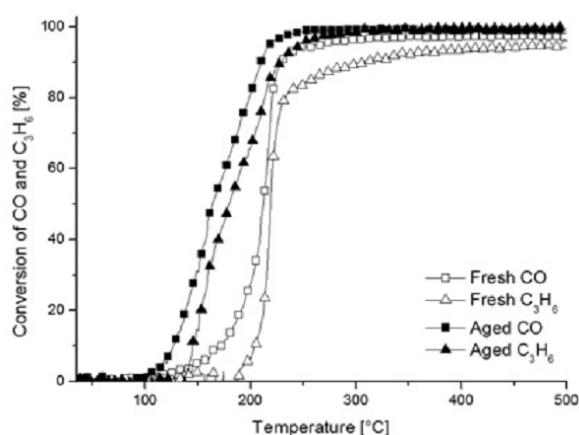
The studied gases in the catalyst performance tests were those typical for lean diesel exhaust gas. CO and C₃H₆ were used to compare the performance of diesel and natural gas catalyst materials. The results of the performance test are presented in Figure 10. As can be observed from the light-off curves of CO and C₃H₆, the aged diesel oxidation catalyst was surprisingly more active than the fresh diesel oxidation catalyst. With the aged diesel oxidation catalyst, after the very lean reaction gas mixture experiment, the colour of the catalyst was changed from black to light grey, as shown in Figure 10. The reason for this phenomenon is that the oxygen has “cleaned” the catalyst surface, by burning carbon, and therefore more active sites for CO adsorption are exposed. This can to some extent explain why the aged catalyst was more active than the fresh one. As seen in Figure 11, a lot of carbon can be found in the aged sheet. The SEM-EDS analyses from these sheets indicate a decrease in the amount of carbon in the sheet surface (from around 30 wt % of carbon in the used sheet to around 15 wt % in the performance-tested light-grey sheet).

Figure 10. The conversion curves of CO and C₃H₆ for the fresh and aged diesel oxidation catalysts. Conditions: m = 530–550 mg, 500 ppm CO, 300 ppm C₃H₆, and 12 vol % air, balanced with N₂.

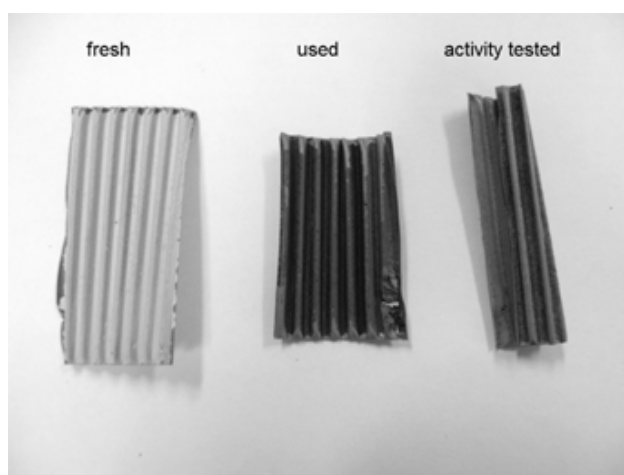
Figure 11. The sections of the diesel oxidation catalyst sheets: fresh, vehicle-aged and performance-tested.

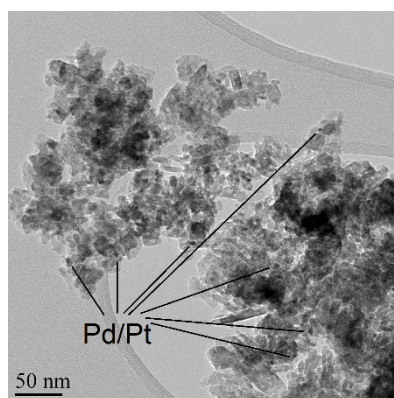
Figure 14. TEM image from the fresh natural gas catalyst.

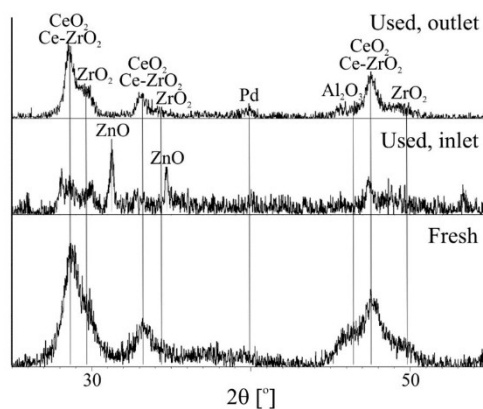
The XRD patterns of the vehicle-aged and fresh natural gas catalysts are presented in Figure 18. The main components of the catalyst are cerium zirconium oxide, cerium oxide, alumina and palladium. The amount of Pt is too low to be detected by XRD. The composition of the catalyst is complex and therefore the analysis of the patterns is challenging, especially for the used samples, where several peaks remained unidentified. However, noble metal crystal growth can be detected, as indicated with

the Pd peak in Figure 18 in the spectra from the inlet and outlet parts of the catalyst. The presence of poisons is obvious in the pattern of the inlet part covering the actual catalyst structure. One of the identified poisons was ZnO, and zinc was also detected by the EDS line analysis (Figure 13).

Figure 18. XRD patterns of the fresh and used natural gas catalysts.

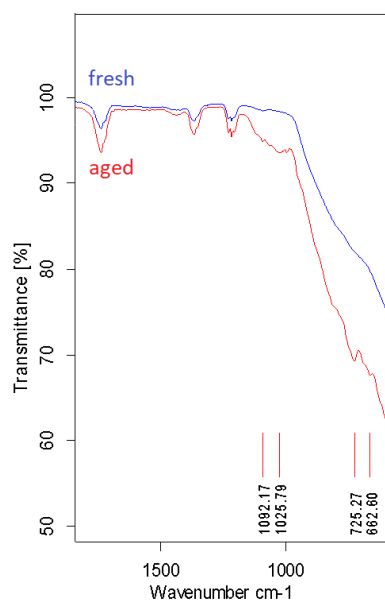
The XPS analysis indicated several catalytic poisons in the inlet end of the aged catalyst, most notably silicon (14 wt %), calcium (4.7 wt %) and phosphorus (2.6 wt %), but also potassium (0.8 wt %) and sulphur (0.14 wt %). Silicon appeared to be as SiO_2 , and calcium was also found to be oxidized [23]. Potassium was metallic, whereas sulphur and phosphorus were found as sulphates and phosphates, respectively [24]. The surveys on the outlet end showed almost no poisons. Only small traces of calcium (0.5 wt %) and sulphur (0.1 wt %) were found. The FTIR-ATR spectra of the vehicle-aged and fresh natural gas catalysts are presented in Figure 19. The clear differences between the fresh and the aged catalyst spectra are indicated by peaks at 1092, 1025, 725 and 662 cm^{-1} . Peaks at around $1100\text{--}1000\text{ cm}^{-1}$ can be assigned, for example, to sulphur species of gas-phase SO_3 and aluminium sulphates. Again, the phosphorus presence is possible, and also the C-S functional group frequencies can be assigned to peaks at 725 cm^{-1} and 662 cm^{-1} [19,25,26].

Figure 19. FTIR-ATR spectra of the vehicle-aged and fresh natural gas catalysts.

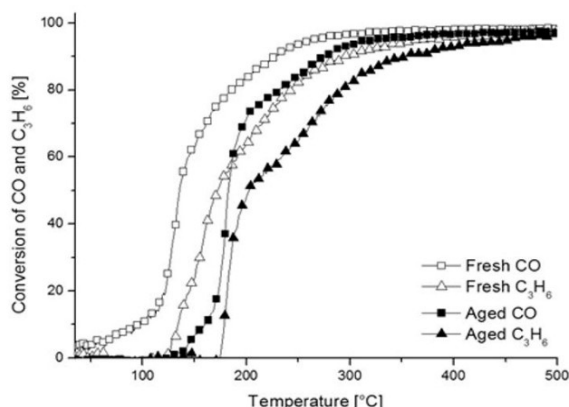
The studied gases in the catalyst performance tests were CO and C_3H_6 . The results of the performance test are presented in Figure 20. For the natural gas catalyst, the fresh one was more active

than the aged catalyst, as expected. Poisons and palladium crystal growth had affected the active sites of the catalyst, increasing the light-off temperature.

Figure 20. The conversion curves of CO and C₃H₆ for the fresh and aged natural gas catalysts.
