THESIS FOR THE DEGREE OF DOCTOR OF PHILOSOPHY

Damage and defects in railway materials:

Influence of mechanical and thermal damage on crack initiation and propagation

CASEY JESSOP

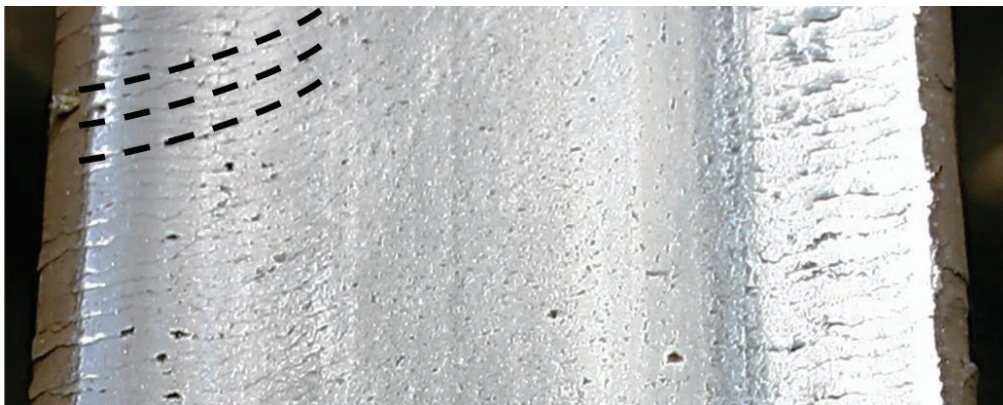
Rolling contact fatigue (RCF) is defined as the fatigue of materials in contact in conjunction with rolling contact and normal loads. A commonly occurring form of RCF cracking is head checks (Figure 2). These are recurring cracks on the gauge corner of rails, but are benign and usually removed by regular rail grinding and maintenance [20]–[22]. However, if not properly maintained, gauge corner cracking (GCC) can lead to the formation of squat cracks. In recent years, the occurrence of this type of surface-initiated defect has been more present and studied. These squats and squat type defects can be a problem due to their location in the rail. Depending on the loading scenario and the orientation of the crack tip, they can either plateau parallel to the surface, or they can turn downwards and cause complete rail fracture.

Figure 2. Commonly occurring RCF defects on the gauge corner of rails. Dashed lines highlight the curvature of the head checks from the gauge corner into the running band. [27]

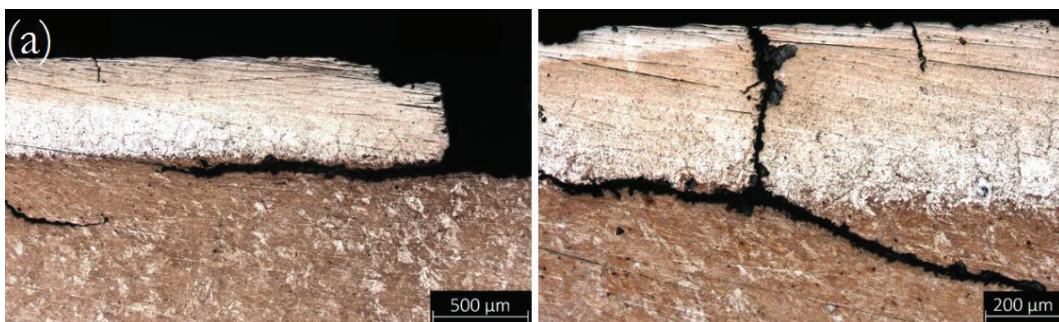
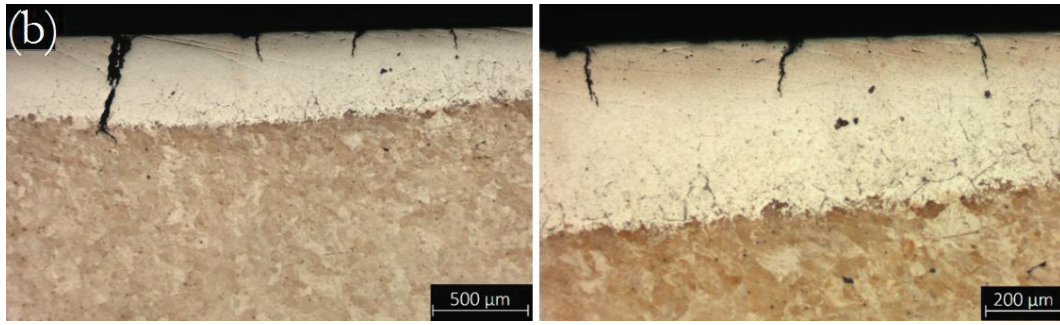
In addition to mechanical damage, the rails and wheels are subject to thermal damage, which can have an effect on RCF crack formation [17], [19]. Rapid heating followed by rapid cooling of a thin layer of material on the surface of the rails and wheels (for example, due to wheels slipping during braking, accelerating) can cause martensite to form. When the temperature at the wheel/rail contact exceeds the effective austenitization temperature (roughly 800 °C [41]), phase transformation to austenite occurs. The thin layer transformed is then rapidly cooled by heat conduction into the cool surroundings. The thin martensite layer forming on cooling is referred to as white etching layer (WEL) due to the white, featureless appearance under optical microscopy after etching (Figure 5) [42], [43]. These WELs have different properties compared to the bulk pearlitic material, and therefore can promote crack initiation as well as spalling. The hard and brittle martensite is more prone to cracking compared to the bulk, which is more ductile. Crack initiation related to WELs is a common problem in the railway industry that is observed in both rails and wheels [11], [24], [42]–[44]. Figure 5 shows two typical types of cracks related to WEL, that is, those that grow at the interface of the WEL and the bulk material (Figure 5a), and those that grow through the WEL (Figure 5b).

Figure 5. (a) Cracks growing at interface of WEL and bulk, and (b) growing through WEL. [45]

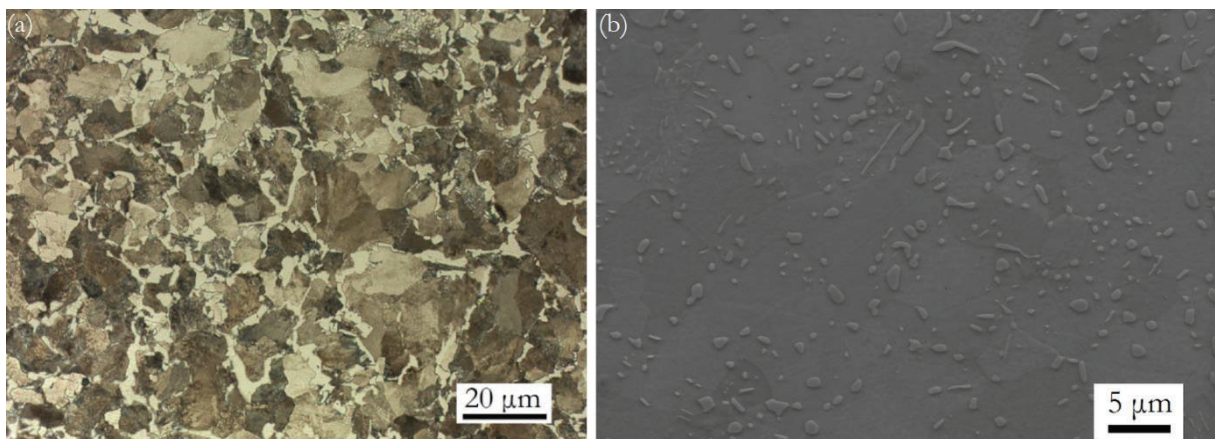
Frequent heating can lead to cracking, but also degradation of the material, and in turn the mechanical properties can deteriorate [48], [50]. One phenomenon which is observed is spheroidization of the pearlitic structure in wheel steel, an extreme example of which is seen in Figure 6b. The effect of this degradation has an impact on both the mechanical properties of the material as well as the fatigue of the component [48], [51].

Figure 6. (a) Microstructure of R8T wheel steel, and (b) SEM micrograph of spheroidized microstructure.

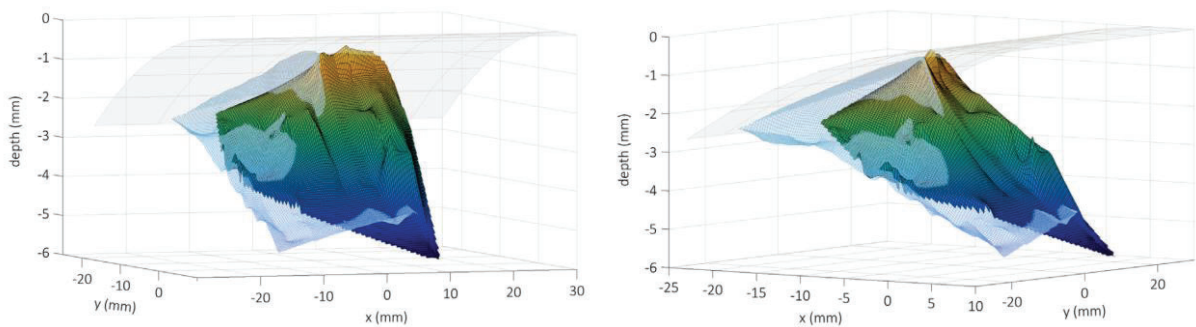
Using a combination of radiography and geometric reconstruction, a squat crack network was reconstructed and compared to the interpolated network obtained from metallographic sectioning (Figure 11) using MATLAB [64]. The geometry is similar to that described in literature [65]. From this, it can be seen that although the overall geometry is well determined from the geometric reconstruction, certain limitations remain, namely in locating the surface-breaking part of the crack and well as the crack tip depth and orientation. The crack tip is, in fact, perhaps the most important point when looking to determine the severity of a crack in field, since the orientation could determine whether the crack will plateau or will turn downwards and potentially cause rail fracture.

Figure 11. 3D plots with surfaces obtained from both 3D reconstruction (colored) and metallography (mesh). The crack network is showed relative to the rail surface (gray). [59]

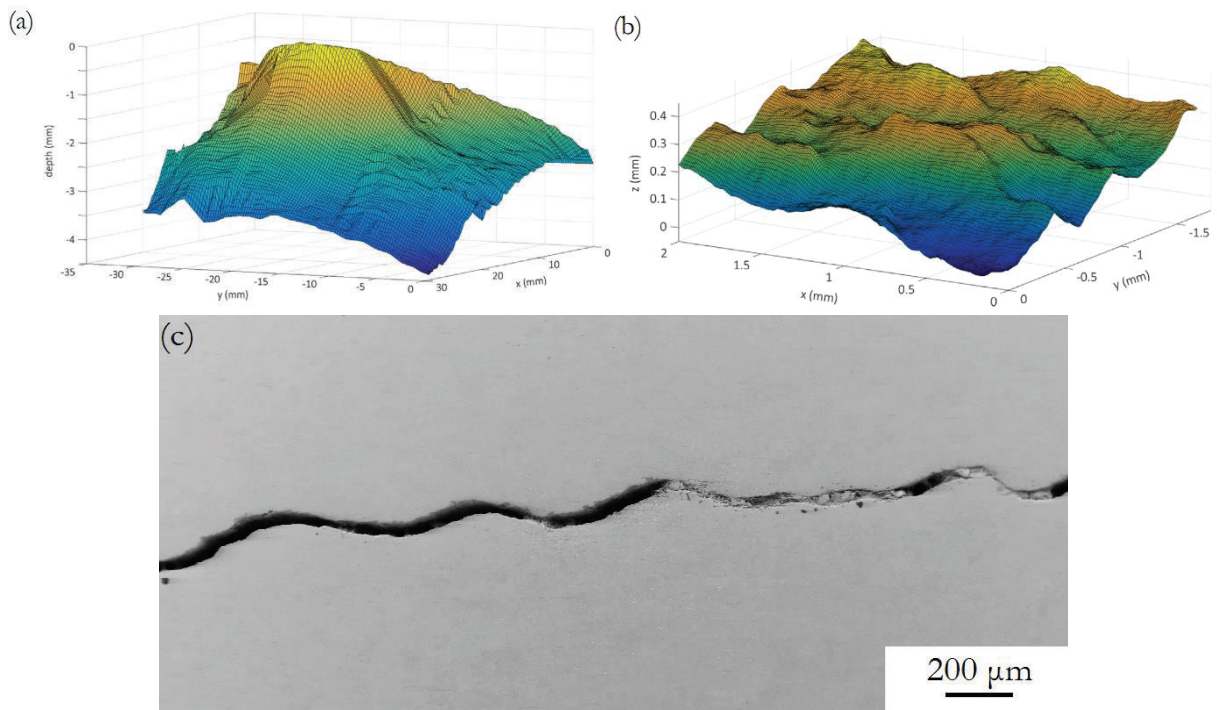
A different squat was broken apart and observed under stereomicroscopy to examine features about the crack morphology and topography, shown in Figure 12. Some observed features were further investigated using topography measurements, as shown in Figure 13. This method allowed for an accurate overall description of the main crack using 1 mm step size, and of the ridges using 50  $\mu\text{m}$  step size.

Additional investigation with SEM revealed crack branching in the transverse sections (e.g. Figure 14); while the longitudinal sections provide additional information about the crack geometry below the surface. Figure 13 shows undulations near the end of the crack network as compared to the detail maps. Furthermore, the 3D mapping (Figure 13b) shows a highly textured surface on different scales: some beach marks, ridges, and surface roughness. It can be speculated that the ridges on the fracture surface (Figure 12b) are a result of repeated relative movement of the two crack surfaces in the same direction, while the smoother regions observed near the surface-breaking part of the crack (Figure 12a, top) are a result of rubbing of crack faces in different directions due to an additional shear displacement. This is thought to be a result of the stresses propagating the crack [35].

Figure 13. (a) Mapping of overall squat geometry, 1 mm step size. (b) Mapping from topography showing ridges, 50  $\mu\text{m}$  step size. [59] (c) Undulations in longitudinal section of squat network. [27]

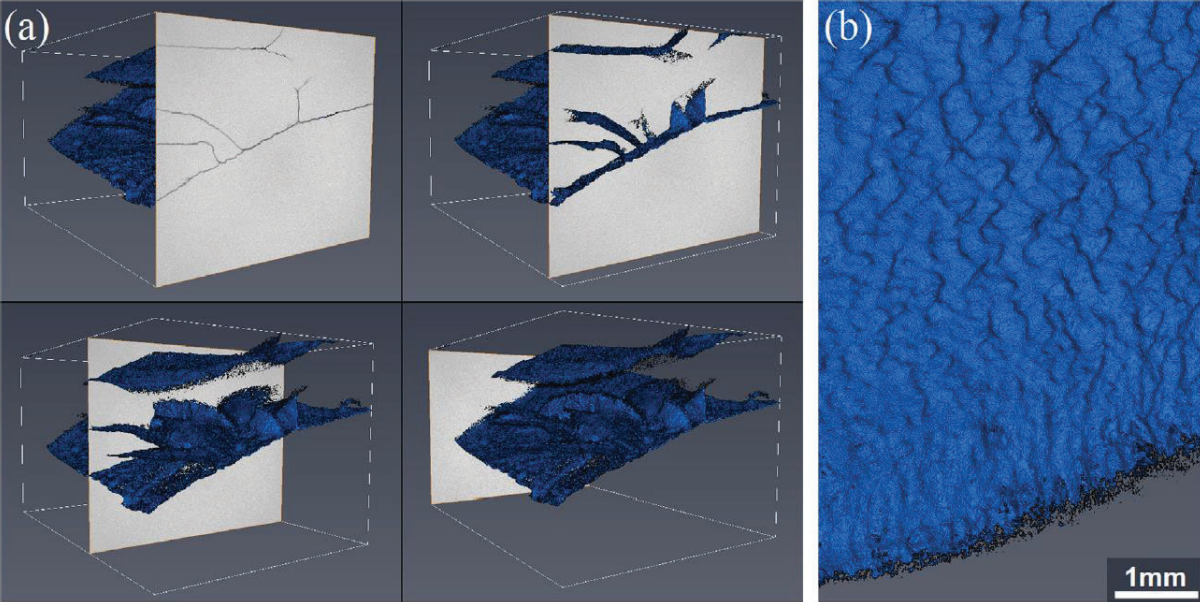
Finally, in Paper 1, X-ray tomography was done on a squat crack network, in order to detect features, such as crack branching, and overall crack geometry and crack face topography. The results are shown in Figure 15. From this study, it was concluded that the different methods are complementary, and observations made using one method can supplement and explain the deficiencies of other methods.

Figure 15. (a) 3D representation of the crack network in blue. Four sections through the reconstructed volume illustrate how the images in [Fig. 9 in [59]] are taken. (b) Overhead view showing crack ridges.[59]

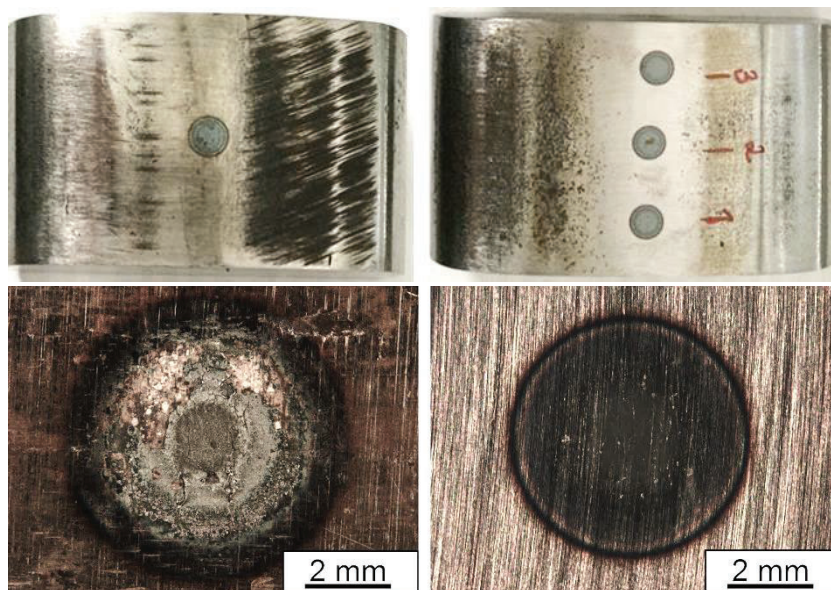
Figure 19. WEL spots on (left) used and (right) new rails.

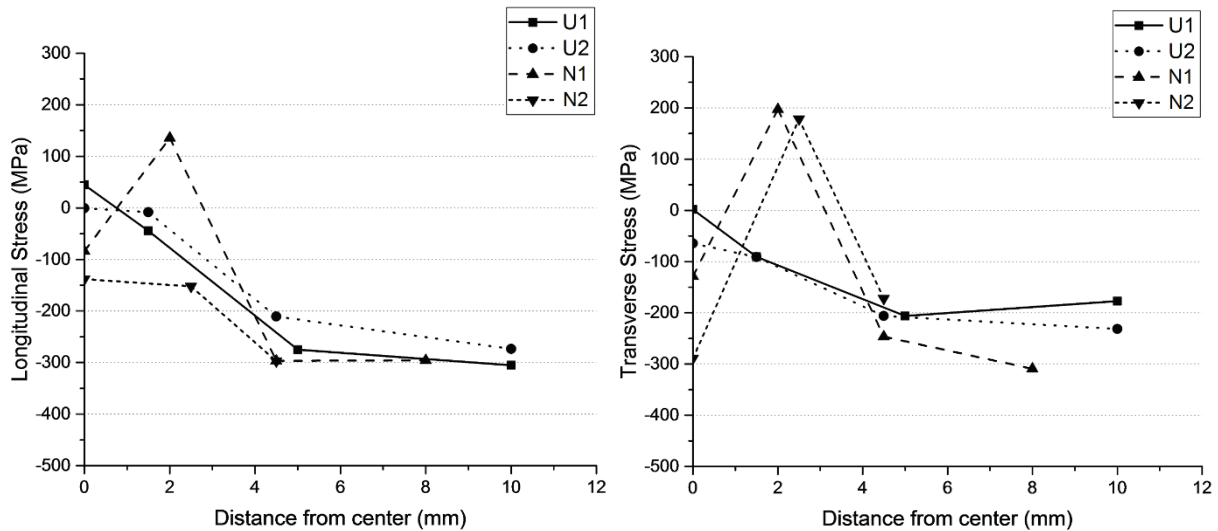
The residual stresses measured in the longitudinal and transverse directions around the 6 mm WEL spots on the used and new rail sections are summarized in Figure 20. The test procedure is fully documented in Paper 2. It is seen that comparatively high tensile stresses are present around the WEL spot on both used and new rails, and the stress value approaches zero in the center of the spots. The explanation could be linked to the thermal expansion and plastic deformation of a material volume around the spot upon heating, and volume expansion on martensite formation during subsequent cooling.

Figure 20. Surface residual stresses around 6-mm WEL spots on used (U1 and U2) and new (N1 and N2) rails.

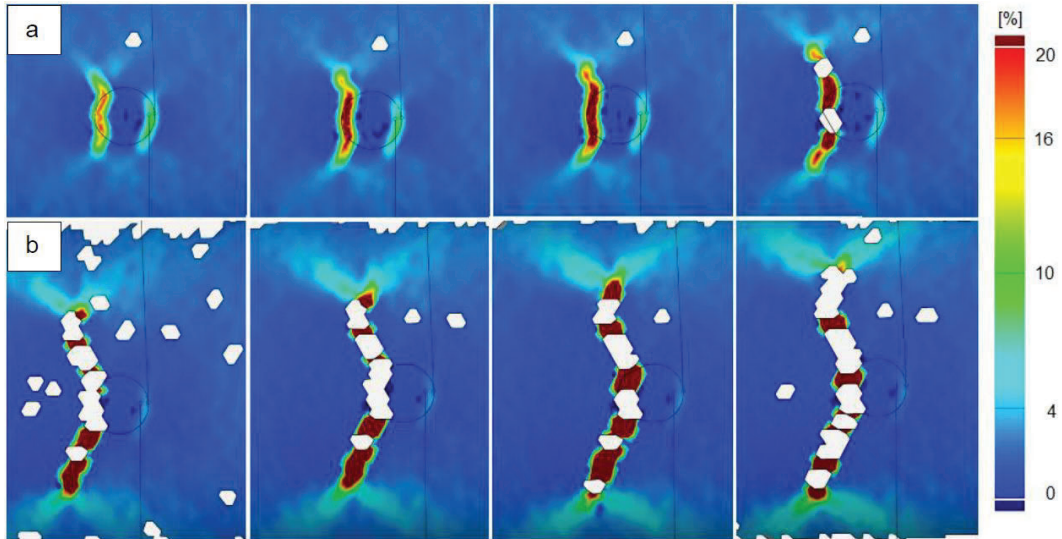
The presence of the WEL spot reduced fatigue life in all but one tests, and it was seen that in test bars with thermal damage, the crack was at or near the WEL spot. In order to investigate further the effect of the thermal damage on the crack initiation, digital image correlation (DIC) equipment was set up for one fatigue test. Using this equipment, the deformation on the surface of the test bar can be measured in real time, and the strains are calculated. It could be clearly seen that within the first cycles already, the strains accumulate at the top and bottom of the WEL, in the loading direction. One crack then becomes dominant, and the strains continue to accumulate until failure occurs (Figure 22).

Figure 22. Strain evolution around the WEL during LCF fatigue test (loading in horizontal direction) a) in early stages, and b) during the final 4 cycles before failure, obtained from DIC.[45]

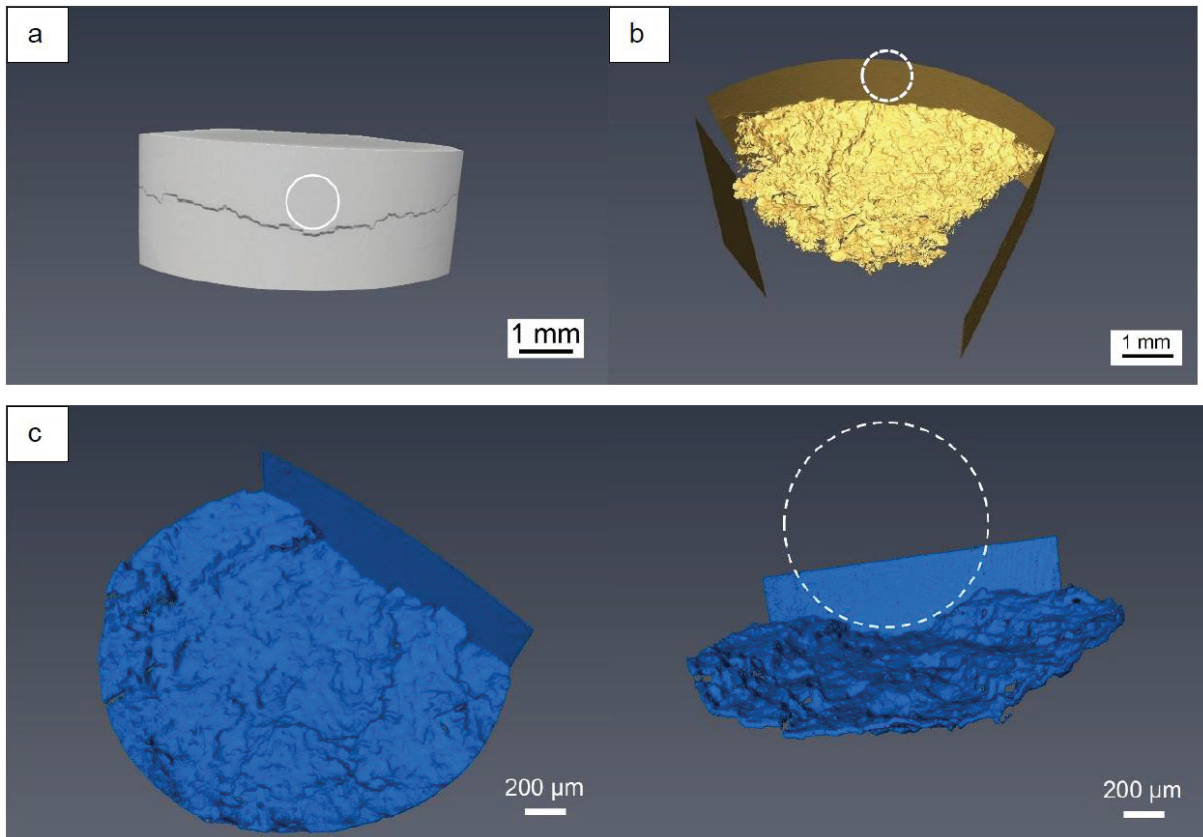
Figure 24. (a) X-ray tomograph of the extent of the crack on the surface of the test bar, (b) overall scan of the crack network within the test bar, and (c) detail scan near the WEL, showing the crack following the bottom of the WEL spot (dashed line represents the approximated location of the WEL spot). [45]

Observation of the fracture surfaces for all tests (with same strain amplitude) revealed that the initial thermal damage does not affect the crack propagation, but only the crack initiation. That is, the WEL spot acts as a stress-raiser during the uniaxial loading, and leads to crack formation earlier, however the remainder of the fatigue life is not affected by the thin WEL spot. The effect of different factors on crack propagation was studied in the next part of the project.

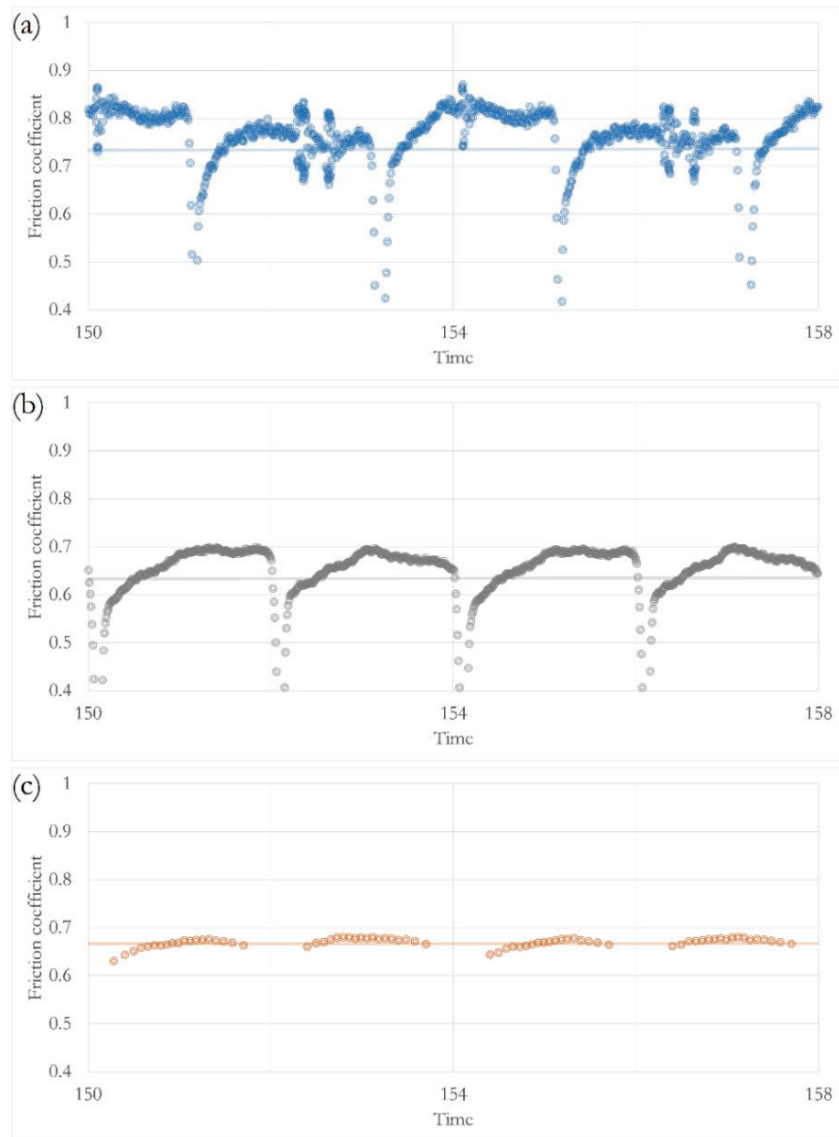
The friction experiments lead to the result that although there appears to be a directional dependence on the measured coefficient of friction, the variation is reduced with increasing normal force. Figure 27 shows the coefficient of friction as a function of time in three experiments with varying normal force. Although the average friction coefficient remains approximately the same for all experiments, the variation during each cycle is reduced with increasing normal force.

Figure 27. Friction coefficient with respect to time for different normal forces equivalent to: (a) 17.5 MPa, (b) 70 MPa, and (c) 140 MPa (Tests F1, F2, and F3, respectively). The difference between the maximum and minimum values decreases with increasing normal force.

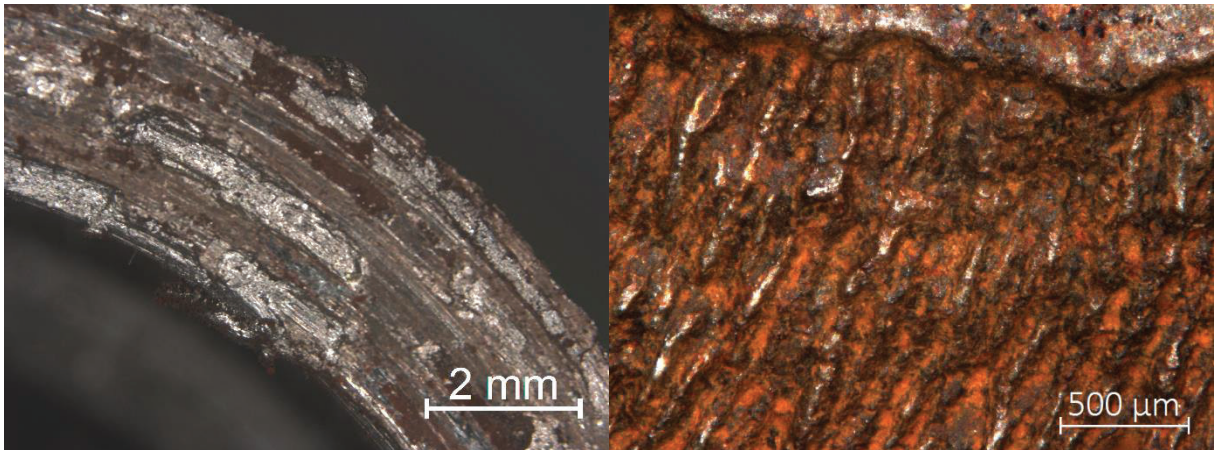
The most significant findings from the friction experiments were related to the deformation of the surfaces, and the effect of adding water to the contact. The ridges on the deformed surfaces are similar to those seen on the squat crack faces, Figure 28. The addition of water in the contact between the two surfaces reduces the coefficient of friction, from approximately 0.63 to 0.38. The reduction of the friction coefficient is accompanied by a reduction in deformation and wear on the surfaces, as seen in Figure 29.

Figure 28. Surface of test bar after friction experiments (left), resembling detail of ridges on squat crack face (right).  
Modified from [63]

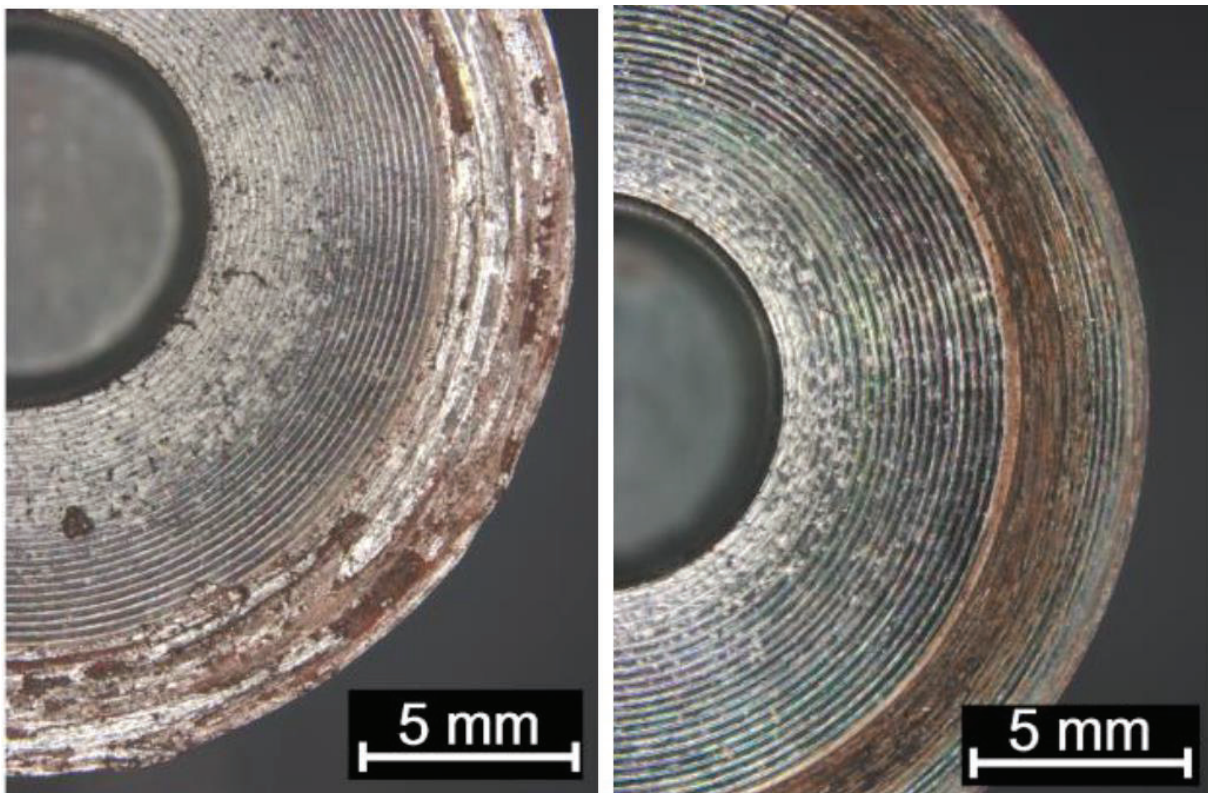
Figure 29. Surfaces of test bar after testing in (left) dry and (right) wet conditions. The more pronounced deformation and wear in the dry conditions is apparent and a reflection of the larger coefficients of frictions calculated. The periphery of the contact surface in the wet tests remains in original condition, while the inner radius is worn and corroded. [63]

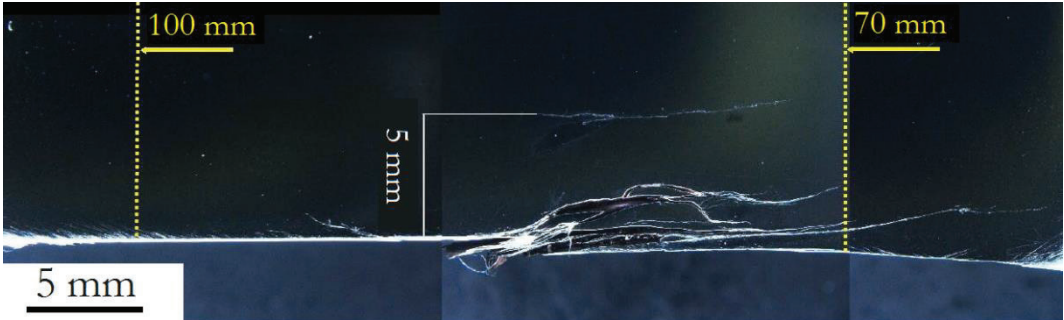
The RCF3 zone in Figure 32 showed a different crack morphology; the cracks are much deeper than in the RCF1 zone, extending to a depth of more than 7 mm, and crack branching is present. It is seen that the RCF3 cracks in the transverse section (Figure 33) are very pronounced, and the majority of the network

extends approximately 2 mm into the wheel. Furthermore, a crack is seen at a depth of 5 mm from the surface. This confirms that dominant cracks extend to at least to this depth, as seen in the longitudinal section, since each section only represents a 2-dimensional image of the whole crack network. It can be concluded that the main damage mechanism is RCF3.

Figure 33. Transverse section through the RCF1 and RCF3 zones. Dotted lines indicate distances of 70 mm and 100 mm from the flange side. These distances correspond to the longitudinal sections of RCF3 and RCF1, respectively.
