Concluding destructive investigation of a nine-year-old marine-exposed cracked concrete panel

Mette Geiker^{a,*}, Samanta Robuschi^b, Karin Lundgren^b, Charilaos Paraskevoulakos^c, Carsten Gundlach^d, Tobias Danner^e, Ulla Hjorth Jakobsen^f, Alexander Michel^c

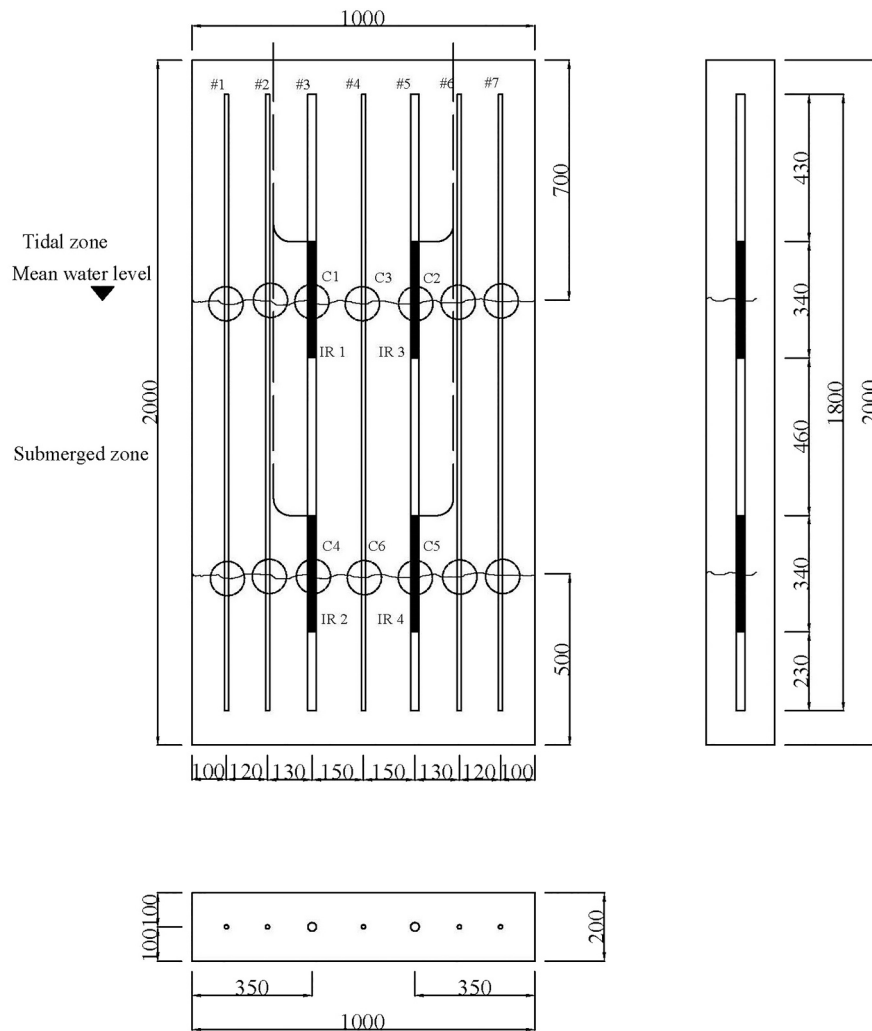
Subsequently and before exposure, two cracks were mechanically introduced in the panel by means of three-point bending. The cracks were located approximately 0.70 m (Crack 1, tidal exposure) and 1.50 m (Crack 2, submerged exposure) from the top of the panel, see Fig. 1. A DEMEC Mechanical Strain Gauge was used to measure crack width in both locations (for three pairs of measuring points along the crack path) both during the cracking and after 1.5 years. Upon cracking, two recesses of approximately 10 cm \times 5 cm \times 5 cm (length \times width \times depth) were cut at the edges and along the crack path of the panel. Subsequently, the recesses were filled with fast-hardening repair mortar to retain induced crack widths (see Table 3). The repair mortar was allowed to cure sealed for 24 h before maintaining the applied load and, thus, the crack widths. Then the specimen was stored for seven months onsite still sealed in plastic until exposure.

Fig. 1. Dimensions of the panel, location of mean water level, the two horizontal cracks, and cores extracted for this study: Series 1: cores C3 and C6 include parts of conventional reinforcing bars, cores C1, C2, C4 and C5 include parts of instrumented reinforcing bars; Series 2: numbering of cores. #1–7, numbering of rebar sections: IR 1–4, instrumented rebars: #3 and #5. All measures in mm.

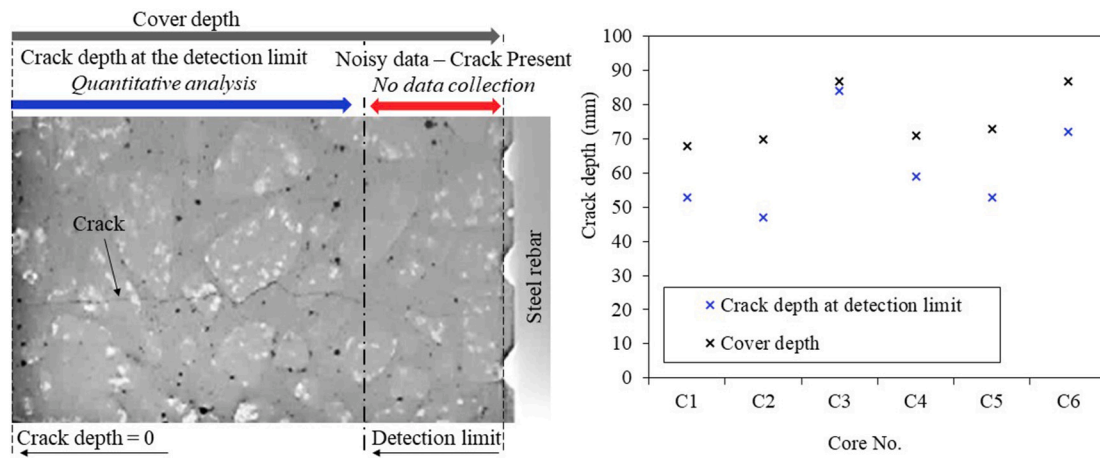
Fig. 4. Schematic illustration of detection limit for quantitative analysis of μ -CT scans due to low resolution and image noise, artefacts associated with scanning near rebars. Left: a representative crack with identification of limit for image segmentation. Right: the crack depths at the detection limit and the cover depth for all six cores (Series 1) investigated.

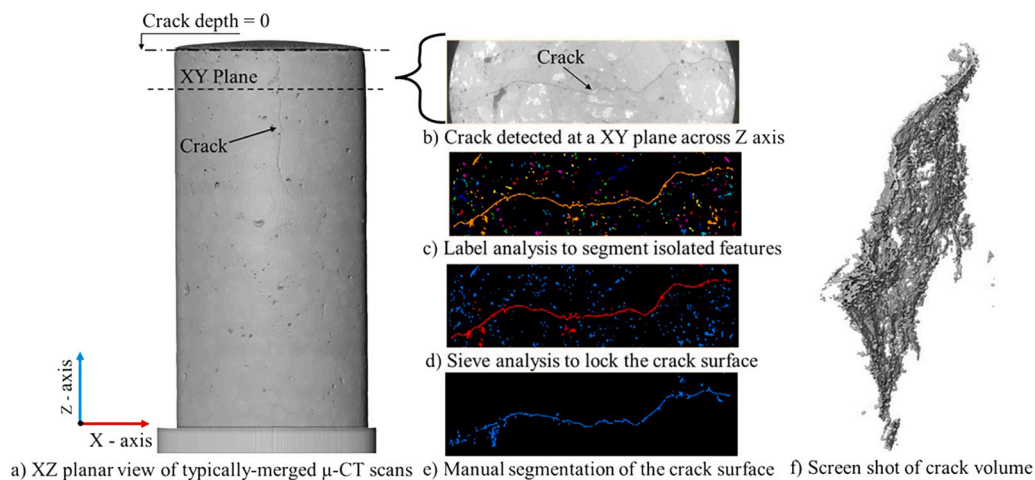
Fig. 5. Schematic illustration of a) an XZ planar view of typically-merged μ -CT scans, b)–e) the process followed to segment the crack in 3D space using the relevant modules available in Avizo, and f) a representative screenshot of the 3D crack volume illustrating the crack from a specific angle. Images of core C1.

The methodology applied is illustrated in Fig. 5 across a 3D profile of a representative crack and was implemented for all samples investigated. The selection of appropriate intensity thresholding range was consistent on all occasions to facilitate comparison. Image segmentation employed to separate cracks failed to provide quantitative data at crack depths near the rebar due to noise artefacts present in the corresponding image datasets induced by the steel rebar. Data were therefore, collected from zero crack depth to the image segmentation detection limit (see Fig. 3). It should be noted that visual observation of μ -CT images near the steel rebar confirmed that the cracks had fully penetrated the concrete cover.
