## **Laboratory study of driving rain resistance of four façade systems with window fittings - Experimental results of leakage flows**

# LABORATORY STUDY OF DRIVING RAIN RESISTANCE OF FOUR FAÇADE SYSTEMS WITH WINDOW FITTINGS – EXPERIMENTAL RESULTS OF LEAKAGE FLOWS

Lars OLSSON<sup>a,b</sup>

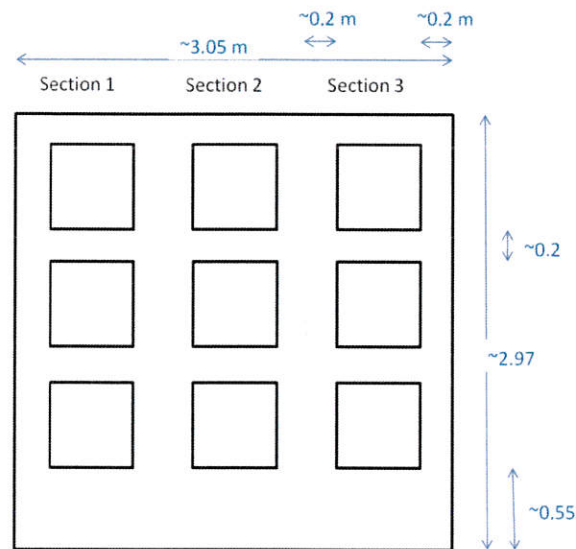
*Fig. 1 Sketch of experimental wall*

Prior to assembly or configuration, the façade suppliers were given the following information. Each façade system (experimental wall) should be built up in three vertical sections (**Fig. 1**). The horizontal rows of windows are meant to simulate each floor level for a three floor building. Section 1 is built up in the best possible way by specially trained installers. This will form the base level for driving rain resistance or leakage. In sections 2 and 3, introduction of a number of possible and verified working procedure defects (5–10 pcs) based on interviews, for example, with system developers, trained installers and experiences gained from testing and investigative activities. The section 3 was expanded in order to allow installation by a carpenter without any specialized knowledge of specific systems, but with access to the installation instructions.

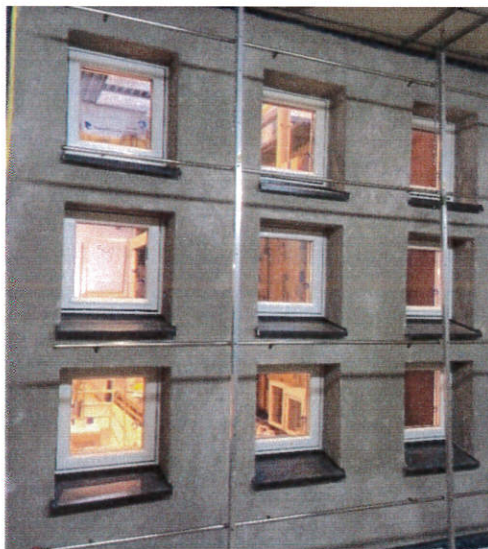
*Fig. 4 Front façade of wall 3 installed in the rain chamber*

3. 20 mm rendering, 200 mm mineral wool insulation with drainage possibility and weather barrier of water-resistant gypsum board (second line of defence) (**Fig. 4**). Joints in the weather barrier and connections to the window were sealed separately. Under the windows and exterior window sills, water discharges (window flashing) were installed directing water away from the wall and discharging just below the front of the exterior window sills. Base flashing were also installed in the bottom wall. Sealing compound was applied to seal between the exterior window sills and windows. The assembly for section 2 deviates from the installation instructions in the sense that the sealing compound has been intentionally omitted between the rear edge of the exterior window sill and the window. In section 3, the installation of the weather barrier and exterior window sills was performed by an experienced carpenter who had not had any special training on the system. However, the carpenter had access to the installation instructions and had the option of observing the assembly of the other sections.

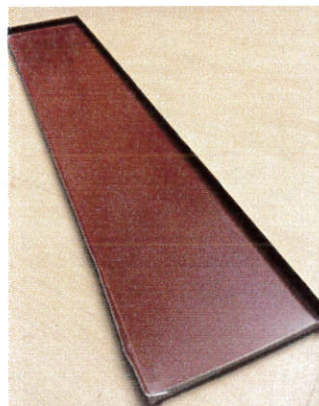
**Fig. 6** Photo of collection trays that were placed in the driving gap under the window frame

Moreover, collection trays with the dimensions 620 x 120 x 15 mm were positioned under each window frame (**Fig. 6**), except in the wall 2 with only two windows. Wall 2 was delivered in four smaller prefabricated elements and was assembled by the supplier in the steel test frame. Under each window and joint, laboratory staff installed collecting funnels made of plastic sheeting that were taped and sealed to the rear façade. Each funnel opened into a glass basin for collecting water. Additionally, two catchment chutes were fitted to vertical joints at the rear façade and moisture indicators at the bottom of the exterior of the wall frame.
