Effect of Powder Recycling on Defect Formation in Electron Beam Melted Alloy 718

Gruber, H., Luchian, C., Hryha, E. et al (2020). Effect of Powder Recycling on Defect Formation in Electron Beam Melted Alloy 718. *Metallurgical and Materials Transactions A: Physical Metallurgy and Materials Science*, 51(5): 2430-2443. <http://dx.doi.org/10.1007/s11661-020-05674-8>

HANS GRUBER, COSMINA LUCHIAN, EDUARD HRYHA, and LARS NYBORG

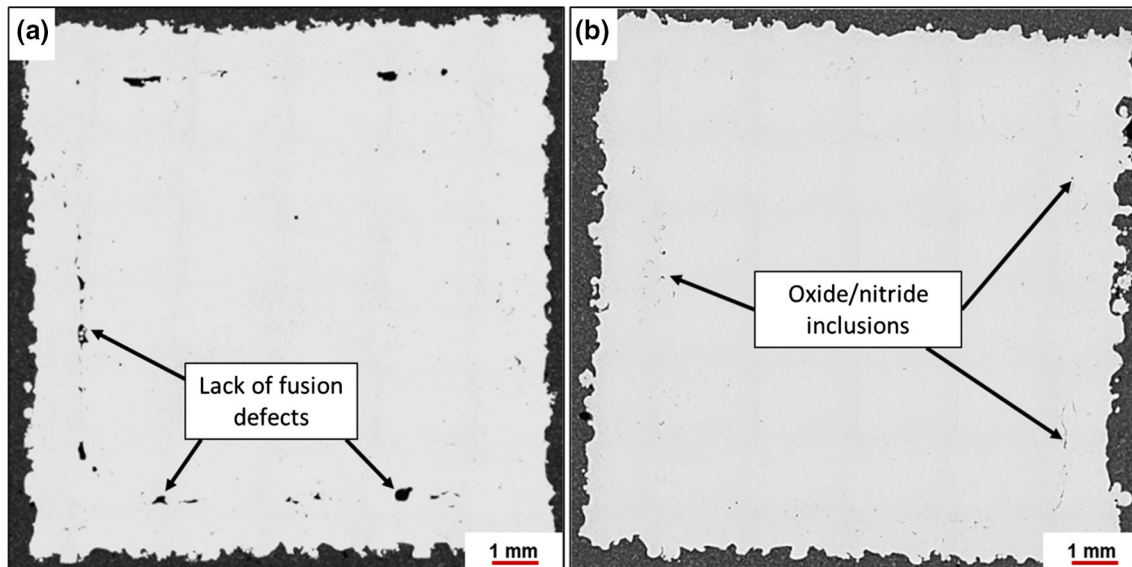
Fig. 4—Light optical micrographs of B30 CVN specimens showing typical distribution of defects on cross-section transversal to the build direction; (a) as-printed condition; (b) as-HIP condition.

Cross-section transversal to the build direction of a B30 specimen in as-printed condition as well as after HIP treatment is shown in Figures 4(a) and (b), respectively. In both cases, larger sized lack of fusion defects and non-metallic inclusions are mainly found along the interface between the contour and hatching regions at around 1 mm from the outer surface. This defect distribution is representative for samples produced from both virgin and re-used powder.

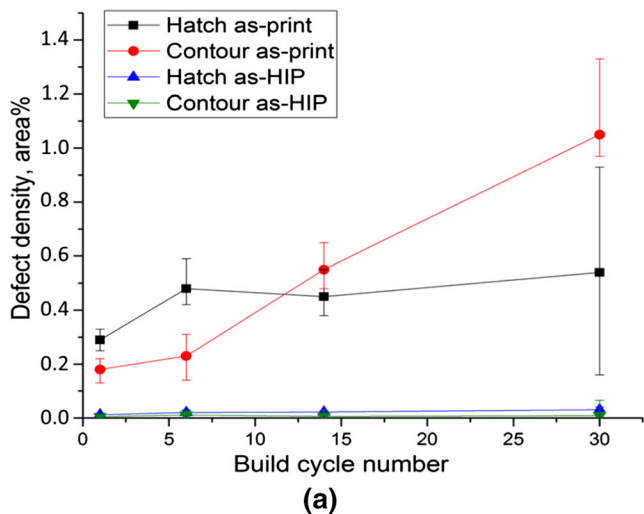
Fig. 9—Defect density in the hatch and contour region measured in (a) as-printed and as-HIP condition (b) as-HIP condition. The error bars indicate the actual measurement range. All data points are average values obtained from measurements in the cross-sections “bottom” and “below top”, as indicated in Fig. 1(b).

The defect density in solid samples produced from virgin and progressively re-used powder, in as-printed and as-HIP condition, is presented in Figure 9(a). As seen here, only a small portion of the defects present in

as-printed condition remain after HIP, which, for improved visualization, is presented separately in Figure 9(b). As seen in Figure 9(a), there is a steady increase in defect density in the contour region with respect to progressive powder re-use. This is mainly due to an increasing amount of LOFDs, which is considerably lower in samples built from virgin powder.

Also after HIP, there is a steady increase in defect density in the contour region with respect to progressive powder re-use, see in Figure 9(b). This is in line with the increased amount of inclusions in consolidated LOFDs, but also other large oxide agglomerations, as shown in Figure 5(c). A much more modest increase in defect density is seen in the hatch region, in agreement with the result presented in Figure 5(d).
