# The influence of a KCl-rich environment on the corrosion attack of 304 L: 3D FIB/SEM and TEM investigations

J. Phother-Simon, I. Hanif\*, J. Liske, T. Jonsson

This study investigates the intergranular corrosion of a stainless steel (304 L) in the presence of KCl(g)/KCl(s) at 600 °C by using a FIB/SEM to perform 3D reconstruction/tomography of grain boundary attacks in combination with TEM. The investigation shows that the combination of the 3D FIB/TEM offers a great potential for the study of complex features, i.e. intergranular corrosion. The initiation and propagation of the grain boundary attack occurred very rapidly below an intact secondary protection. No large accumulations of metal chlorides were observed at the grain boundary regions. Instead, indications of very rapid alloy diffusion in grain boundary regions were observed.

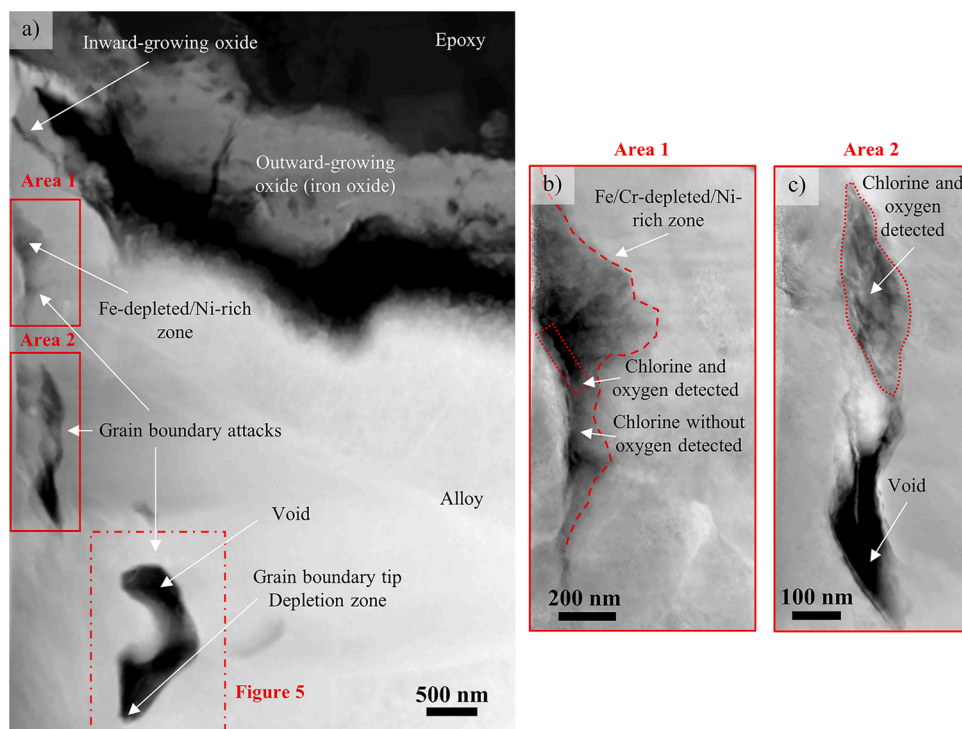
**Fig. 3.** High-angle annular dark-field scanning TEM (HAADF-STEM) micrographs showing the a) thin lamella of a 304 L sample exposed to 5% O<sub>2</sub> + 20% H<sub>2</sub>O + N<sub>2</sub> (bal.) under continuous KCl deposition at 600 °C for 1-h (red box labelled “TEM lamella” in Fig. 1); b) high magnification image of the beginning of the GB attack, close to the metal/oxide interface and c) high magnification image of the apparent middle section of the GB attack. (For interpretation of the references to colour in the Figure, the reader is referred to the web version of this article).

The HAADF image (Fig. 3a) was complemented with STEM/EDX analysis showing that the GB region was covered by an outward-growing oxide scale characterized as iron oxide (interpreted as hematite) and a thin inward-growing FeCrNi (interpreted as spinel) oxide scale of 300 nm thickness. The GB attack in the lamella could be segmented into three separate voids. The voids in Fig. 3a marked with red rectangles 1 and 2, i.e. representing the outer part of the void (1) and the middle part of the void (2), were investigated in detail. The STEM/EDX analysis revealed a depletion zone next to the void as well as traces of Cl (up to approximately 1 at. %) with and without low levels of oxygen (up to 28 at. %). Representative STEM/EDX line scan profiles across the GB void

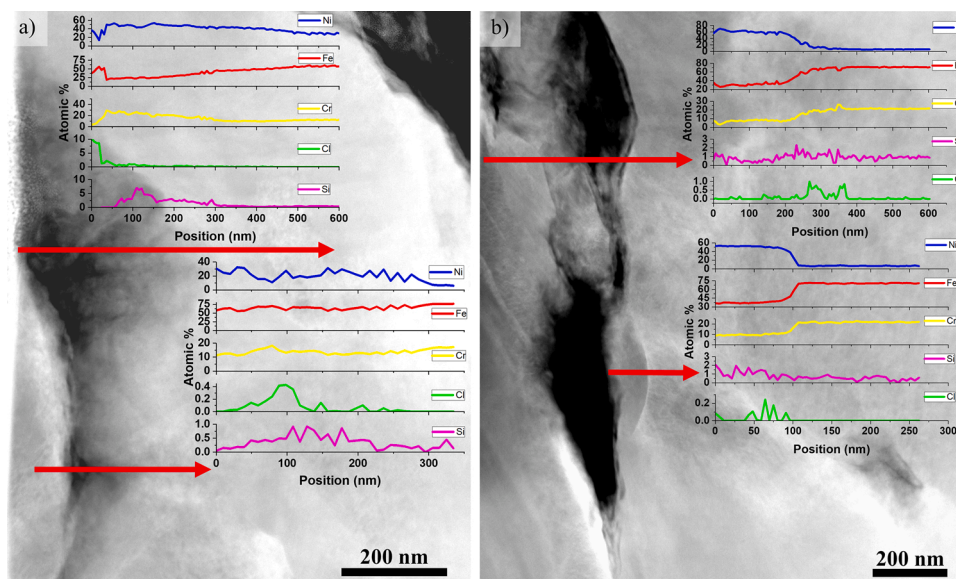
**Fig. 4.** High magnification HAADF-STEM micrographs (a, b) of Fig. 3b) and b) Fig. 3c) with corresponding STEM-EDX line scans (at. %), the red arrows shows the direction of the line scan. (For interpretation of the references to colour in the Figure, the reader is referred to the web version of this article).

regions are shown in Fig. 4a and b. Although STEM/EDX offers high signal-to-background ratio and resolution, limitations were found in some thin regions. Thus, special effort was made to identify elements when present at low concentrations, e.g. Cl where the spectrum showed a clear peak. The results showed a Fe-Cr depletion zone of about 600 nm and 300 nm in area 1, i.e. closest to the surface. High nickel content was subsequently observed in these depletion zones. The compositional variation of different elements was compared with the alloy composition in order to be able to determine the depletion zones. The 2D representation of the complex 3D structure may overestimate the depletion zones. A large number of line scans were therefore performed and analyzed.

the GB attack (see, Fig. 4b). It revealed the same type of features including traces of Cl (up to approximately 1 at.%) with oxygen. The Fe-Cr depletion zone surrounding the void in area 2 had a similar profile to the depletion zone in area 1 with high content of Ni, reaching approximately 110 nm and 300 nm.

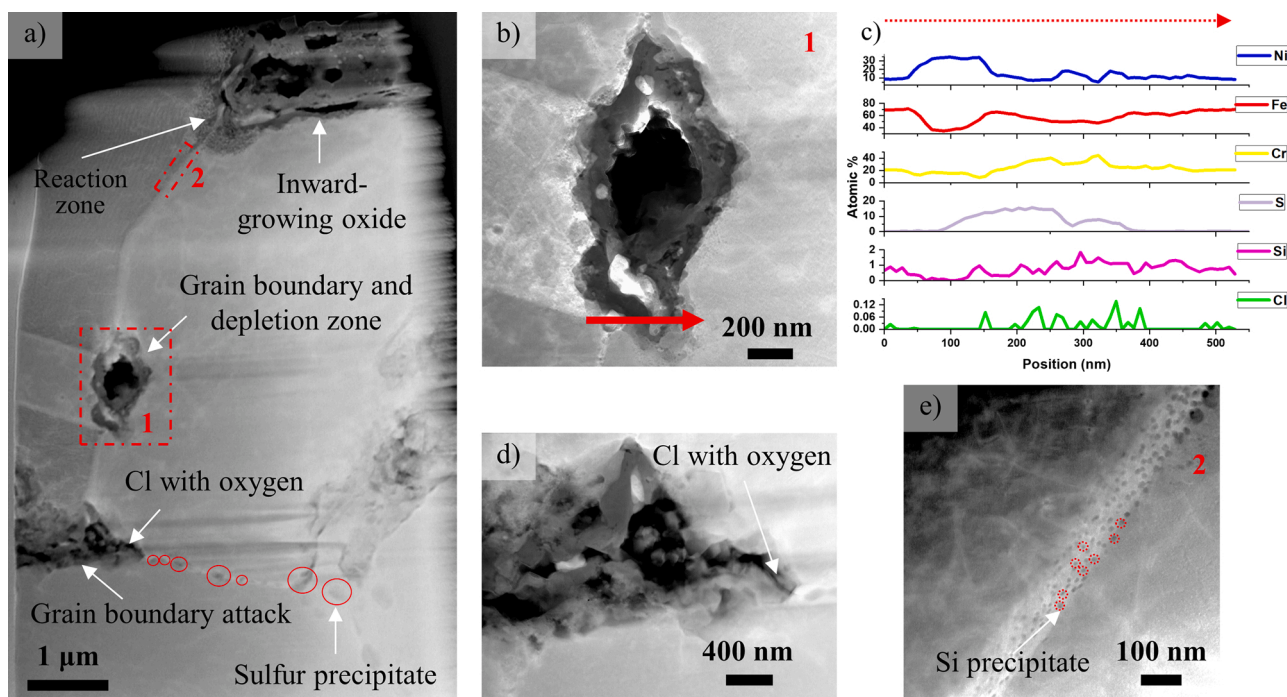
**Fig. 11.** HAADF-STEM micrographs showing the a) thin foil; b) high magnification image of the void considered to be a cross-section of GB attack and red arrow showing the direction of the line scan; c) line scan profile showing the distribution of different elements (at. %); d) high magnification of the tip of the highly attacked region and e) segregation of Si precipitates at a non-attacked GB. (For interpretation of the references to colour in the Figure, the reader is referred to the web version of this article).

Fig. 11a shows a HAADF image of a lamella made to further characterize the corrosion front as well as the GB ahead of the front of the GB attack. The void marked with the red dotted rectangle 1 in Fig. 11a was presumed to be a cross-section of a GB attack close to the corrosion front. A high magnification image of this area is shown in Fig. 11b, and an EDX line scan of the cross-section was performed. Very small amounts of chlorine were identified together with a small Fe/Cr-depletion zone along with high Ni content was observed in the line scan (see Fig. 11c). An in-depth analytical investigation within the attacked GB (Fig. 11d) in front of the corrosion fronts revealed large local variations with depletion of especially iron in combination with low concentrations of Cl (below 1 at. %) with oxygen, sulphur (below 1 at. %).
