A method for in-field railhead crack detection using digital image correlation

Knut Andreas Meyer, Daniel Gren, Johan Ahlström & Anders Ekberg

Railway infrastructure managers must decide when and how to maintain rails. However, they often have insufficient information about railhead cracks. Therefore, we propose a new method for rail crack detection using a train-mounted digital image correlation (DIC) camera system. The measurement train's weight cause rail bending, allowing the DIC to measure strain concentrations caused by surface-breaking cracks. In this study, we evaluate the method under laboratory conditions. The detected cracks correlate to the actual crack network in the analysed rail field sample. Furthermore, finite element simulations show the method's high sensitivity to crack depths. Existing methods, such as ultra-sonic and eddy-current, produce damage severity indications. The proposed method complements these techniques by providing a discrete description of the surface-breaking cracks and their depth. This information enables infrastructure managers to optimize rail maintenance. Additionally, such detailed measurements can be valuable for research in railhead da

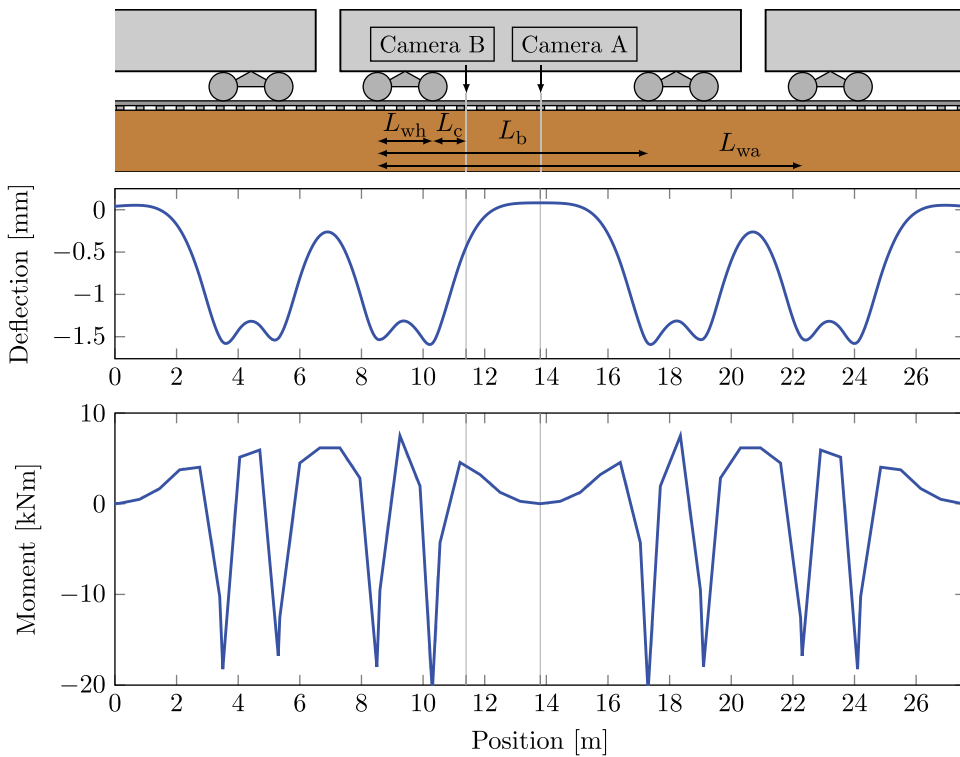
Figure 1. Rail deflection and bending moment due to a train passage. Camera A measures the undeformed rail surface while Camera B measures the deformed surface. The dimensions L_{wb} , L_b , and L_{wa} are described in Table 1, and L_c is the distance from the wheel to Camera B.

Rails, sleepers and the ground deflects when a train rolls over, as illustrated in Figure 1. These results are calculated for a freight train with a 25-ton axle load using the methodology described in Section 5.1. The rail deflections give rise to bending moments in the rail. Figure 1 shows that the bending moment in the middle of each wagon is approximately zero. Camera A can then take a reference image, showing the rail surface without an applied bending moment. When the train has moved so that Camera B is approximately in Camera A's previous position, Camera B acquires an image of the same area as Camera A's reference image. This approximate position is calculated from the train speed. The DIC pattern recognition is then used in an optimization loop to accurately determine the relative position of the images. The image from camera B shows the surface being affected by tensile strains due to a positive rail bending moment. These tensile strains cause the cracks to open, see Figure 2. The crack opening causes a displacement jump over the crack mouth leading to an infinite strain.

zero. However, at Camera B, the moment fluctuates when rolling between two sleepers. To maximize the method’s sensitivity for all positions, we must maximize the minimum moment over such a cycle by adjusting the camera position, L_c (see Figure 1 for the definition of L_c). Figure 11b shows how the minimum moment varies with camera position. The maximum moment is also included as a reference. The black dot marks the minimum moment at the position of camera B that maximizes the minimum moment. For the parameters in Table 1, this bending moment is 3.8 kNm. The DIC method can calculate the average surface strain and thereby also the bending moment. Hence, a varying bending moment during rolling does not pose an issue for the proposed method. For shallow cracks, there is no discernible difference between a tensile strain for the entire rail or a bending strain in the railhead. Therefore, the method can account for varying complex static and dynamic loading conditions.

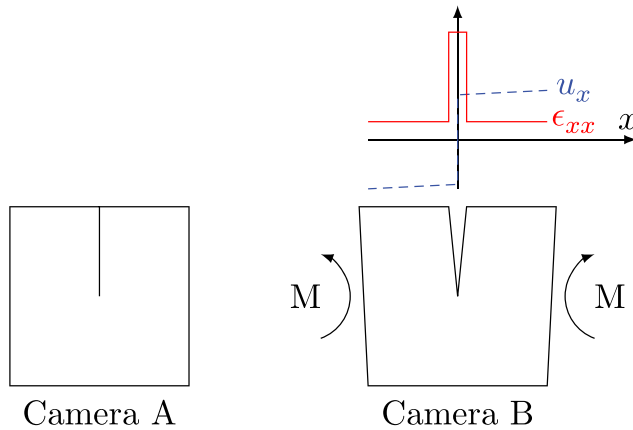
Figure 2. Illustration of the measured strain around a crack mouth in a rail subjected to a positive bending moment.

However, in DIC, the strain is calculated based on displacement between points with a finite spacing. Therefore, the strain illustrated in Figure 2 is not a Dirac delta function. If the point spacing is small enough, a high strain concentration is detected around the crack mouth. This strain concentration is the proposed crack indicator. Finally, we note that the train direction does not matter: the reference image from Camera A can be taken before or after the image from Camera B.

The DIC results provide two relevant sources of information. Firstly, an accurate 3D-map of the rail surface is obtained. This map describes the surface state and the degree of spalling. Secondly, and the primary purpose of the present study, is the strain field due to rail bending. As previously discussed, some strain concentrations continue from regions with high surface irregularities (e.g. at F and E). For the bands denoted by D, several bands almost coalesce into one very long band. At A and C, there are also pronounced bands of high strain concentration. All of these results show the pattern expected based on the simple illustration in Figure 2.

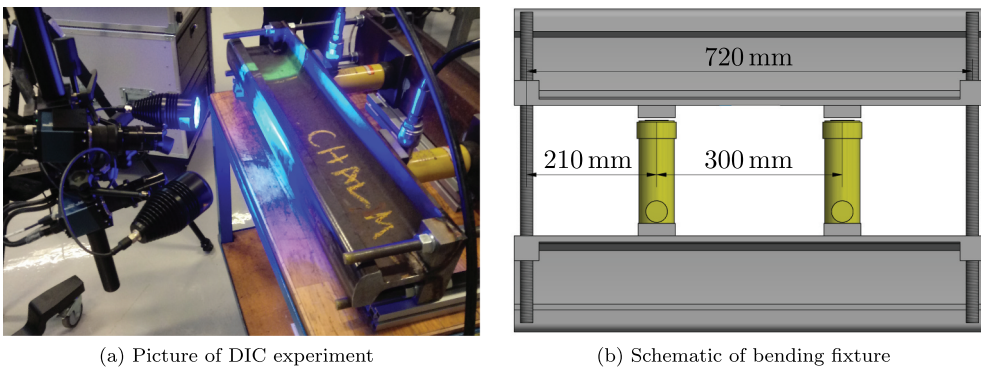
(a) Picture of DIC experiment

(b) Schematic of bending fixture

Figure 3. DIC experimental setup with the yellow hydraulic cylinders exerting a 4-point bending in the rail samples.

Two rail field samples were connected by threaded rods, as shown in Figure 3. Two hydraulically connected cylinders load the samples in 4-point bending. This setup gives a constant bending moment in the part of the rail located between the cylinders. The hydraulic pressure was controlled by a manual pump and measured by an electronic pressure sensor.

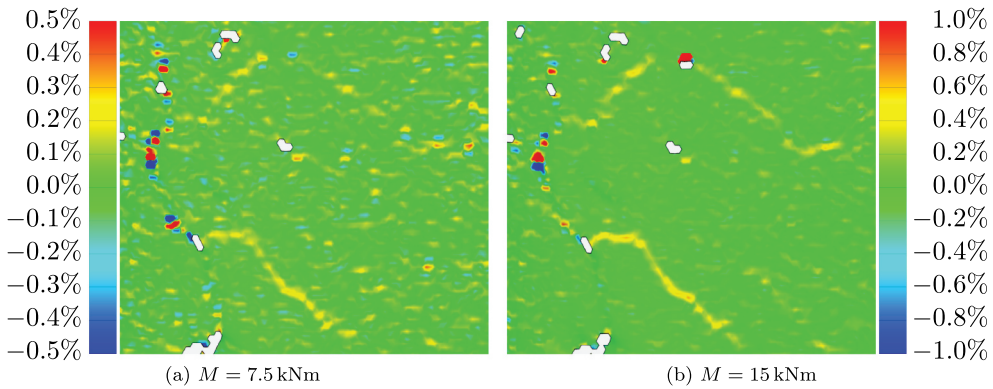
Figure 4. Surface strain distribution along the rail (horizontal in this figure), measured by DIC.

Figure 4 shows that strain concentrations can be observed at a 7.5 kNm bending moment. Increasing the bending moment to 15 kNm improves the Signal to Noise Ratio (SNR) and makes the strain concentrations clearer, see Figure 4(b). The results in Figure 1 only show a 3.8 kNm bending moment. However, this moment can be increased to above 10 kNm following the optimization of train parameters described in Section 5.1.

In Section 3.1, we discussed how the Signal-to-Noise-Ratio (SNR) increases with increasing load, illustrated in Figure 4. Therefore, it would be advantageous to increase the bending moment of 3.8 kNm. With the parameters from Table 1, the maximum and minimum rail bending moments are 8.0 kNm and -21.1 kNm respectively. To calculate this, 50 different train positions relative to the sleepers are considered. By adjusting the train’s wheel positions, the bending moment at the camera location can be increased without increasing the load on the rail. Using $L_{wh} = 1.0\text{m}$, $L_b = 8.0\text{m}$,

where σ_T is the thermal stress. The safety factors A , B , C , and D vary. Denoting $s = (1 + A)(1 + B)(1 + C)(1 + D)$, the different recommendations in Robnett et al. [27] yield $s \in [1.81, 2.14]$. Taking the yield stress for R260 of 534 MPa [28] and assuming a 30°C temperature drop, the conservative maximum bending stress $\sigma_{b,max}$ becomes 228 MPa . For the rail foot of a 50E3 rail, this corresponds to a bending moment of -49 kNm . Hence, the wheel load can be doubled without violating this limit, if the train is slow enough to neglect dynamic effects. In this case, the minimum bending moment at Camera B's position becomes 10.2 kNm . In Figure 4, a reasonably good SNR is obtained at 7.5 kNm , hence 10.2 kNm should give a good SNR.

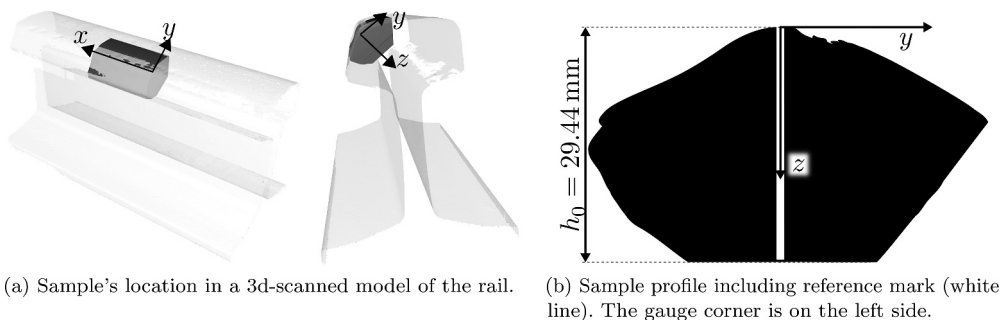
Figure 5. The extracted sample used to characterize the crack networks.

The proposed crack detection method is based on surface strains. To investigate how this method performs, detailed information about the true crack network is required. To this end, the analysed section of the rail was extracted and characterized using serial sectioning and microscopy, see Figure 5. The extracted sample was surface ground, followed by polishing, in increments of approximately 0.25 mm. From the initial height, h_0 in Figures 5(b), 9 mm was taken off starting from the gauge corner. A 1 mm wide, 0.25 mm deep, reference line for positioning was milled on one side. This line is shown in Figure 5(b).

The strain field in [Figure 7](#) is visualized for a 15 kNm bending moment. The reference mark, see [Figure 5](#), is on the right side of the strain field. Furthermore, the reference line in [Figure 7](#) shows the horizontal direction in the section images that is along the rail. Hence, it is perpendicular to the reference mark shown in [Figure 5\(b\)](#).

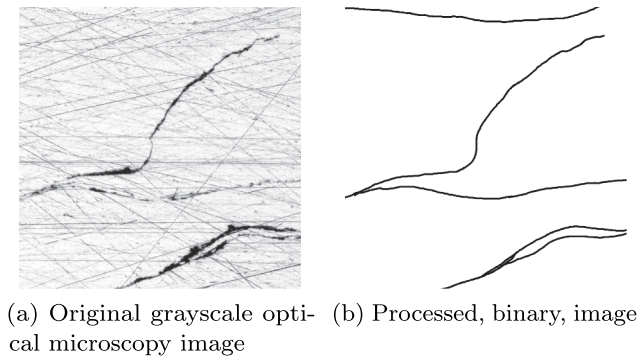
Figure 6. Example of conversion from optical microscopy images to binary images. The shown images are $1.5\text{mm} \times 1.5\text{mm}$.

Using a 5X objective lens, resulting in a pixel size of $0.88 \mu\text{m}$, 74 mm along the rail was characterized. Multiple image tiles were taken and stitched into one image. For this stitching to work efficiently, a mirror-polished surface is not favourable. For that reason, and from a time-efficiency perspective, grinding marks are still clearly visible in Figure 6. A semi-automated procedure for generating binary images was therefore adopted. Two image layers were created, where the bottom layer contained the raw image. Large dark areas in the bottom layer were filled to become fully black. In the initially transparent top layer, a stylus was used to mark cracks by a 10 pixel ($8.8 \mu\text{m}$) wide line. After that, we binarized the bottom layer with

a threshold of 3 on a 255-level greyscale where 0 is black. Hence, only very dark areas became black. Subsequently, Gaussian filtering (size 20.5 pixels), followed by a binarization (threshold 127), was applied three times to smoothen the image. At this point, the binarized bottom layer contained all large defects that could be identified automatically. As a final step, the top layer, with cracks marked by a stylus, was projected onto the bottom layer.

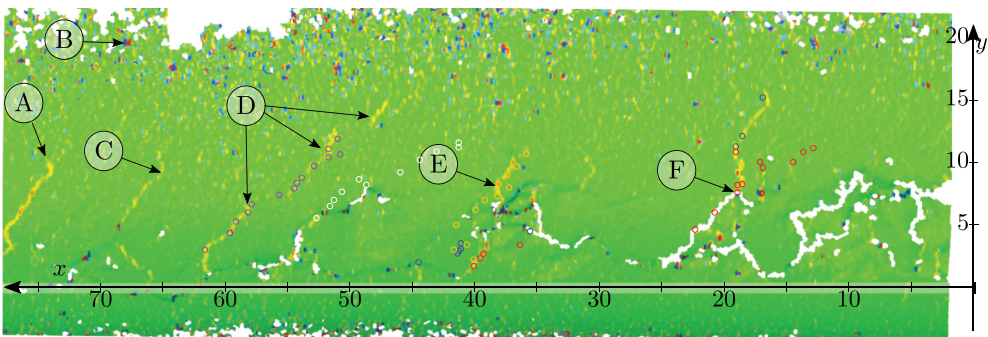
Figure 7. DIC results, viewed from above the microscopy sections. The black rectangle at $x = y = 0$ shows the location of the reference mark, and axes correspond to the axes in [Figure 9](#) with dimensions in mm. The same strain scale as in [Figure 4\(b\)](#) is used. The coloured circles show the end-points of the cracks marked with the corresponding translucent colour in [Figure 9](#)

Two types of artefacts are observed in [Figure 7](#). First, the white areas are places where the DIC algorithm was unable to identify the surface. Typically, these artefacts are caused by severe surface irregularities, for example at crack mouths. At reference mark F in [Figure 7](#), the artefact is located in the lower part of the crack mouth, where the geometry is too irregular to be accurately captured by the DIC system. In the upper part, the strain concentration is visible.

The second artefact is the occurrence of red and blue dots. They typically occur in pairs (see e.g. reference mark B). This result implies that high strains of opposite signs are detected close to each other, and the effect cancels out. When these appear just at points and do not coalesce into

Figure 7 shows the heterogeneous surface strain caused by cracks. Figure 9 reveals an intricate crack network with a maximum depth of about 3 mm . To better understand the correlation between surface strains and crack morphologies (Figure 12), we use a linear elastic finite element study of a cracked rail subjected to a 15 kNm bending moment (Figure 13). Specifically, we investigate how different crack inclinations, α_{crack} (Figure 12b), affect the surface strains. Note that the xyz -coordinate system here is only approximately equal to the coordinate system used on the field sample. The crack is further parameterized by the crack depth, r_{crack} . This depth is also the radius of the crack projection onto the yz -plane. As shown in Figure 12a, the crack is located in the middle of the gauge corner on the nominal rail profile. Symmetry boundary conditions are applied on the right side sufficiently far from the crack to ensure homogeneous strains at the boundary.

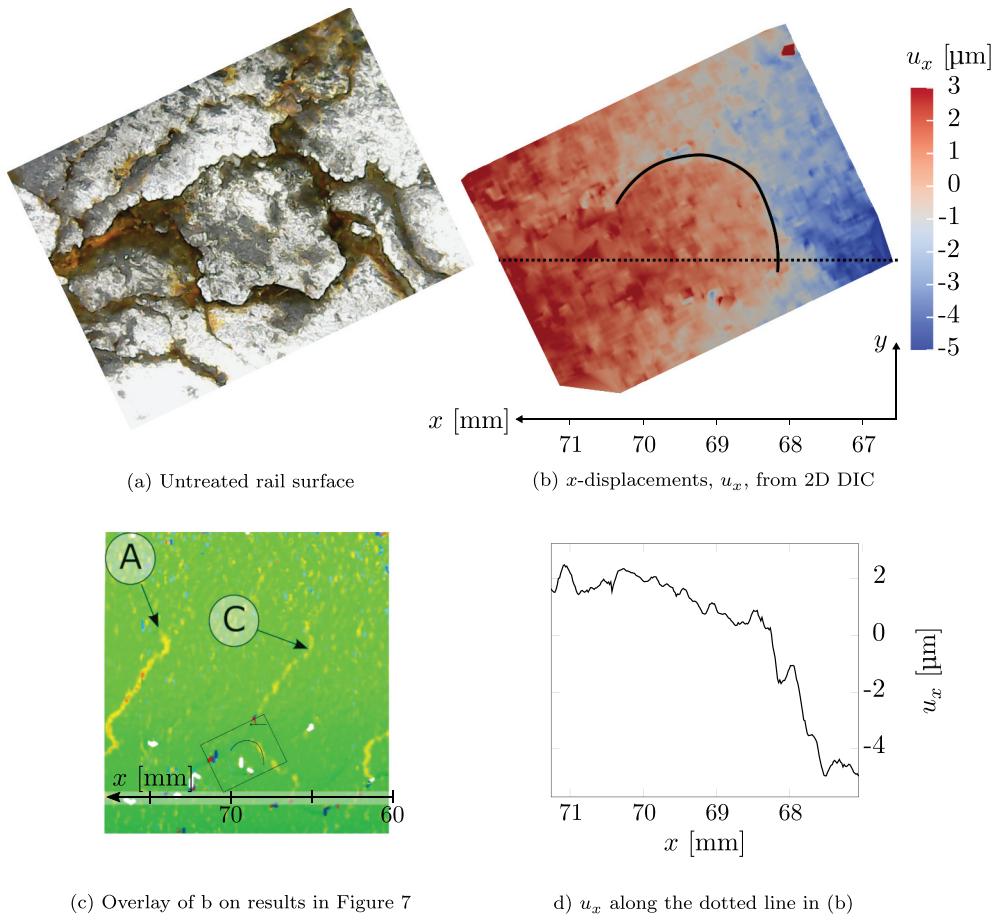
Figure 8. 2D DIC displacement identification based on the natural speckle pattern.

A major drawback with the methodology described so far, is its reliance on a painted speckle pattern. Taken by a simple, low-resolution, USB-microscope, the image in Figure 8(a) shows the rail surface's natural texture. While the GOM DIC system with the lens used herein gives a 78 pixels/mm resolution, the 640×480 USB-microscope's resolution is 123 pixels/mm. Using this 1.6 times higher resolution enabled subset matching. The open-source software DICe [22] was used to simplify the data processing. While the measured strain field is rather noisy, the displacement field in Figure 8(b) shows a distinct crack (highlighted by the black solid line).

Figure 8(c) shows the location of the 2D-DIC analysis in the 3D-stereo results from Figure 7. The crack indicated in Figure 7 is clear but less severe than some other cracks. To further visualize the displacement jump, Figure 8(d) shows the x -displacements jump over the crack mouth. The analysis in Appendix A shows that this 2D-DIC processing also works when considering motion blurring effects. For currently available cameras an analysis speed of 100 km/h is possible considering the motion blurring effect.

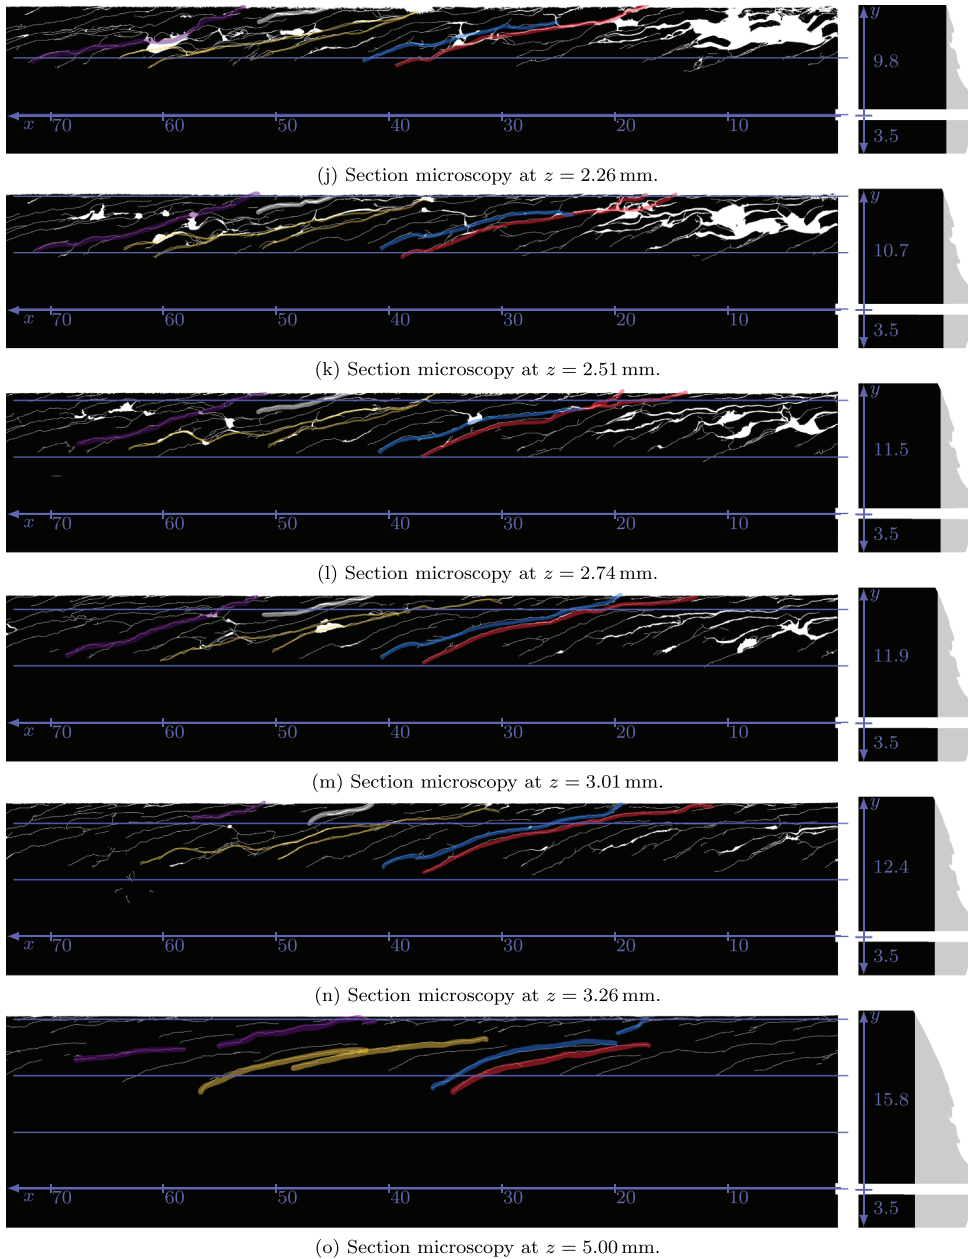
Figure 9. Sections showing the crack patterns with inverted colours compared to Figure 6. All coordinates are in mm. The horizontal lines have 5 mm spacing, the numbers next to the positive and negative y -axes denote the respective axis' length, and the z -coordinate is defined in Figure 5(b). The translucent colours show how different cracks evolve between the sections and their top endpoints are marked by circles of the corresponding colour in Figure 7

Figure 9. Continued.

Figure 9 shows microscopy sections with approximately 0.25 mm spacing down to $z = 3.26\text{mm}$, as well as the section at $z = 5.00\text{mm}$. On the right side, the side view of the sectioned part's profile is shown for clarity. Ground off material is marked with a grey colour. The upwards arrow indicates the approximate distance from the reference line ($y = 0$) to the end of the ground surface. The sections in Figure 9 were processed further to improve crack visibility and reduce the manuscript's file size.¹ The full-sized images are available as a dataset [23]. These binary images also contain sections at 3.75, 4.5, 7.0 and 9.0 mm, which are not included in Figure 9 due to space constraints. Only cracks close to the surface appear in the sections at $z = 7.0\text{mm}$ and $z = 9.0\text{mm}$.

The first section, Figure 9(a), was made after a skim pass in the surface grinder and defines $z = 0.00\text{mm}$. Distinct cracks appear as thin white lines against the ground surface appearing black. Depressions due to plastic deformation and material fall-out (spalling) result in larger white areas. Throughout the sections, we will follow five cracks, indicated by purple, yellow, blue, red and white colours. In the supplementary material 'CracksToDIC_Correlation.pdf', the sections are put on top of the results in Figure 7 to facilitate interpretation. As an example, the results for $z = -1.51\text{mm}$ are shown in Figure 10.

The purple crack breaks the surface at $z = 0.00\text{mm}$ around $x = 62\text{mm}$. Moving down 0.28mm, it extends quite far along the rail (x -direction), just under the surface. The crack keeps appearing in roughly the same location, slightly shifting in the positive y -direction as the depth increases. Its surface-breaking point also shifts in the positive y -direction which is also observed in the DIC results in Figure 7, indicated by the purple circles. The crack appears to be shallow in Figure 9(n). It is marked further into the material as it likely remains connected in the z -direction, based on observations in the next section at $z = 3.75\text{mm}$ (only included in supplementary materials). Parts of the crack is also visible in Figure 9(o) ($z = 5.00\text{mm}$), and an approximate crack depth of 1.5 mm can be inferred. Note that the z -coordinate does not indicate the crack depth: it is measured perpendicular to the surface (see the profile views on the right in Figure 9.)

We will now consider the near-surface geometry of the blue crack that also break the surface around $x \approx 40$ mm in [Figure 9a](#). From the first 3 sections, the blue crack seems to extend normal to the surface. At its initial surface-breaking point at $x = 44.5$ mm, $y = 2.0$ mm, a slight strain concentration can be observed in [Figure 7](#). Within the first 0.28 mm the crack mouth moves quite a lot to the right, indicating an almost horizontal crack plane, even if the part of the crack around $y = 0$ mm extends downwards. No clear strain concentration occurs in [Figure 7](#) at the first 5 blue dots. This observation indicates that the DIC results are less sensitive in areas with almost horizontal cracks.

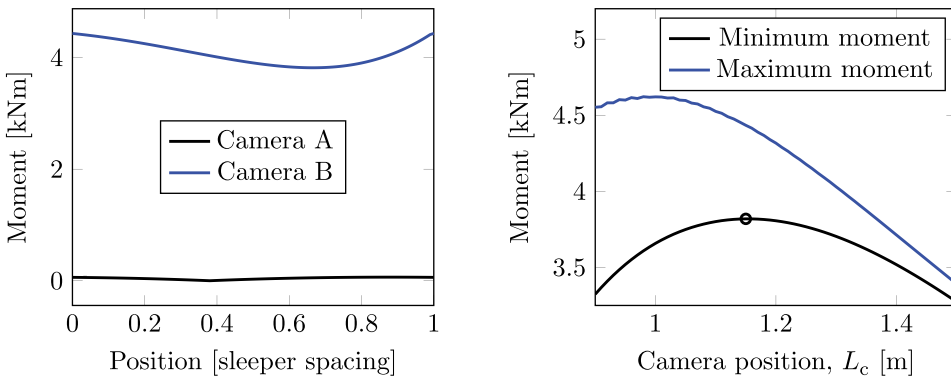
(a) Moment variation over one sleeper spacing for Camera B at position $L_c = 1.15\text{ m}$.

(b) The maximum and minimum moment in rail beneath Camera B depending on its distance, L_c , from the wheel.

Figure 11. Moment variation beneath cameras during rolling. (a) shows the moment variation for the position of Camera B indicated by the black circle in (b).

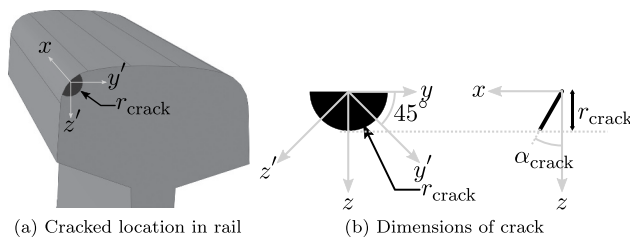
Figure 12. Dimensions of the crack in the finite element model.

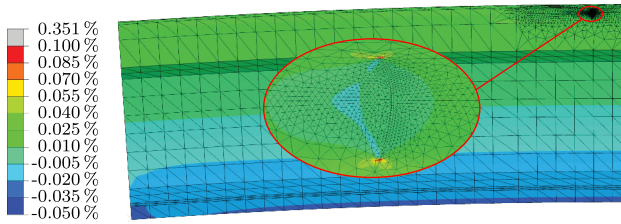
Figure 13. Longitudinal strain for a 5 mm deep crack with $\alpha_{\text{crack}} = 45^\circ$. Displacements are amplified 50 times.

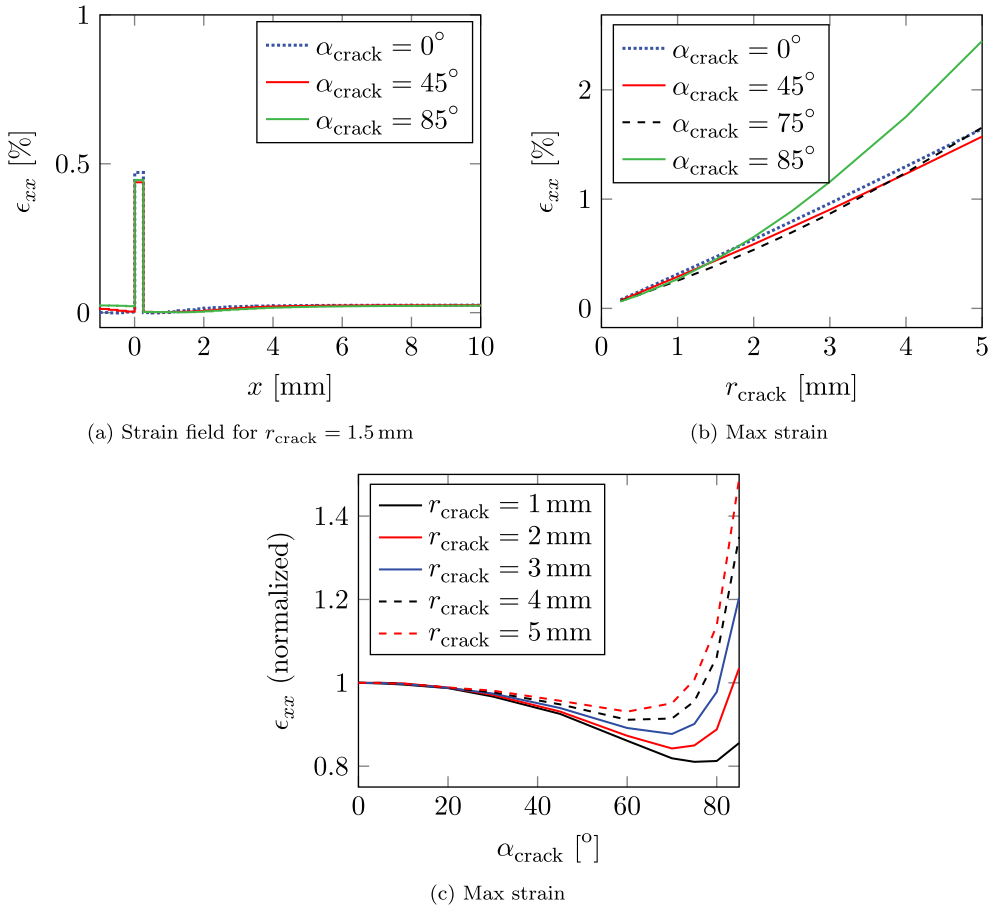
Figure 14. FE-modelling results.

As discussed in conjunction with Figure 2, the DIC method uses the displacement in a discrete set of points to calculate the strain. A facet size of 19 pixels , corresponding to 0.25 mm , was used in the present study. The strains in Figure 14 were calculated from displacements projected onto a grid with 0.25 mm spacing. Hence, these strains can be compared with the strains in Figure 7.

The surface strains at the cracks in Figure 7 are about 0.5% , corresponding to the maximum depth of about 3 mm (Figure 9). The finite element simulation predicts a crack depth of 1.5 mm for 0.5% strain (Figure 14b). Hence, if processing the finite element results as

Figure 14a shows the strain along the x -axis for three crack angles, α_{crack} , with a crack depth $r_{\text{crack}} = 1.5 \text{ mm}$. Due to the numerical approximation of the strain described above, the width of the strain concentration band is 0.25 mm. While the vertical crack has the highest strain concentration

at $r_{\text{crack}} = 1.5\text{mm}$, Figure 14b shows that this trend reverses for deeper cracks with high α_{crack} . The strain concentration increases approximately linear with crack depth, up to a depth of 5 mm and for $\alpha_{\text{crack}} < 75^\circ$. Furthermore, the strain concentration is not strongly dependent on the crack angle. Figure 14c shows this independence: The strain concentration changes less than 20 for $\alpha_{\text{crack}} < 80^\circ$. The strain concentrations for cracks almost parallel to the surface (high angle) are strongly affected by their angle. However, friction, roughness, and non-planar crack surfaces are not considered in the finite element simulations. These features influence such high-angle cracks more than the low-angle cracks. Therefore, a less excessive strain concentration will occur in the field for high-angle cracks.

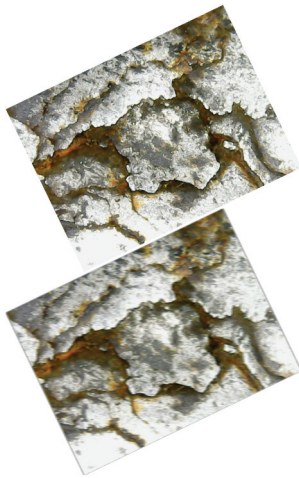
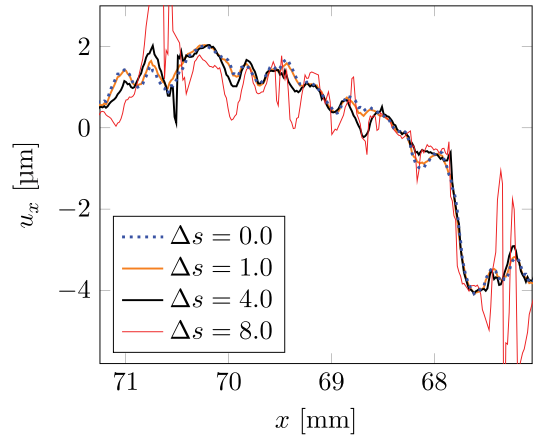
(a) $\Delta s = 0.0$ (upper) and $\Delta s = 8.0$ (lower)

(b) Identified displacements along line in Figure 8b

Figure 16. The motion blur effect.

By applying these filter kernels to raw reference and deformed images like the one in Figure 8a, we simulate a motion blur effect, see Figure 16a. When too much blurring occurs, fewer subsets can be identified in the DIC analysis. Errors are thus introduced in the displacements. Figure 16b shows this effect. In contrast to Figure 8, the image was rotated before the DIC analysis, causing a slightly different result for $\Delta s = 0.0$. Travelling 1 pixel during the exposure time, $\Delta s = 1.0$, has minimal impact on the results. At $\Delta s = 4.0$, the noise increases, but the displacement step around $x = 64.7\text{mm}$ is still distinct. However, for a longer exposure time, $\Delta s = 8.0$, the data noise are at a similar level to the displacement step. In conclusion, an exposure time resulting in 4 pixels traversed provides sufficient measurement accuracy.
