## **High-Temperature corrosion of P91/T91, 304L, Sanicro 28 and Inconel 625 exposed at 600 °C under continuous KCl deposition**

Phother Simon, J., Hanif, I., Jonsson, T. et al (2024). High-Temperature corrosion of P91/T91, 304L, Sanicro 28 and Inconel 625 exposed at 600 °C under continuous KCl deposition. *Fuel*, 357. <http://dx.doi.org/10.1016/j.fuel.2023.130012>

# High-Temperature corrosion of P91/T91, 304L, Sanicro 28 and Inconel 625 exposed at 600 °C under continuous KCl deposition

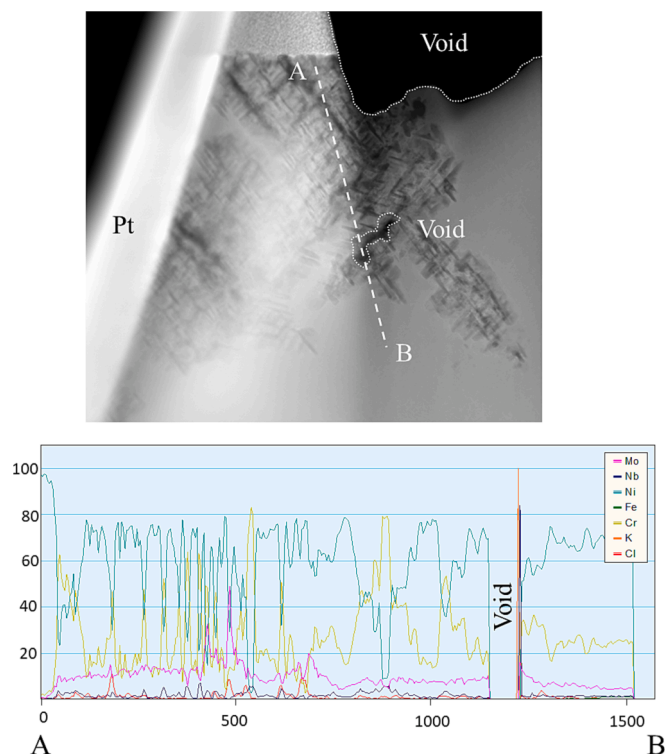
Fig. 9. TEM Line scan analysis of the BIB cross section of Inconel 625 through the internal oxidation zone.

zone was performed, see Fig. 9. The analysis revealed a Ni-rich area, about 75 at. % Ni, interrupted by Cr-rich bands. In these bands, the Ni content dropped to about 20–30 at. % whereas the Cr content increased from about 15 at. % to about 45–80 at. %. Throughout the internal oxidation zone, Mo was around 10–15 at. %, except for two bands where the Mo content increased to about 30–50 at. %. According to the line scan, Cl was unevenly distributed and in the range 0–15 at. %.
