# Environmental Risks Posed by Sunken Wrecks

Research methods and environmental aspects

*Case No.: 1399-14-01942-6*

Swedish Maritime Administration, 2014

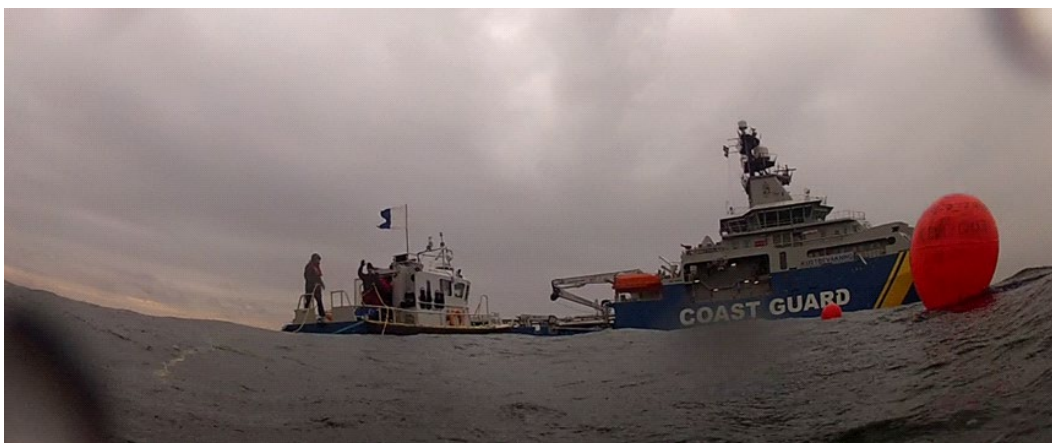
Certain diving operations require additional arrangements to ensure safety (Figure 3). A safe and effective diving operation requires planning and preparations, which, among other things, means taking weather conditions into account—such as waves, wind, and currents—and also the light and visibility conditions in the water. The type of work, methods, tools, and other aids must be carefully planned and prepared. A safe and stable platform with proper equipment and detailed information for preparations are required to be able to perform the work safely and effectively, which will also minimize the time the vessel spends in the area. A diving operation for documentation of a large wreck in water that is shallower than 40 meters normally takes one day. Investigations involving measurement of hull thickness and sampling normally take an additional day.

Figure 3. Diving inspection of KBV 003 Amfitrite. Photography: The Coast Guard

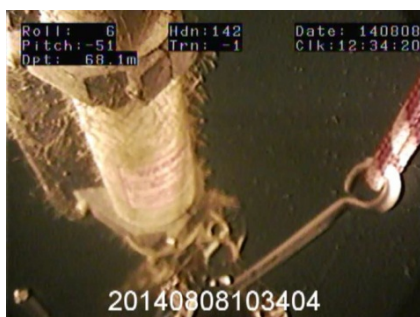
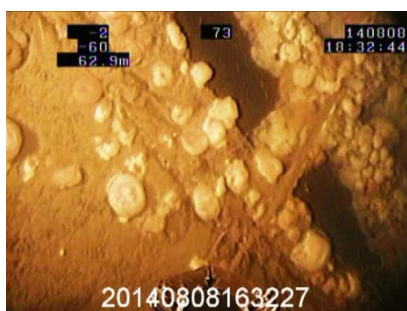
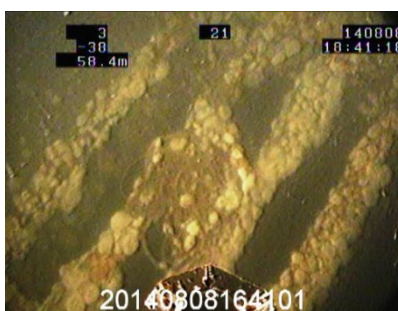
The remains of the fishing gear are located next to the bow on the port side.
