INTERNAL REPORT FOR LICENTIATE LEVEL SEMINAR

Carbon Fiber Mesh as Anode for Corrosion Free Reinforced Concrete

Emma Qingnan Zhang

Department of Civil and Environmental Engineering
CHALMERS UNIVERSITY OF TECHNOLOGY
Göteborg, Sweden 2015

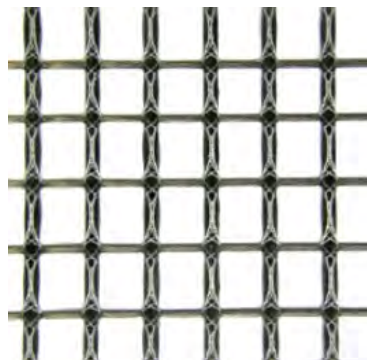
Figure 3.1: Carbon fiber mesh (SIGRATEX Grid 300) as anode material

- Swedish structural cement (Slite Anläggningcement) with a w/c ratio of 0.6;
- Steel reinforcement (plain bars) with a diameter of 10 mm;
- Titanium oxides anode mesh (ELGARDTM 210 CORRPRO®) used in one specimen as comparison;
- Carbon fiber reinforced polymer (CFRP) mesh as anode as shown in Figure 3.1 (SIGRATEX Grid 300 supplied by SGL Group) with inner spacing of 25 mm \times 25 mm, containing two fiber threads in both vertical and horizontal directions. Each fiber thread was about 2-3 mm in width.

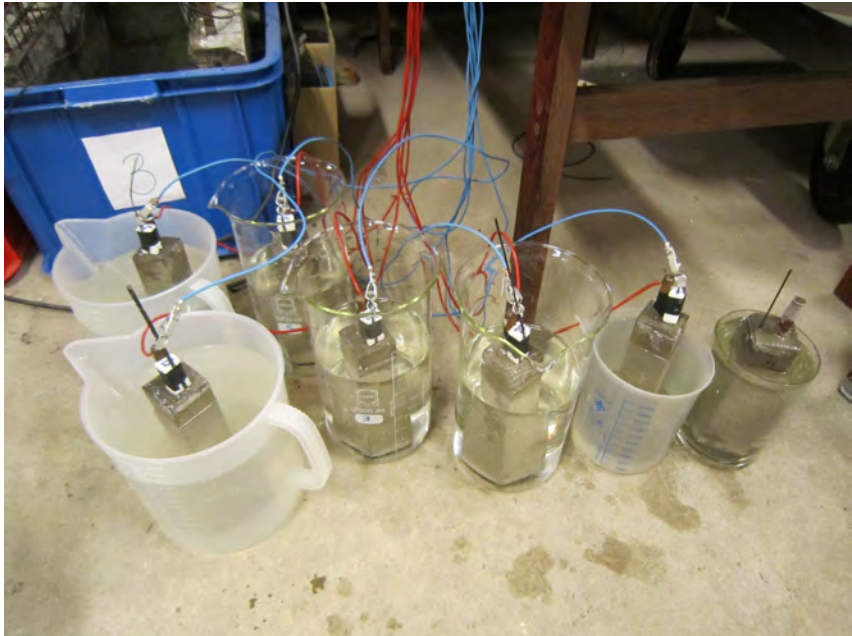
Figure 3.5: Group ACC-P2 specimens before the accelerated test

Figure 3.5 shows the experiment set-up of paste group ACC-P2. Specimen group ACC-P2

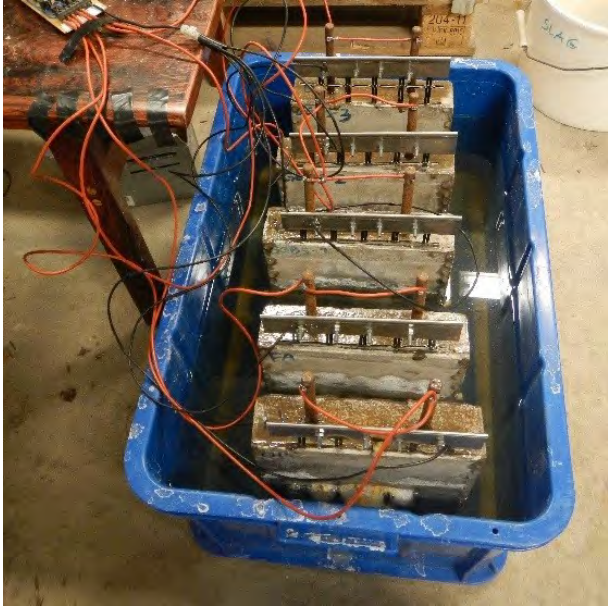
Figure 4.2: Experiment set-up for group ACC-M2

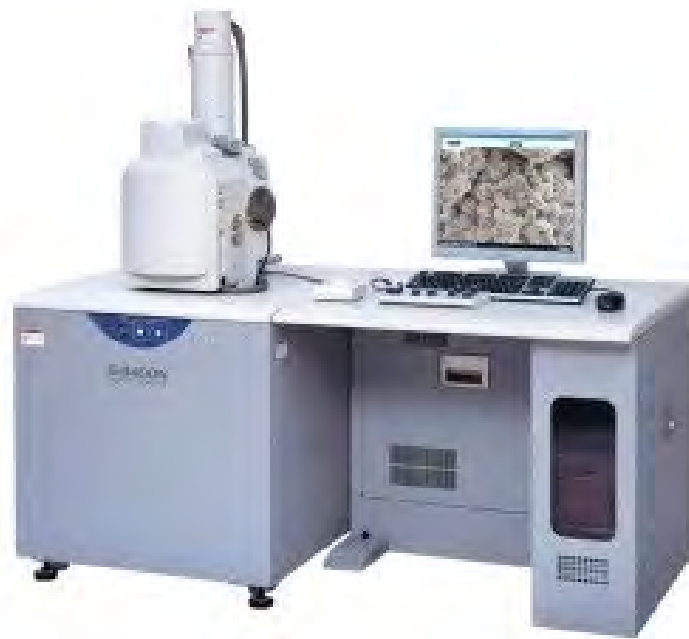
Figure 5.2: Hitachi S-3400N Variable Pressure SEM with EDS spectrometer

spectrometer (EDS). Accelerating voltage was 20kV. Detection limits were about 0.1% with EDS (1000 ppm). Backscattered electron (BSE) mode was used to examine cement paste samples. A picture of Hitachi SEM instrument is shown in Figure 5.2.

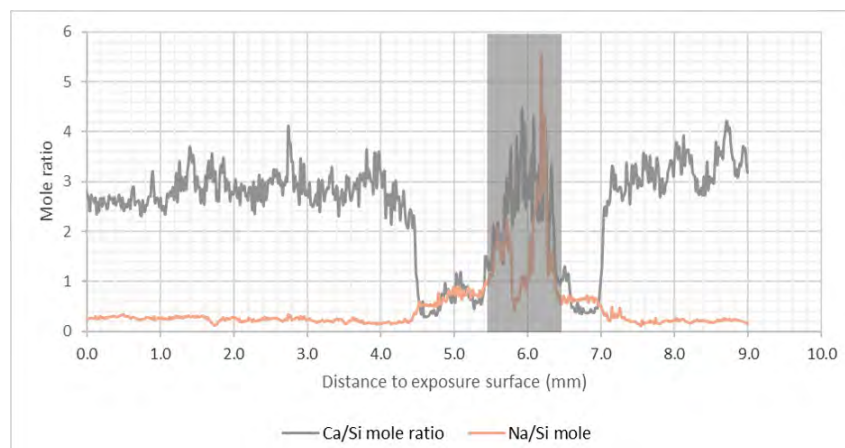
Figure 6.6: [ACC-P2-3, 360 years of equivalent service life] Line scanning by LA-ICP-MS across the cross-section of accelerated specimen. The shadowed area indicates the position of carbon fiber

On the other hand, positive ions sodium (Na^+) did not show the same movement as calcium. In Figure 6.6, the molar concentration of sodium reached a peak and then gradually decreased to a base level. The possible explanation might be as follows. Under the electrochemical treatment the hydrogen ions were formed around the anode from the electrolysis of water. These hydrogen ions (H^+) produced locally acidic condition which dissolved Portlandite. The dissolved calcium ions moved away from the zone around the anode, forming rings with lower ratios of Ca/Si, as discussed above. After termination of the electrochemical treatment, sodium ions, which have significantly higher diffusivity than that of calcium ions, diffused from the surrounding cement paste matrix back to the zones around the anode to substitute the negatively charged sites of C-S-H gel previously occupied by the calcium ions to keep the electroneutrality, resulting in peaks of Na/Si around the anode.

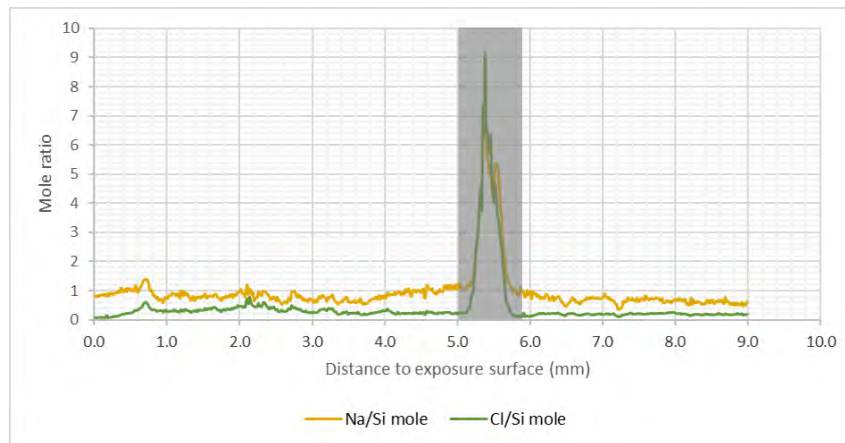
Figure 6.8: [ACC-P2-3, 360 years of equivalent service life] High concentration of Na and Cl at anode area. The shadowed area indicates the position of CFRP anode

LA-ICP-MS analysis has detected high concentration of NaCl in the anode area but not in the ring-pattern affected area, as shown in Figure 6.8, compared with the baselines of Na/Si and Cl/Si in Figure 6.9). This is probably due to sample preparation of SEM analysis. After careful surface polishing, substances in the ring-pattern affected zone and the anode area could move around because they are relatively loose; while sample polishing for LA-ICP-MS was very brief and fast.

Precipitation of NaCl at the anode can be considered as a preventative effect of hindering chloride further migrating towards steel reinforcement. However higher concentration of chloride might promote the production of chlorine gas which has potential risk of inducing internal cracks and hazard issue.

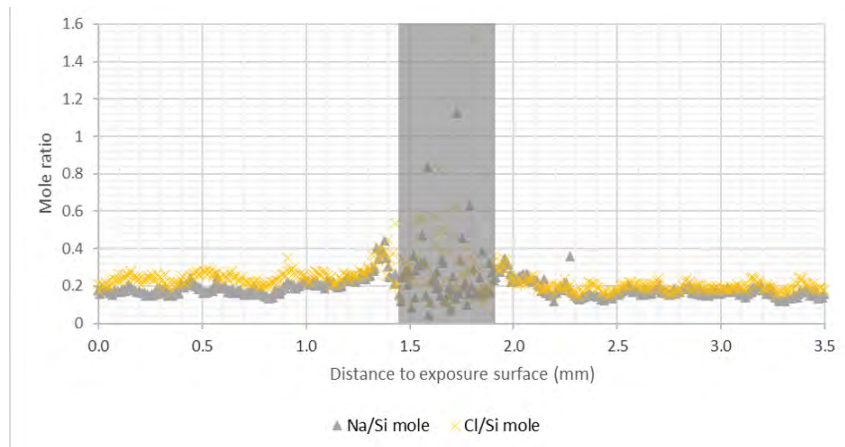
Figure 6.9: Concentration of Na and Cl of the control sample. The shadowed area indicates the position of carbon fiber

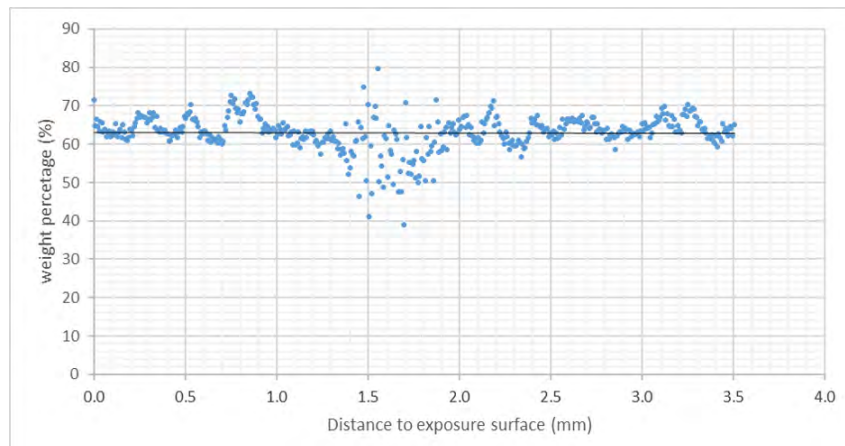
Figure 8.1: CaO baseline at approximately 64% of mass cement

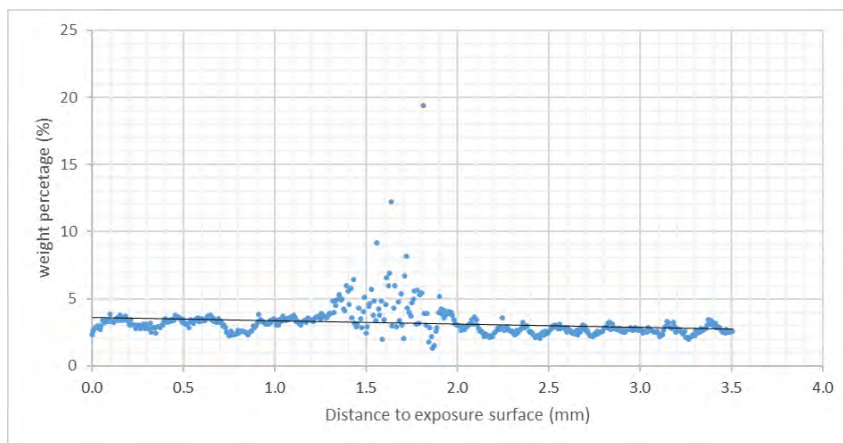
Figure 8.7: Cl baseline at approximately 3.4% of mass cement
