## **Experimental and Numerical Investigation of the Cavitating Flows over a Modified NACA0009 Foil**

Arabnejad Khanouki, M., Amini, A., Bensow, R. et al (2018). Experimental and Numerical Investigation of the Cavitating Flows over a Modified NACA0009 Foil. Proceedings of the 10th International Symposium on Cavitation (CAV2018). [http://dx.doi.org/10.1115/1.861851\\_ch71](http://dx.doi.org/10.1115/1.861851_ch71)

<sup>1</sup>Mohammad Hossein Arabnejad\*,<sup>2</sup> Ali Amini; <sup>1</sup>Rickard Bensow; <sup>2</sup>Mohamed Farhat;

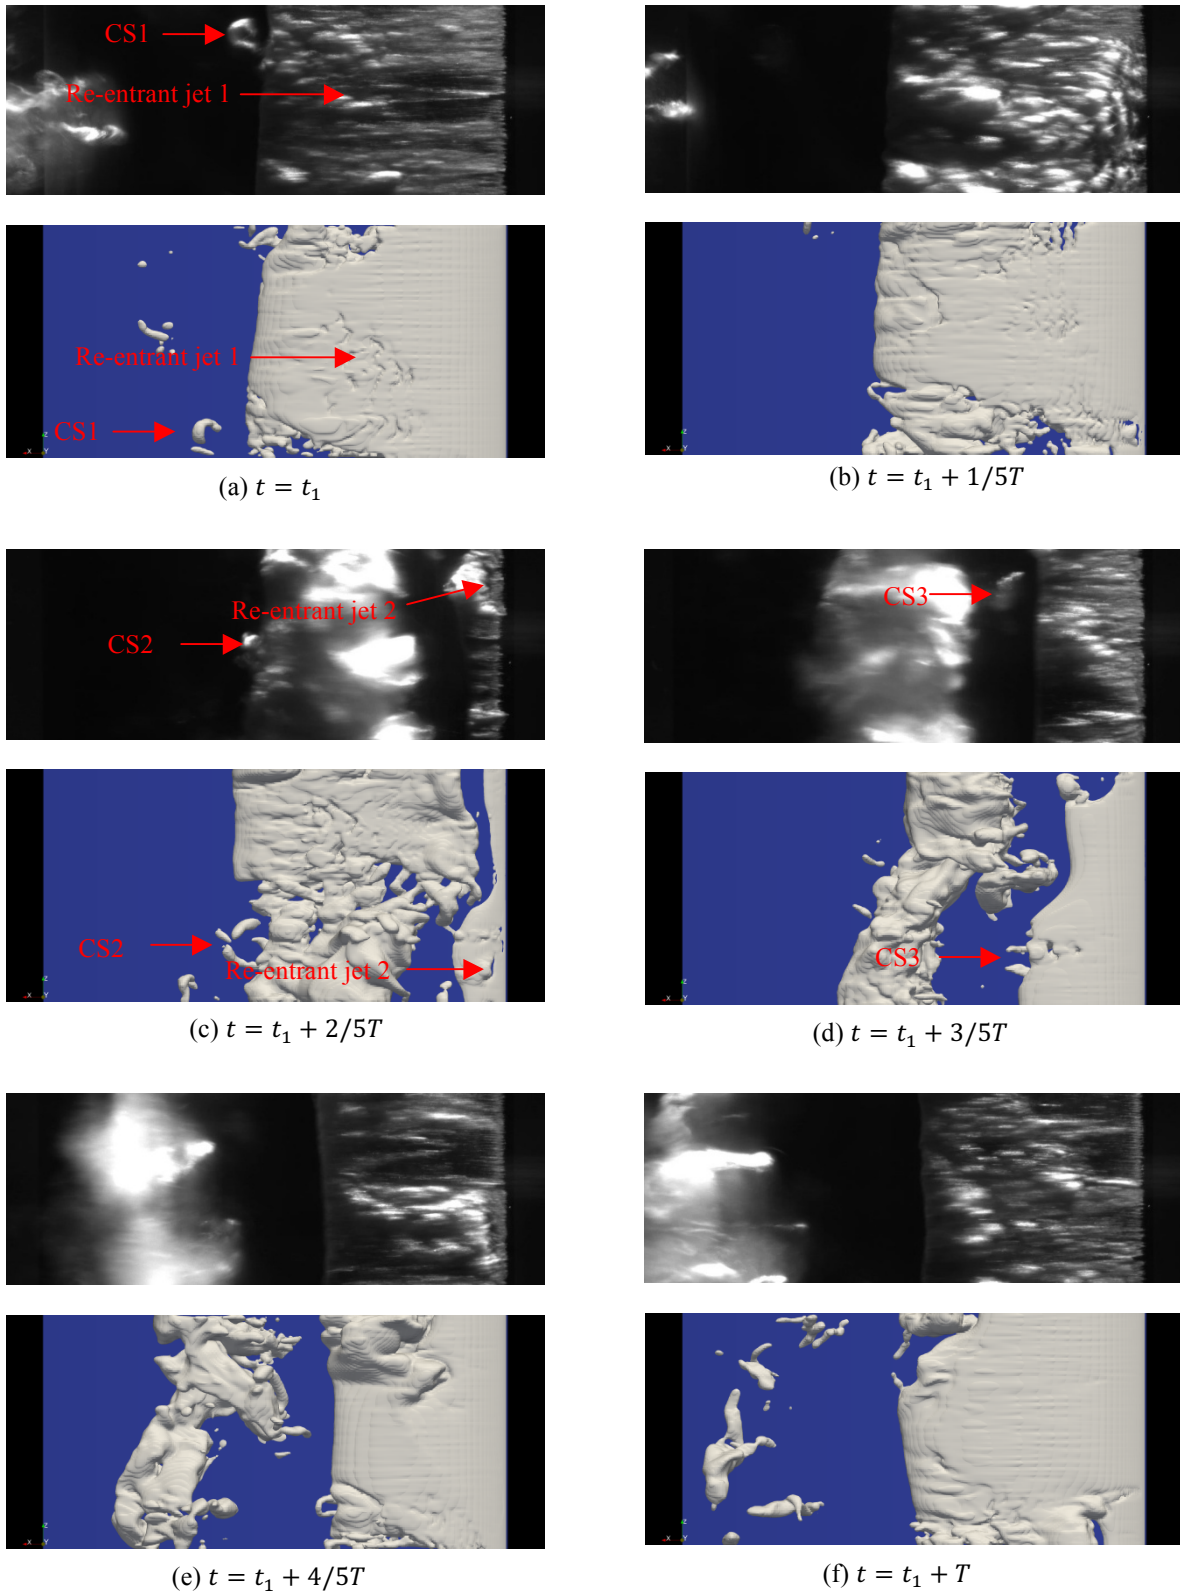
Figure 1: Shedding of the cloud cavitation in one cycle, top) experimental high-speed visualization, bottom) numerical results

Figure 1 shows the shedding of the cloud cavitation during one cycle in both experimental and numerical investigations. In figure 1a, the sheet cavity has reached its maximum length, which is 55% of the chord length. At this stage, a re-entrant jet has been developed from the closure line of the sheet cavity. The front line of this re-entrant jet is marked by red arrows in figure 1a. As the re-entrant jet moves towards the leading edge, it creates disturbances on the interface of the sheet cavity. The disturbances on the surface of the sheet cavity can become larger and lead to the detachment of cavity structures. These structures are marked as CS1 in figure 1a. In figure 1b, the re-entrant jet has reached the leading edge and caused the pinch-off of the cloud cavity. The cloud cavity has a rolling motion due to the interaction between the re-entrant jet and the bulk flow. As the cloud cavity rolls up, some vapor structures of horse-shoe shape are detached from the trailing part of the cloud cavity. In figure 1b and 1c, these structures, marked as CS2, collapse as they travel downstream. In figure 1c, the new sheet cavity has appeared at the leading edge. While the sheet cavity is growing, another re-entrant jet moves upstream and reaches the leading edge. The front line of this re-entrant jet is marked by red arrows in figure 1c. This re-entrant jet does not lead to the pinch-off of the cavity, but it only creates a disturbance on the interface of the sheet cavity. This disturbance leads to the detachment and collapse of vapor structures (marked by CS3 in figure 1d) close to the closure line of the sheet cavity. In figures 1f and 1e, the sheet cavity grows to its maximum length and the cycle repeats. The comparison between the numerical simulation results and the experimental high-speed visualization shows that the numerical simulation with the current set-up and grid resolution is able to capture the main features of

the cavitating flow. In the experiment results, the shed cloud turns into a U shape as it moves downstream while in the numerical results the cloud does not have any particular shape. The reason for this difference might be that the side walls in the simulation are defined as slip boundary condition, therefore the effect of the side walls are not present.

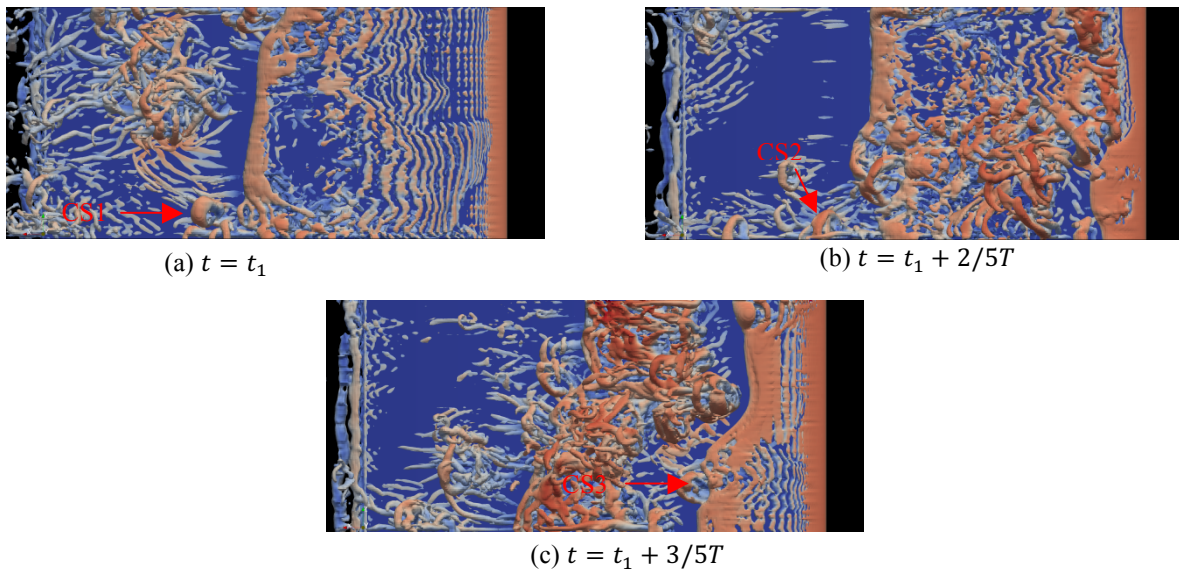
Figure 2: Q criteria in one shedding cycle

In figure 2, the vortical structures for three time instances are shown by the iso-surface of the Q criterion. These time instances corresponds to figure 1a, figure 1c, and figure 1d. As it can be seen from this figure, the structure CS1, CS2, and CS3 are horse-shoe vortical structures detached from the closure line of the sheet cavity or the downstream end of the cloud cavity.

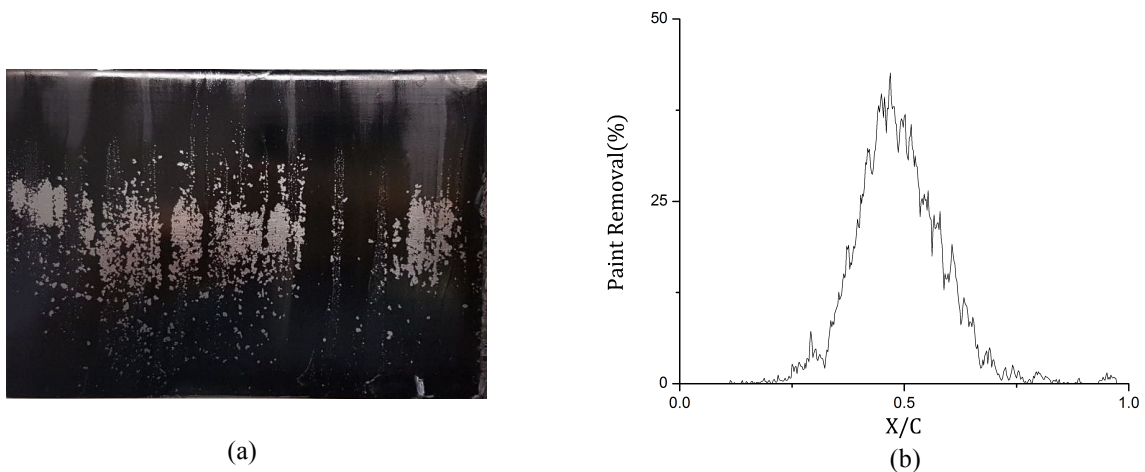
Figure 2: a) Paint removal after 10 minutes. b) Span-wise average of paint removal as a function of streamwise location

In order to locate the areas with high risk of cavitation erosion, a stencil ink is applied to the surface of the foil. Figure 3a shows the status of the stencil ink after 10 minutes and figure 3b shows the span-wise average of the paint removal. A region with severe paint removal is observed in the stream-wise location of  $0.3 < X/C < 0.7$ . This region coincides with the collapse location of cavity structures CS1, CS2, and CS3, identified in figure 1. This suggests that the cavity structures detached from the closure line of the sheet cavity and the downstream end of the cloud cavity can be responsible for paint removal seen in figure 3.
