THESIS FOR THE DEGREE OF DOCTOR OF PHILOSOPHY

Surface Integrity of Case-hardened Gears –
with Particular Reference to Running-in and Micropitting

Department of Industrial and Materials Science
CHALMERS UNIVERSITY OF TECHNOLOGY
Gothenburg, Sweden 2018

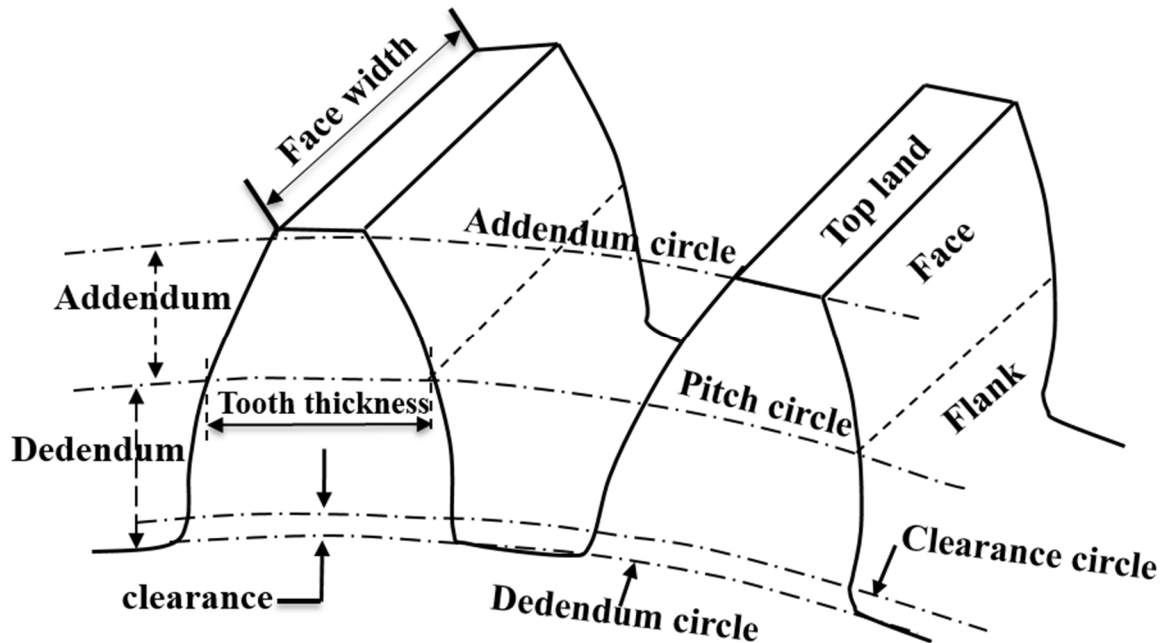
Nomenclature of spur gears

Pitch circle: A normal section of the pitch surface

Addendum circle: A circle bounding the ends of the teeth, in a normal section of the gear.

Pitch surface: The surface of the imaginary rolling cylinder that replaces the toothed gear.

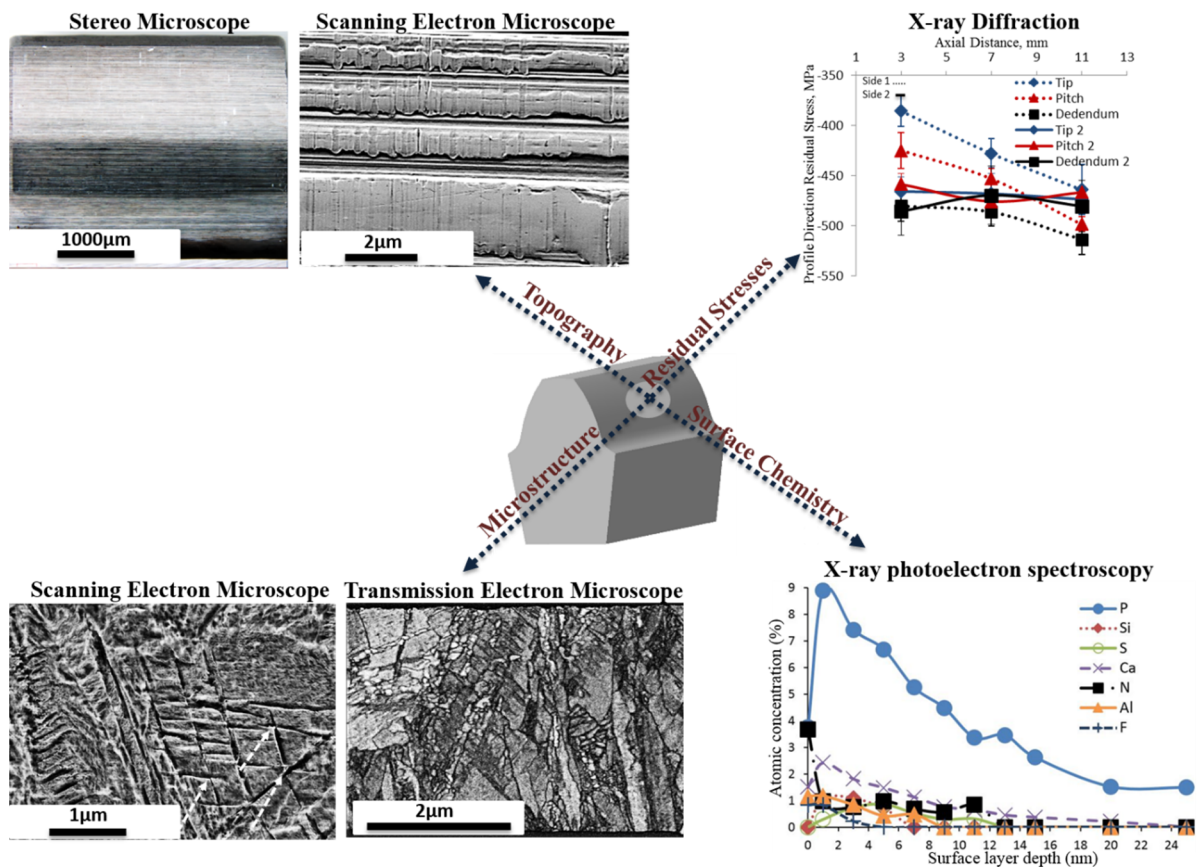
Figure 1. Overview of the analysing techniques used to characterize gear surface characteristics.

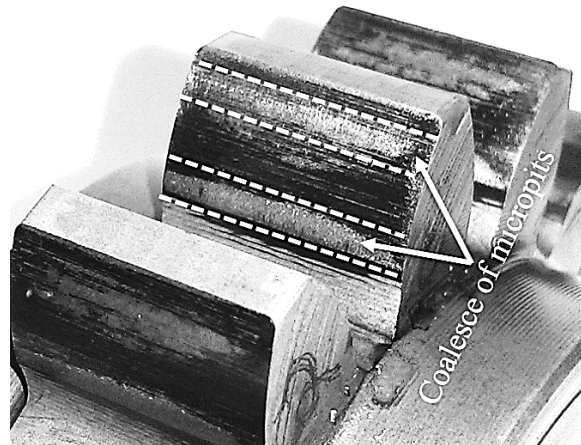
Figure 3. Micropitting on a gear tooth.

Micropitting appears like dull matte or grey stained to the naked eye. The major difference of this damage mechanism in comparison to macro-pitting is that it initiates on the surface asperity level. Interaction of asperities under high tractional forces generate a multitude of surface cracks. Thus generated cracks, then grow into the surface at a shallow angle [5] and break off

material forming a pit in the microns range i.e. around 5-10 μm in depth. The detailed mechanism of micropitting will be discussed in a later section of the thesis.

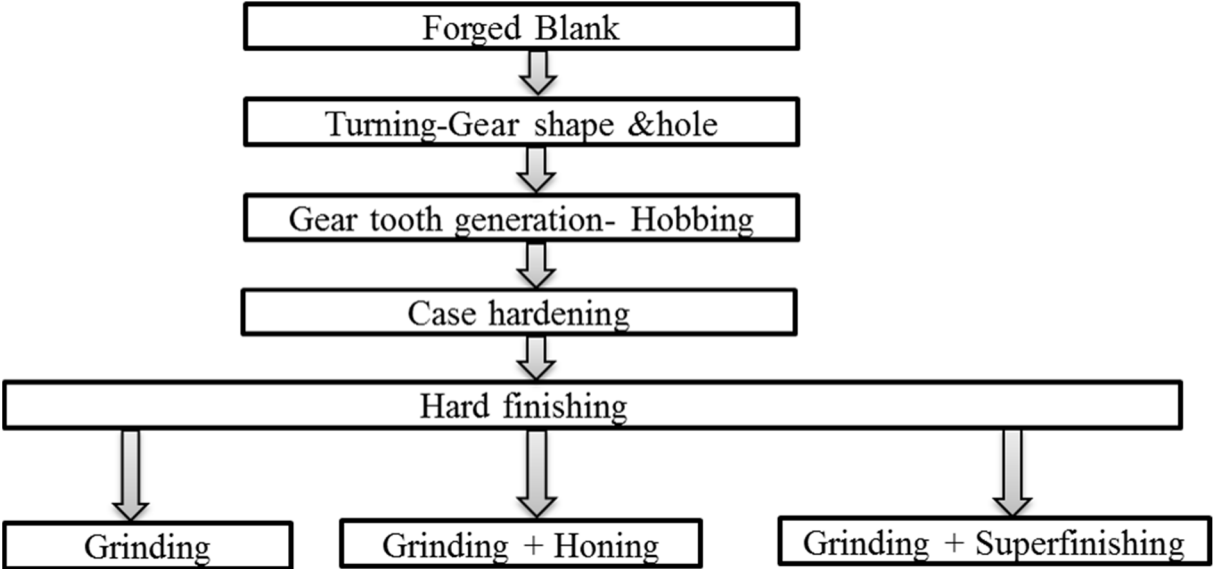
Figure 18. Flow chart representing manufacturing steps in gear manufacturing.

The generation of gear teeth demands consistency and accuracy with respect to geometrical aspects like tooth size, shape and runout etc. [78]. The technology has advanced in recent times to produce gears with specified tight geometrical tolerances in less production time. For example, this includes generating gear teeth by using hob tool instead of form milling-cutters on milling machines. The flow chart representing the sequence of steps involved in manufacturing spur gears used in this study is shown in Fig. 18.

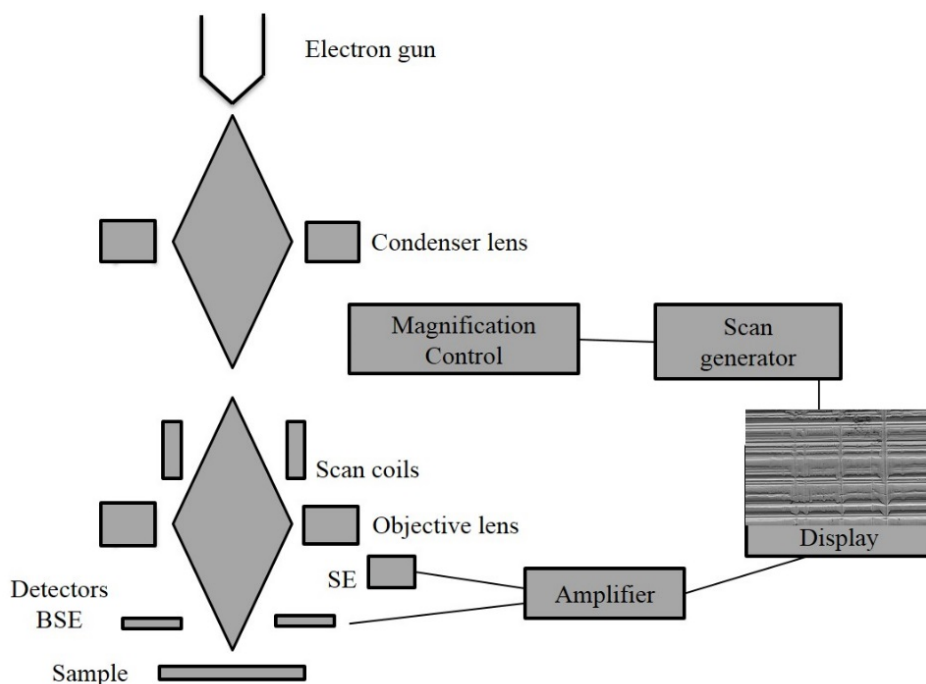
Figure 21. Working principle of a scanning electron microscope.

The scanning electron microscopy (SEM) is a resourceful technique for characterizing materials in different aspects. Its high spatial resolving capabilities (1-5 nm) and depth of field helps to explore finer details present in bulk object. The schematic, illustrating the working principle of SEM instrument is shown in Fig. 21. The beam of electrons emitted from the electron gun is focused down to nanometer width on to a sample surface by using condenser and objective lenses. The interaction of electrons with surface results in a “pear” shaped interaction volume [84], from which back scattered electrons, characteristic X-rays and secondary electrons are emitted. Thus emitted electrons and X-rays are then detected by using different detectors. The size of interaction volume is dependent on the accelerating voltage and sample density, but typically of the size of up to 1 μm for the X-ray emission.

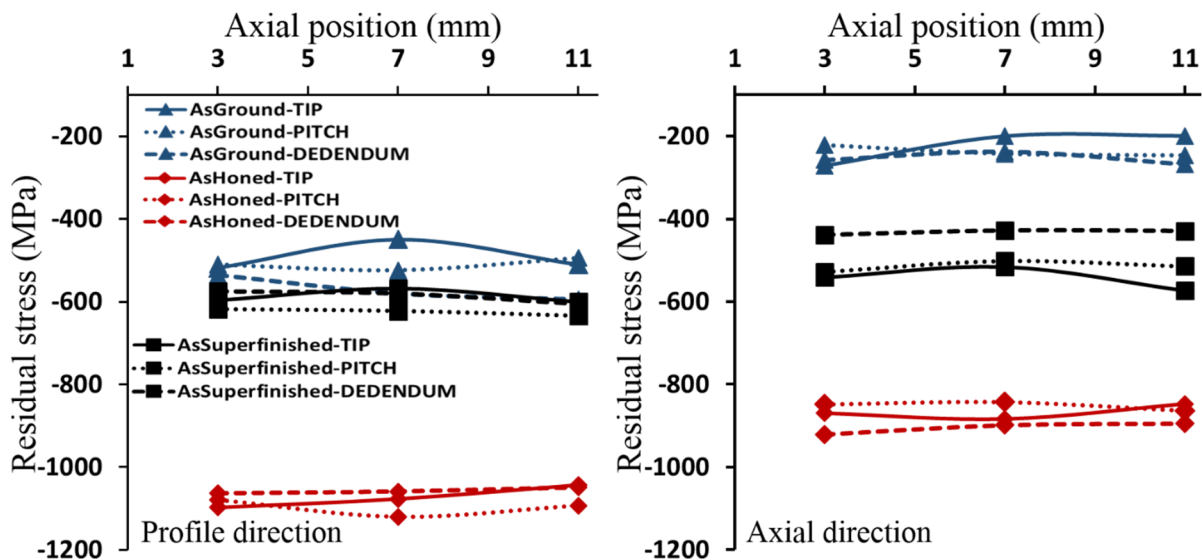
Figure 33. Surface residual stresses of as ground, honed and superfinished (paper IV).

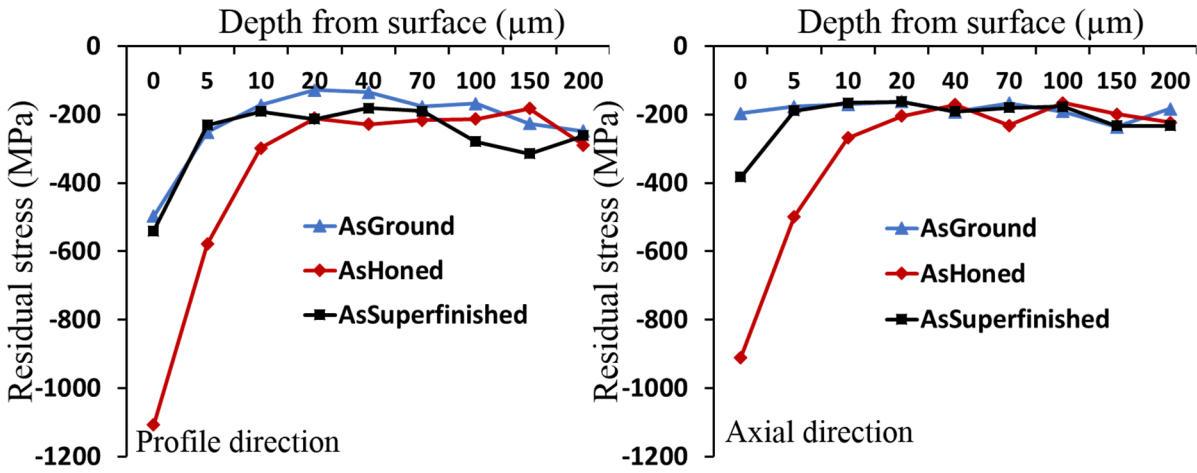
Figure 34. Depth profiles of residual stress measured at center of the dedendum.

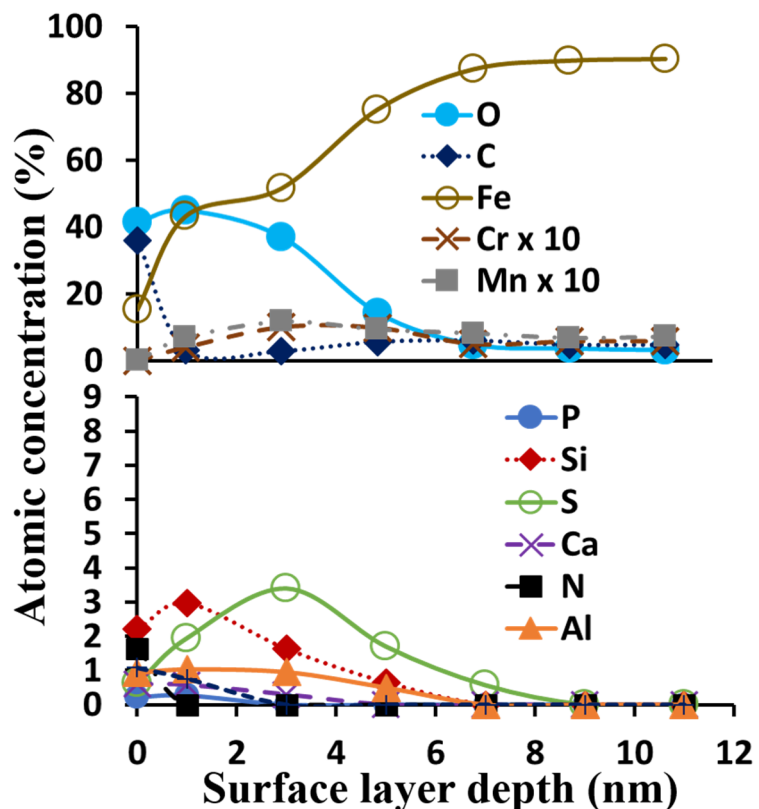
Figure 36. XPS depth profile analysed at dedendum surface of an as-ground gear tooth (paper II).

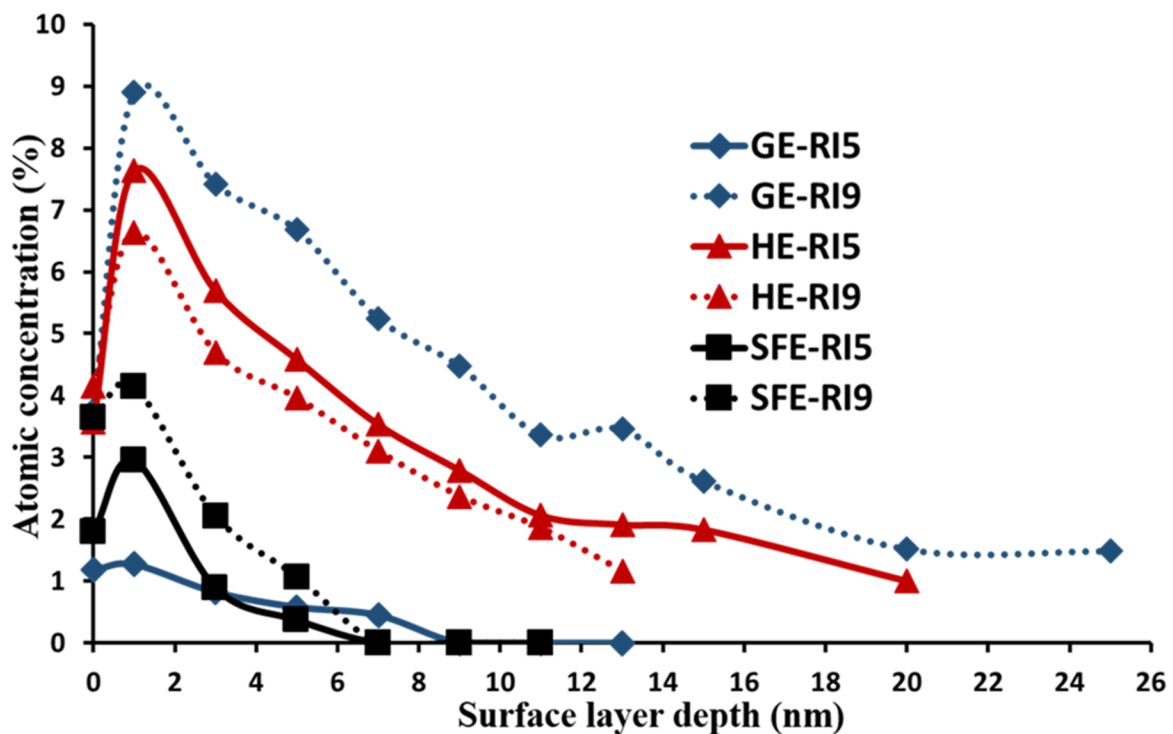
Figure 39. Phosphorous depth profiles after efficiency test for different conditions (paper IV).
