Performance of insulation materials for historic buildings

Case studies comparing a super insulation material and hemp-lime

P. Johansson¹, A. Donarelli², P. Strandberg³

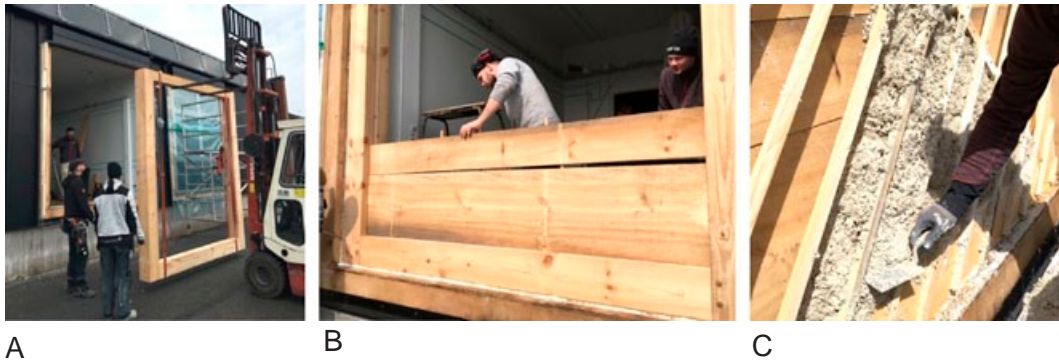
Figure 5. Construction of two full-scale test walls at Lund University, A) Construction of post-and-plank walls, B) Timber planks mounted between the posts, C) Application of hemp-lime on the post-and-plank wall. Photos: Paulien Strandberg.

At Lund University, two façades have been built at the laboratory of the Division of Energy and Building Design, see Figure 5. One façade resembles a traditional post-and-plank construction with a thick lime render about 80 mm. The other façade resembles a traditional post-and-plank construction that is renovated using hemp-lime (~100 mm) as additional external insulation. Behind each façade there is a room (3x3 m) that is insulated at all sides (floor, walls, ceiling). Therefore, the only heat loss that takes place will be through the façade. The energy use for heating the rooms behind the façades is monitored to evaluate the thermal performance of both façades. This way, a historic façade with a lime

render can be directly compared to a façade that is renovated with hemp-lime. The façades were constructed in April/May 2017, monitoring started in September 2017 and continues for one year. The façades are exposed to the outdoor climate. Moisture conditions (RH and moisture content) and temperature are being monitored at four depths inside the wall. The aim of the study is to compare the walls with regards to their energy performance. Therefore, the energy use (kWh/m², year) is measured and recorded continuously.

The preliminary results from the laboratory show a lower energy use for heating in the room behind the hemp-lime façade. The room behind the hemp-lime façade uses 60–70 % of the energy use that is required by the room with the lime façade. The temperature variations are also less apparent in the insulated room.
