THESIS FOR THE DEGREE OF LICENTIATE OF ENGINEERING

# High Temperature Corrosion of Superheaters in Biomass- and Waste-Fired Boilers: Combat on two fronts

Towards a better understanding of corrosion mechanisms and the development of solutions

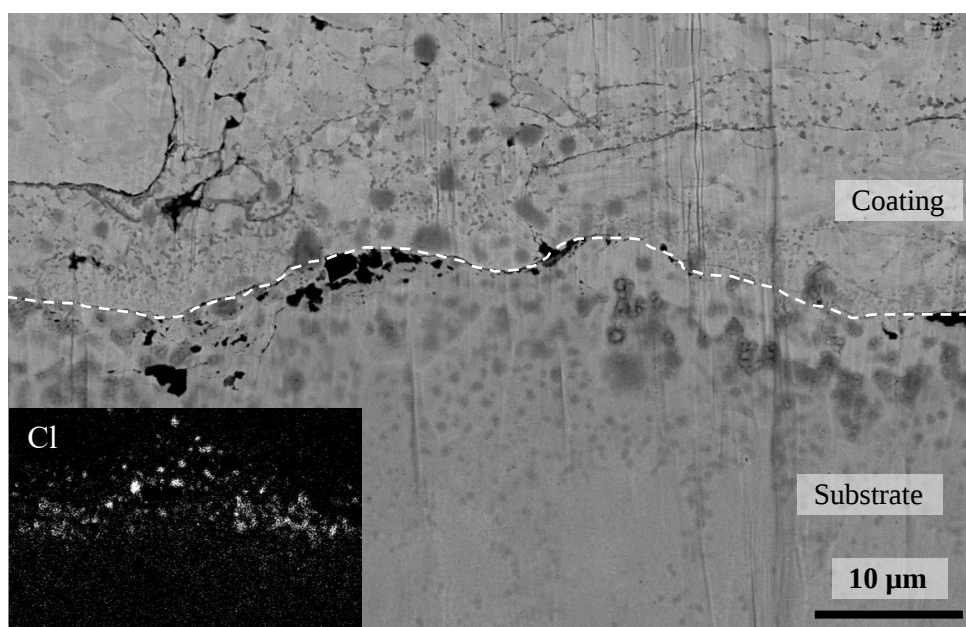
Figure 46: SEM image using BSE of a cross section of the coating/substrate interface of a NiCr-coated sample after exposure in 5% O<sub>2</sub> + 20% H<sub>2</sub>O + N<sub>2</sub> + 1.0 mg/cm<sup>2</sup> at 600 °C for 168 hours. The signal for chlorine from the EDX analysis is located at the bottom left of the picture. The dashed line represents the coating/substrate interface.
