Goel, S., Bourreau, K., Olsson, J. et al (2020). Can Appropriate Thermal Post-Treatment Make Defect Content in as-Built Electron Beam Additively Manufactured Alloy 718 Irrelevant?. *Materials*, 13(3). <http://dx.doi.org/10.3390/ma13030536>

Can Appropriate Thermal Post-Treatment Make Defect Content in as-Built Electron Beam Additively Manufactured Alloy 718 Irrelevant?

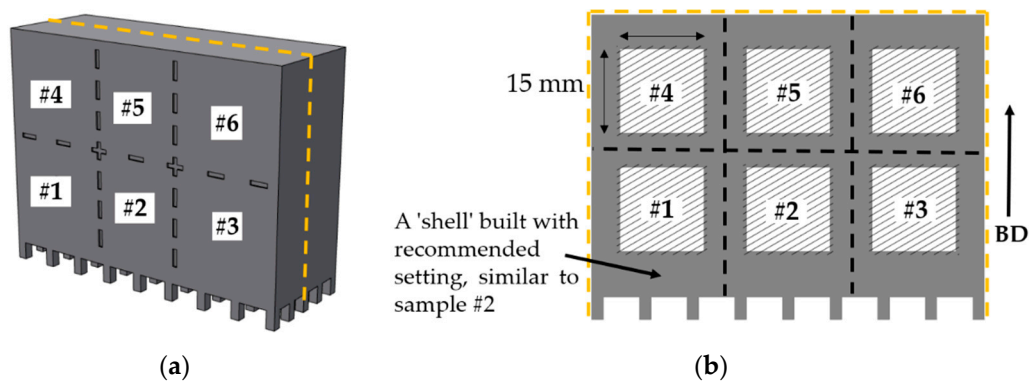
Figure 1. Schematic of the CAD model of one of multiple identical blocks comprising the electron beam melting (EBM) build (a), and cross-section view of the block revealing the cubes (marked by hatched lines) processed with different line spacing (b). The arrow on the right shows the build direction, BD.

Samples were EBM built with different defect contents by varying LS to assess their response to identical post-treatments, particularly HIPing. Plasma atomized Alloy 718 powder (AP&C, Québec, Canada) [5] recycled ~20 times was used. Six different samples (15 × 15 × 15 mm³) (Figure 1), henceforth referred to as AB#1 to AB#6, were built using EBM (Model A2X, Arcam AB, Gothenburg, Sweden) with varying LS corresponding to different processing speeds (expressed as relative melting time and relative melted area per unit time by normalizing with the “standard” values), as summarized in Table 1. All the samples were melted by a snake hatch method during which the electron beam was moved in a back-and-forth raster scan pattern [18]. All the other process parameters were kept constant as per the EBM process theme version 4.2.205, and some of the key process parameters associated with this theme are listed in Table 2. It is worth mentioning that the parameter speed function dynamically adjusts the electron beam scan speed depending on the scan length [22].

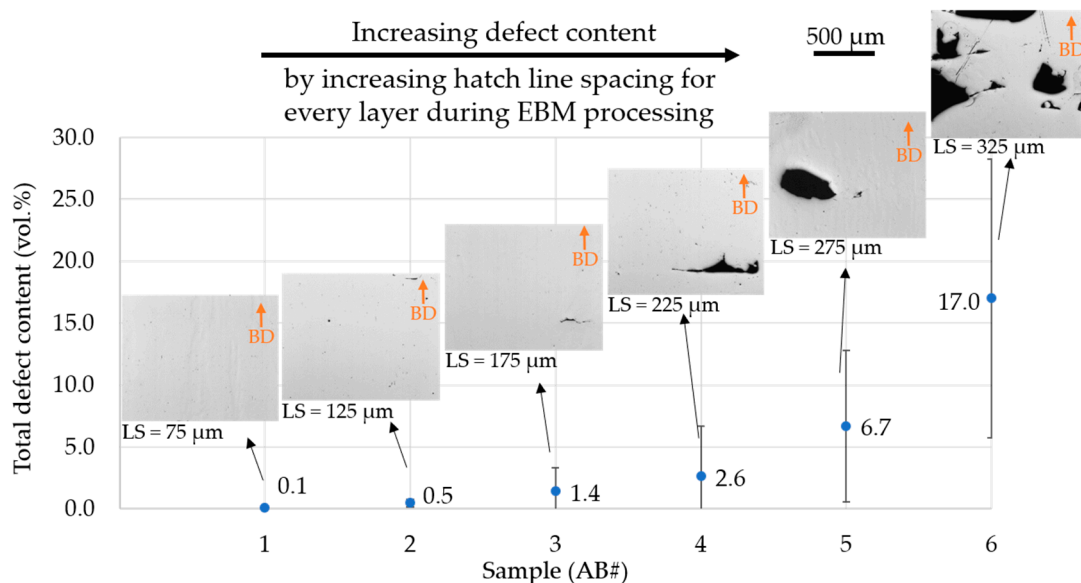
Figure 2. Defect content in as-built samples intentionally built with varied hatch line spacing (LS). The size and amount of defects are visualized in the insets. Arrows in the inset indicate build direction.

The as-built microstructures of samples processed with varying LS corresponding to different melting speeds (Table 1) are depicted in Figure 2. Increase in LS above the “recommended” value resulted in a rise in the defect content, as shown in Figure 2. The defect contents stated represent the sum of all types of defects observed in the as-built samples, i.e., gas and shrinkage porosity, and lack of fusion. Incidentally, these defects were also present in samples produced at the recommended LS = 125 μm (AB#2) as well as at lower LS = 75 μm (AB#1). Samples intentionally produced with higher LS exhibited defect contents up to 17%, as shown in Figure 2 and also visualized in accompanying micrographs. In a word, a systematic increase in line offset (processing speed) from 75 to 325 μm resulted in an increased defect content ranging from 0.1% to 17% in the investigated samples. It is worth mentioning that large defects such as those observed in samples AB#5 (LS = 275 μm) and AB#6 (LS = 325 μm) are not typical of an EBM built even with not fully optimized processing conditions [23]. However, these samples were produced for the present ‘proof of concept’ investigation regarding the extent of defect closure enabled through HIPing.

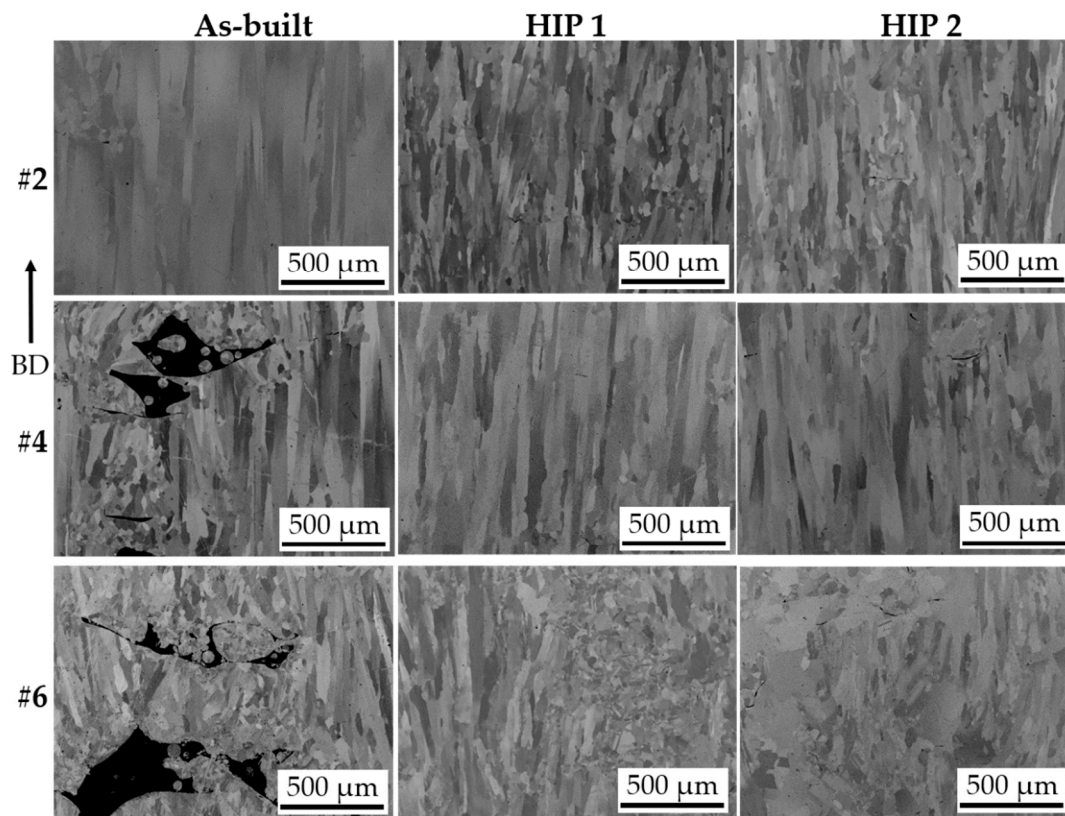
Figure 3. SEM micrographs showing defects in samples #2 (LS = 125 μm), #4 (LS = 225 μm), and #6 (LS = 325 μm) in as-built and HIP'ed conditions. The arrow indicates the build direction.

Samples with distinct defect contents, i.e., AB#2, AB#4, and AB#6 were subjected to two HIPing treatments to investigate the efficacy of defect closure. The defect contents in as-built samples AB#2, AB#4, and AB#6 (corresponding to LS = 125, 225, and 325 μm , respectively) were 0.5%, 2.6%, and 17%, respectively. After both the HIPing treatments, the defect content in all samples was significantly reduced, regardless of the original extent, as summarized in Table 4. Moreover, the difference in the extent of defect closure accomplished at 1120 $^{\circ}\text{C}$ (HIP1) and 1185 $^{\circ}\text{C}$ (HIP2) was not significant. The considerable densification of samples achieved by HIPing is also visualized from the microstructures in Figure 3. Furthermore, the small amount of remnant defects in all HIP'ed samples discussed were found to be typically associated with the presence of Al-rich oxide, which can inhibit complete defect closure. This is clearly evident from the representative EDS results given in Figure 4. It is worth mentioning that Al-rich oxides are thermodynamically very stable and not removed by HIPing, as previously observed in HIP'ed EBM Alloy 718 [24].

Such extensive and efficient reduction in the defect content by orders of magnitude (as evident from Table 4 and Figure 3) *prima facie* provides an opportunity to also potentially increase productivity—at least to some reasonable extent—during EBM processing. It is worth mentioning that the melting step typically comprises ~35% (the exact value depends on the build design [22]) of the layer heating time (preheat + melt + post-heat), which corresponds to 15% of the total layer processing time (also including lowering of build platform + powder raking) spent during the EBM process. Therefore, decreasing the melting time (by increasing the LS, as done in this study) would also have a corresponding effect on the overall EBM processing time.

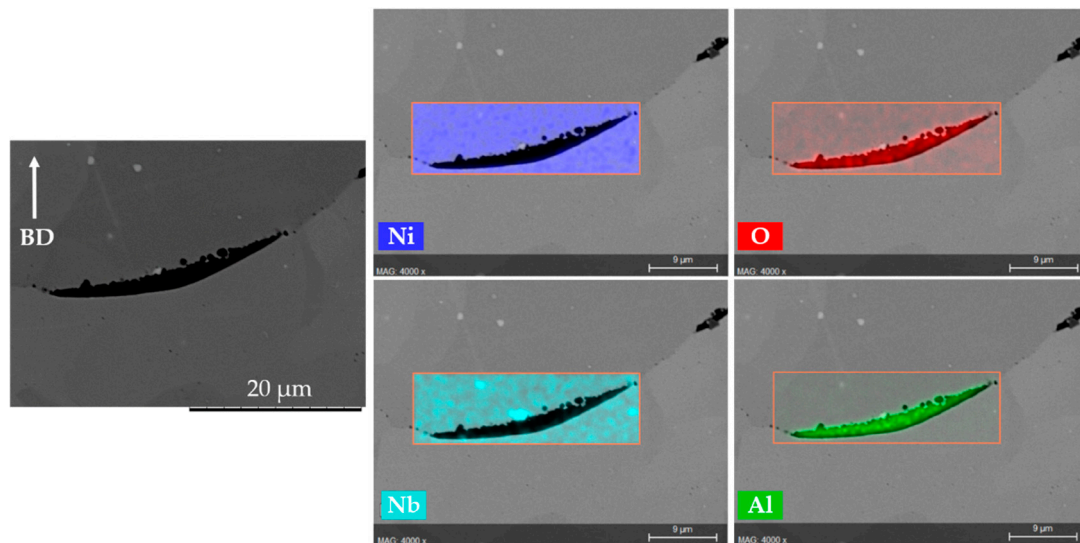
Figure 4. Representative EDS analysis showing inclusions typically associated with many remnant defects in sample #4 (LS = 225 μm) after HIP1. The arrow indicates the build direction.

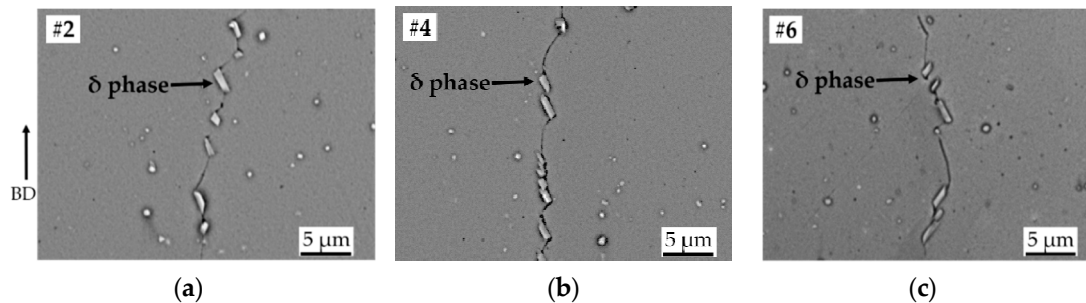
Figure 5. SEM micrographs of HIP1 + STA samples (a) LS = 125 μm , (b) LS = 225 μm , and (c) LS = 325 μm showing similar distribution of the δ phase. The arrow indicates the build direction.

Since the solution treatment was carried out at 954 °C, all the HIP1 + STA samples #2, #4, and #6 (corresponding to LS = 125, 225, and 325 μm , respectively) exhibited a virtually similar distribution of grain boundary δ phase, as shown in Figure 5a–c. This is in accordance with the reported time–temperature–transformation diagram of Alloy 718 [29], and has also been previously

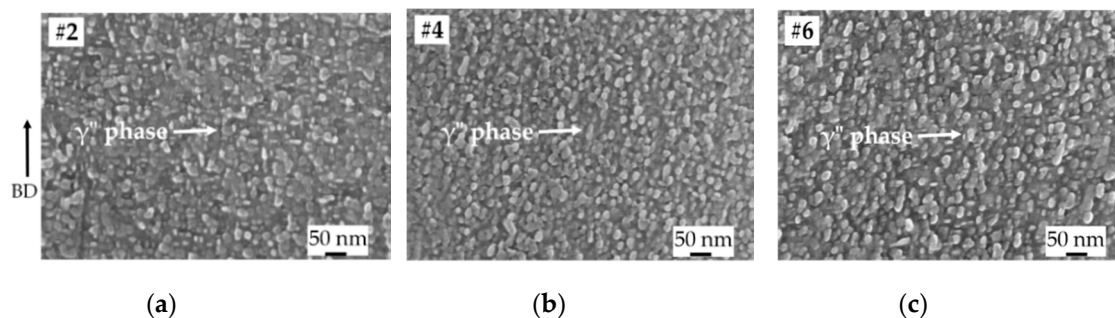
Figure 6. SEM micrographs of HIP1 + STA samples (a) LS = 125 μm , (b) LS = 225 μm , and (c) LS = 325 μm showing similar distribution of the γ'' phase. The arrow indicates the build direction.

observed in solution-treated EBM Alloy 718 that was not subjected to prior HIPing [10]. The effect of aging treatment can be readily seen from the similar distribution of γ'' phase as shown in Figure 6a–c. These microstructural similarities in the three samples (HIP1 + STA #2, #4, #6) were also reflected in the microhardness results, as described below.

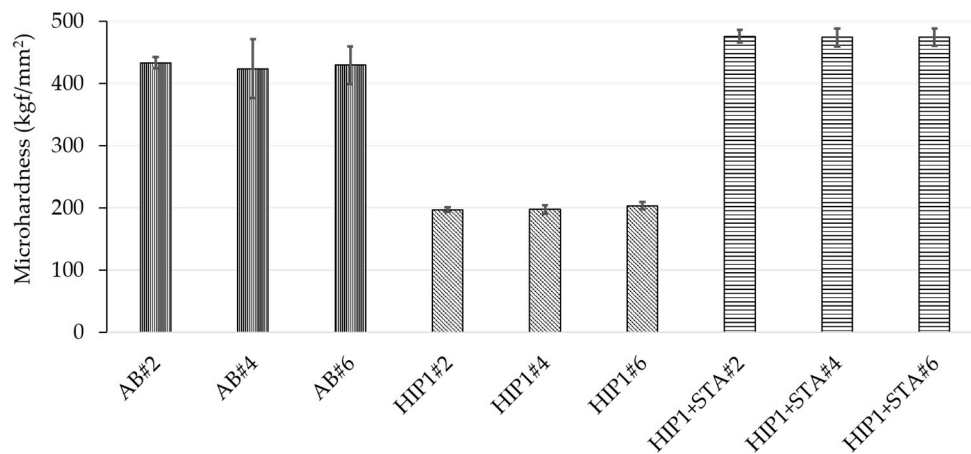
Figure 7. Microhardness values of the as-built and post-treated samples #2 (LS = 125 μm), #4 (LS = 225 μm), #6 (LS = 325 μm).

The average microhardness values of the as-built and post-treated samples, determined as previously described in the experimental procedure, are shown in Figure 7. It can be seen that, although the defect contents in the as-built samples were vastly different, they exhibit similar hardness values of $\sim 430 \text{ kgf/mm}^2$. This can be explained by the similarity in local melting conditions for the three as-built specimens, as the electron beam parameters were unchanged, and only the line spacing was varied. This contrasts a previous reported study by Lee et al. [23], where hardness was observed to vary ($405\text{--}450 \text{ kgf/mm}^2$) with defect content ($4.5\%\text{--}0.5\%$) of the EBM Alloy 718 samples. In the study by Lee et al. the local melting conditions were varied between the different specimens by changing the focus offset, thereby influencing energy density. The HIP1 treatment caused a reduction in the hardness of all the samples to nearly identical values of $\sim 200 \text{ kgf/mm}^2$. This is consistent with the previous observations on EBM and LPBF Alloy 718 [30,31]. After HIP1 + STA, all the samples exhibited similar hardness values ($\sim 475 \text{ kgf/mm}^2$), which were higher than in the as-built condition. This value is close to the reported peak hardness ($\sim 490 \text{ kgf/mm}^2$) of Alloy 718 [10]. Previous studies on EBM Alloy 718 have also reported an increase in hardness in the as-built condition from 410 kgf/mm^2 to 470 kgf/mm^2 after aging [32–34]. Thus, the foregoing results amply reveal that, regardless of the vastly different defect content in the as-built condition, the final post-treated condition exhibits a very similar density (Figure 3), phase constitution in terms of δ phase and γ'' phase distribution (Figures 5 and 6), as well as microhardness values (Figure 7).
