## **Fatigue crack repair in welded structures via tungsten inert gas remelting and high frequency mechanical impact**

al-Karawi, H., von Bock und Polach, R., al-Emrani, M. (2020). Fatigue crack repair in welded structures via tungsten inert gas remelting and high frequency mechanical impact. *Journal of Constructional Steel Research*, 172.  
<http://dx.doi.org/10.1016/j.jcsr.2020.106200>

# Fatigue crack repair in welded structures via tungsten inert gas remelting and high frequency mechanical impact

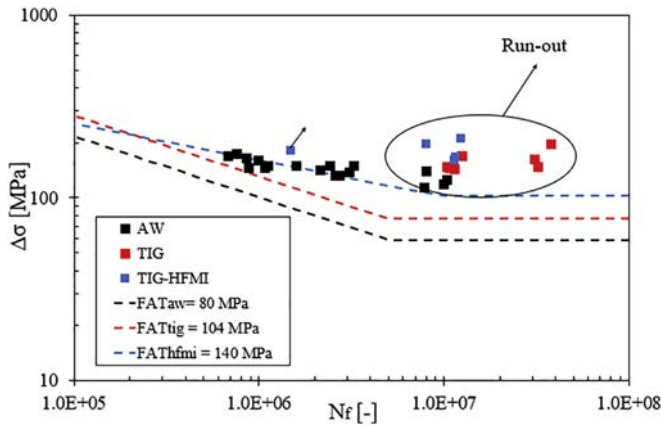
Fig. 7. The fatigue test results of the as-welded and TIG-remelted and TIG-HFMI treated specimens.

The as-welded specimens in series A were subjected to different stress ranges between 118 and 175 MPa. The fatigue test results are given in Table 5 and summarized in Fig. 7. Burst fracture of the specimens was set to be the tests abort criterion. However, three specimens ran-out after being subjected to 10 million of cycles. Therefore, the stress ranges were increased to achieve failure within reasonable number of cycles. Notably, the obtained characteristic fatigue strength (FAT) was found to be 125 MPa which is 4 fatigue class higher than the FAT value for transverse attachment stated in the Eurocode [38]. The fatigue strength was estimated by the prediction interval method given by [39]. It is noteworthy that the run-out tests were excluded from the evaluation of the FAT value.

The test results of the specimens in series C and D are given by the red and blue solid rectangles respectively in Fig. 7 and the detailed results of the test are given in Table 6. The S–N curves of these series could not be constructed because they failed at the clamping position. However, the tests showed that all the specimen failures lay above the design S–N curve of the TIG-treated new transverse attachment detail proposed by the IIW

Despite the long fatigue life obtained for the as-welded specimens, both treatment methods resulted in significant fatigue lives extension. That is conspicuous in Fig. 7 where the solid red and blue rectangles (TIG, TIG-HFMI respectively) are located to the top of the black rectangle (AW). The successful fatigue life extension by the treatment can be explained by the shallowness of the existing crack and the efficiency of the treatment in terms of local geometry improvement, residual stress change, and local material hardening. The combined effects of these three factors could be grasped by Goodman's mean stress correction given in Eq. (5).

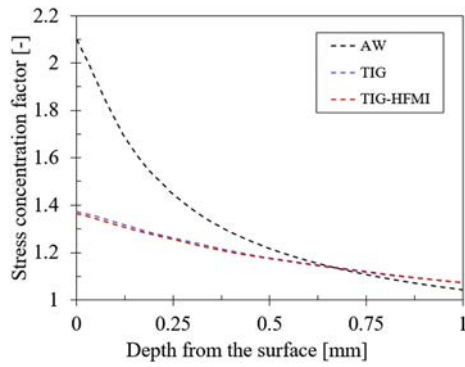
Fig. 11. The elastic stress concentration factor.

respectively. The stress concentration factor at the weld toe  $K_t$  were obtained from Fig. 11.

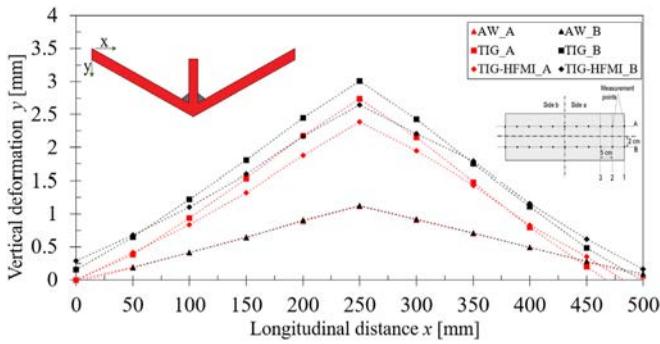
Fig. 15. The distortion of the specimens before and after treatments.

The relative displacement of different points along the as-welded specimens was measured so they could be compared to the corresponding points after treatment as shown in Fig. 15. The TIG-remelting caused additional distortions in the longitudinal direction and twisting the specimens in the transverse direction. This caused a divergence of the two curves corresponding to TIG-remelting in Fig. 15. The high distortion was caused by the high heat input used to achieve deep fusion.

On the other hand, TIG-HFMI treated specimens in series D were less distorted than TIG-treated specimens in series C because of the applied constraint on the specimen when HFMI treated.

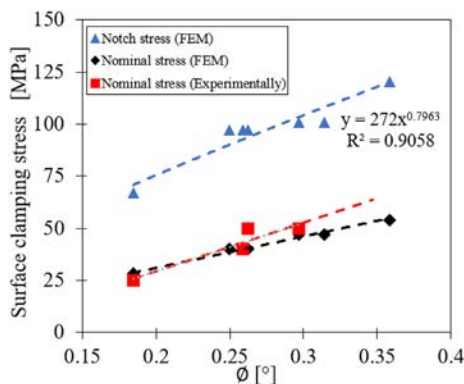
Fig. 16. The correlation between the angular distortion and the clamping stress.

The as-welded specimens showed a remarkably long fatigue life as mentioned in the previous section. This might be explained by the presence of compressive residual stress at the weld toe as shown in Fig. 9. On the other hand, straightening of the distorted specimens upon clamping by the test machine would give rise to tensile mean stress at the weld toe which counteracts the effect of compressive residual stress. In light of that, the relation between the angular distortion and the clamping stress was studied thoroughly. The clamping stresses were evaluated experimentally by the attached strain gauge 40 mm away from the weld line (i.e. SG 11 shown in Fig. 3). The expected correlation between the clamping stress and the angular distortion was found, see Fig. 16.

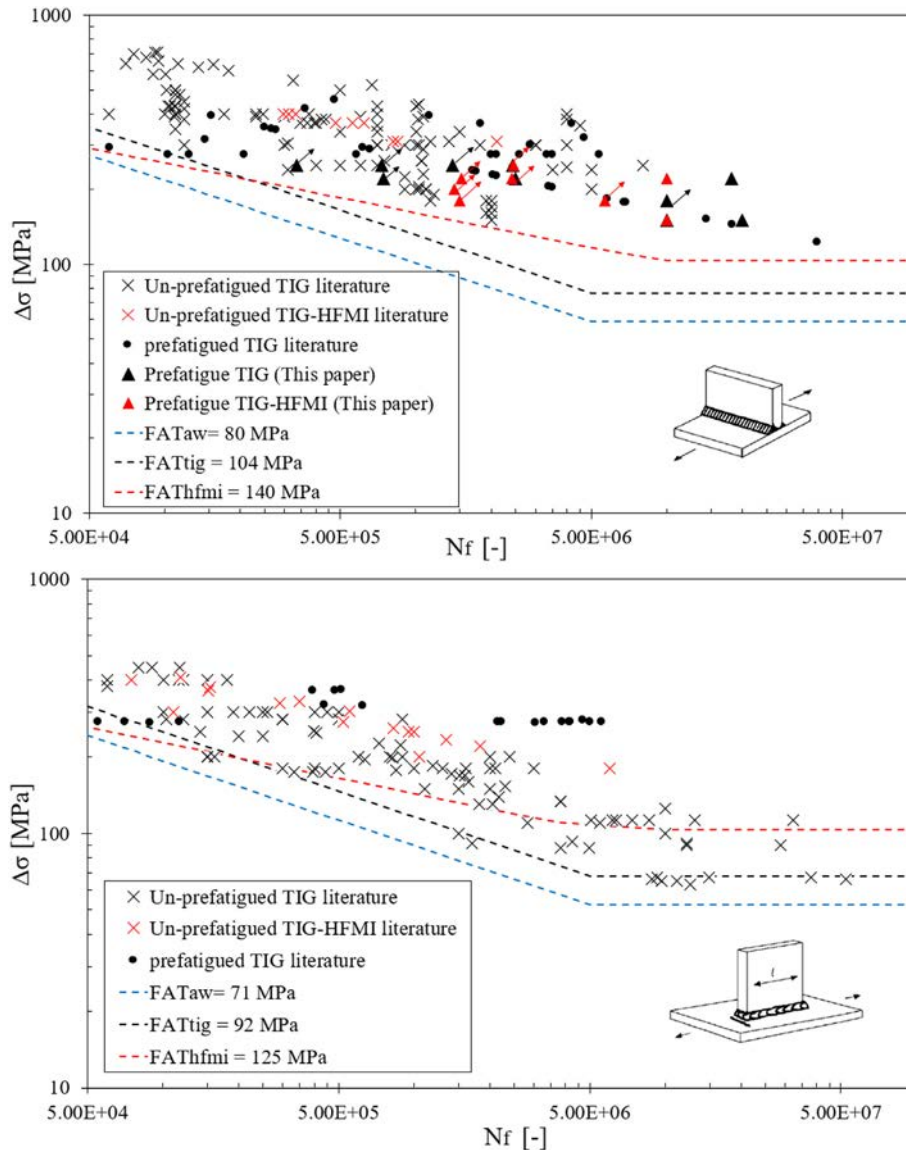
Fig. 19. Fatigue test results of TIG and TIG-HFMI treated transverse and longitudinal attachments respectively.

Several fatigue test results of TIG-treated and TIG-HFMI treated transverse and longitudinal attachment specimens were collected from the literature [7,9,14,15,17,32,33,40–42] and are presented in Fig. 19. No distinction was made based on the failure position, mean stress, stress ratio or plate thickness. The fatigue test results of the treated specimens —In this paper- are denoted by the black and red triangles in the figure. The characteristic S—N curve of the as-welded, TIG-dressed and HFMI-treated specimens are also shown in the figure.

For transverse attachments, more than 98% of the collected data points exhibited longer fatigue life than the characteristic life for new TIG-treated attachment (i.e. Un-prefatigued) given in the IIW [2] at the same stress range. The only two points lying below the line are referred to prefatigued specimens containing deep crack at the weld toe (deeper than 5 mm). Otherwise, the rest of the prefatigued specimens (Including the tested ones in this paper) are lying within the scatter band of the new ones (i.e. Un-prefatigued ones). The resistance of the longitudinal attachments was found to be more scattered because of its dependency on the attachment length. However, the prefatigued specimens showed relatively long fatigue lives with an exception for
