THESIS FOR THE DEGREE OF DOCTOR OF PHILOSOPHY

# High-Temperature Corrosion Behavior in Biomass- and Waste-Fired Boilers

Insights into catastrophic corrosion and corrosion mitigation techniques

Julien Phother-Simon

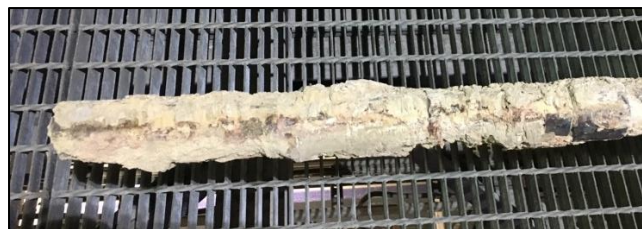
Figure 67: Air-cooled probe exposed 1000 h in the Sulfur Recirculation line (first) and 1000 h in the reference line (after).
