THESIS FOR THE DEGREE OF DOCTOR OF PHILOSOPHY

# Assessment of the lifetime of district heating pipes

Department of Industrial and Material Science  
Chalmers University of Technology  
Gothenburg, Sweden, 2020

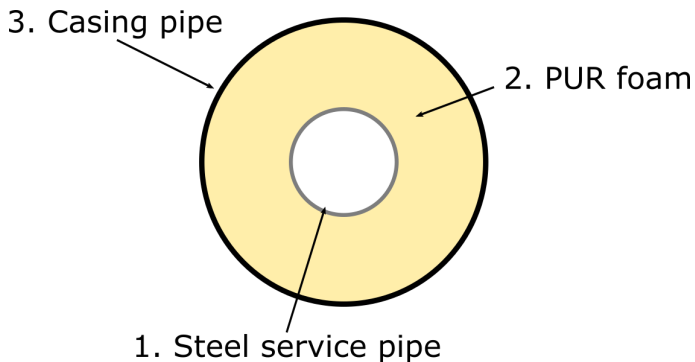
**Figure 1.1:** Sketch of DH pipes showing the three main components.

The third generation of DH pipes currently predominates and it is the focus of this work. The pipes consist of three bonded components: an external casing made of high-density polyethylene (HDPE), an intermediate insulating layer made of rigid polyurethane (PUR) foam, and an internal steel pipe, as shown in Figure 1.1. This type of DH pipe is called a pre-insulated pipe or a bonded pipe. Currently, the DH systems work at varying operating temperatures and these variations lead to axial movement of the steel pipe. The shear force generated between the PUR foam and the steel pipe can cause failure and in the worst scenario leakage in the joints between pipes. After many years of service, the mechanical and insulating properties of the pipes deteriorate.

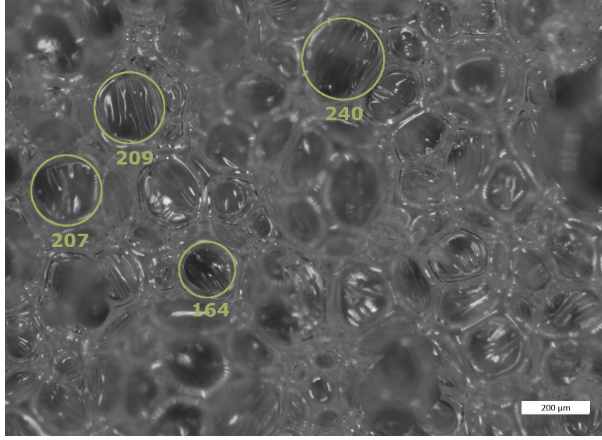
**Figure 2.1:** Photomicrograph of an unaged PUR sample showing four cells with diameters of 164, 207, 209 and 240  $\mu\text{m}$ , respectively.

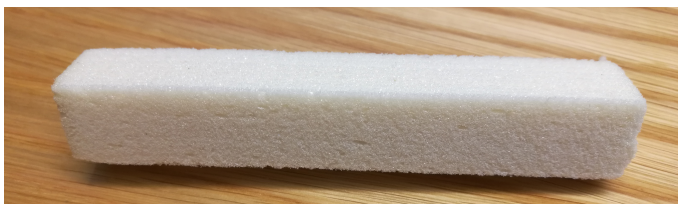
**Figure 3.1:** Rectangular PUR foam sample with dimensions 114 x 19 x 18 mm.

For this experiment, rectangular samples were cut from ordinary PUR foam (called o-PUR) obtained directly from DH pipes and from the ideal PUR block (called i-PUR), as shown in Figure 3.1. The samples were placed in ovens at  $150 \pm 2^\circ\text{C}$ , in two different environments, air and nitrogen. The experimental design is shown in Table 3.1.

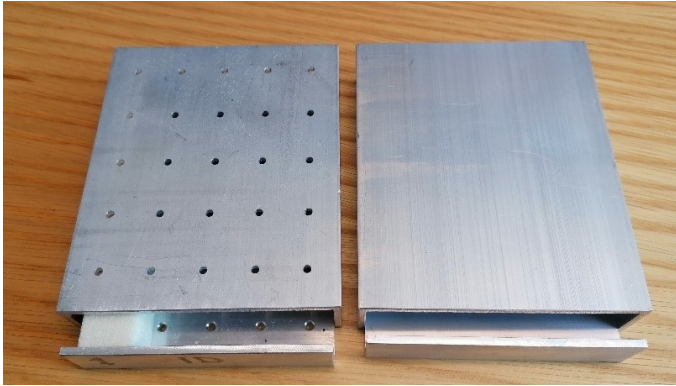
**Figure 3.2:** Aluminium boxes with and without holes for the ageing of PUR foam samples.

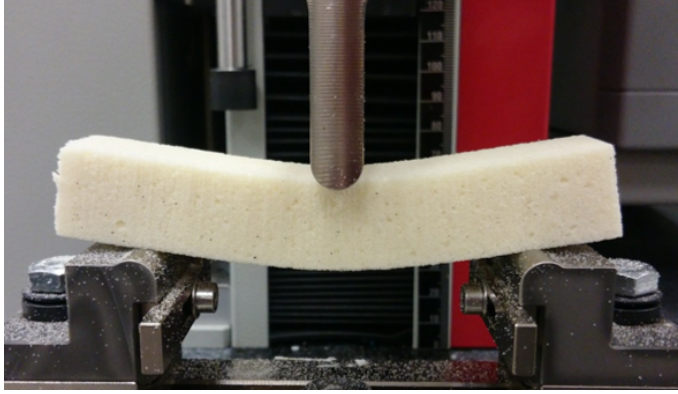
**Figure 3.3:** Three-point bending test on a PUR foam sample.

A three-point bending test was performed with a universal testing machine to evaluate the force at break and how it was affected by the accelerated ageing, as shown in Figure 3.3. The chemical structure was analysed using FTIR, and the gas composition by gas chromatography with tandem mass

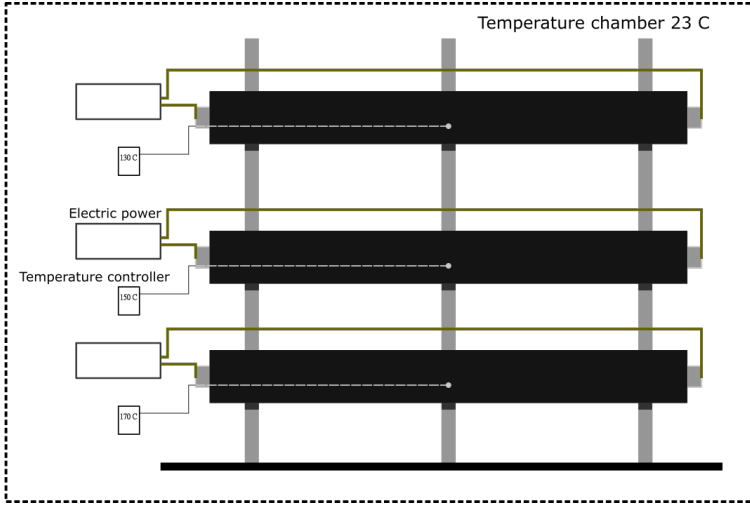
**Figure 3.4:** Sketch of DH pipes arranged in the temperature chamber in the first accelerated ageing experiment.

In the first experiment, three DH pipes DN50/160 were placed in the chamber, and the desired ageing temperatures were 130, 150, and  $170^\circ\text{C}$ . Figure 3.4 shows the experimental set-up. The lowest temperature,  $130^\circ\text{C}$ , was chosen to be close to the highest temperature prevailing in a DH network. The highest temperature,  $170^\circ\text{C}$ , is recommended for accelerated ageing of DH pipes in the

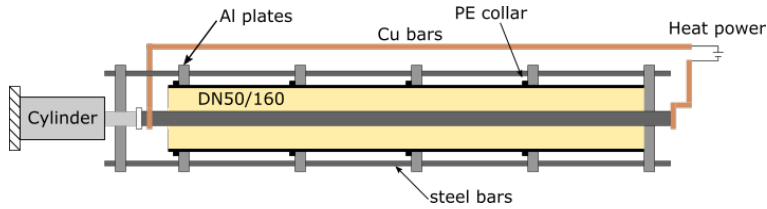
**Figure 3.5:** The test rig used to combine thermal and mechanical axial loads in the second ageing experiment [Figure 1 in Paper IV].

In the second experiment, the effects of both temperature and cyclic axial loads on the degradation of the PUR foam were studied. Two temperatures were chosen, 130 and 140°C. Ageing at 150°C and higher temperatures was excluded because of the results obtained in the first experiment and explained in Paper II. An axial load of up to 20 kN with a cycle time of one hour was applied to the steel pipe. Figure 3.5 shows the test rig for the cyclic axial loading. We hypothesised that the combination of a thermal and a mechanical load should further accelerate the degradation of the pipes. The adhesion strength was measured to determine the degradation level of the pipes. More details can be found in Chapter 4 and Paper IV.

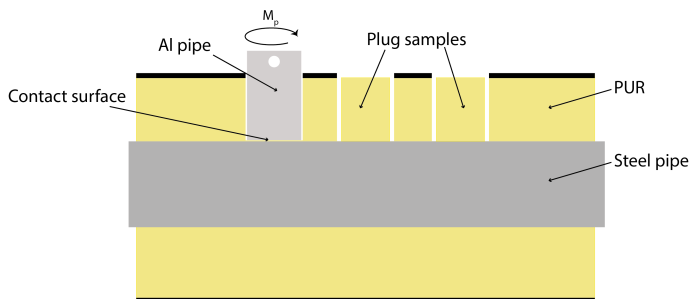
**Figure 3.6:** Sketch of the RISE plug method.

Adhesion between the PUR foam and the steel service pipe is essential for the good functioning of DH pipes. If this adhesion is lost, the DH pipes can fail. To study this property, a method developed at RISE and called the RISE plug method was used. This method was first described by Sällström [18] and developed further in this project. The adhesion strength is determined with a cylindrical test sample still adhering to the service pipe, the torque required to remove the PUR cylinder from the steel service pipe being measured with a torque transducer, as shown in Figure 3.6. Full details about the test procedure are given in Paper II.

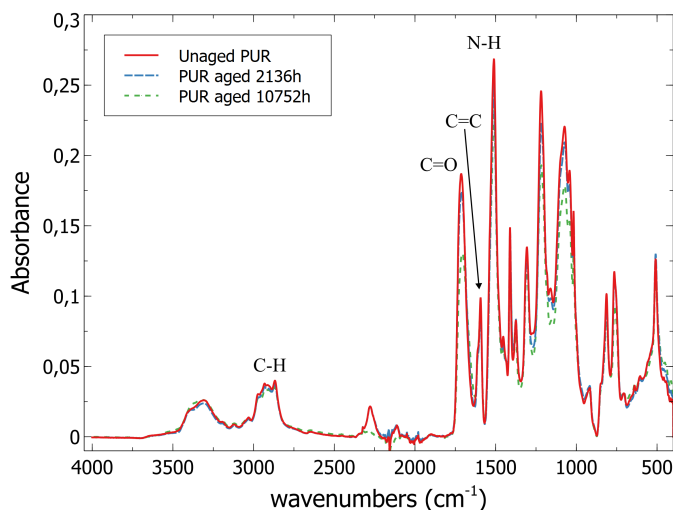
**Figure 3.7:** FTIR spectra of unaged and aged samples.

Figure 3.7 shows the spectra of unaged and aged PUR samples. To make the changes easier to assess, the relevant peaks were normalised with respect to the reference peak at  $1595\text{ cm}^{-1}$  corresponding to the vibration of C=C bond in the aromatic rings, which are thermally stable, was chosen. Particular attention was paid to the peaks at  $1712\text{ cm}^{-1}$  for the C=O bond and  $1512\text{ cm}^{-1}$  for the N-H bond in the urethane linkage, to indicate degradation of the PUR foam. Indexes of absorbance were obtained and plotted as a function of ageing time. This methodology was used in Papers I–IV.

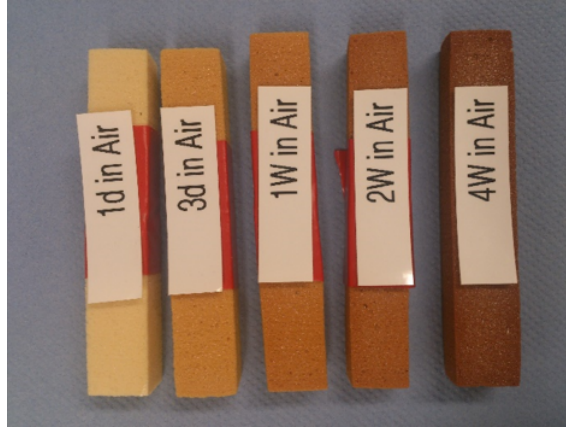
**Figure 4.1:** PUR samples aged at 150°C in air shows a progressive change in the colour with increasing ageing time.

Ageing in an inert nitrogen environment led to no remarkable change except for a small decrease in the weight of the samples, probably due to loss of volatile components that diffused out from the PUR foam. In contrast, changes in the dimensions and weight were observed in addition to the discolouration of PUR samples aged in air. In the case of the PUR samples marked o-PUR and i-PUR, the measurements of weight and dimensions showed some differences in behaviour between the o-PUR and i-PUR samples at the beginning of the ageing. The i-PUR was produced in a more controlled manner, which probably gave it a more homogeneous PUR morphology, mak-

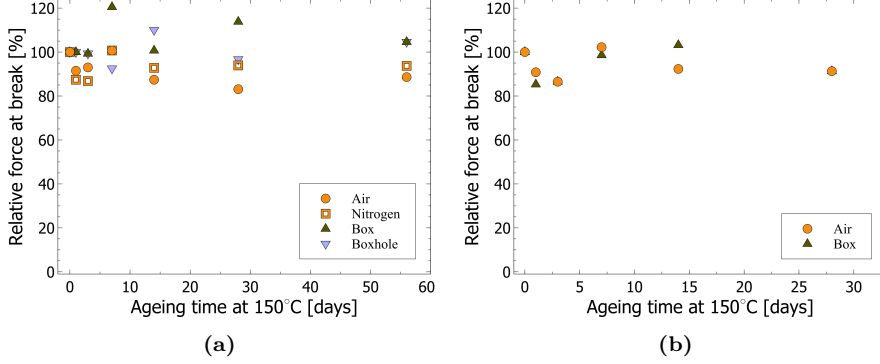
**Figure 4.2:** Relative force at break in a three-point bending test after different ageing times in different environments. (a) o-PUR foam and (b) i-PUR foam [Figure 8 in Paper I].

The force needed to break the samples in a three-point bending test after different ageing times is shown in Figure 4.2. Each point is the average of five measurements and the values are normalised with respect to a reference value measured on unaged samples. The breaking force did not decrease with increasing ageing time regardless of the ageing condition. This breaking force is a measure of the cohesion strength of the PUR foam and is not related to the strength of the adhesion between the PUR foam and the steel pipe. To clarify this difference, a single-point bending test was performed on triangular PUR samples still attached to the steel pipe aged at 150°C in a nitrogen environment, as described in Section 3.3.5. Figure 4.3 shows that the force measured in the single-point bending test decreased by 40% after approximately 20 days and remained at this level after 90 days, whereas the breaking force measured by the three-point bending test decreased by only about 7% and remained at the same level for almost 60 days.

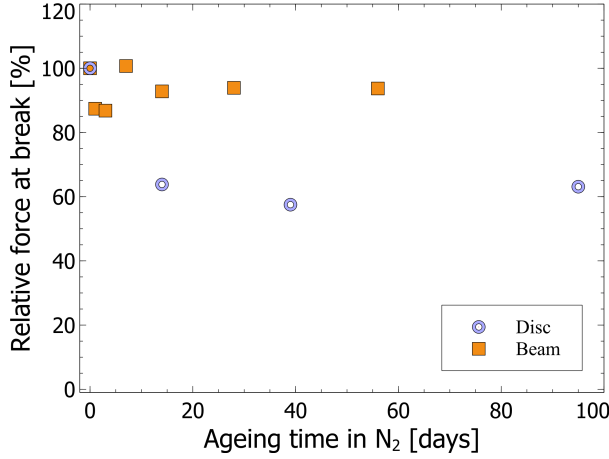
**Figure 4.3:** Comparison between the force at break measured in the single-point bending test and in the three-point bending test on PUR samples aged at 150°C in nitrogen [Figure 9 in Paper I].

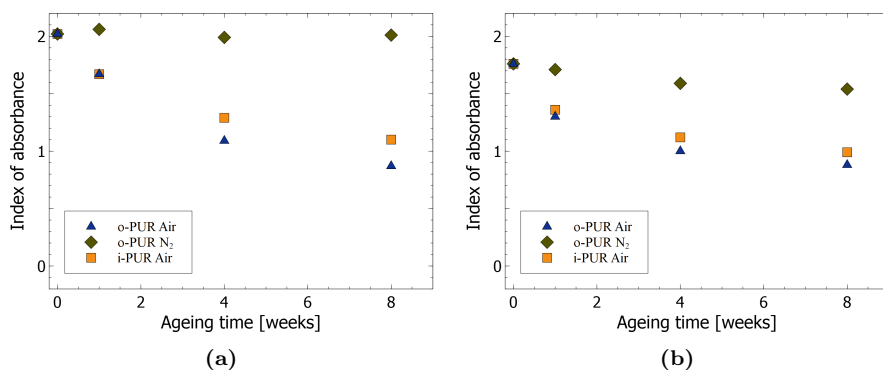
**Figure 4.4:** Index of absorbance of peaks (a)  $1512\text{ cm}^{-1}$  for the N–H bond and (b)  $1712\text{ cm}^{-1}$  for the C=O bond.

the micro-ATR technique, focusing on the intensities of the absorbance peaks for the C=O bond at  $1712\text{ cm}^{-1}$  and  $1512\text{ cm}^{-1}$  (N–H bond), which are sensitive to oxidative degradation, as shown in Figure 4.4. These bonds are parts of the urethane linkage and any decrease in their absorbance is a sign of degradation of the PUR foam. Other peaks of interest, e.g. the C–H bond in  $\text{CH}_2$  at  $2975\text{ cm}^{-1}$ , the NCO group at  $2277\text{ cm}^{-1}$  and the isocyanurate group at  $1411\text{ cm}^{-1}$ , were also studied as an indication of degradation. The peak corresponding to the NCO group showed that extra isocyanate had been added during production to ensure that all the polyol had been consumed. The intensity of this peak decreased rapidly at the beginning of the ageing because isocyanate reacts with itself when heated. PUR foam with an excess of isocyanate also contains a significant amount of isocyanurate, which increases the thermal stability of the foam. Samples aged in nitrogen did not show any remarkable changes during the ageing, as shown in Paper I.

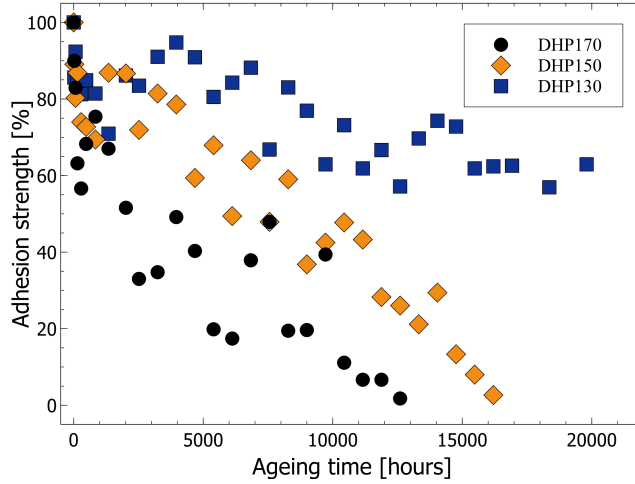
**Figure 4.5:** Adhesion strength measured using the RISE plug method on DHP170, DHP150, and DHP130 for more than two years [Figure 4a in Paper II].

strength changed during the total ageing time, more than two years, the results here being normalised with respect to the initial value. Each point is the average of three measurements. More information can be found in the Appendix. The values obtained with the RISE plug method are presented as relative measurements to make it easy to compare the changes in different pipes.

During the initial stage, the predominant fracture mode was a cohesive fracture in the PUR sample itself, meaning that the strength of the adhesion between PUR foam and the steel pipe was still higher than the strength of the PUR sample. This stage lasted for different periods depending on the ageing temperature; the fracture mode eventually changed and become a purely adhesive failure at the contact surface between PUR foam and the steel pipe, as explained in Paper II. For DHP150 and DHP170, the adhesion strength decreased until it was entirely lost, but the process was different for DHP130. The adhesion strength decreased to approximately 60% of the original value 10 000 hours after the initial stage and then remained at a plateau value, as shown in Figure 4.5. The ageing of DHP130 was stopped after more than two years because it was not possible to take more test samples from the pipe.

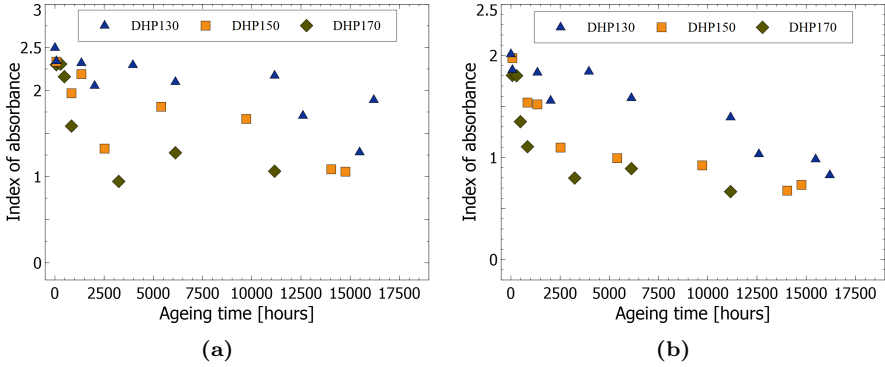
**Figure 4.6:** Index of absorbance of peaks corresponding to (a) the N-H bond at  $1512\text{ cm}^{-1}$  and (b) the C=O bond at  $1712\text{ cm}^{-1}$ .

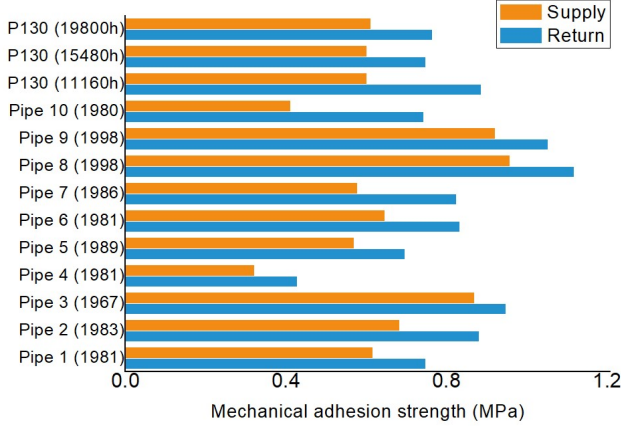
**Figure 4.7:** Adhesion strength measured on DH pipes aged naturally and DH pipes aged in the laboratory at 130°C [Figure 3 in Paper III].

The adhesion strength of the R pipes,  $\sigma(\text{R-pipe})$ , was slightly higher than the adhesion strength of the S pipes,  $\sigma(\text{S-pipe})$ , as expected. We calculated the ratio  $\sigma(\text{S-pipe})/\sigma(\text{R-pipe})$  to compare the adhesion strength of the different pipes.  $\sigma(\text{S-pipe})$  was approximately 80% of  $\sigma(\text{R-pipe})$ .

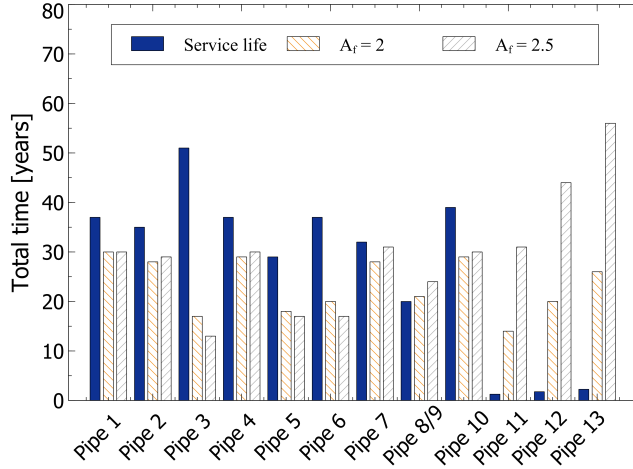
**Figure 4.8:** Real and recalculated service time at  $95 \pm 5^\circ\text{C}$  of supply pipes using  $A_f = 2$  and  $A_f = 2.5$  [Figure 6 in Paper III].

Using these values, we recalculated the service life of all collected DH pipes to a reference temperature of  $95 \pm 5^\circ\text{C}$  for the S-pipes and  $55 \pm 5^\circ\text{C}$  for the R pipes. The differences between the recalculated service time using  $A_f$  equal to 2.0 and 2.5 were quiet small, except for the values from DHP130, labelled Pipe 11, Pipe 12, and Pipe 13, as shown in 4.8. The calculations resulted in a service time of 26 and 56 years at  $95^\circ\text{C}$  for Pipe 13, depending on the  $A_f$  value used.

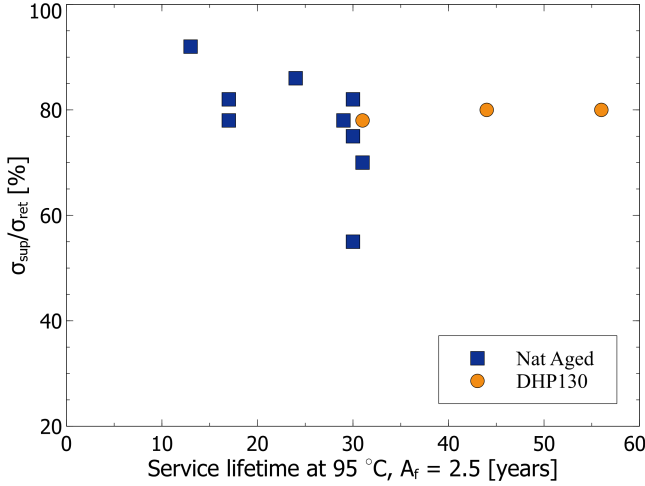
**Figure 4.9:** Adhesion strength ratio as a function of the calculated service time at 95°C using  $A_f = 2.5$ .

the calculated service times with  $A_f = 2.5$ . Most of the points are located between 70% and 90% and independent of the recalculated time. Only one measurement was outside this range. The PUR foam of this pipe could be damaged due to leakage, but we did not receive enough information to confirm this. Three points from DHP130 were also added to Figure 4.9 and showed that the results from the accelerated ageing at 130°C were consistent with the results from the naturally aged DH pipes.

According to this result, the strength of the adhesion between the PUR foam and the steel pipe in a DH pipe that is operated continuously at 95°C for 56 years will decrease to 80%. It is noteworthy that other external factors can damage or alter the functionality of the DH pipes and end its service time earlier.

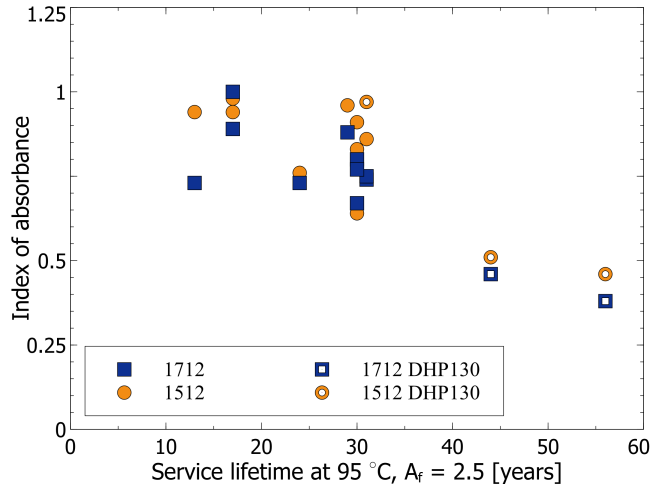
**Figure 4.10:** Index of absorbance from S pipes and three points from DHP130 for peaks at 1512 and 1712  $\text{cm}^{-1}$ .

of the results. Figure 4.10 suggests what can happen if the DH pipes are operated at 95°C for 56 years.

Accelerated ageing at 130°C caused a further degradation of PUR foam as indicated by the decrease of the index of absorbance. Meanwhile, the adhesion strength remained unchanged, as shown previously in Figure 4.9. This finding suggests that the IR analysis could be useful to find indications of degradation in an early stage before the loss of the adhesion strength.

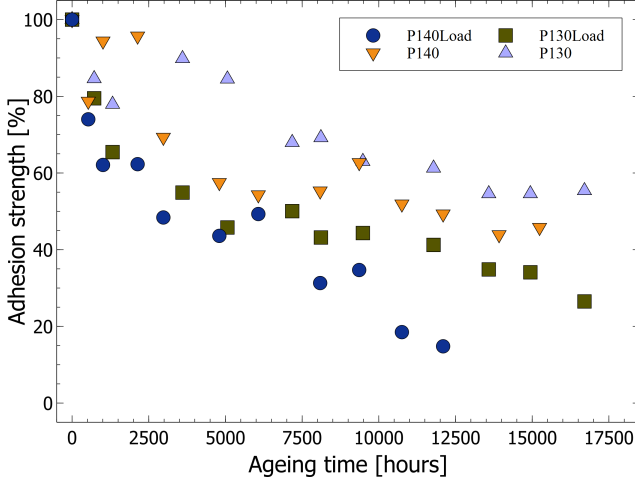
**Figure 4.11:** Adhesion strength measured on P140, P140Load, P130 and P130Load pipes over two years.

points represent the average of three measurements. The absolute value for the adhesion strength was between 0.13 and 0.88 MPa. The standard deviation was around 0.04 to 0.24 MPa. More information can be found in the Appendix.

The adhesion strength of P140Load decreased to 15% after 12096 hours. Similarly, the adhesion strength of P130Load decreased to 22% after 17544 hours. Figure 4.11 shows a similar behaviour of the adhesion strength for P130 as the results presented in Figure 4.5 for DHP130. The adhesion strength decreased to approximately 60% and then entered a plateau after approximately 11800 hours of ageing. The adhesion strength for P140 decreased also to approximately 55%, and then entered a shorter plateau after 8088 hours. However, it seems that the adhesion strength decreased again after 12000 hours. The 10°C difference could explain why P140 entered the plateau earlier than P130.

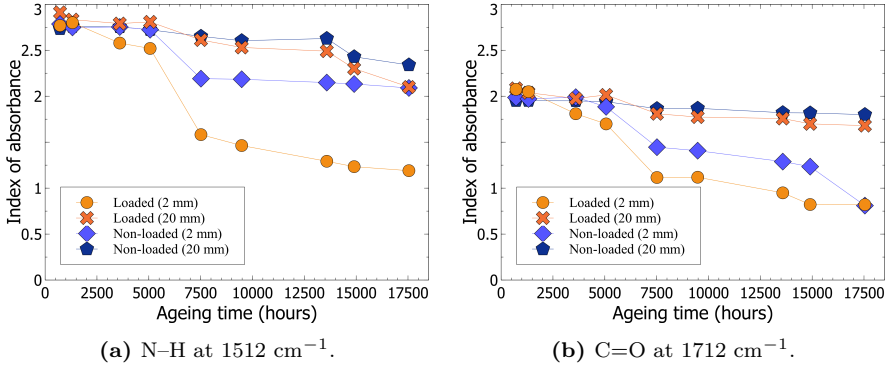
**Figure 4.12:** Index of absorbance for the peaks at  $1512\text{ cm}^{-1}$  (a) and  $1712\text{ cm}^{-1}$  (b) from P130 and P130Load [Figure 13 in Paper IV].

presented in Figure 4.12 and Figure 4.13, we observed an additional decrease of the index of absorbance in the pipes that were stressed mechanically.

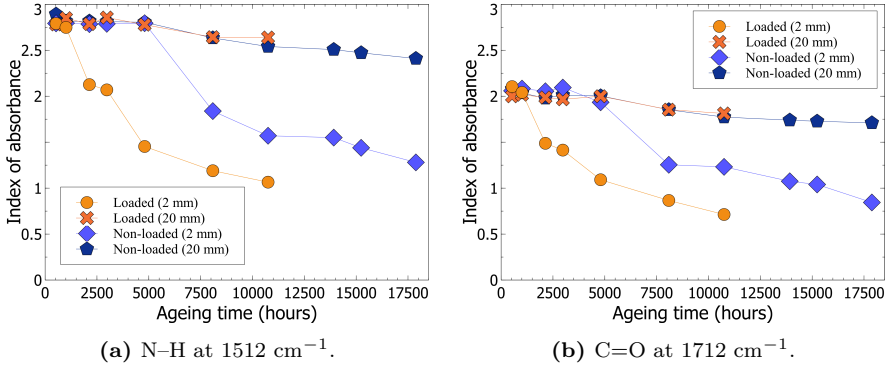
**Figure 4.13:** Index of absorbance for the peaks at  $1512\text{ cm}^{-1}$  (a) and  $1712\text{ cm}^{-1}$  (b) from P140 and P140Load [Figure 14 in Paper IV].

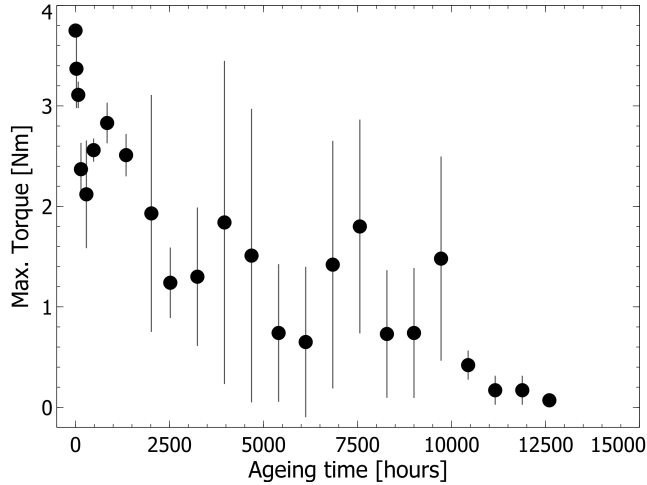
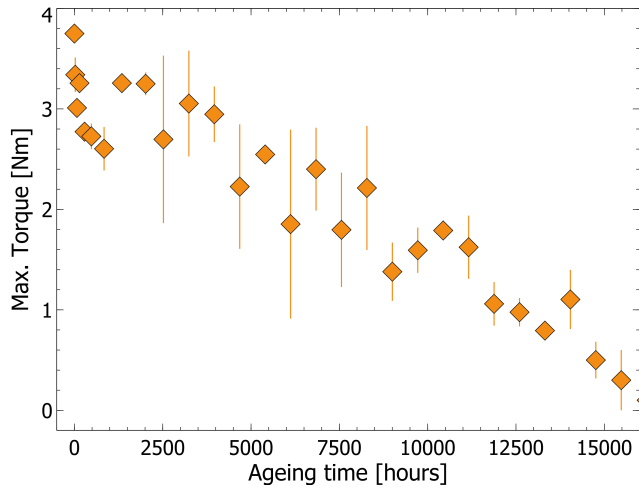
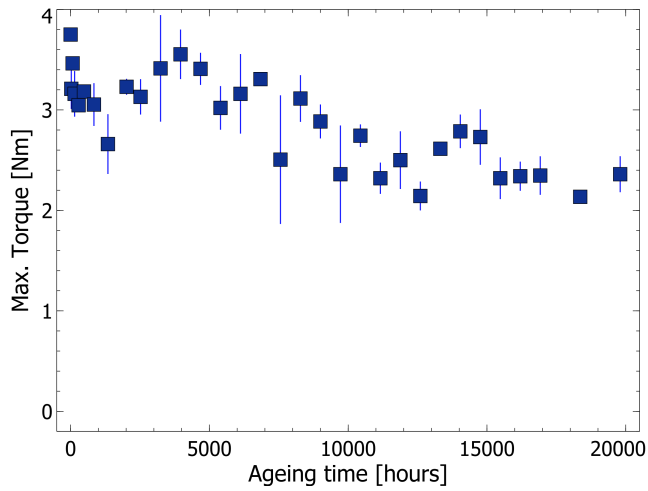
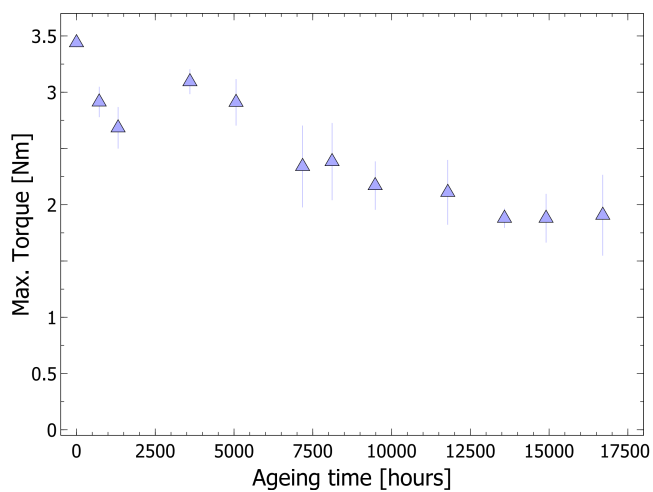
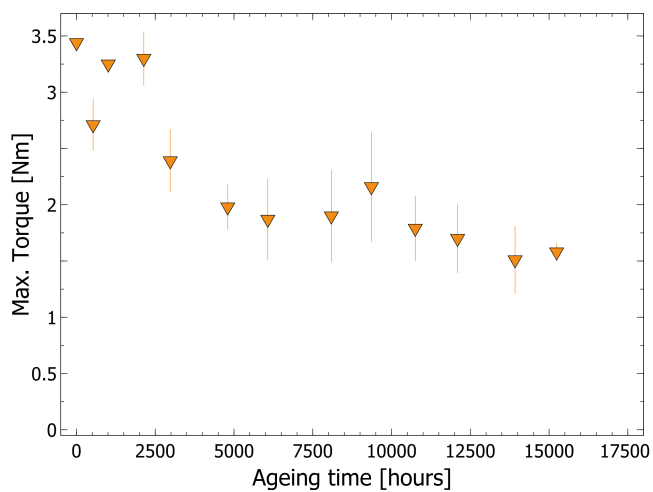
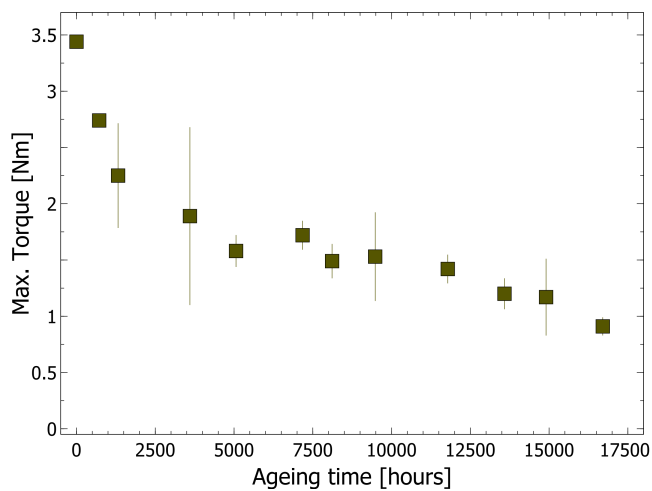
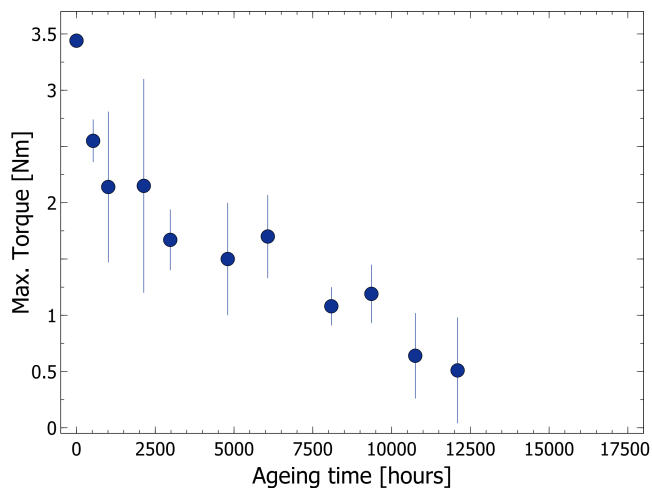
**Figure A.1:** Average and standard deviation of the mechanical tests performed on DHP170.

**Figure A.2:** Average and standard deviation of the mechanical test performed on DHP150.

**Figure A.3:** Average and standard deviation of the mechanical test performed on DHP130.

**Figure A.4:** Average and standard deviation of the mechanical tests performed on P130.

**Figure A.5:** Average and standard deviation of the mechanical tests performed on P140.

**Figure A.6:** Average and standard deviation of the mechanical tests performed on P130Load.

**Figure A.7:** Average and standard deviation of the mechanical tests performed on P140Load.

Figure A.4, Figure A.5, Figure A.6 and Figure A.7 show the average values and the corresponding standard deviation for P130, P130Load, P140 and P140Load, respectively, from the second accelerated ageing test. The nominal values for the measured torque were between 0.55 and 3.44 Nm (0.13 and 0.88 MPa). The highest standard deviation was registered at 2 136 hours, 0.95 Nm (0.24 MPa), for P140Load. The standard deviation values were lower in general compared with the values obtained in the first ageing test. A reason can be the introduction of an electrical torque transducer that apply the force with the same rate every time.
