Exploratory investigation of return air temperature sensor measurement errors in refrigerated display cabinets

Månsson, T., Ostermeyer, Y., Sasic Kalagasidis, A. (2021). Exploratory investigation of return air temperature sensor measurement errors in refrigerated display cabinets. *Energy Efficiency*, 14(1). <http://dx.doi.org/10.1007/s12053-020-09912-1>

Tommie Månsson · York Ostermeyer ·
Angela Sasic Kalagasidis

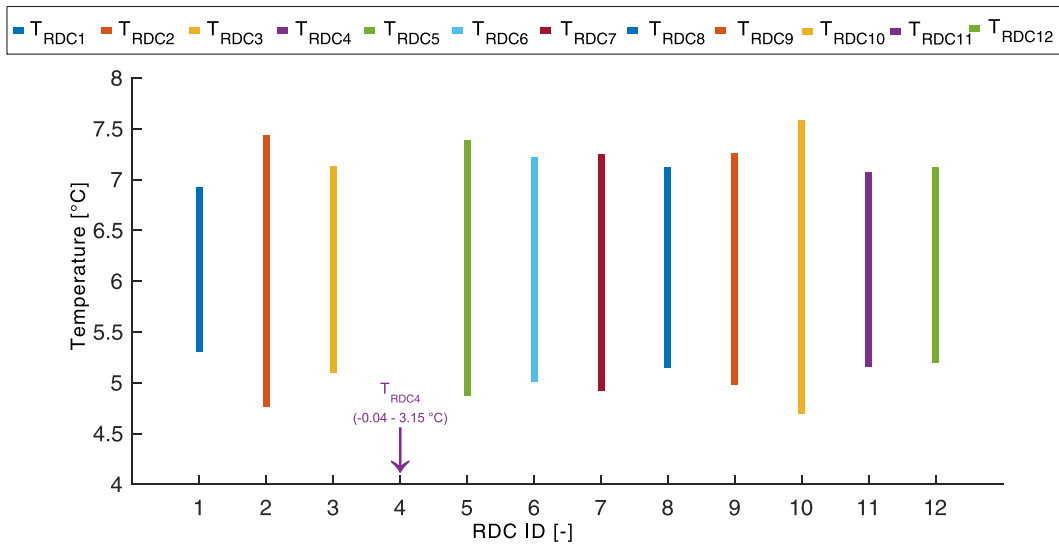
Fig. 2 Mean T_{DA} and T_{RA} for the 12 RDCs in the supermarket during four Sundays (10, 17, 24, 31/1—2016). Significant differences between RDCs can be noticed. Special notice for $RDC_{1,2,3}$ which are internally connected and would thereby be

expected to show readings of same magnitude. Note: The temperature of RDC_4 is set to 2 °C as it mainly contains meat products

In Fig. 2, the average return air and discharge air temperature for four Sundays (10, 17, 24, 31/1—2016) is presented. As can be seen, the variations among the RDCs are significant, even for RDCs connected in the same line. For example, RDC_2 had a 0.64 °C higher difference between T_{RA} and T_{DA} than RDC_3 , even though they were directly connected (See Fig. 1). This difference corresponds to a 32% higher sensible heat extraction rate in RDC_2 , which is dubious for two connected RDCs of the same brand and design, exposed to the same ambient condition and at times of no interaction. There were, however, some minor differences between RDC_2 and RDC_3 . The right side of RDC_2 was openly connected to RDC_1 whereas there was an intermediate division wall between RDC_3 and the neighbouring meat RDC, RDC_4 . From the pictures

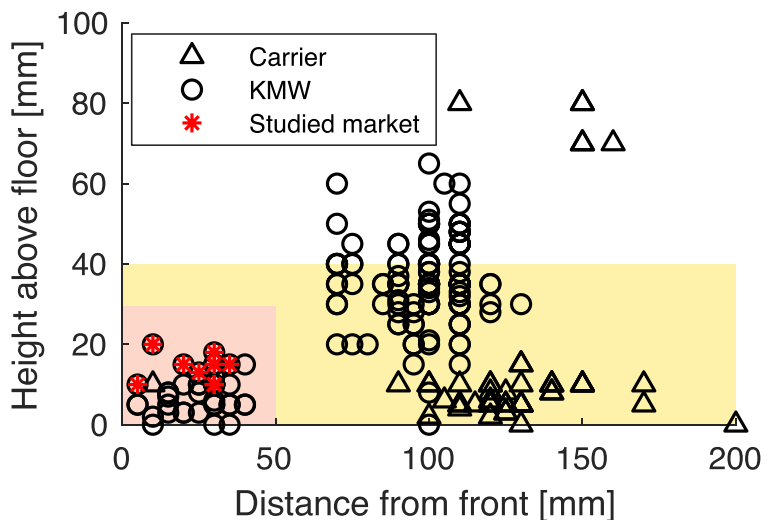
Fig. 15 Scattered plot showing the position of return air temperature sensors in 221 refrigerated display cabinets in supermarkets around Hamburg. The light red area indicates the warmest zone of the heated air layer and the yellow indicates the outline. The red asterisk indicates the position of the RA temperature sensors from field study 1 (4 sensors are not represented in the figure as they were placed at heights between 100 and 120 mm)

In total, 12 RA temperature sensors were re-positioned in this supermarket. In Fig. 15, the original position is marked with red in the graph and in Fig. 12 the effect on the measured temperature of the relocation can be seen. The presented graphs in Fig. 12 are showing the measured daily average temperature for the return and discharge air. Here the relocation of the return air temperature sensors occurred on the 33rd day. This is clearly visible as a step-change in both T_{RA} and T_{DA} . The increase of T_{DA} is a consequence of the control system responding to the
