Laser-based powder bed fusion of non-weldable low-alloy steels

Hearn, W., Steinlechner, R., Hryha, E. (2022). Laser-based powder bed fusion of non-weldable low-alloy steels. *Powder Metallurgy*, 65(2): 121-132.
<http://dx.doi.org/10.1080/00325899.2021.1959695>

This study focuses on the processability of four low-alloy steels (AISI 4130, 4140, 4340 and 8620) via laser-based powder bed fusion (LB-PBF). In the as-built condition, the alloys consisted of tempered martensite that was the result of an intrinsic heat treatment (IHT) during LB-PBF. In terms of defects, a distinct transition in porosity was observed that correlated to the volumetric energy density (VED). At low VED, specimens contained a lack of fusion porosity, while at high VED, they contained keyhole porosity. Additionally, cold cracking was observed in 4140 and 4340 specimens produced at low/intermediate VEDs. This cracking could be mitigated by increasing the VED or laser power, as both enhance the IHT. This enhanced IHT lowered the material hardness below specific thresholds (<500HV 4340 and <460 4140), increasing ductility and allowing the specimens to avoid cracking. From these findings, crack-free, high-density (

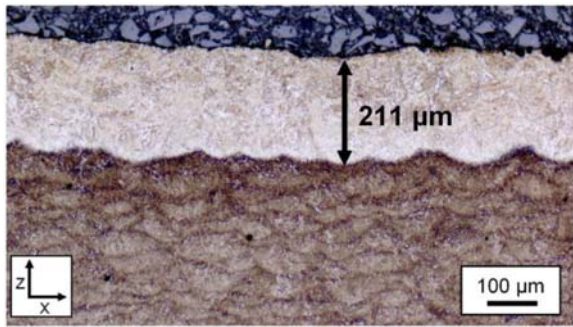
**Figure 1.** OM image of the unetched top layer found in an AISI 4140LC specimen produced at 160 J mm^{-3} using a 140 W laser power. Measurement of the melt pool depth was conducted by measuring the depth of this unetched top layer using ImageJ software. An example measurement of the melt depth (as well as the corresponding value) is included in the figure using a black line and text.

depth was estimated by measuring the top layer of etched specimens (see Figure 1). For each set of processing parameters, 10–15 melt pool depth measurements were conducted.

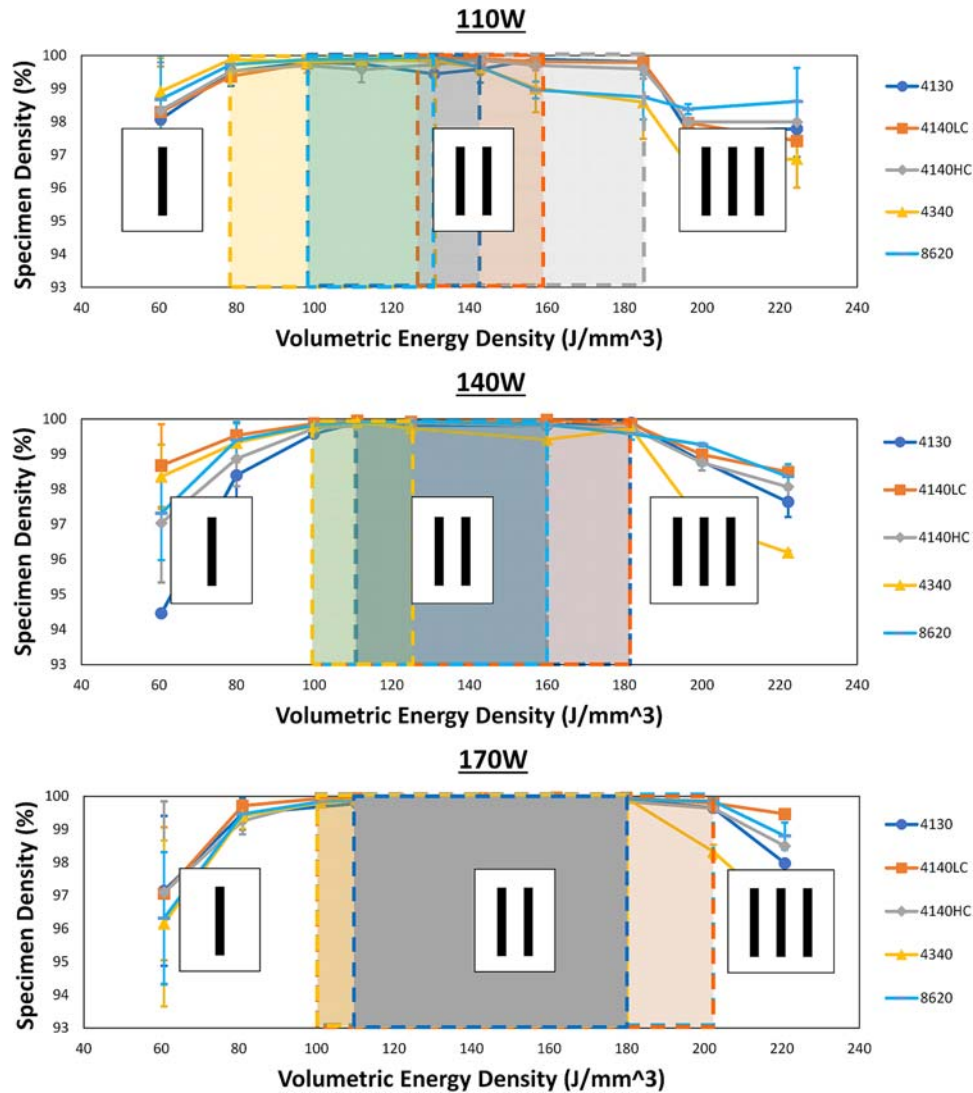
Figure 2. Relative density as a function of VED for each examined low-alloy steel. Marked areas (I, II or III) denote the defined process regions, where the segmentation of each region is marked using dashed box lines. Region II represents the ideal processing window where specimen densities of $>99.8\%$ are produced.

Measurement of the as-built specimen density revealed its strong dependence on the VED, where three distinct regions could be identified (see Figure 2). At low VED (Region I), irregularly shaped pores (up to $500 \mu\text{m}$ in size) could be

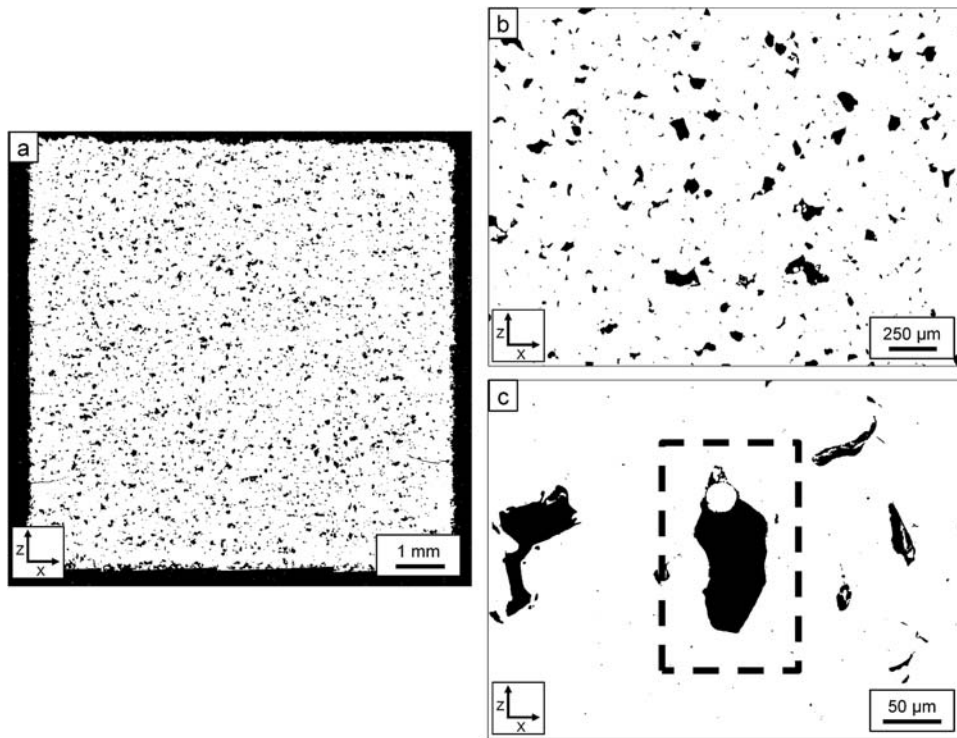
Figure 3. (a) Lack of fusion porosity in an AISI 4140HC specimen produced at 60 J mm^{-3} using a 170 W laser power. (b) Higher magnification of image (a). (c) Higher magnification of image (a) showing a lack of fusion porosity within a partially sintered powder particle (outlined by the black box).

found within the as-built specimens (see Figure 3). These characteristics, coupled with the presence of unmelted powder particles, helped identify them as lack of fusion defects [2122]. The formation of the lack of fusion porosity at these low VEDs was not caused by inadequate bonding between layers, as the melt pool depths were much larger than the chosen layer thickness (see Figure 14). Instead, the lack of fusion porosity formed due to inadequate overlap between deposited melt tracks. This insufficient overlap could be observed within the top surface of the specimens, as lower VED specimens had a more irregular surface that contained numerous cavities between deposited melt tracks (see Figure 4a). These issues of surface irregularity and cavities went away once higher VEDs

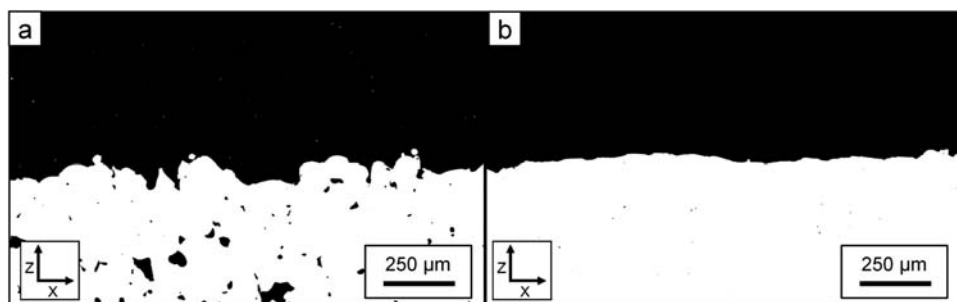
Figure 4. (a) Top surface of an AISI 4140LC specimen produced at 60 J mm^{-3} using a 170 W laser power. Here, the top surface is highly irregular, with many cavities and pores between deposited melt tracks. (b) Top surface in an AISI 4140LC specimen produced at 120 J mm^{-3} using a 170 W laser power. Here, the top surface is less irregular and is free of any large cavities or pores between deposited melt tracks.

were used that allowed for adequate overlap between melt tracks (see Figure 4b).

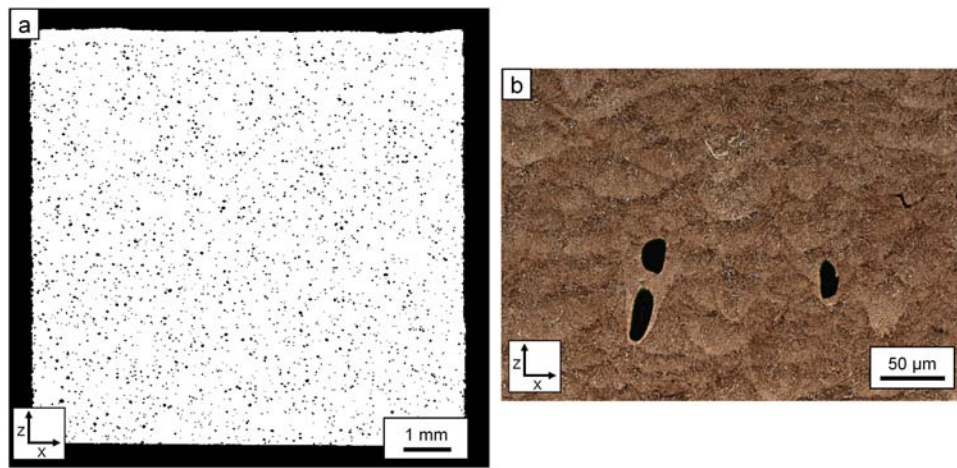
Figure 5. (a) Keyhole porosity in an AISI 4340 steel specimen produced at 185 J mm^{-3} using a 110 W laser power. (b) Example of keyhole pores at the bottom of melt pools in an AISI 4340 specimen produced at 140 J mm^{-3} using a 110 W laser power.

At high VED (Region III), oval-shaped pores (up to $150 \mu\text{m}$ in size) could be found within the as-built specimens (see Figure 5). These pores formed at the bottom of the melt pool boundaries (see Figure 5) and could be identified as keyhole porosity [23–25].

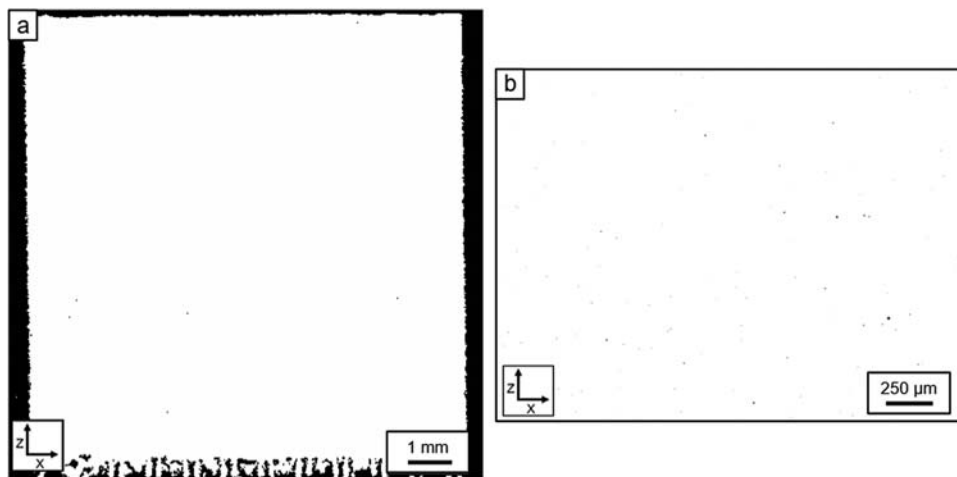
Figure 6. (a) High-density ($>99.8\%$) AISI 8620 specimen produced at 110 J mm^{-3} using a 110 W laser power. (b) Higher magnification of specimen from (a) showing the presence of minimal porosity.

At regions of intermediate VED (Region II), high-density ($>99.8\%$) specimens with minimal porosity could be produced (see Figure 6).

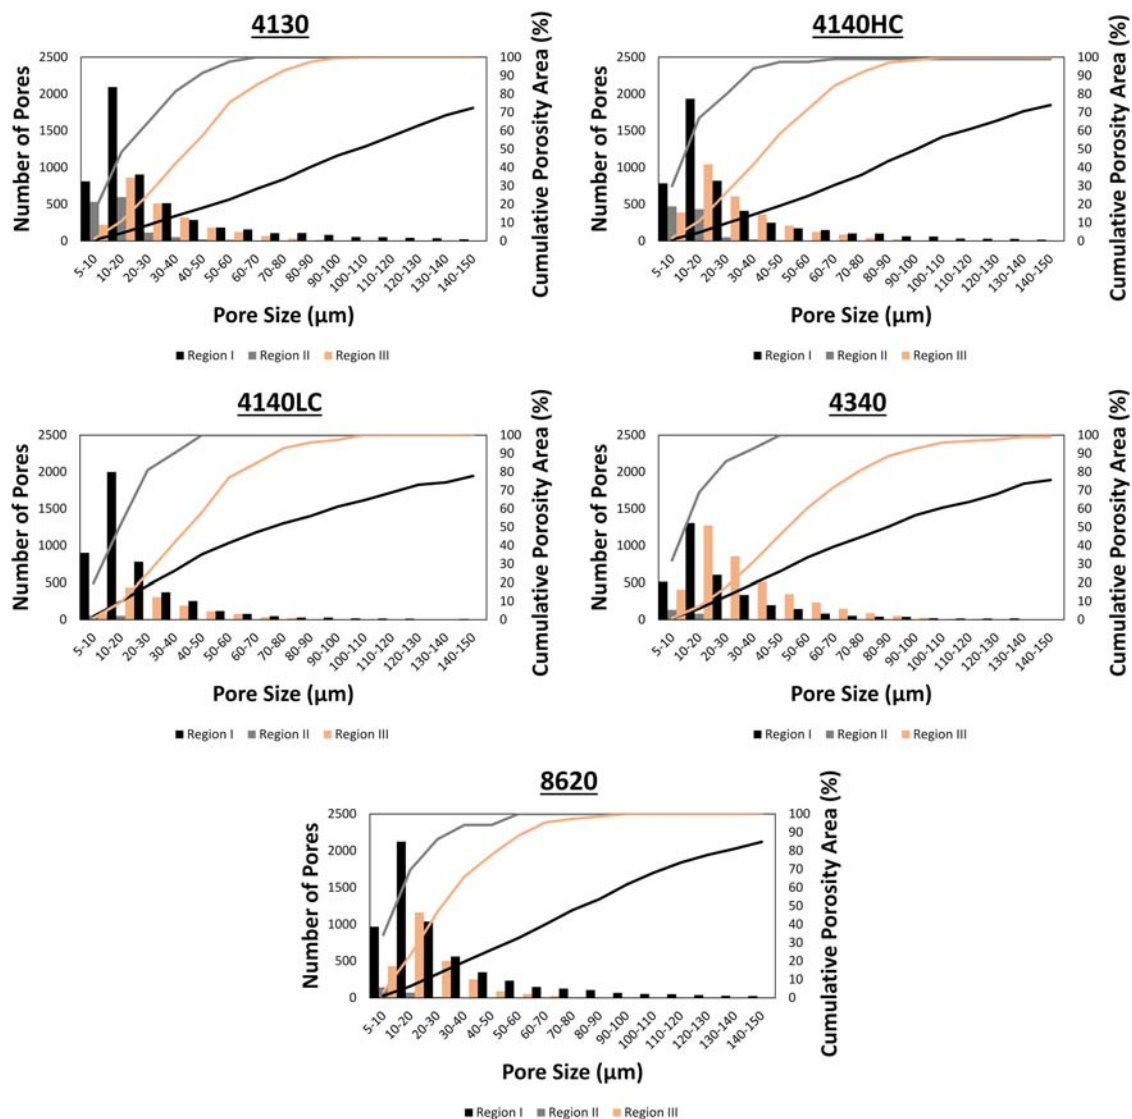
Figure 7. Histogram and cumulative porosity area for low-alloy steel specimens from each process region.

Quantitative image analysis of this porosity was conducted to define the size, shape and distribution of pores from each process region. The results of this evaluation (see Table 4 and Figure 7) indicated that a majority of the cumulative porosity area in Region I specimens consisted of larger pores

(>50 μm). Additionally, porosity in Region I was the most irregularly shaped, as evidenced by the large aspect ratio and low roundness. These characteristics indicate the presence of the lack of fusion porosity.

Region II specimens were characterised by high specimen densities ($>99.8\%$) and contained a relatively low number of pores that were small (<20 μm) and circular in shape. The cumulative porosity area of pores found in Region III related

primarily to medium-sized pores (20–100 μm) that maintained similar shape characteristics to the porosity found in Region II specimens. A comparison of the pore size distribution (see Figure 7) helped to better distinguish the porosity found in Region III from the porosity found in Region II. First, Region III specimens contained pores sized 20–100 μm, which were not present in Region II specimens. This size range is the characteristic of keyhole porosity (see Figure 5). Second, Region III specimens also had an increase in small pores (<20 μm), which helped to distinguish the transition from Region II to Region III as marking the beginning of keyhole porosity as well as an increase in small, circular pores.

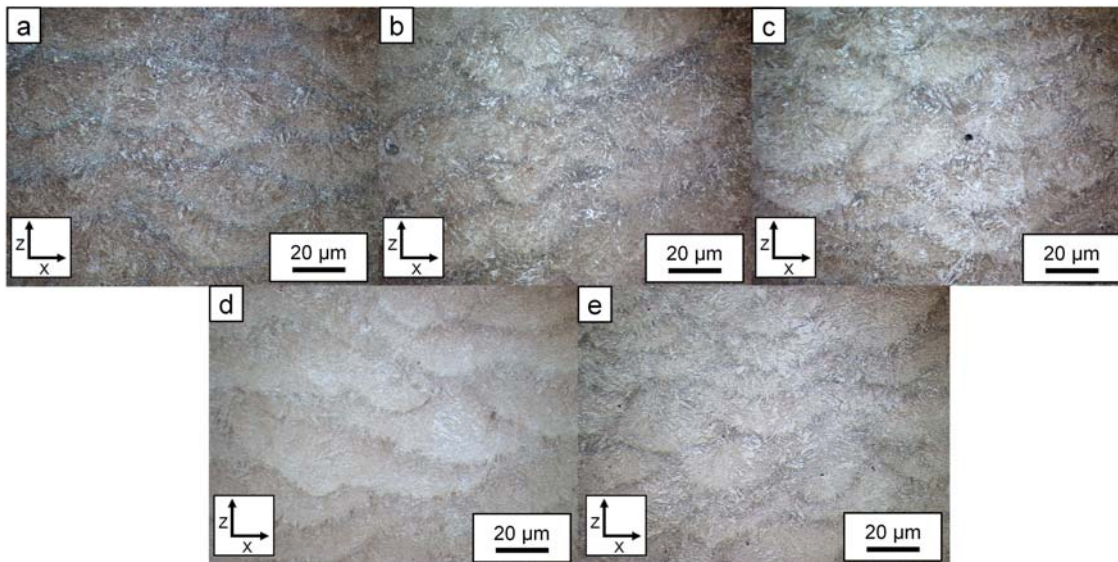
Figure 8. As-built microstructure for (a) AISI 4140LC alloy specimen produced at 110 J mm^{-3} using a 140 W laser power, (b) AISI 4130 alloy specimen produced at 110 J mm^{-3} using a 170 W laser power, (c) AISI 4140HC alloy specimen produced at 100 J mm^{-3} using a 110 W laser power, (d) AISI 4340 alloy specimen produced at 110 J mm^{-3} using a 170 W laser power and (e) AISI 8620 alloy specimen produced at 100 J mm^{-3} using a 110 W laser power.

Figure 8 shows the as-built microstructure of each low-alloy steel. For all alloys, a martensitic microstructure was observed. In addition, these microstructures displayed numerous overlapping boundaries that

related to the heat-affected regions of deposited melt tracks. These boundaries could be distinguished because they were preferentially etched in comparison to the rest of the material.

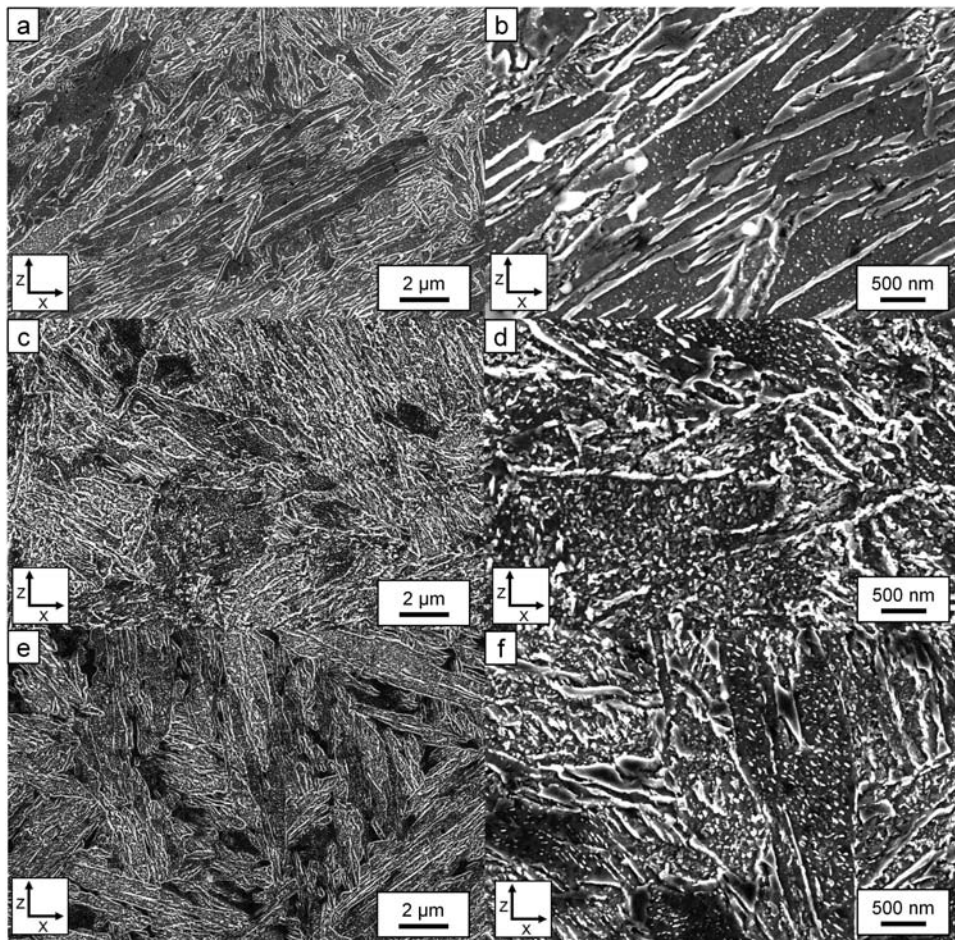
Figure 9. SEM images of tempered lath martensite in (a,b) an AISI 4130 alloy specimen produced at 80 J mm^{-3} using a 110 W laser power, (c,d) an AISI 4140HC alloy specimen produced at 200 J mm^{-3} using a 140 W laser power and (e,f) an AISI 4340 alloy specimen produced at 140 J mm^{-3} using a 170 W laser power.

SEM analysis (see Figure 9) was used to study the as-built specimen microstructure at a higher resolution. Said analysis revealed a fine lath structure of martensite that had an abundance of nanoscale precipitates, that are likely small cementite or transitional carbides that can form during the short-time tempering of a martensitic structure [26–29]. Hardness measurements (see Figure 10) provided additional evidence of tempering, as the as-built specimens had a hardness that was similar to specimens that had been quenched and tempered after processing.

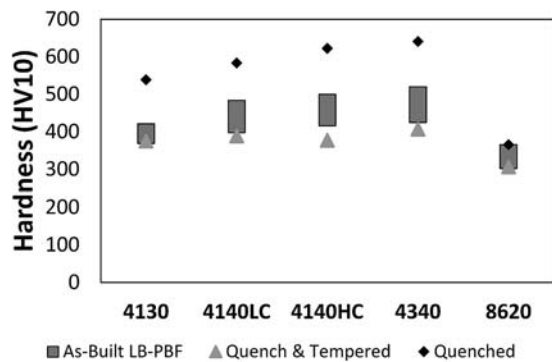
Figure 10. Bulk hardness (HV10) for each low-alloy steel in the as-built, quenched, and quenched and tempered conditions.

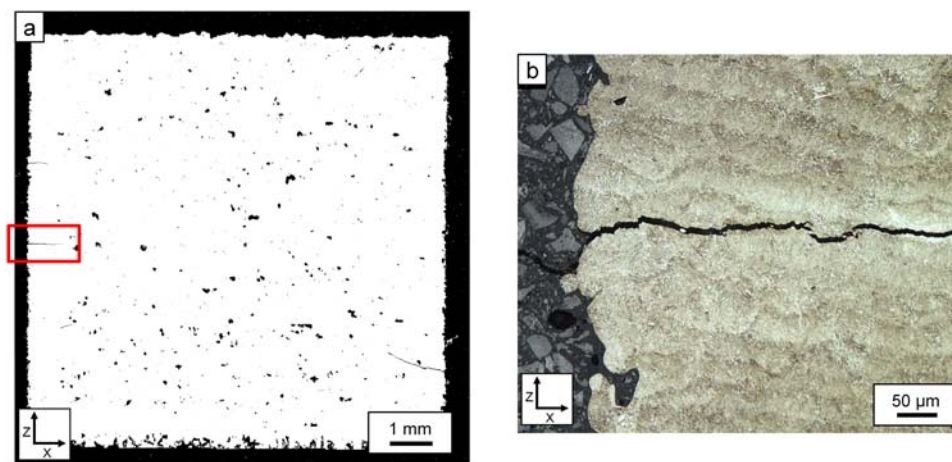
Figure 11. (a) Cracking defects in an unetched AISI 4340 specimen produced at 80 J mm^{-3} using a 140 W laser power. (b) Etched, higher magnification image of a crack from (a).

cracking mainly originated at the specimen surface and grew towards the centre (see Figure 11). Micro-hardness measurements across the crack interface (see Table 5) showed that the hardness in both regions was similar, indicating a comparable microstructure and suggesting that solidification had occurred before

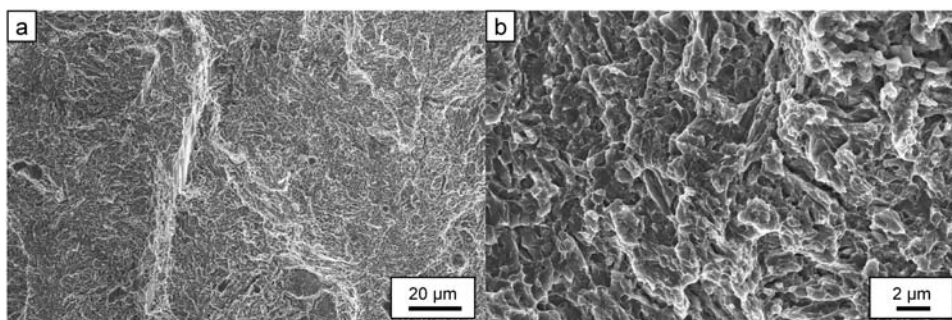
Figure 12. Fracture surface of AISI 4340 specimens produced at 80 J mm^{-3} using a 170 W laser power, showing transgranular decohesion facets.

crack formation. These findings helped to distinguish these cracks as a post-solidification cold cracking phenomenon. SEM evaluation of fractography specimens (see Figure 12) revealed that transgranular fracture was the dominant micro-failure mechanism, reinforcing the notion that these cracks were related to a cold cracking phenomenon that was a result of the brittle martensitic microstructure and internal residual stresses [78].

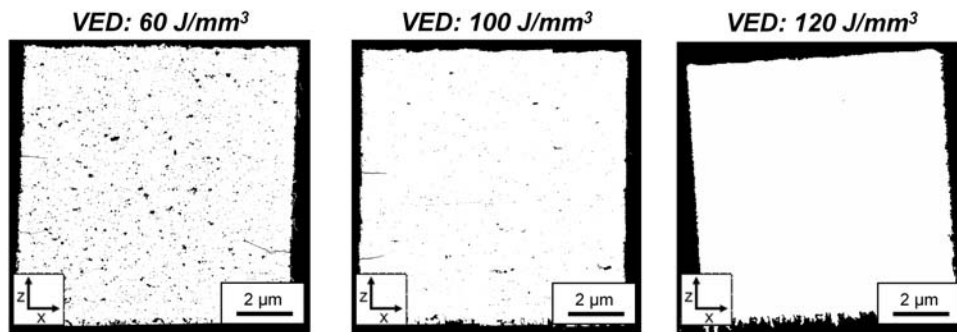
**Figure 13.** Evolution of cold cracking in the AISI 4140LC alloy as a function of VED for specimens produced with a laser power of 140 W.

The occurrence of cold cracking in the AISI 4140LC, 4140HC and 4340 alloy specimens was dependent on both the VED and the laser power (see Table 6). Increasing the VED reduced crack propensity and crack size until an upper VED threshold was reached, above which no cracking occurred (see Figure 13). While increasing the laser power would reduce the VED that was required to avoid cold cracking.

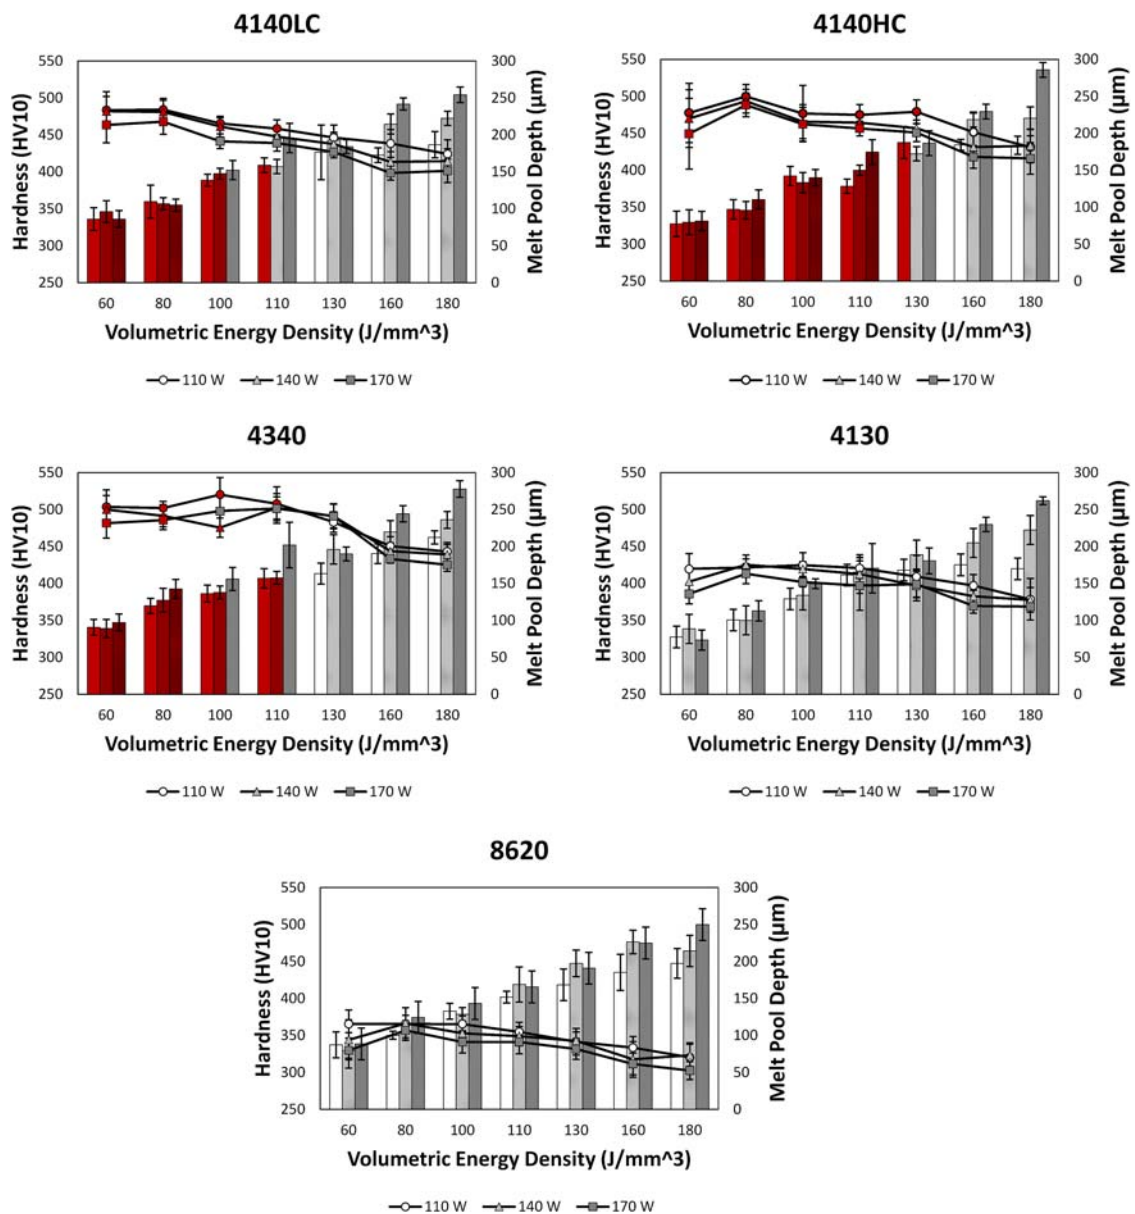
**Figure 14.** Variation in bulk hardness and melt pool depth as a function of the VED. Hardness is displayed as a scatter plot, while melt pool depth is displayed as a bar chart. The VEDs at which cold cracking occurred are indicated with fill.

and melt pool depth were plotted as a function of VED (see Figure 14). This analysis showed that increasing the VED or laser power increased the depth of the melt pool and subsequently decreased the hardness of the as-built material. During LB-PBF, an intrinsic heat treatment (IHT) occurs as new layers of material are deposited on top of previously solidified layers [3031]. The extent of this heat treatment is influenced by the distance from the deposited layer and the number of times the material is reheated. Owing to the larger melt pool depths at higher VEDs and laser powers, there is a larger volume of melted and subsequently reheated material, providing an enhanced IHT.

The hardness measurements from Figure 14 showed that cold cracking would occur at a hardness level >460HV for the AISI 4140 alloys and >500HV for the AISI 4340 alloy. This indicates that if a large enough VED or laser power is used, the IHT during LB-PBF can adequately temper the material so it can avoid cold cracking defects. This hardness threshold could also explain why the AISI 4130 and 8620 alloys did not display any cold cracking, as the highest hardness for said alloys (~425HV) was below the aforementioned thresholds.
